## Incident Summary (5620634)

SUPPORTING INFORMATION	Incident Date		August 26, 2017		
	Location		Surrey		
	Regulated industry sector		Natural Gas		
	Impact	Injury	Qty injuries	0	
			Injury description	N/A	
			Injury rating	None	
		Damage	Damage description	Several ¾” black iron pipes fell from their horizontal mounting points, shearing a gas line causing an uncontrolled release of gas	
			Damage rating	Moderate	
Incident rating		Moderate			
Incident overview		Black iron gas piping installed horizontally on the side of a commercial building broke free from its supports and fell to the ground, creating an uncontrolled release of gas into the atmosphere.			
INVESTIGATION CONCLUSIONS	Site, system and components		<p>Natural Gas is distributed by the utilities through a series of underground gas lines to a bank of gas meters mounted on the side of the commercial building wall. The gas then passes through the Fortis supplied regulator and meter set.</p> <p>Natural gas is then fed to appliances through a piping grid typically constructed of threaded black iron piping and fittings.</p> <p>The piping or tubing routed on the side of the building must be properly supported and secured to the

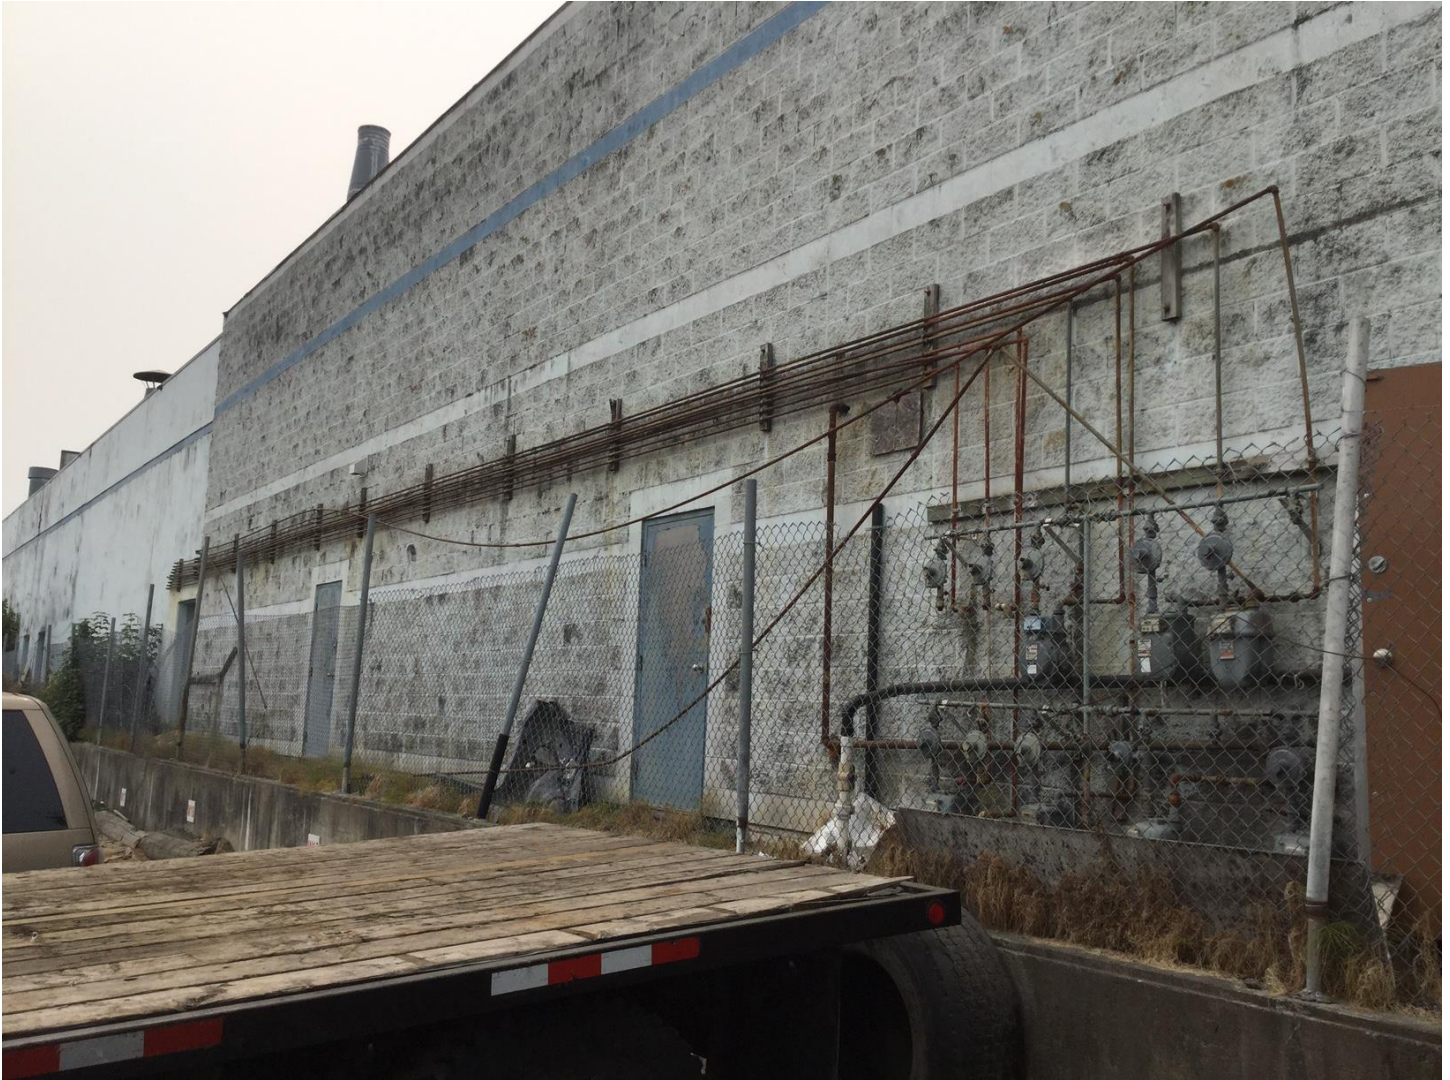
Failure scenario(s)		<p>Wooden 2x4’s were installed on the side of the commercial building and the black iron gas lines were mounted to these 2x4’s using metallic clamps.</p> <p>These wooden 2x4’s eventually rotted and deteriorated with age, allowing the screws to break free from the wood support and fall to the ground. The rotting wood along with the weight of the black iron pipe allowed the piping to break free and fall off the side of the building.</p> <p>The force of the piping falling from the wall at a height of 12 feet sheared the pipe at a threaded section connected to a black iron coupling.</p>		
	Facts and evidence		<p><u>Statement made by witness working nearby</u></p> <ul style="list-style-type: none"><li>Working in garage adjacent to the Commercial property.</li><li>While working in garage, “could smell strong odor of natural gas”</li><li>When he stepped outside to investigate, he could hear loud hissing sound originating from the neighboring industrial building and observed the broken pipes.</li><li>Witness grabbed wrench and ran over to bank of meters installed on side of building and shut off the 2 affected gas meters, leaving the rest active</li><li>Witness contacted owner of building who asked him to call the fire dept.</li><li>Witness contacted Fortis and the Fire department who attended shortly after</li></ul>

<p><u>Piping and Supports</u></p> <ul style="list-style-type: none"> <li>• Wooden 2x4 studs bolted to concrete wall</li> <li>• 2 hole metallic pipe clamps secured piping to wooden stud</li> <li>• Wood shows signs of severe cracking and rotting</li> <li>• At time of investigation, numerous pipe clamps absent and several damaged and being support by only 1 screw</li> <li>• 2 of the 10 gas lines installed horizontally on side of building had broken free from their supports and fallen.</li> <li>• 1 of the 2 fallen gas lines had broken, causing a release of gas</li> </ul>
	<p>Causes and contributing factors</p>	<p>It's highly probable that the use of wood as a supporting material for the black iron piping is what led to the gas lines becoming unsecure and falling from the side of the building. Wood that is exposed to the elements for long periods of time will absorb moisture and begin to rot. Penetrations such as screw holes/ nail holes are especially susceptible to rot . The fasteners become loose and can no longer support the weight of the materials that are clamped to them.</p>

Fallen gas lines along side of Commercial building
