Appendix F

Photographs

**TECHNICAL
SAFETY BC**

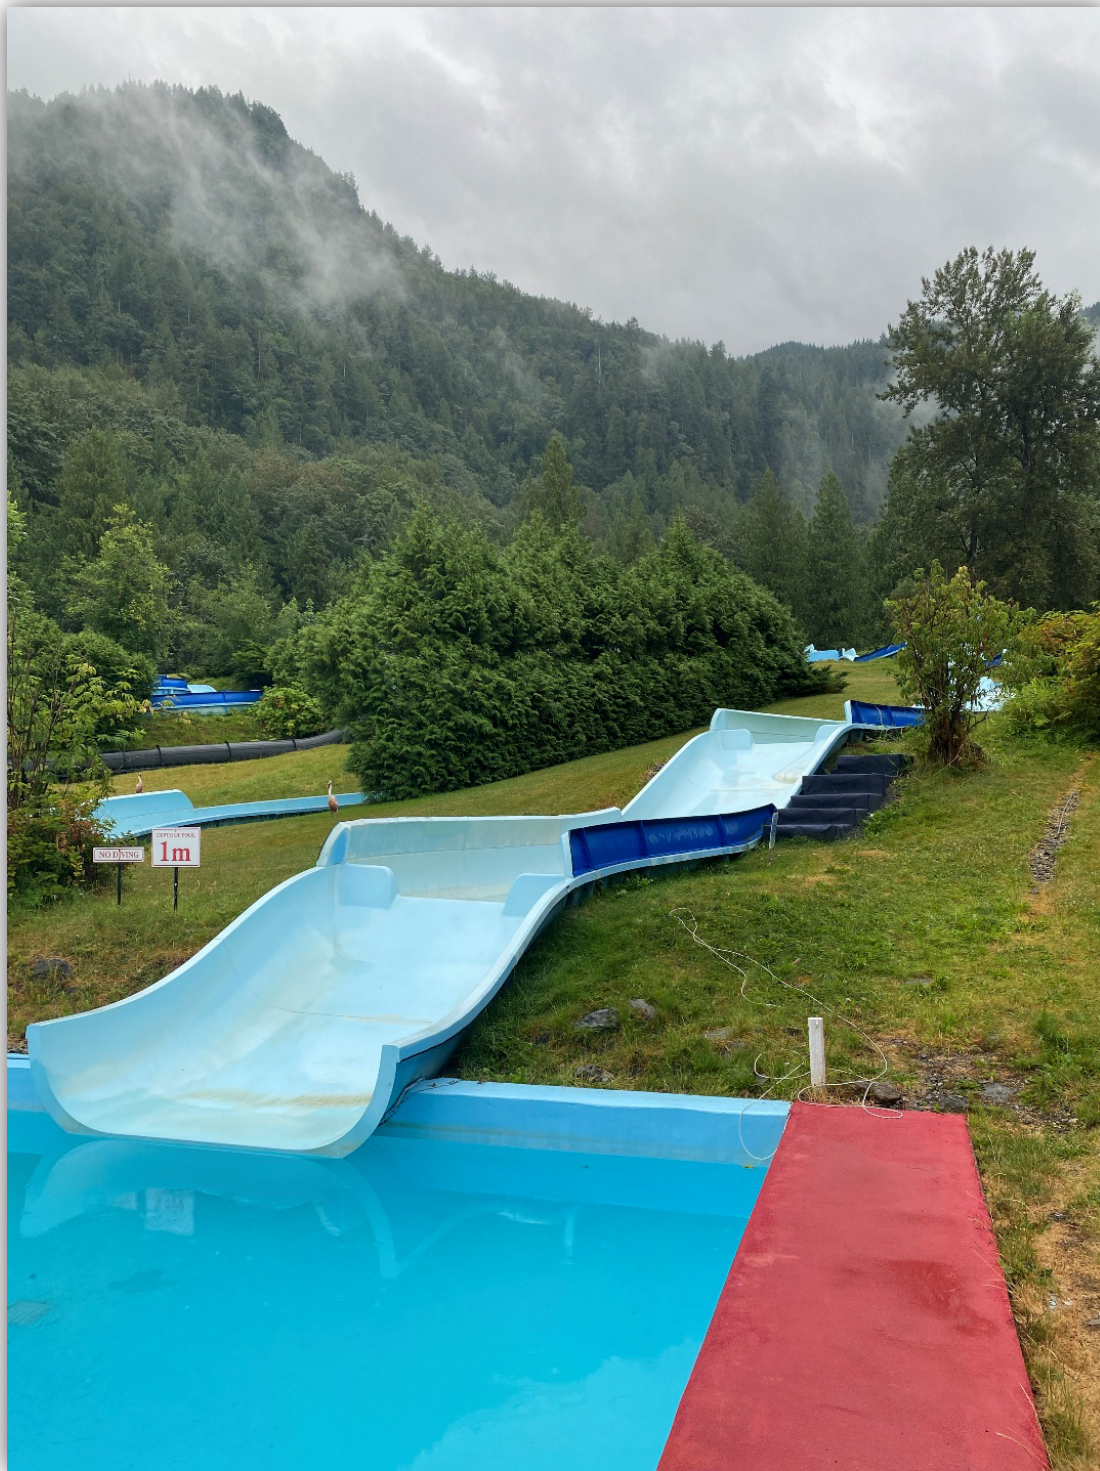
Image 1 – The tube ride (July 25, 2024).

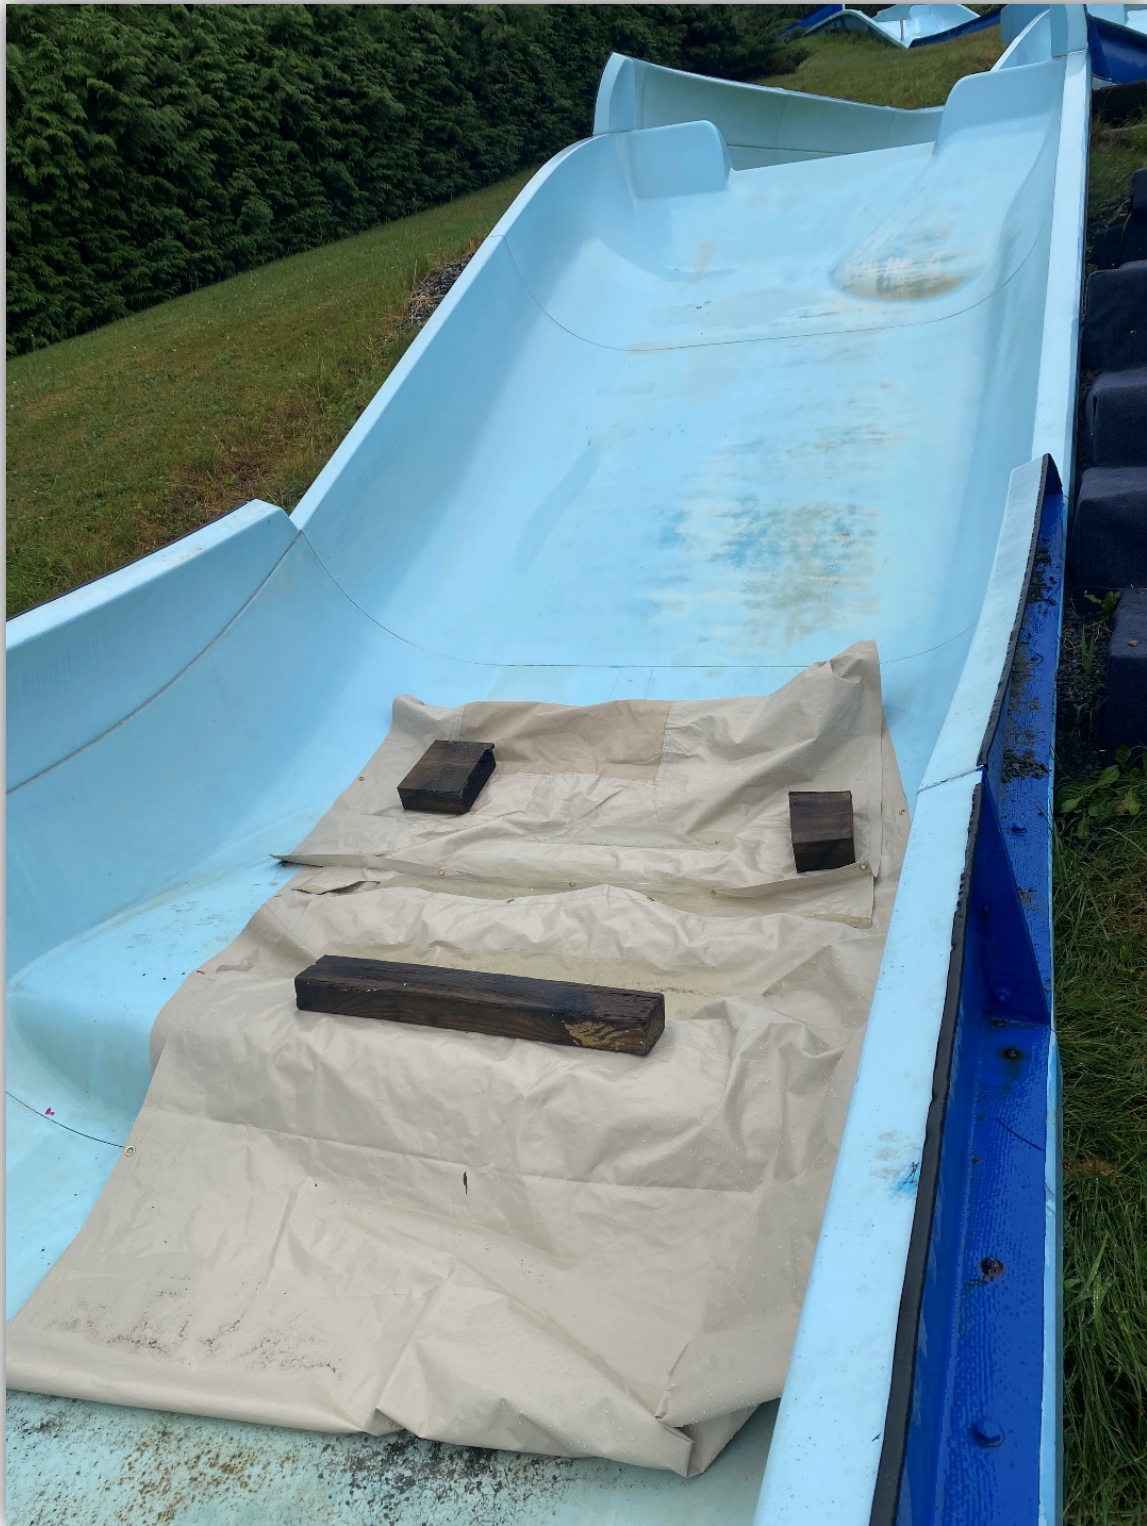
Image 2 – Area of the tube slide failure covered in a tarp at the time of inspection.

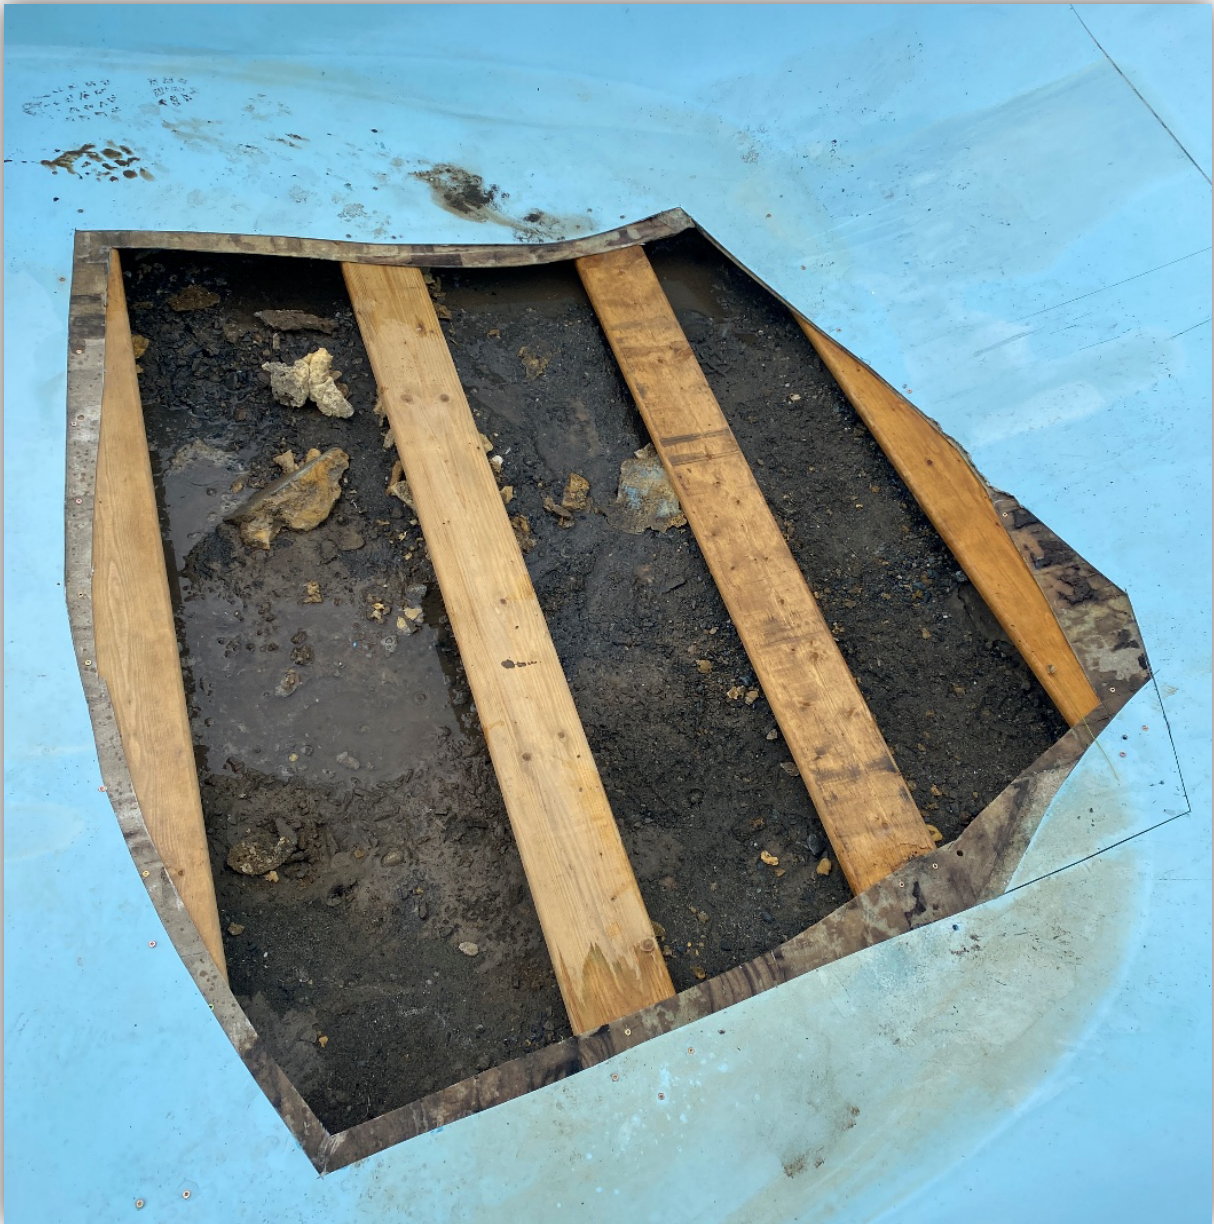
Image 3 - Failed section removed at the time of inspection. The void beneath the slide was up to 5 inches in some areas.

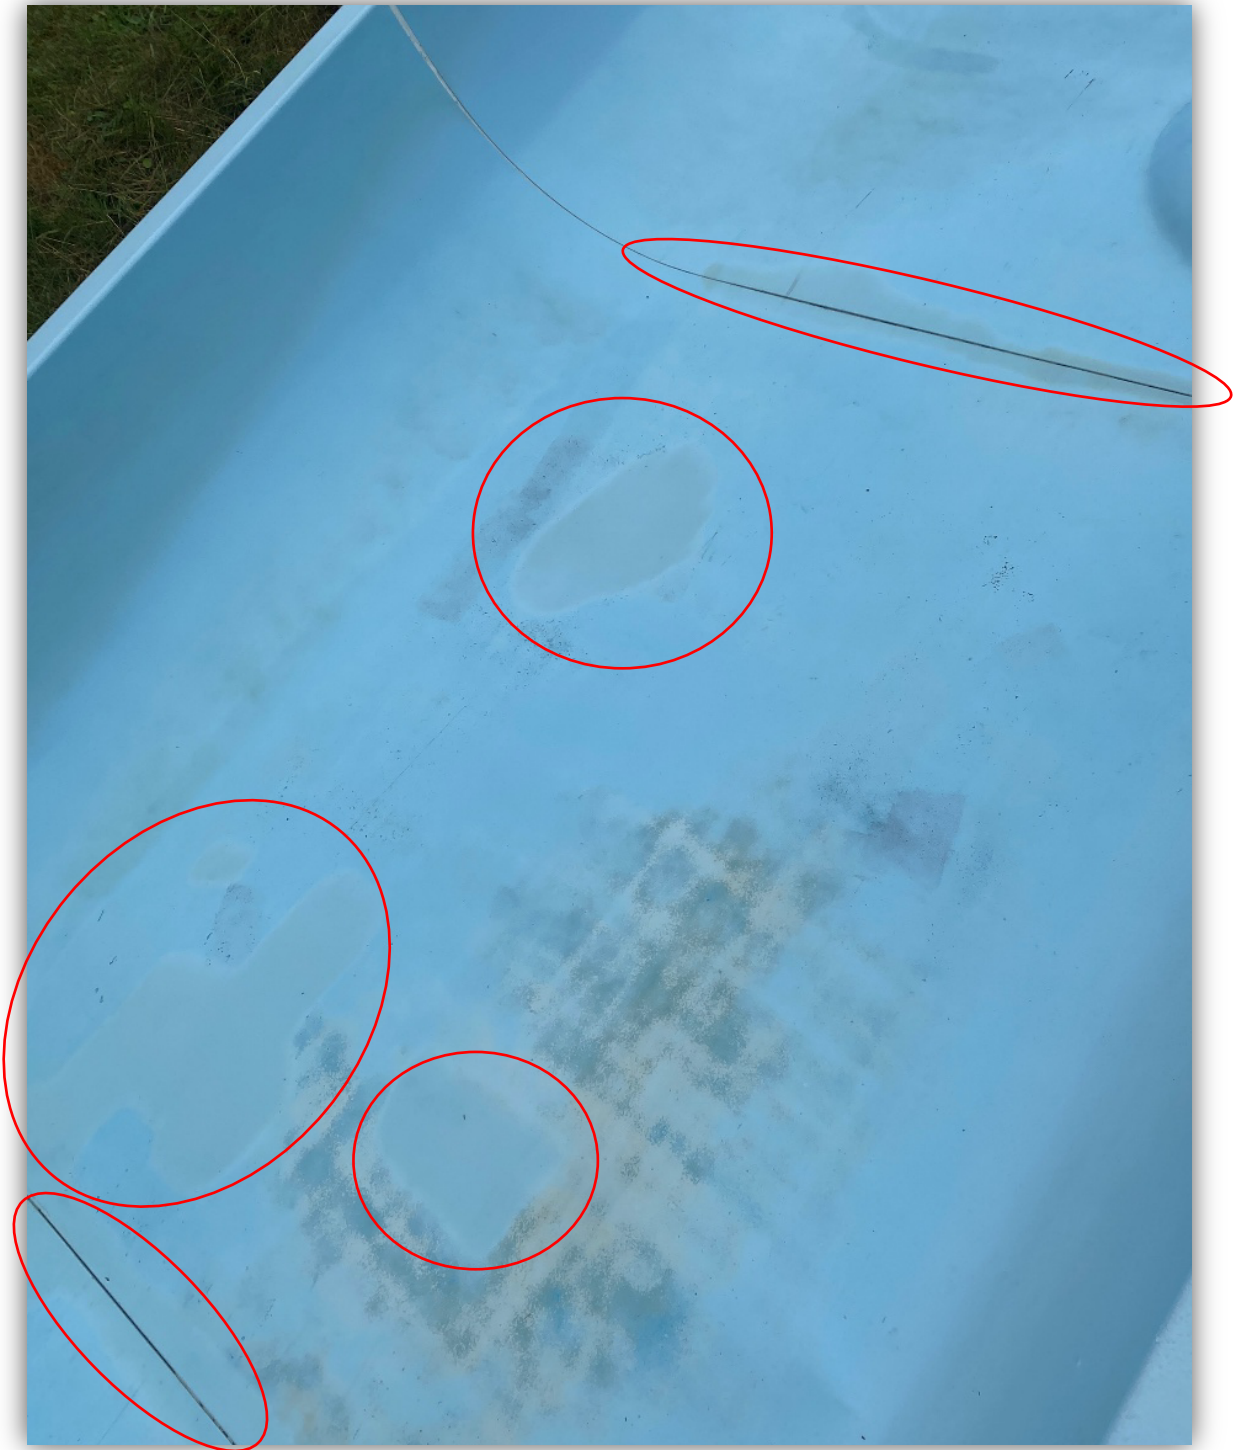
Image 4 – Patched areas of the flume near the failure.

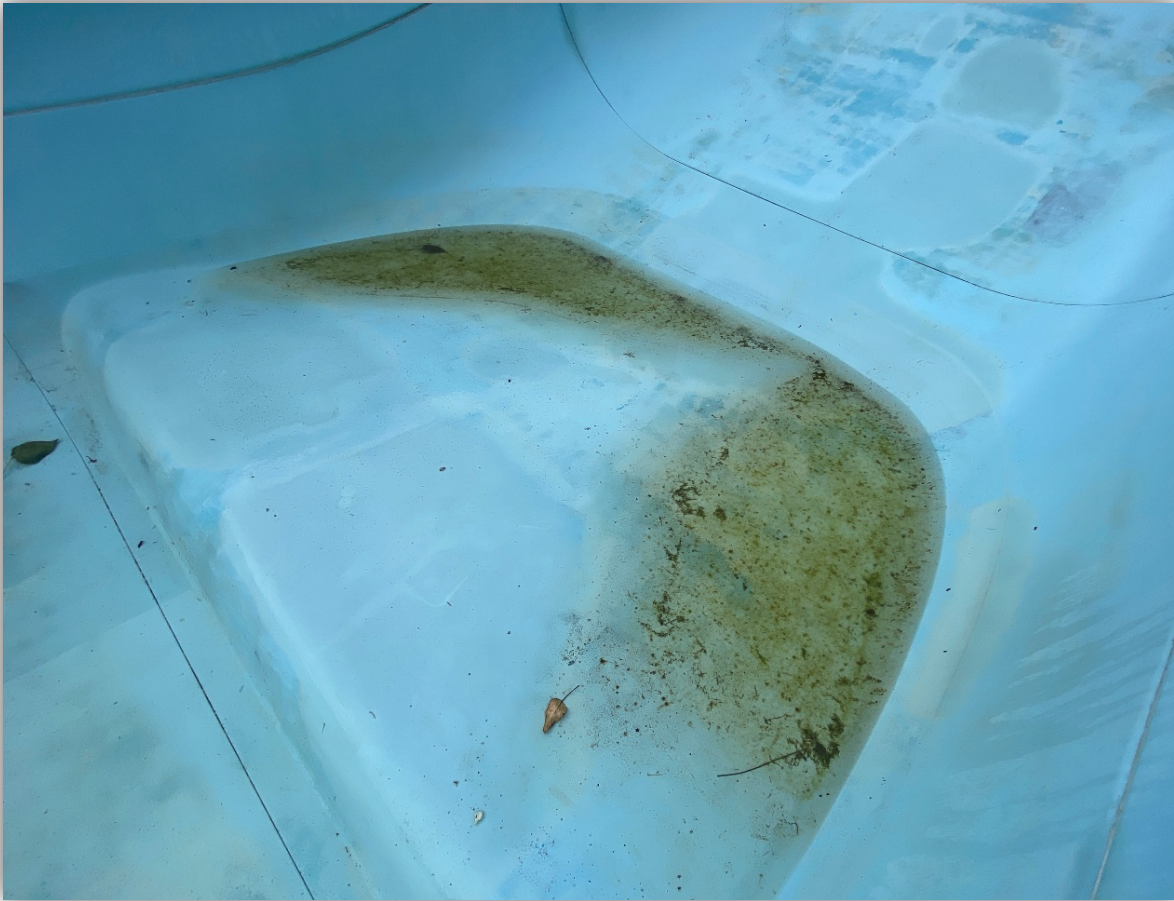
Image 5 – Bubbled section of flume as shown by the water pooling at the edges.

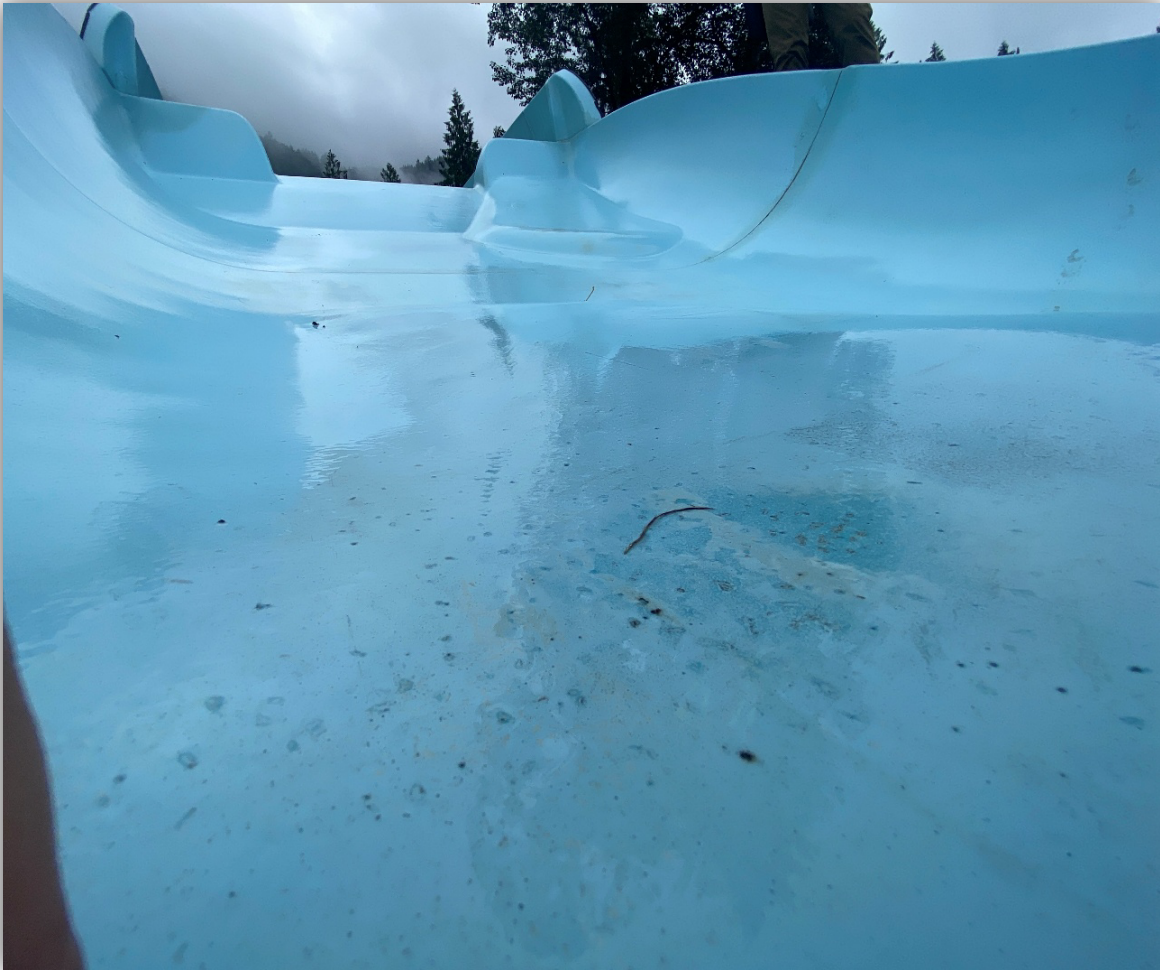
Image 6 – Side view of another bubbled section on a separate section of flume.

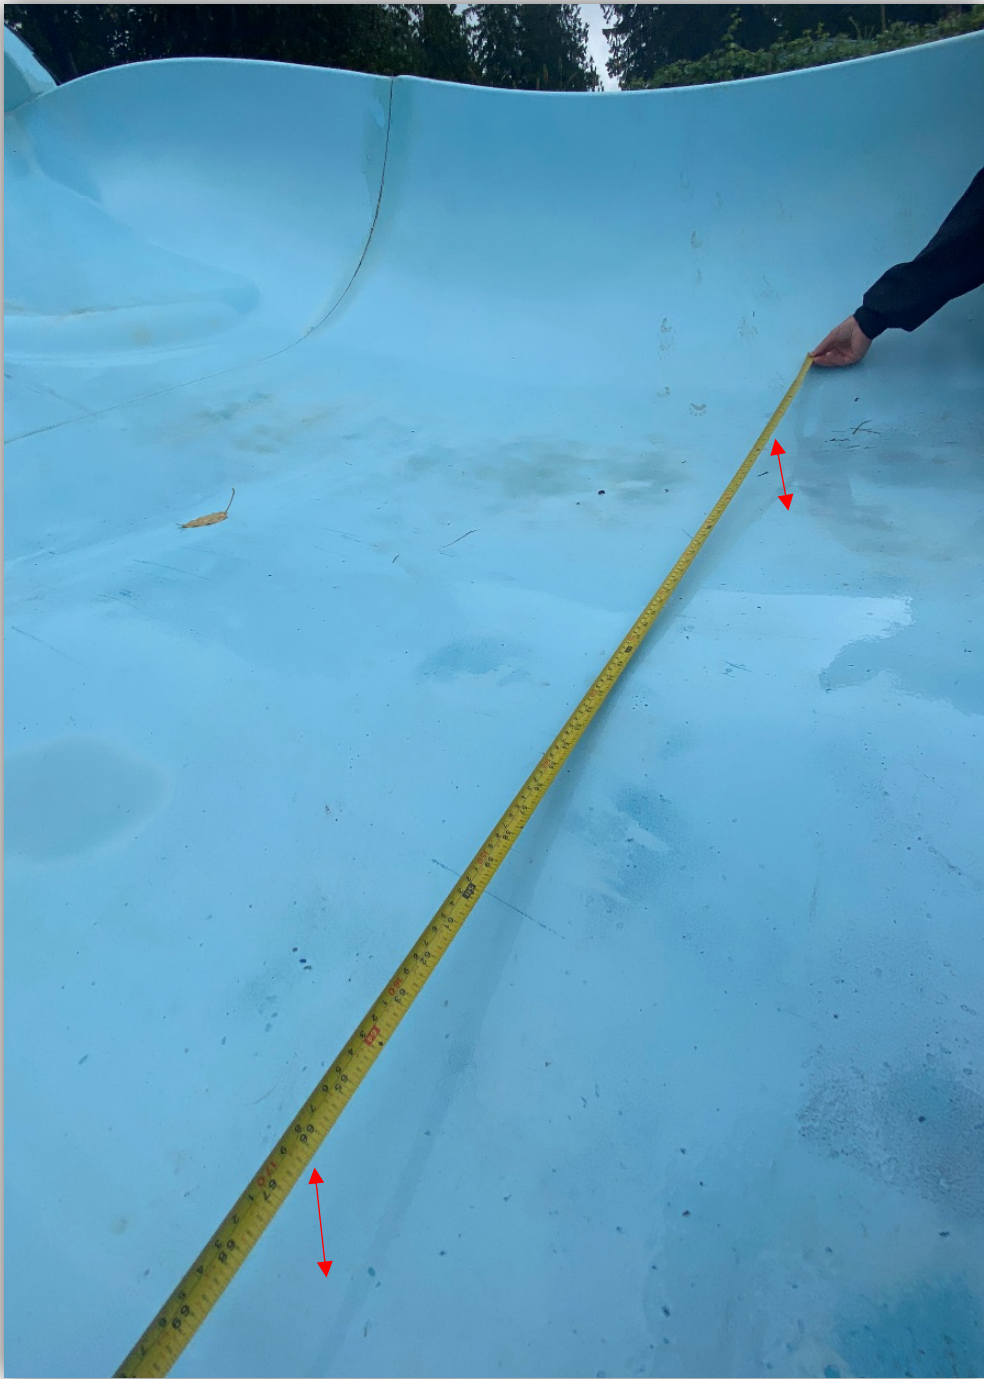
Image 7 – Measuring tape held flat to show the extent of bubbling from the area shown in Image 6.

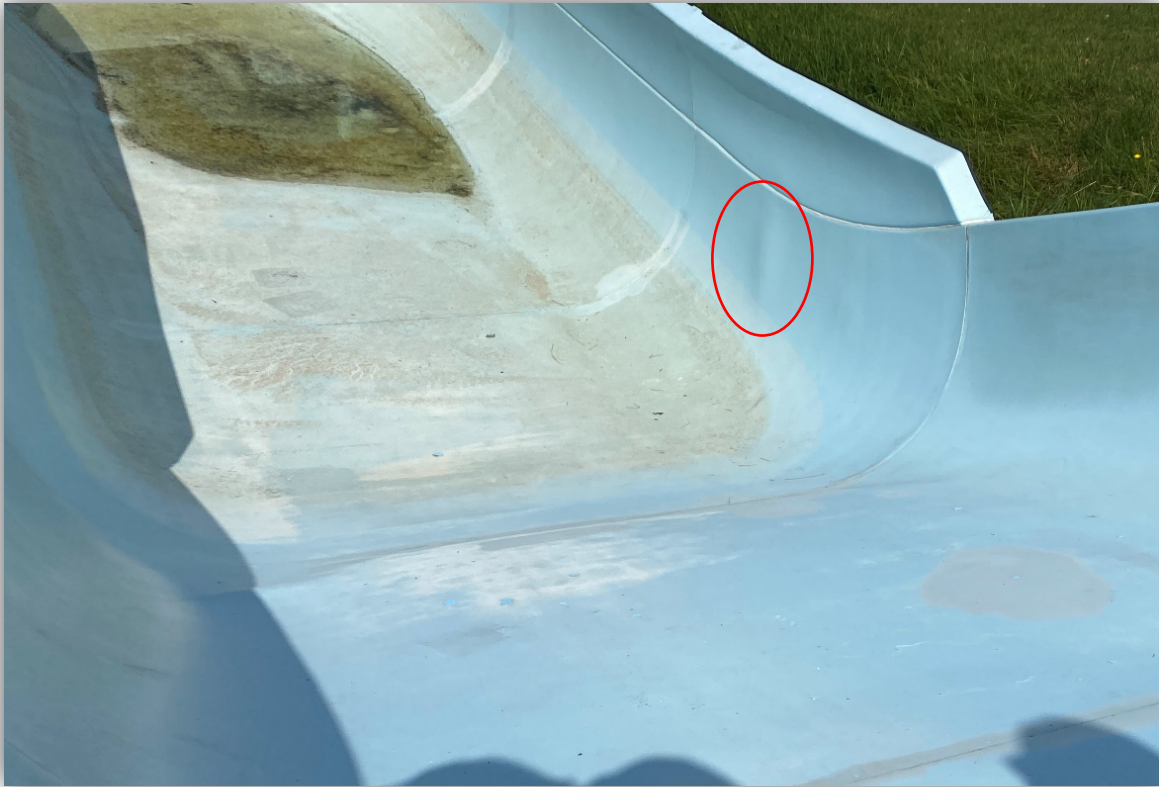
Image 8 – Ground contours pushing in and deforming the fiberglass.

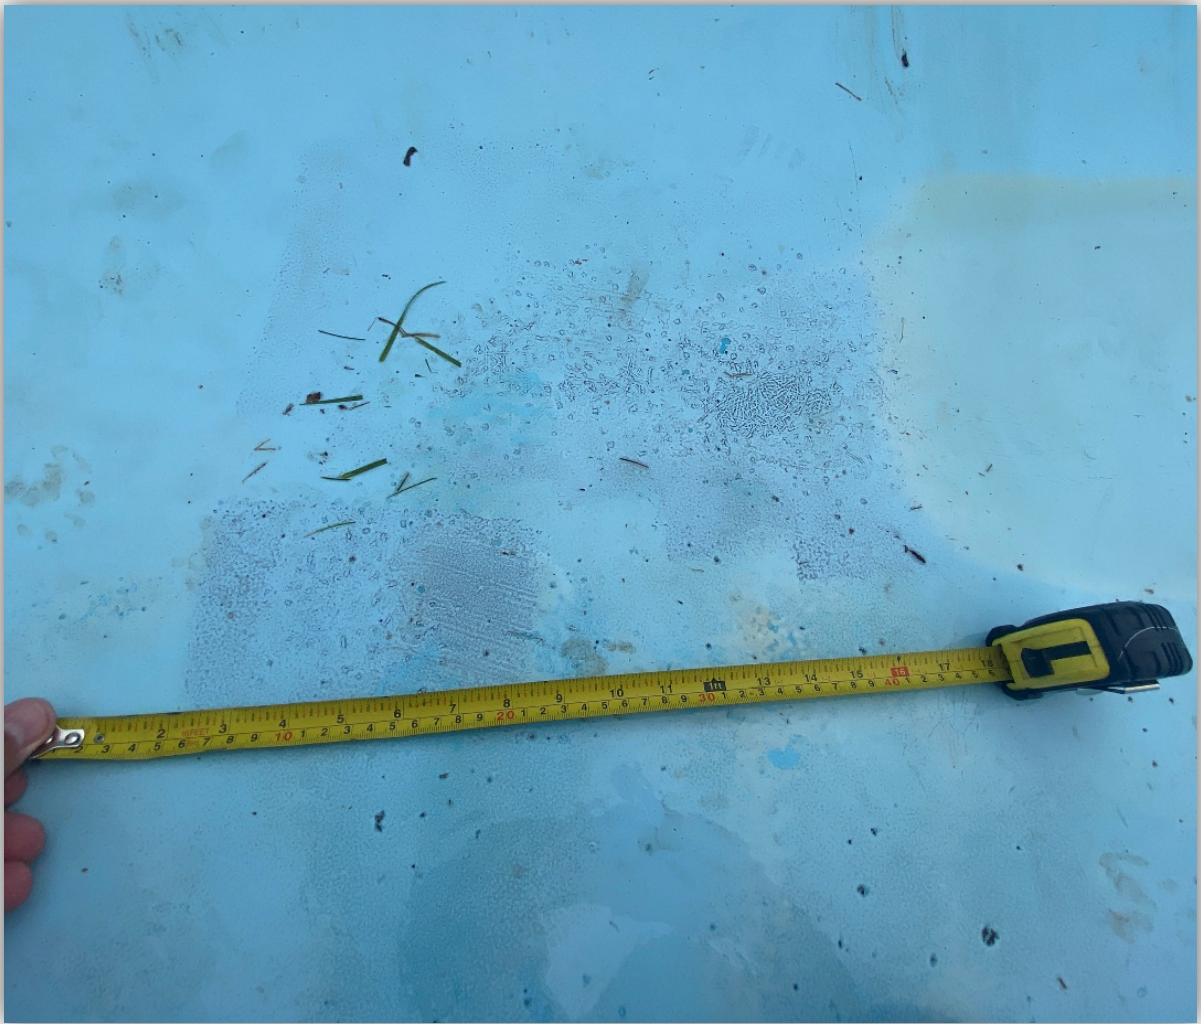
Image 9 – Exposed resin on one section of flume.

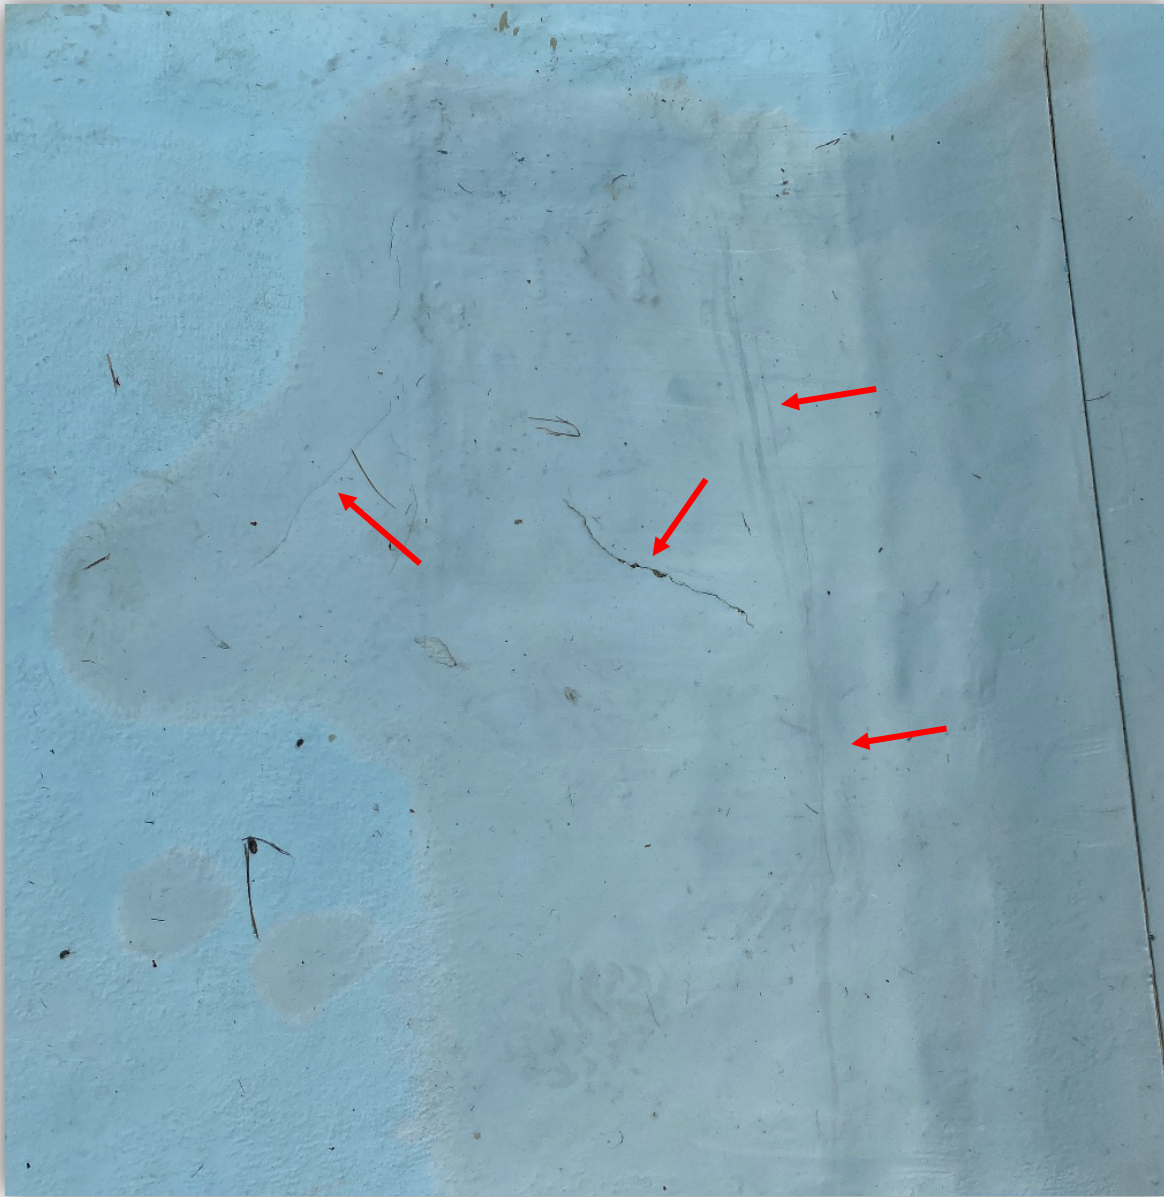
Image 10 – Patched and cracked section at the bottom of a sloped flume. Cracks highlighted with arrows.

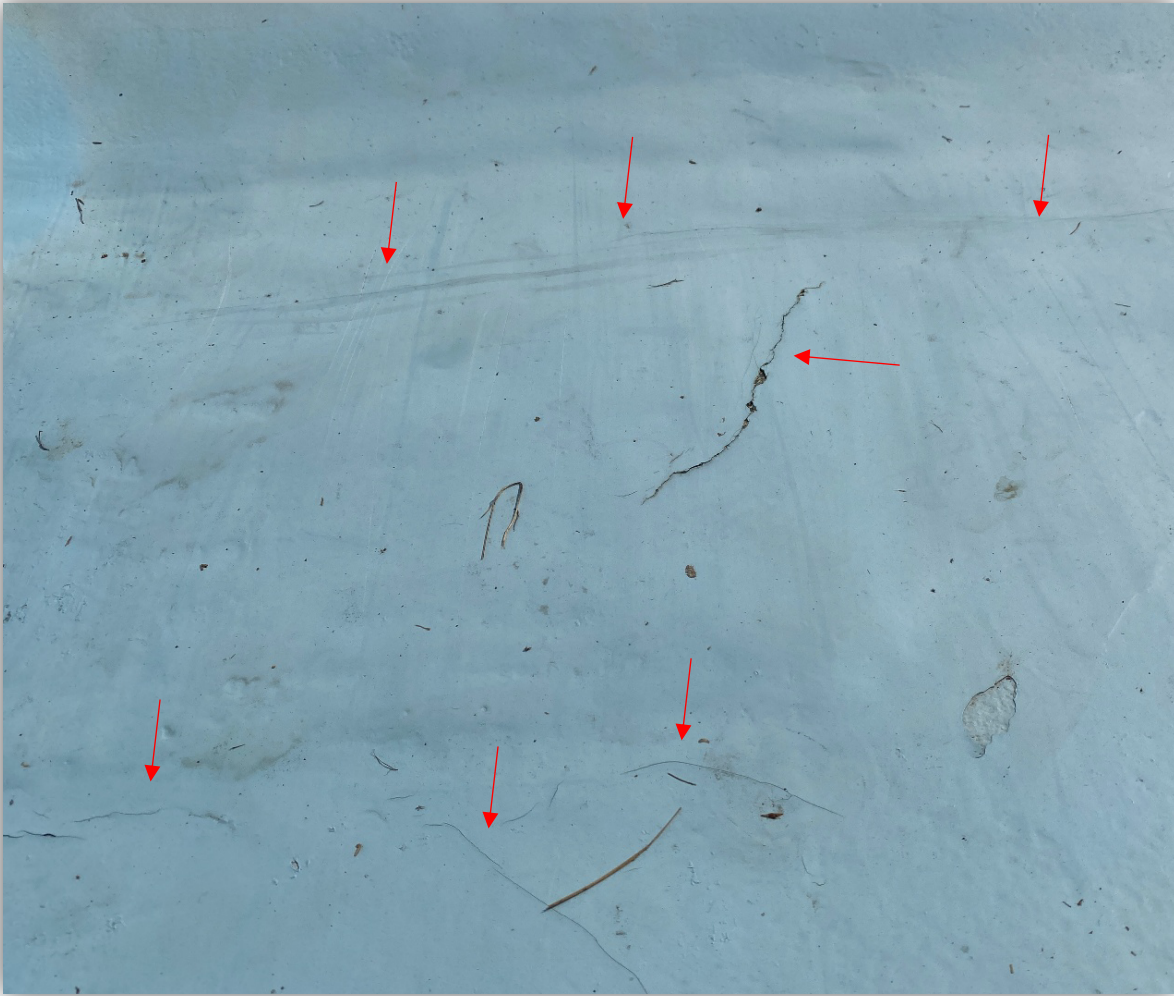
Image 11 – Close-up of the cracked flume section.

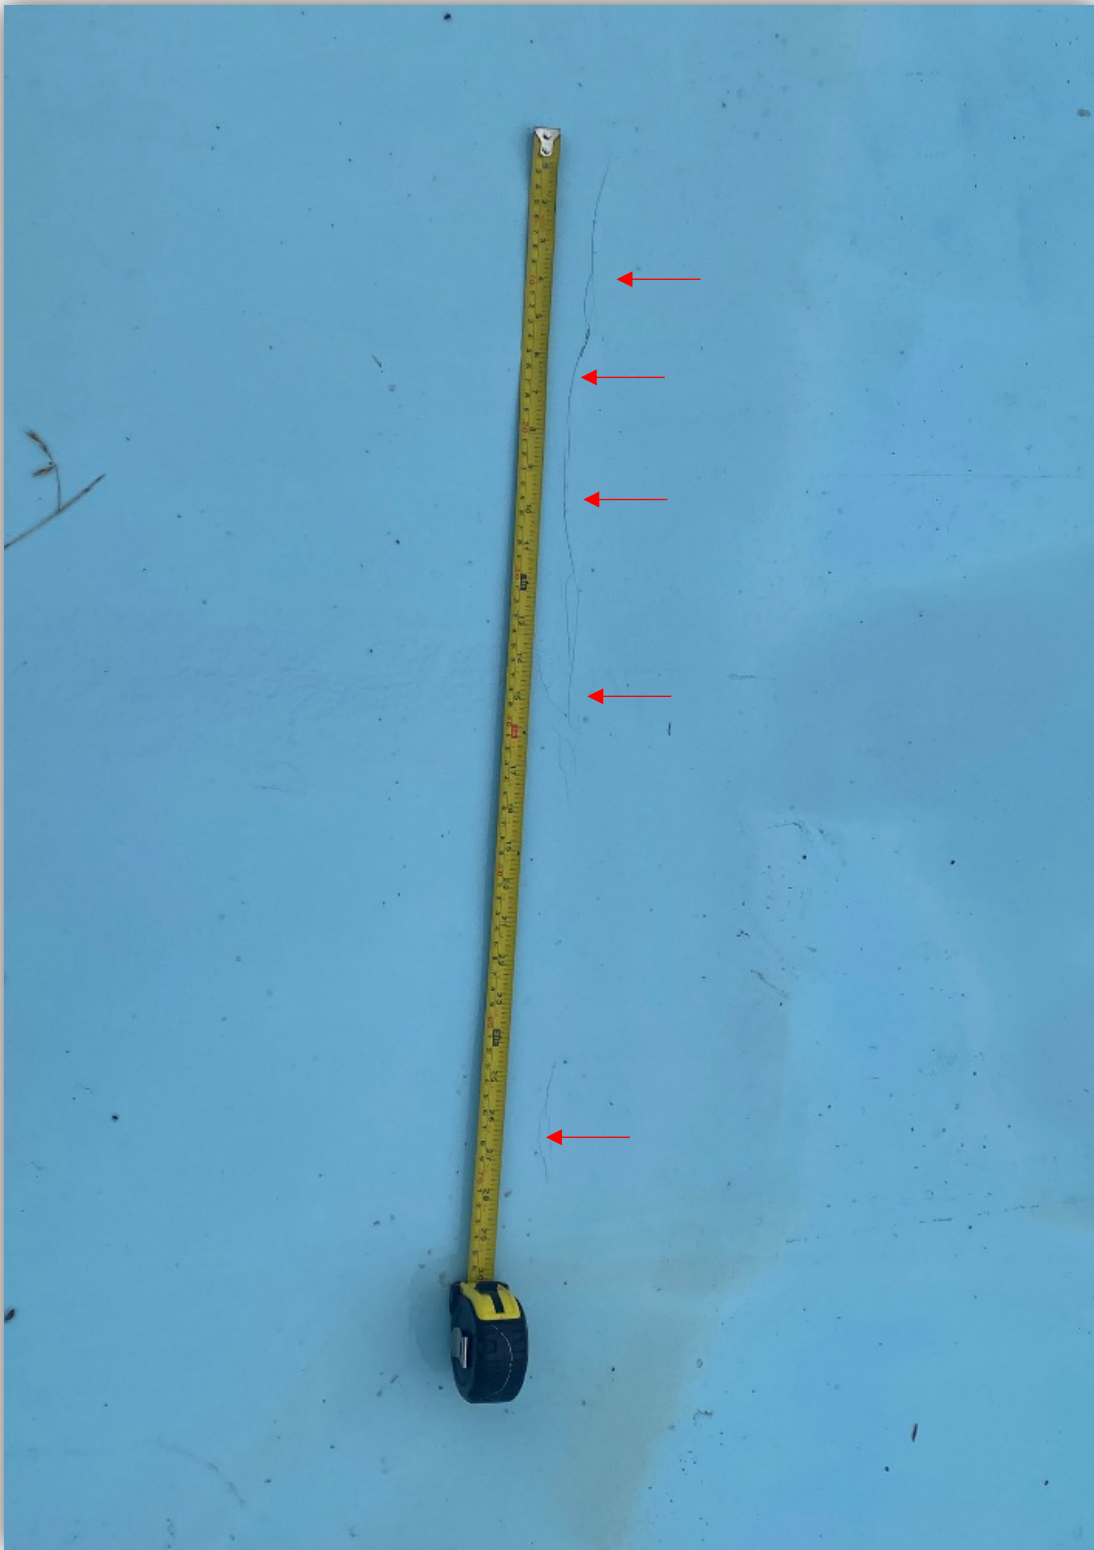
Image 12 – Another crack located at the base of a sloped flume section.

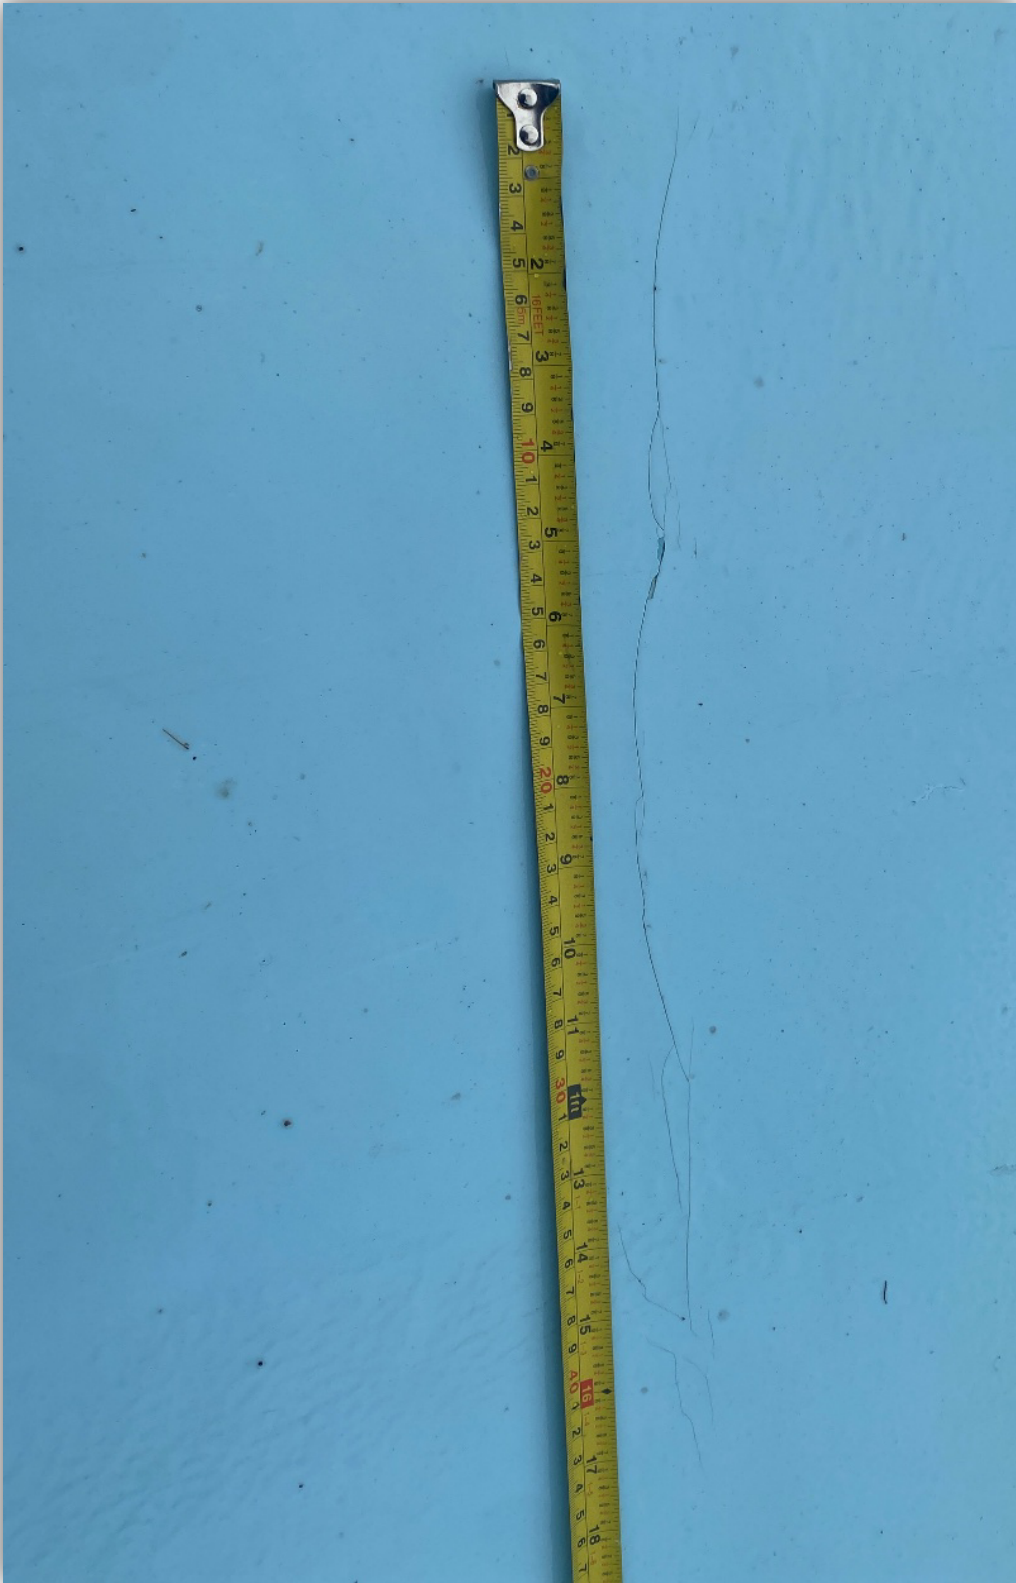
Image 13 – Close-up of the crack shown in image 12.

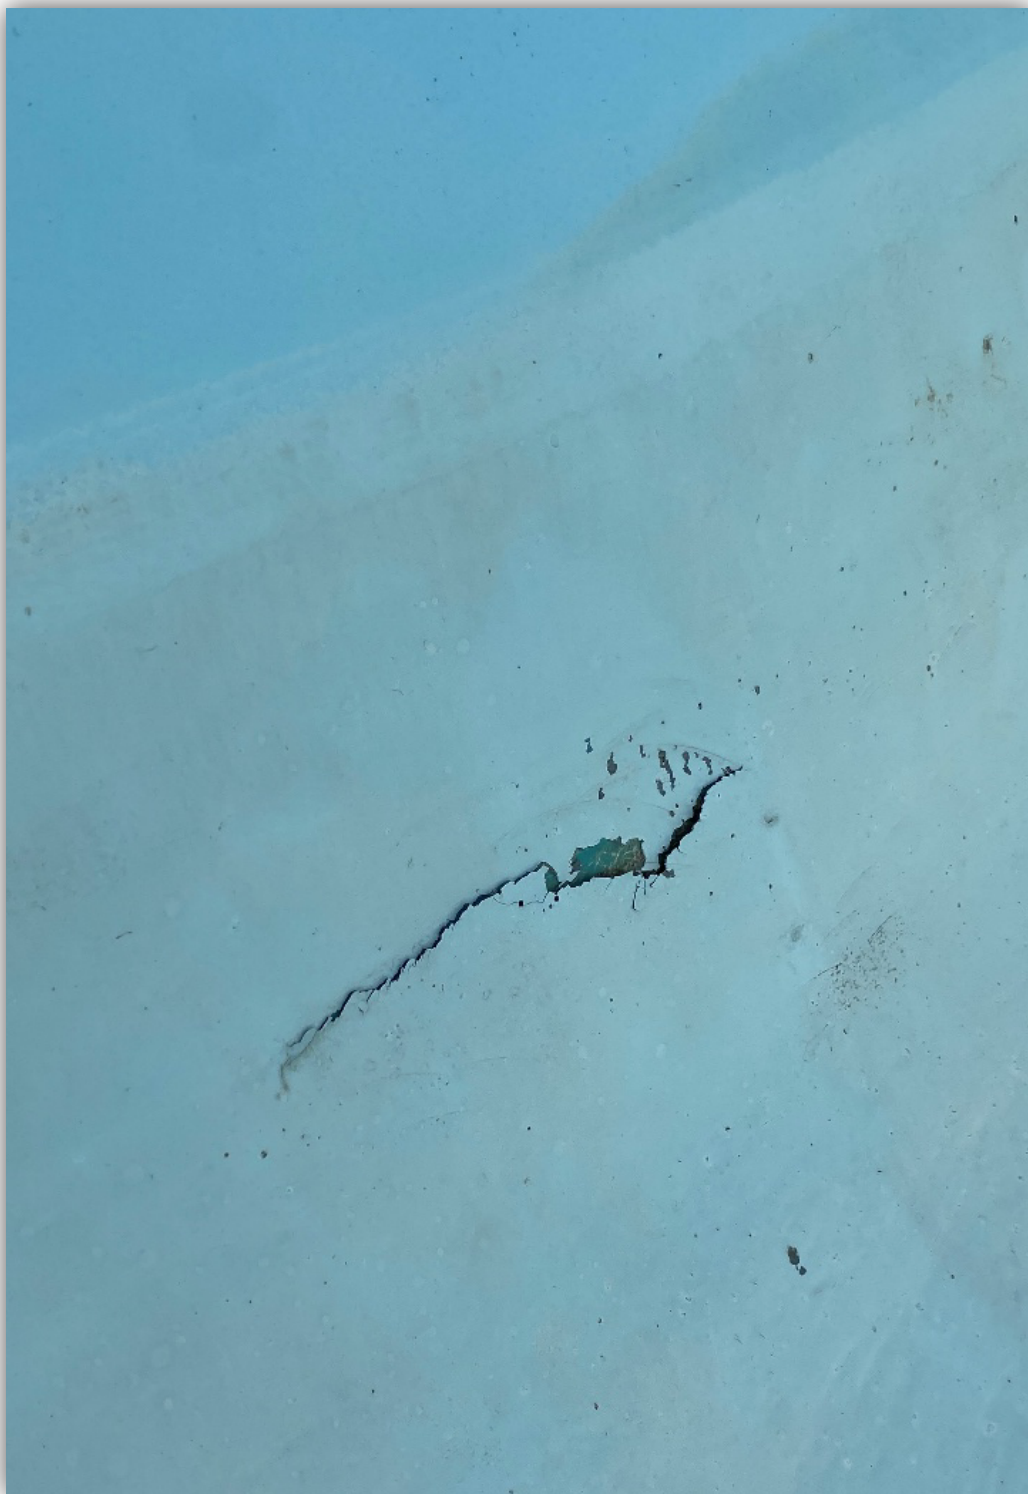
Image 14 – A crack located on the side of a fiberglass pool section.

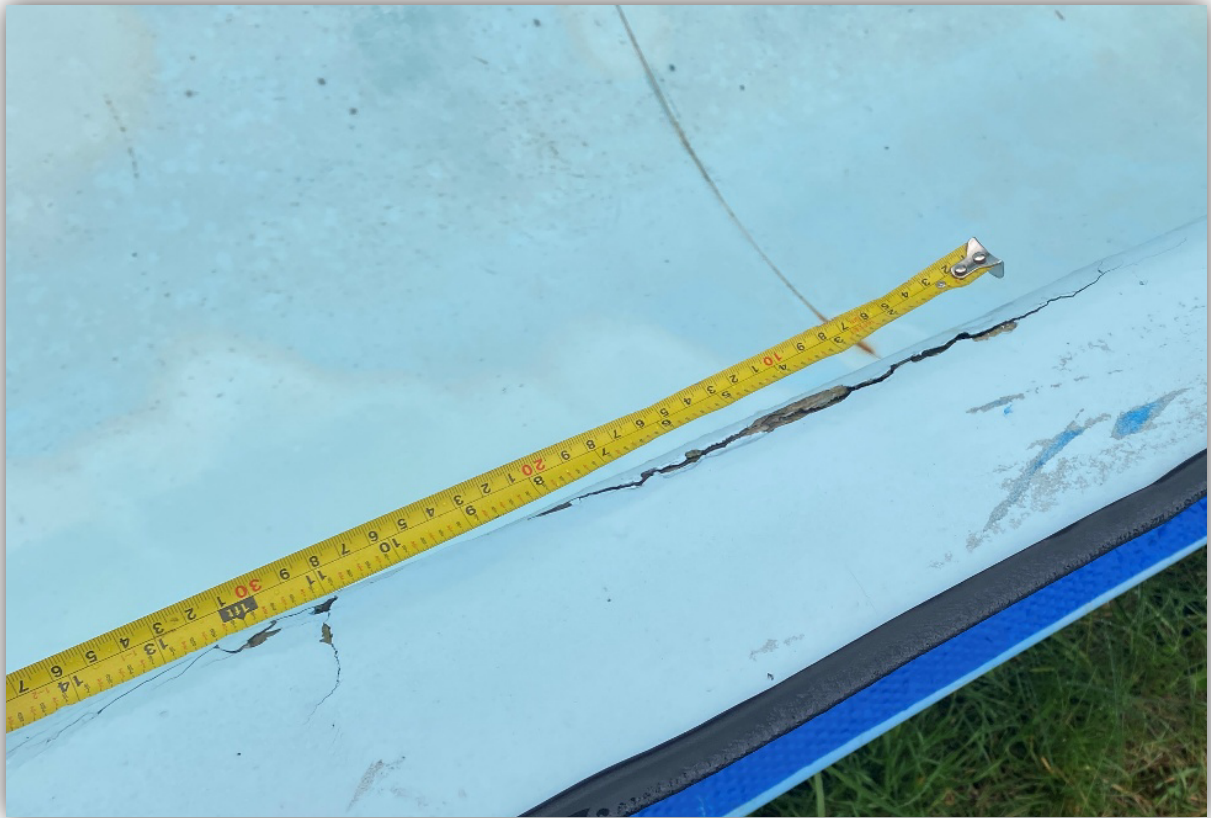
Image 15 - A cracked fiberglass pool edge.
