Incident Summary #II-966933-2020 (#16355) (FINAL)

SUPPORTING INFORMATION	Incident Date		January 14, 2020	
	Location		Nelson, BC	
	Regulated industry sector		Electrical - Low voltage electrical system (30V to 750V)	
	Impact	Injury	Qty injuries	0
			Injury description	None
			Injury rating	Minor
		Damage	Damage description	Internal components and terminated conductors of a 100A 240V 1PH fused disconnect switch were damaged. Damage resulted from the electrical fire were contained by and isolated to the disconnect enclosure.
			Damage rating	Minor
			Incident rating	
Incident overview		A high impedance arcing condition was created by a loose conductor termination. Over time, the arcing condition resulted in an elevated temperature at the termination point. The elevated temperature exceeded the temperature rating of the conductor insulation and component temperature termination ratings resulting in an electric fire incident.		
INVESTIGATION CONCLUSIONS	Site, system and components		The multi dwelling structure is serviced with a 400amp, 240volt electric supply to an array of service equipment installed in an attached electrical room. A 400amp, 240volt single phase main fused service dis

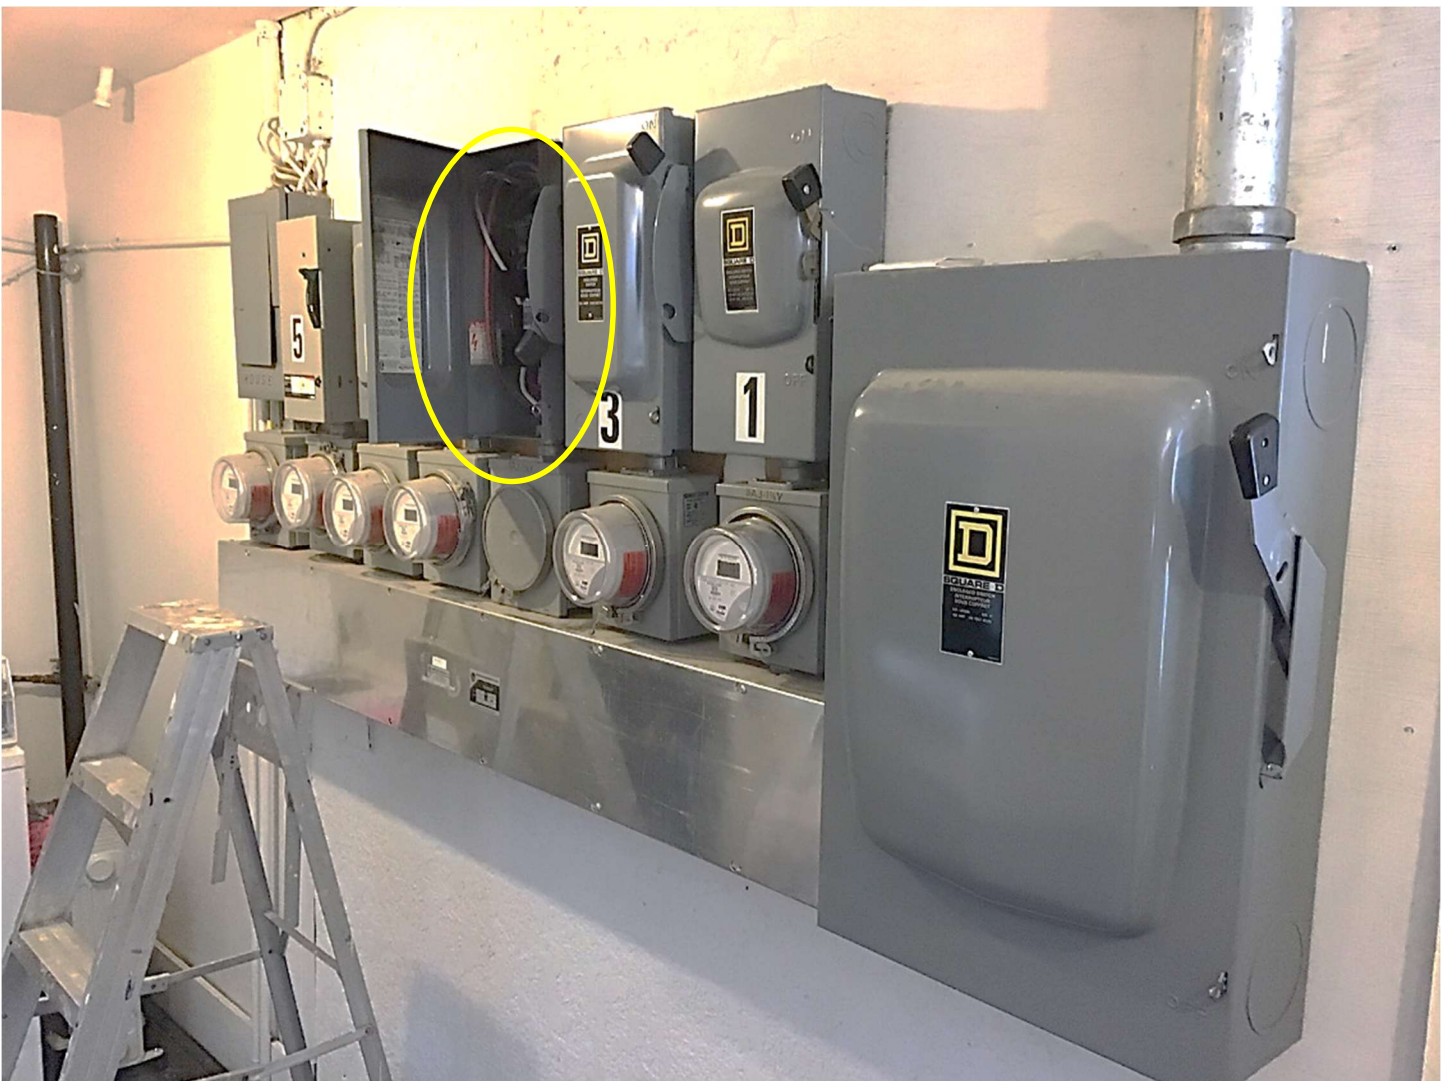
Main fused disconnect, far right, sub-distribution to the left – circled area is the damaged fused disconnect supplying unit #2

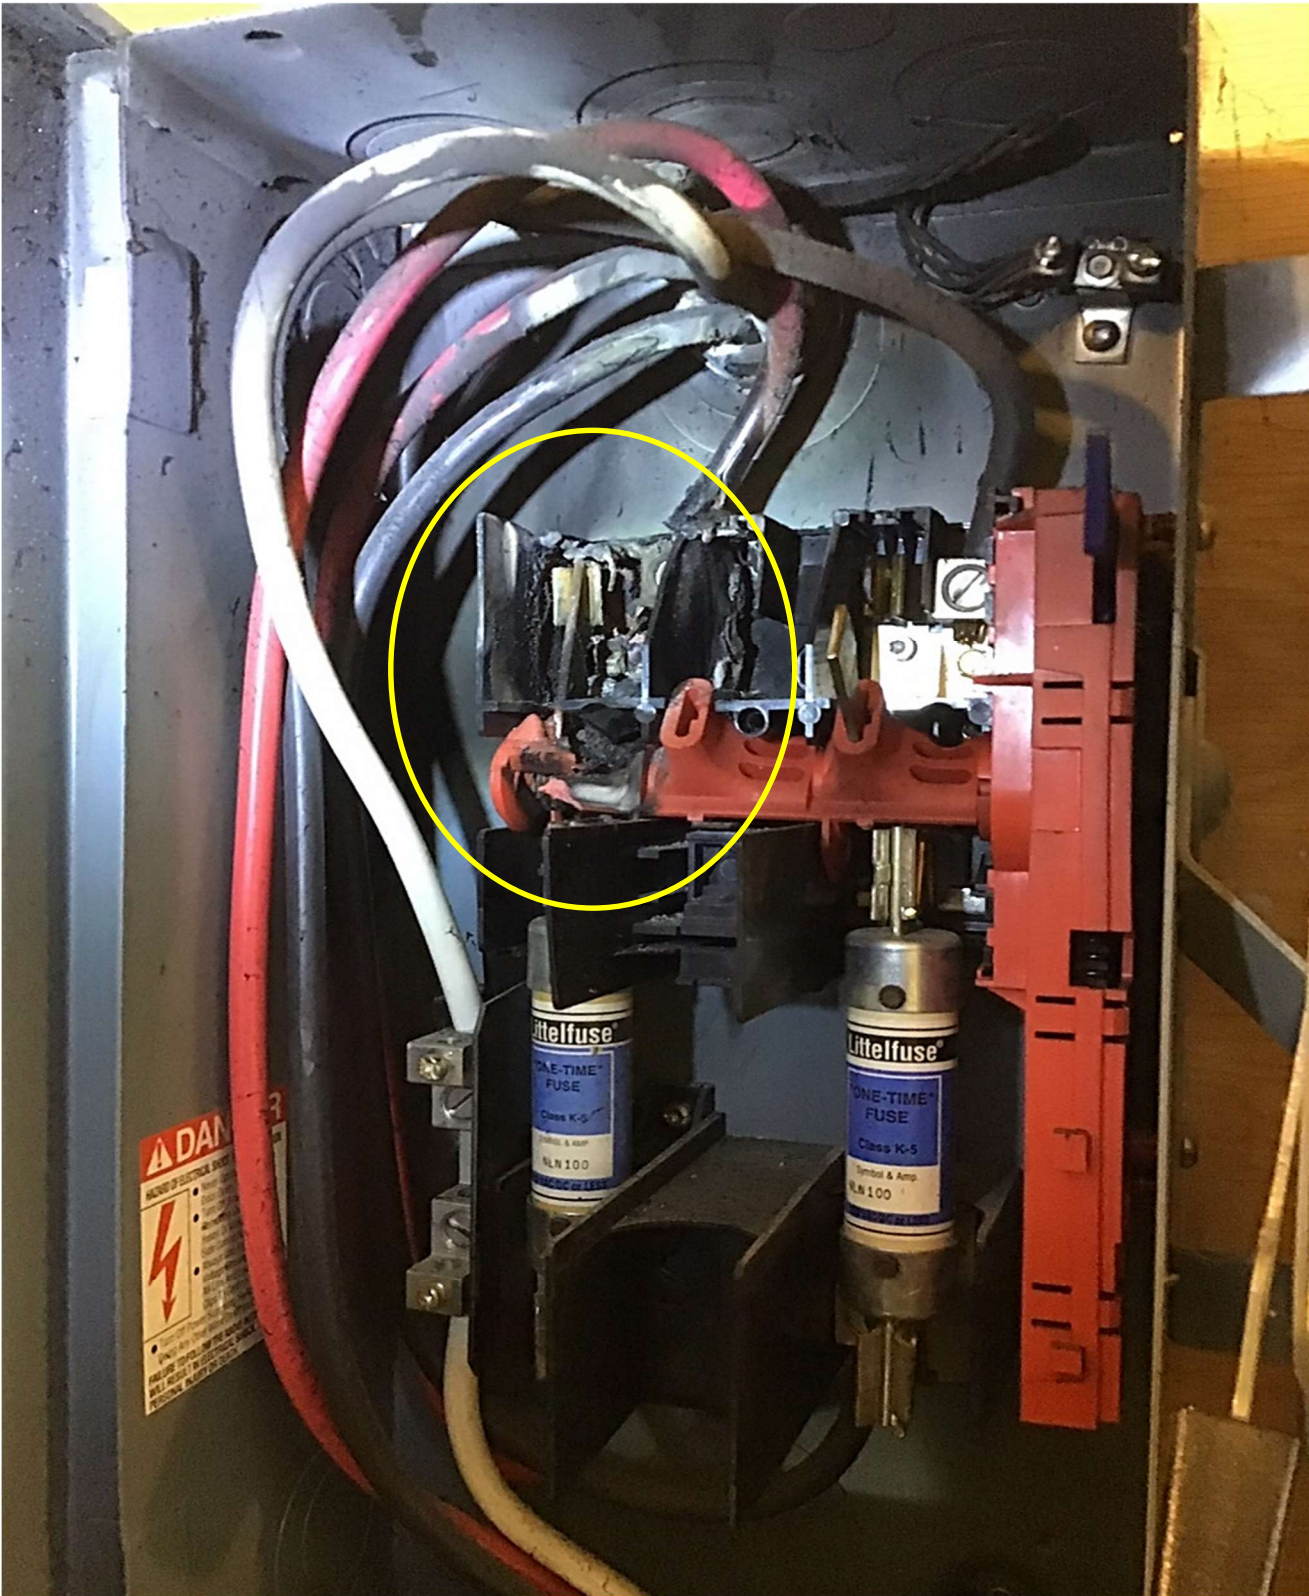
Failure scenario(s)		Evidence gathered from the site revealed that the 'line' conductor termination of one pole of the 100amp 240volt fused disconnect supplying energy to unit 2 was not tight. Over time, the loose termination resulted in a high impedance arcing condition. The high impedance arcing condition created a high temperature condition at the termination. The high temperatures reached a level that exceeded the conductor and component temperature ratings The high temperatures reached a critical level resulting in a breakdown, meltdown, fire and failure of the conductor insulation and termination components.	
	Facts and evidence		Evidence was obtained by the field safety representative (FSR) of a local licensed electrical contractor and reviewed by the local safety officer. The FSR opened the damaged fused disconnect, obtained photographs, dis-assembled the internal components and discovered the loose conductor termination that resulted in the electric fire incident.

intermittent receptacle operation, intermittent appliance operation increased in frequency over time and the days prior to the incident. The power quality issues are classic symptoms of poor or loose conductor terminations creating high termination impedance, high electric currents, high temperature conditions, potential incidents.

Internal components and damage of fused disconnect, unit #2 – circled area: loose conductor termination, failure and damage – note that the articulating blade is melted into the jaw at the failed termination, it will not move to open the contact; the other blade is moving effectively.
