Incident Summary #II-788966-2018 (#10224) (FINAL)

SUPPORTING INFORMATION	Incident Date	December 15, 2018	
	Location	Delta	
	Regulated industry sector	Boilers, PV & refrigeration - Refrigeration system	
	Impact	Qty injuries	0
		Injury description	none
		Injury rating	None
	Damage	Damage description	Cracked bellows on ammonia thermal expansion valve
		Damage rating	Moderate
	Incident rating	Moderate	
Incident overview	In an industrial food processing facility an ammonia leak occurred from the thermal expansion valve diaphragm, that required replacement.		
INVESTIGATION CONCLUSIONS	Site, system and components	The thermal expansion valve and diaphragm controls the rate of flow of liquid ammonia that feeds the spiral freezer. The freezing temperatures are obtained when liquid ammonia evaporates to vapour in the series of evaporators within the spiral freezer and draws heat energy from within the room. This expansion valve maintains the exact freezing temperatures needed for the quick freeze of a variety of frozen food products that move along a conveyor within the freezer.

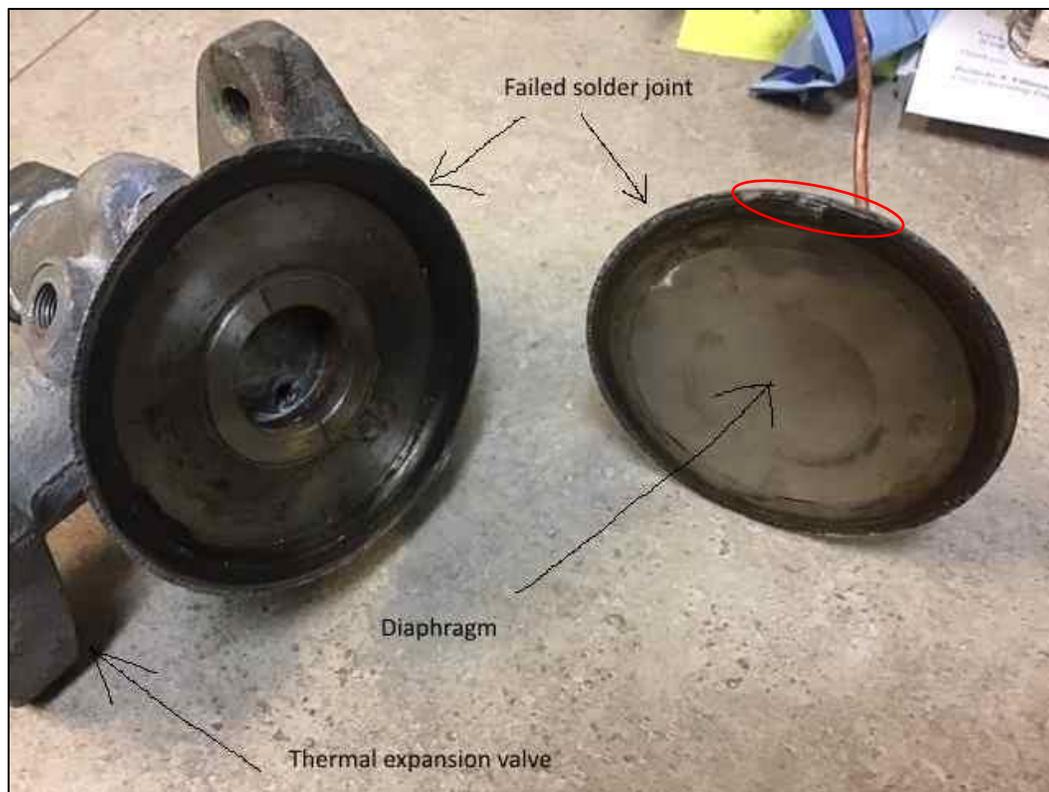
Failure scenario(s)	As a result of scheduled maintenance on a liquid ammonia line, ammonia was trapped within an isolated piping line on the downstream side on the thermal expansion valve under the diaphragm. During this maintenance the trapped ammonia boiled off within the control valve diaphragm increasing the pressure. This increased pressure caused the diaphragm to split apart on the weld as shown in Photo # 2. Photo #3 shows the diaphragm cap in its original position for reference.	
	Facts and evidence	The Chief Engineer and qualified licensed refrigeration contractor were performing scheduled maintenance on the ammonia line that feeds the expansion valve and diaphragm. Isolation valves on each end were closed and the ammonia removed from the line and captured to be added back later. When maintenance was completed the ammonia supply line and the isolation valves were opened up slowly to re-pressurize the ammonia piping. The Chief Engineer reported there was delay from the time of pressurization to the actual time a leak was detected by the room sensors. Ammonia sensors then alerted staff by sirens and lights that a leak had occurred in the spiral freezer. The ammonia piping, including the thermal expansion valve, was then isolated to prevent more ammonia from leaking into the spiral freezer. Only after the residual ammonia subsided with the help of ventilation fans in 2 to 3 hours did the qualified refrigeration contractor technicians enter the freezer to assess the repairs required. The expansion valve was replaced and the freezer was back in service within 24 hours.

<p>Photo # 1 shows evidence of existing diaphragm corrosion that appears as dark spots compared to the areas of shiny metal that are recent fractures. The presence of corrosion indicates that the age of the thermal expansion valve could have been a contributing factor.</p> <p>There was no mechanical or impact damage evident on the diaphragm. The diaphragm was connected to a flexible 1/8 inch copper line which did not cause undue stress on the diaphragm welds due to its flexibility.</p>
Causes and contributing factors	<p>The most likely the cause of the diaphragm failure is overpressure due to trapped liquid ammonia on the downstream side of the thermal expansion valve that applied an excessive force to the inside of the diaphragm. A contributing factor may be the corrosion noted on the failed soldered edge as less area of weld was holding the diaphragm together. Also the age of this valve, at 18 years, may have resulted in corrosion to form over an extended length of time and weaken the soldered weld.</p>

Photo # 1: Diaphragm body separated into two pieces along the welded seam. Weld fracture appears as shiny metal, circled, compared to darker corrosion surfaces on either side.

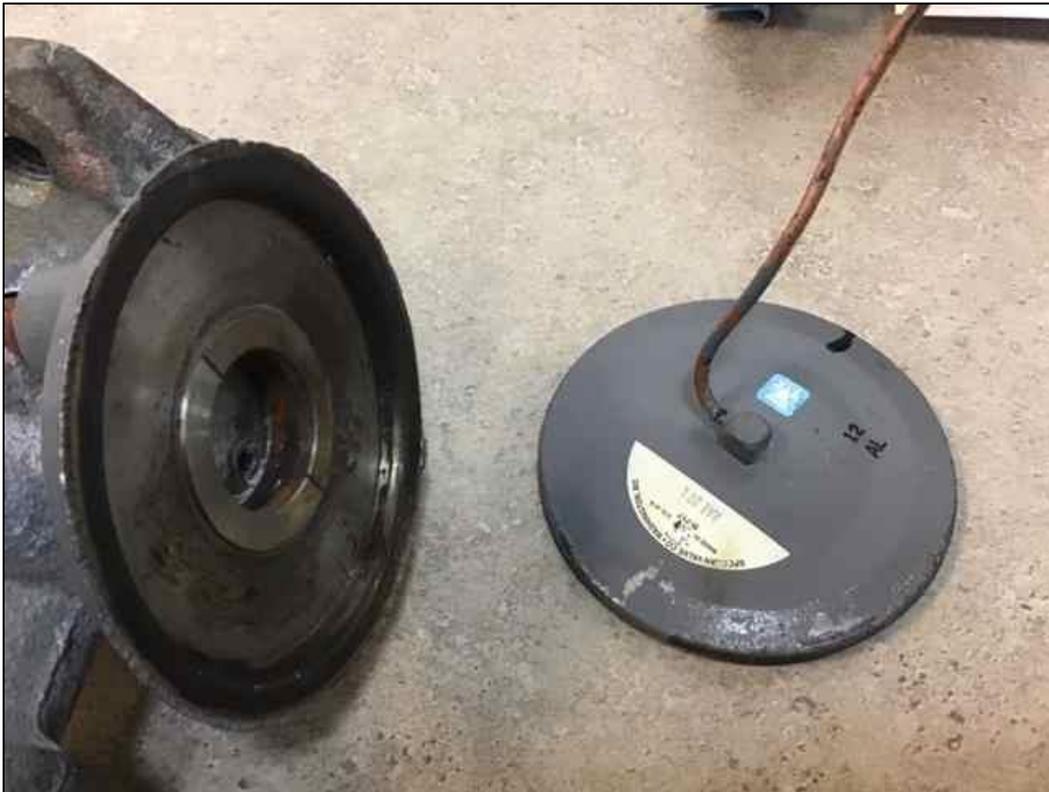
Photo # 2: Approximately 3 inch diameter diaphragm (7.2 sq. in.) with 1/8 inch I.D. copper line attached.

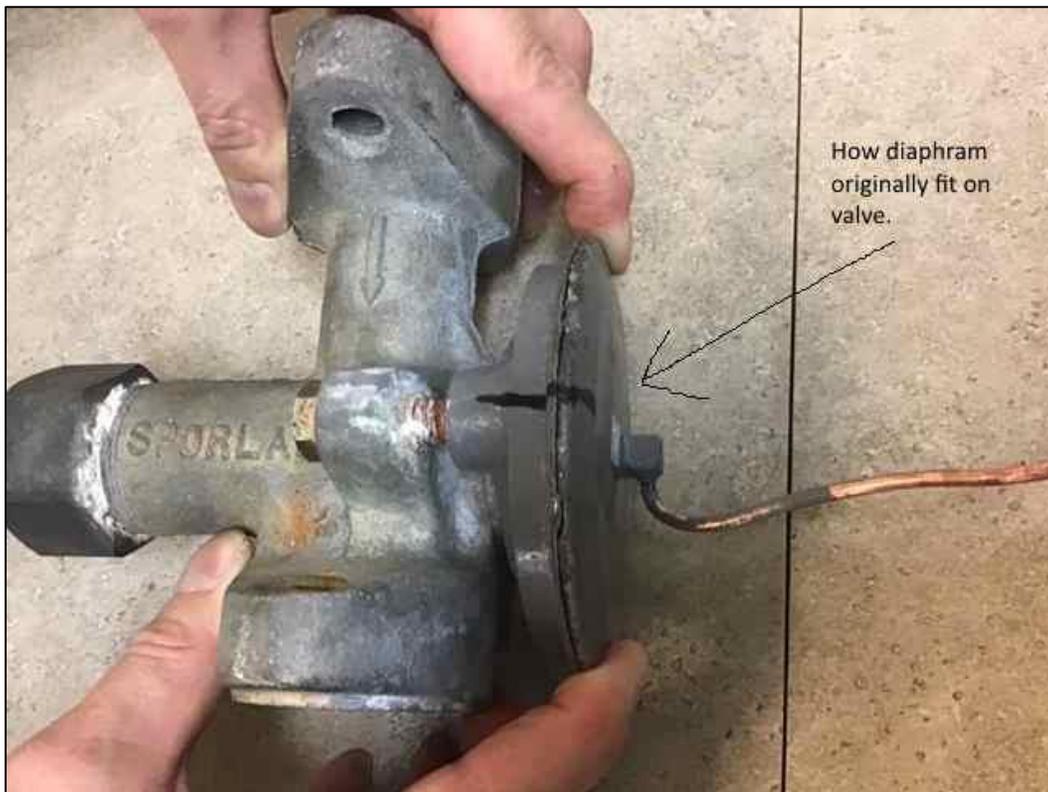
Photo # 3: Cap re-positioned to show how diaphragm originally fit on thermal expansion valve.
