Incident Summary #II-1806066-2024 (#55151) (FINAL)

SUPPORTING INFORMATION	Incident Date		September 3, 2024
	Location		West Vancouver
	Regulated industry sector		Gas - Natural gas system
	Impact	Qty injuries	6
		Injury description	Several people residing and working in a residential home experienced illness symptoms related to carbon monoxide exposure.
		Injury rating	Minor
	Damage	Damage description	Dangerous concentrations of carbon monoxide were being produced by a heating boiler and migrated indoors causing exposure to the occupants.
		Damage rating	Moderate
	Incident rating		Moderate
Incident overview		A wall hung condensing boiler installed in a large residential home, produced high concentrations of carbon monoxide (CO). The venting system for the boiler allowed the flue gasses to enter the home and expose the occupants to levels of CO that resulted in illness symptoms over a two-year period.	
INVESTIGATION CONCLUSIONS	Site, system and components		<p>The 13,359 square foot residential home was built in 2009. The radiant heating and domestic hot water system for the home was designed to use a geothermal heat pump system as the primary source for heat, with a gas fired condens

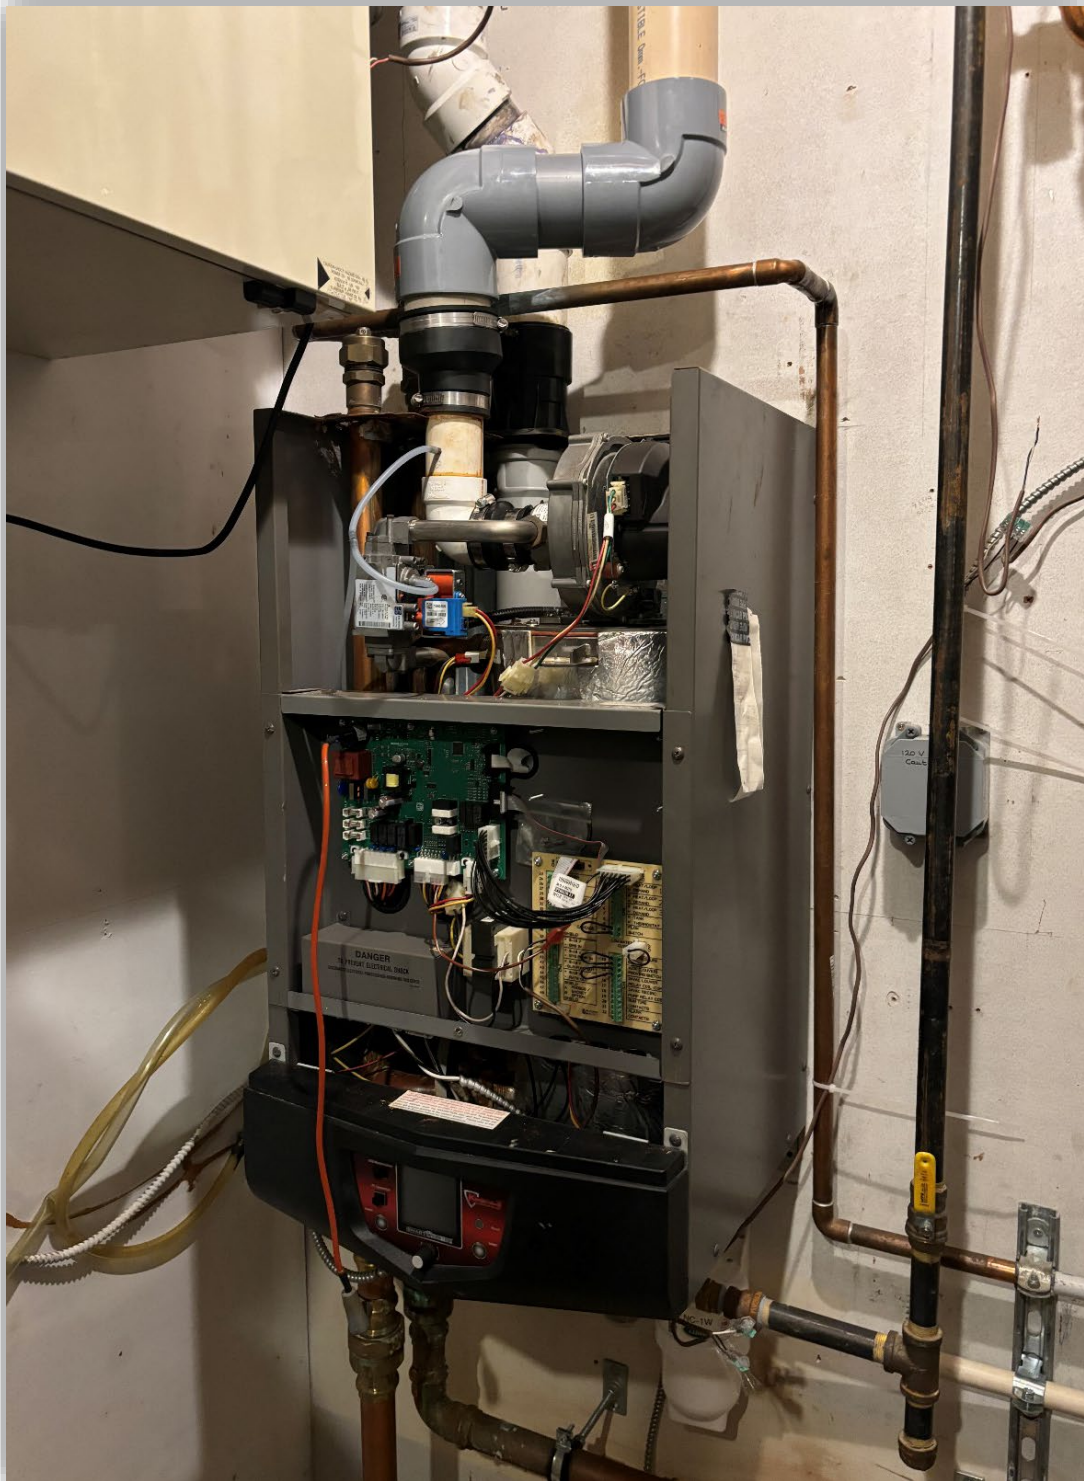
- When testing the boiler flue gas with a calibrated combustion analyzer, the high fire settings were within the manufacture's specifications. When the boiler was set to low fire, the O2 level dropped to 0% then the CO rose above the 4000ppm CO maximum advertised accurate testing level of the instrument and the max reading on the display of the instrument was recorded at 75,272 ppm CO before the instrument went into sensor protection mode.

- Combustion analysis of the boiler (as found) showed high fire readings to be within the boiler manufacturer's specification range ([Appendix A](#)).
- On low fire the (10% fire) oxygen reading went to 0% and the CO reading rose to a max display reading on the analyzer of 75,000ppm before the analyzer went into protection mode.

Image 2 – The boiler installed in the mechanical room.

- The boiler was reassembled and adjusted to correct the combustion.
- The gas valve was able to be adjusted to get correct combustion readings at low and high fire that were within range on the manufactures specified targets.

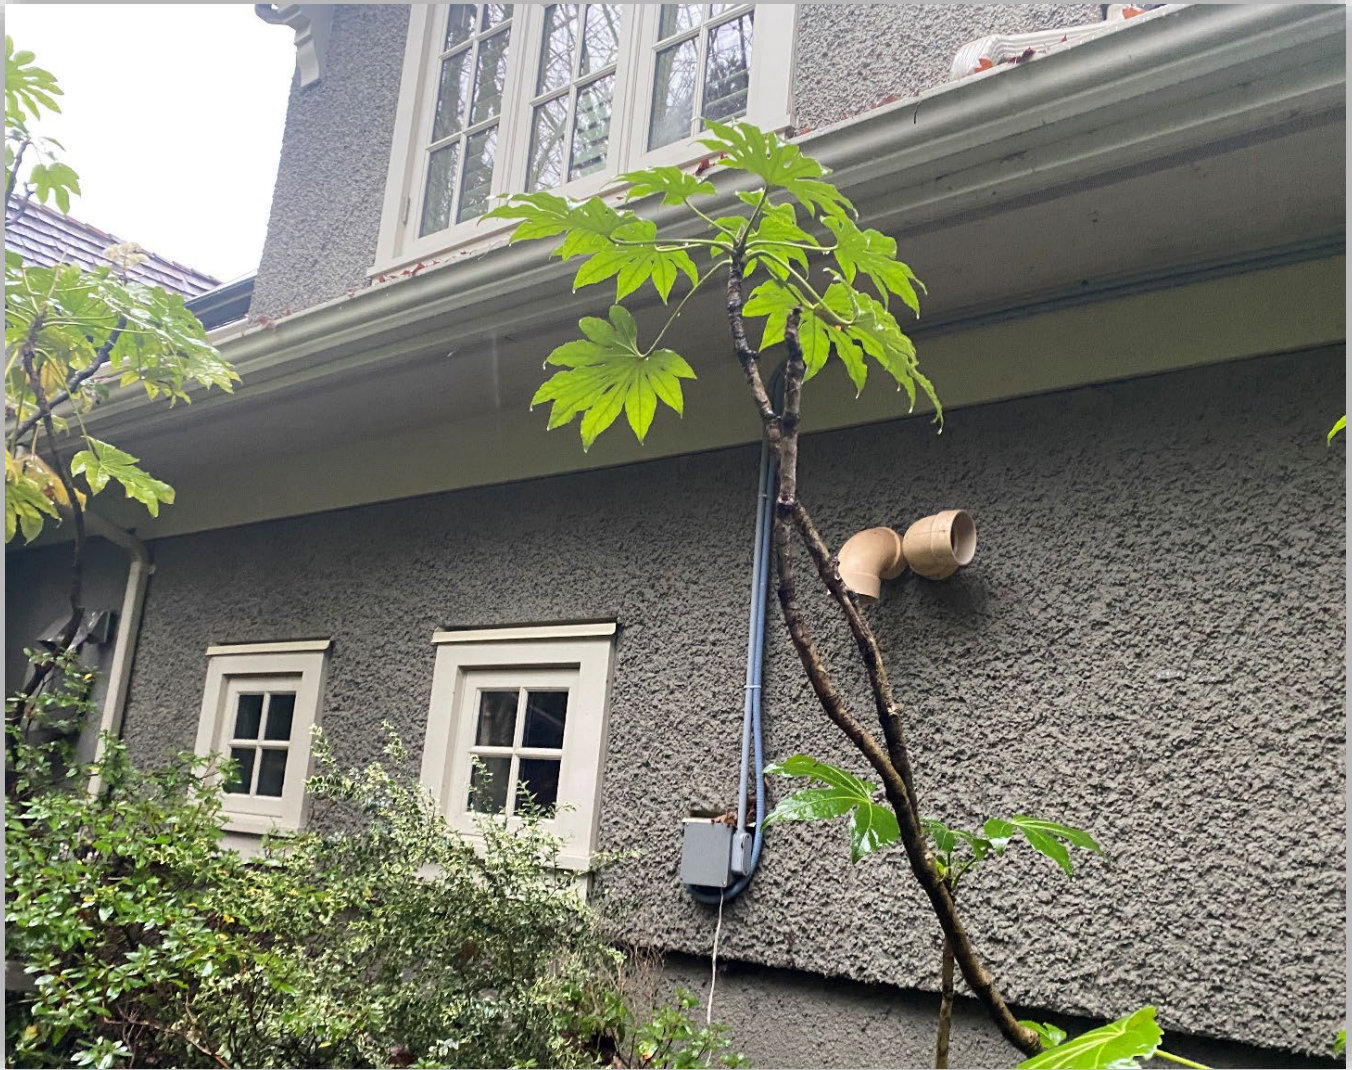
- The vent was 3" diameter in the mechanical room but increases to 4" behind enclosed walls and terminated outdoors at 4".
- Due to a leak on air intake piping from an unglued joint, a section above the boiler in the mechanical room had been replaced with CPVC piping.
- The sidewall vent termination was non-compliant. It was too close to a separation between the air intake and exhaust piping and the exhaust was directed alongside the home's exterior wall under a ventilated soffit.
- The air intake was at the same height as the vent outlet.

- The vent termination was oversized at 4" for the boiler model and, with no bird screens and improper spacing between the air intake and exhaust.
- The termination was observed to be under a soffit near the windows.

Image 3 - The boiler vent termination on the West side of the home.

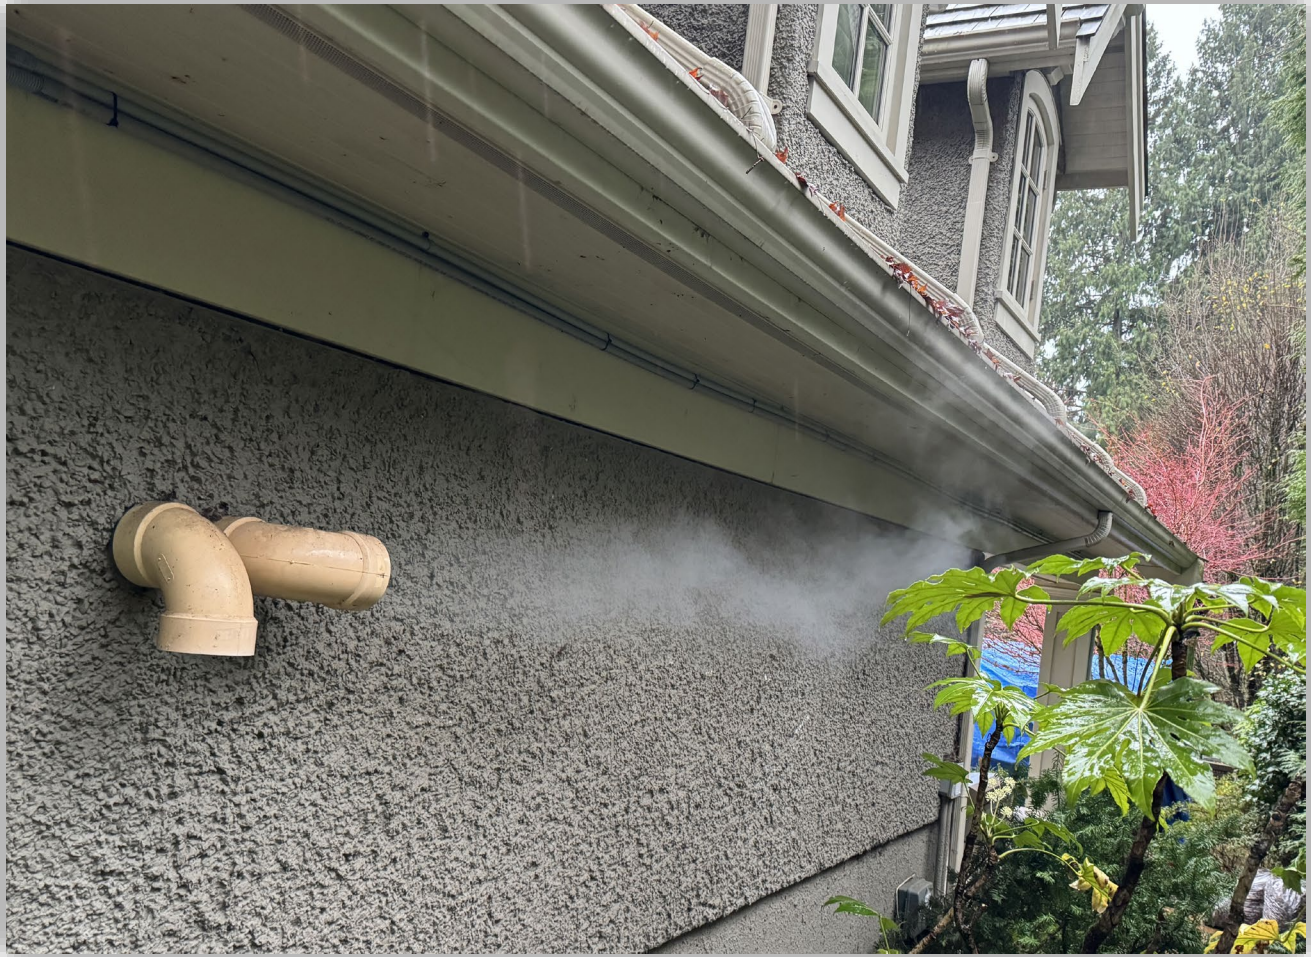
<p>along side the house under a ventilated soffit. The oversized vent piping reduced the velocity of the flue gasses coming from the boiler, especially during the periods of low fire. The 90-degree elbow on the vent termination combined with the low velocity of the flue gas at low fire, allowed the flue gasses containing high amounts of CO to rise alongside the exterior of the home and infiltrated into the ventilated soffit and migrated into the walls of the home.</p> <p>During multiple service calls by contractors hired by the owner to troubleshoot the plumbing, boiler and heating system, the non-compliant venting system, and improper low fire combustion went unidentified by the contractor's technicians.</p> <p>The home was equipped with a total of 9 operational built-in combination smoke/carbon monoxide detectors. Three were located in the hallways of each floor and an additional plug-in dedicated CO detector in the hallway outside the mechanical room. It is likely that although high concentrations (<400ppm CO) were measured within the walls of the third floor at West side of the home while the boiler was operating on low fire, that concentrations may not have reached the threshold required to cause the CO detectors in the home to alarm.</p>

- While in low fire, the volume of vent products was very low and while exiting the 4" vent termination, it was observed having a very low velocity.
- The vent had an elbow pointing the vent parallel to the exterior wall and the flue products were witnessed rising up into the soffit located 24" above which had a ventilation strip that allowed the flue products, containing very high concentrations of CO, to enter the soffit and wall spaced at that location of the home.

Image 4 - The boiler vent termination showing the flue gasses on high fire directed along side the house under the ventilated soffit.

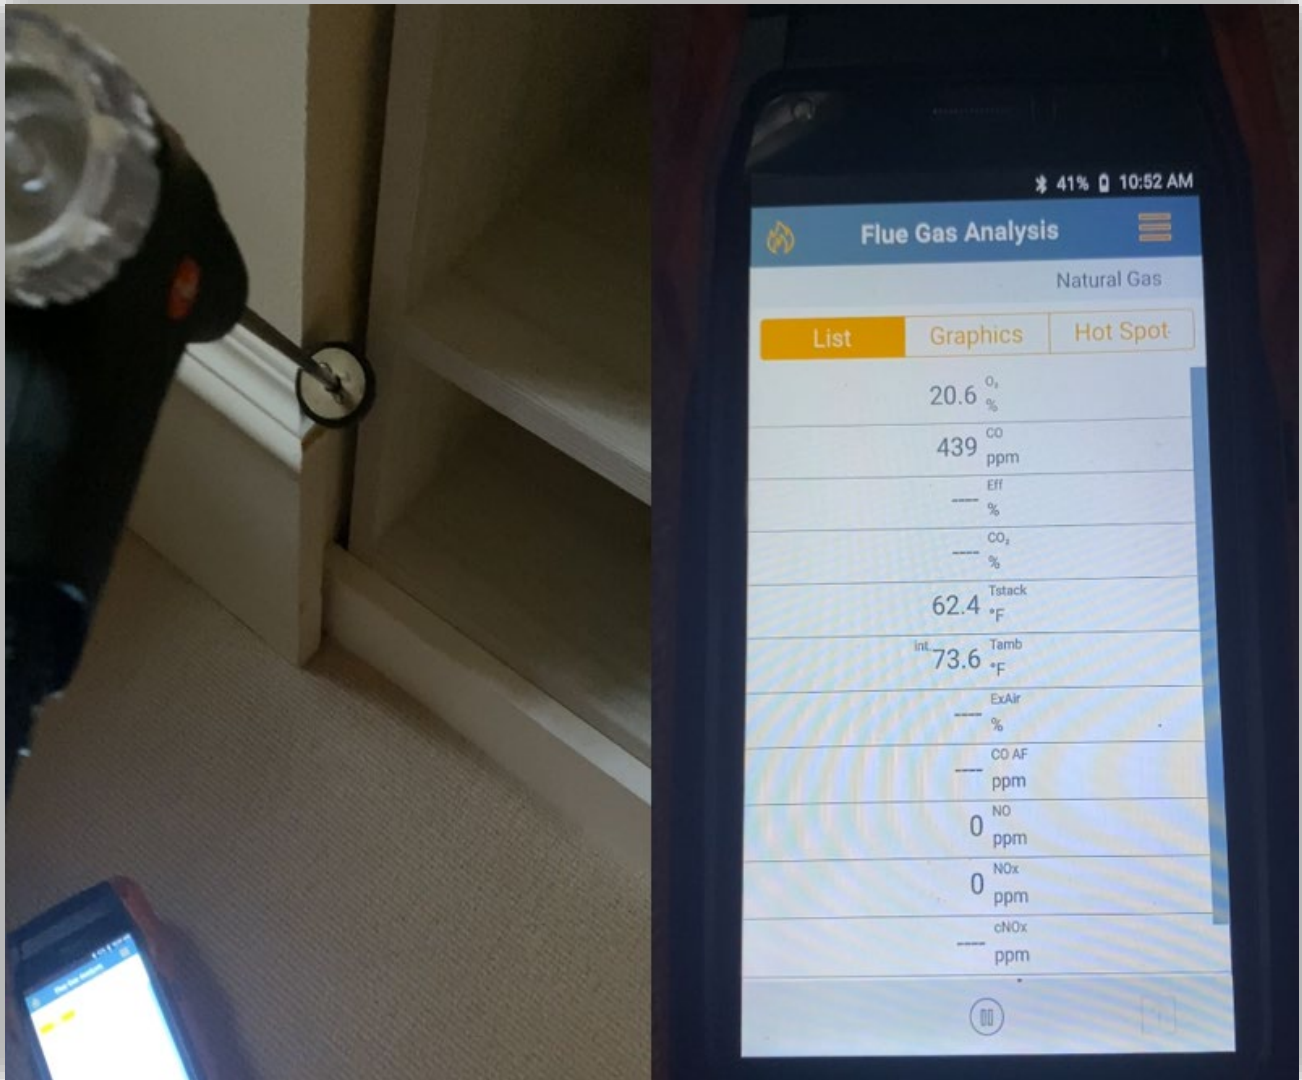
Measurements were taken with a calibrated combustion analyzer throughout the home while the boiler was held on a low fire over a time of approximately 30 minutes. On all three levels from the East side and center of the home no measurable CO was found indoors. On the West side of the home where the boiler and vent termination are located. Very small amounts (3-5ppm) of CO were measured in the ambient air of the walk-in closet. When the analyzer probe was placed between the built-in cabinetry in the closet the wall the CO measurements rose to a maximum of 439ppm ([Image 5](#)) while the immediate area outside of the probed location measured up to 26ppm. In the office on the main floor the probe was placed into a cable access hole inside a built-in cabinet and measured to a max of 72 ppm. In the laundry room on the main floor measurements taken from inside a wall cavity though an already removed access grill for water valves measured a maximum of 38ppm.

Image 5 - The CO testing location in the master bedroom closet and highest CO reading on the analyzer.
