Incident Summary #II-888382-2019 (#14664) (FINAL)

SUPPORTING INFORMATION	Incident Date		August 2, 2019	
	Location		Vancouver	
	Regulated industry sector		Amusement Devices - Amusement ride	
	Impact	Injury	Qty injuries	2
			Injury description	Headache, dizziness, some nausea.
			Injury rating	Insignificant
	Damage	Damage	Damage description	No damage
			Damage rating	None
Incident rating		Insignificant		
Incident overview		During the ride cycle, the gondola rotation did not come to a stop in the horizontal position, passengers were unable to disembark the spinning ride until an emergency stop was initiated by maintenance personnel, who had been alerted by the ride operators, through dispatch.		
INVESTIGATION CONCLUSIONS	Site, system and components		<p>Up to 2 people sit in one of the twenty gondola cars, which are arranged in a circle, and loaded with passengers, while the ride frame is in a horizontal position. At start, the ride moves in a clockwise direction on the horizontal plane and then a hydraulically operated arm raises the ride frame, so it is at an almost vertical plane for a specific period of time.</p> <p>The ride frame is then lowered back hydraulically to the horizont

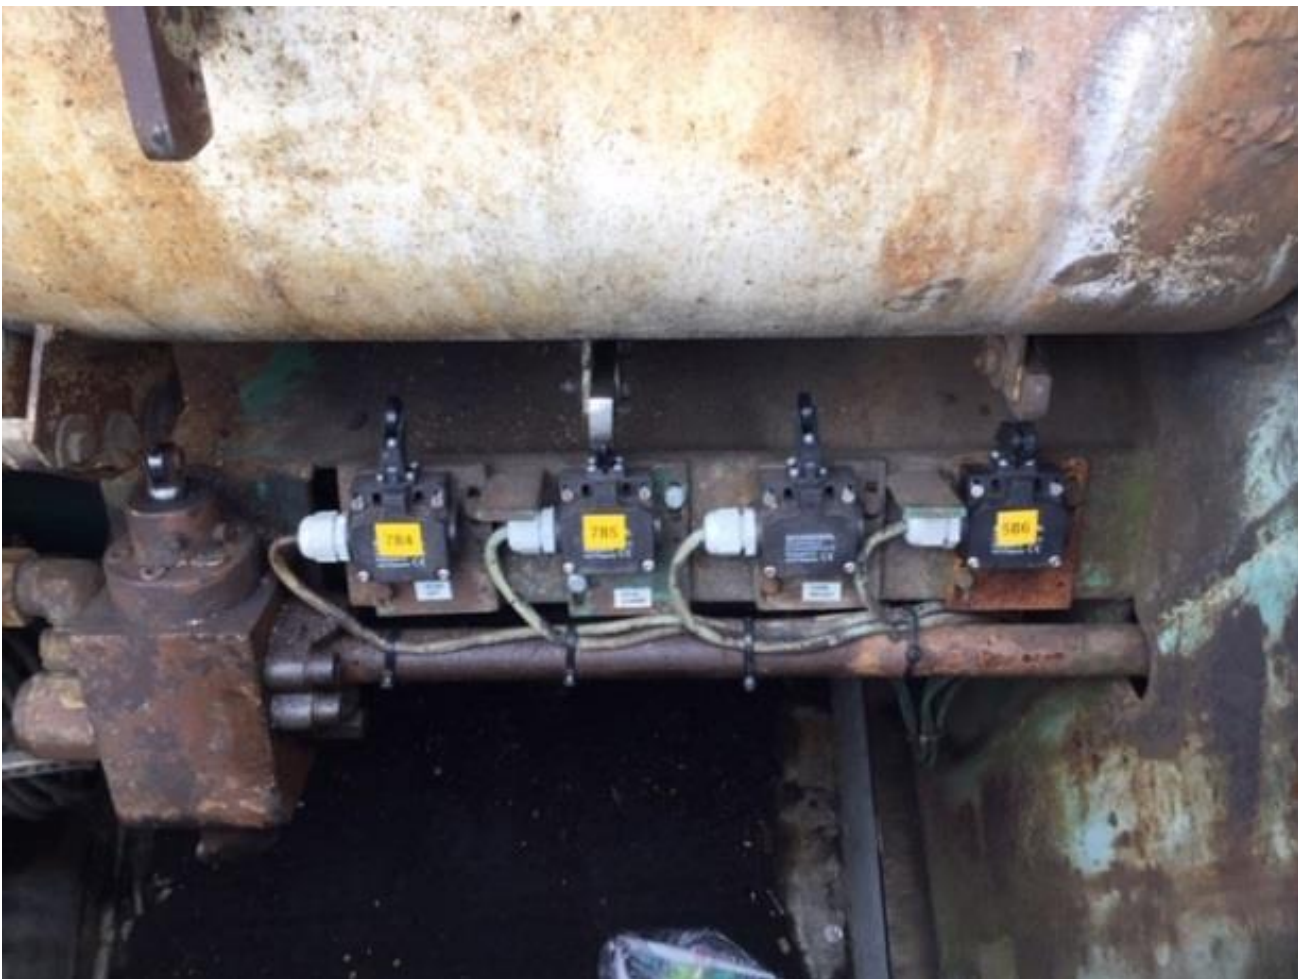
Proximity switch rack, and base of hydraulic arm with actuator cam(s)

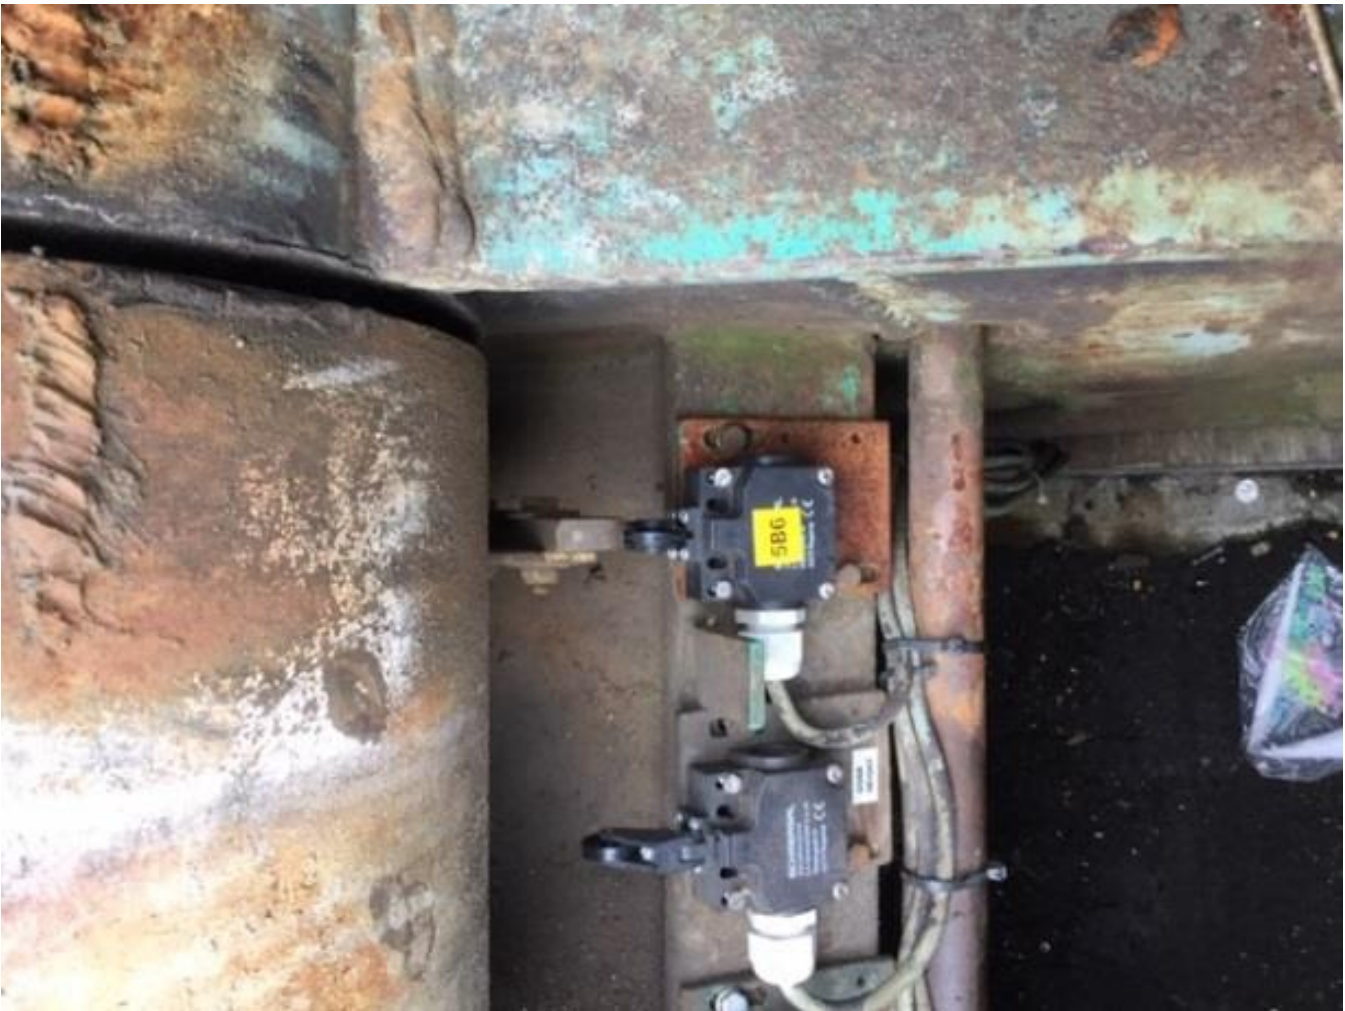
It is highly likely that the loose mounting plate for the proximity switch (5B6), permitted the actuator cam on the hydraulic arm to miss the proximity switch (5B6), allowing the ride to continue to rotate in the horizontal position, until an emergency stop was depressed.

It is likely that the mounting plate became loose due to vibrations during operation.

Proximity switch 5B6, proximity switch bolted mounting plate, hydraulic arm actuator cam.

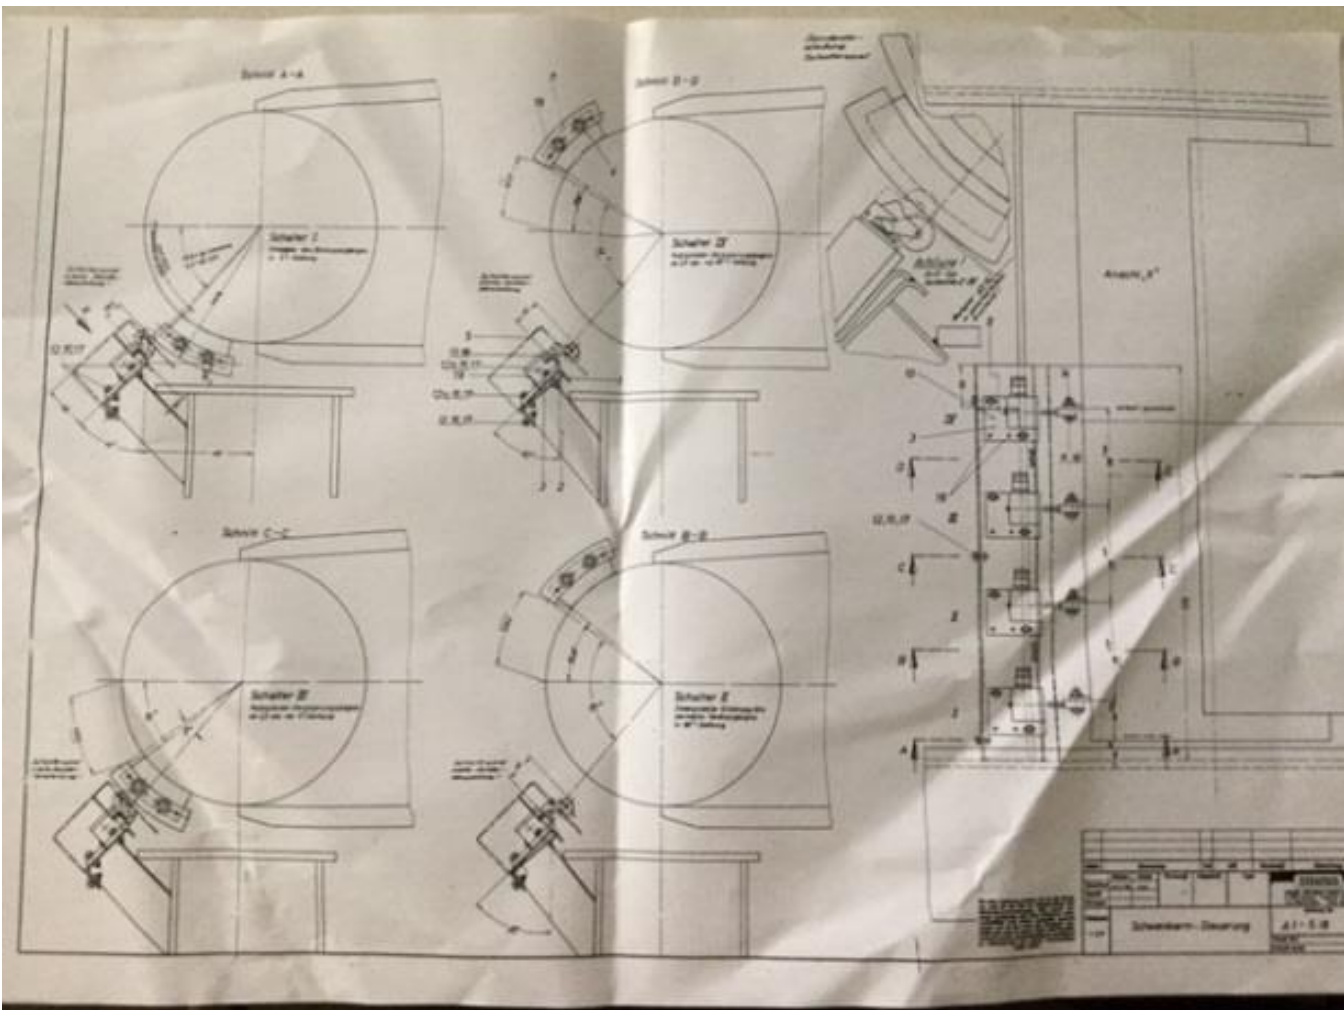
Technical drawing of relationship between proximity switches and actuator cams.
