## Incident Summary #II-727632-2018 (#8165) (FINAL)

SUPPORTING INFORMATION	Incident Date	June 26, 2018			
	Location	White Rock			
	Regulated industry sector	Gas - Natural gas system			
	Qty injuries	0			
	Injury description	None			
	Injury rating	None			
	Damage  Damage rating	Front glass of fireplace shattered into living area.			
	Damage rating	Minor			
	Incident rating	Minor			
	Incident overview	Delayed ignition occurred in a direct vent fireplace, causing the front glass to shatter and send glass fragments into the residential living space.			
INVESTIGATION CONCLUSIONS	Site, system and components	Natural Gas is supplied to the residence by a gas utility which is then sent through a series of piping or tubing to the fireplace intended to be used as a source of heat.  A call for heat is made via a switch installed in close proximity to the direct vent fireplace.  When there is a call for heat the gas valve opens and the spark ignitor is energized in attempt to ignite the gas as it exits the burner.  Once the burner has been ignited it sends a signal back to the fireplace to confirm it senses a flame and to de-energize the ignitor. The flue products produced from the combustion

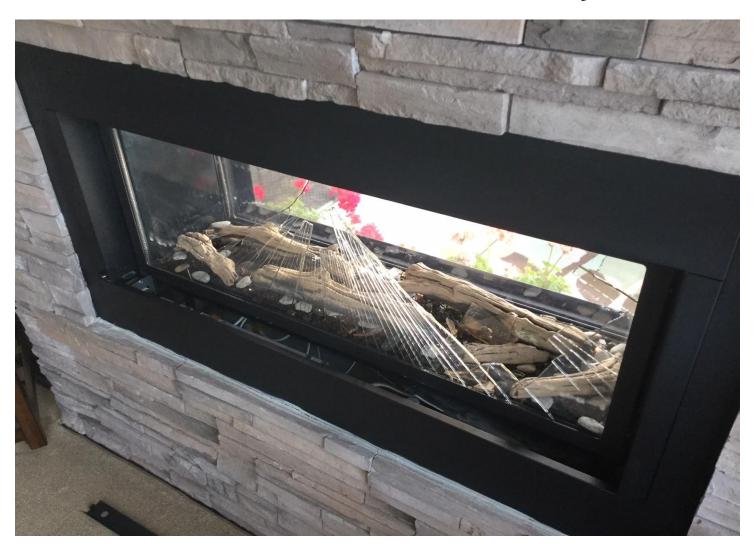
Fireplace with damaged glass

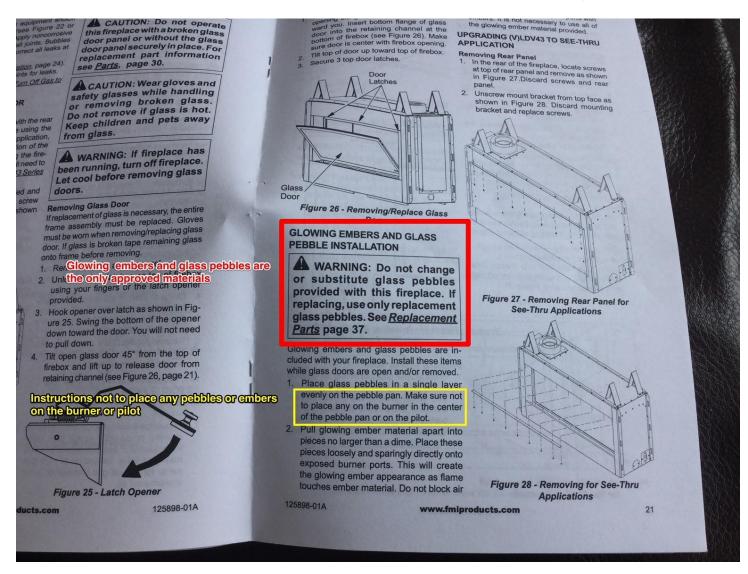
Failure scenario(s)	This model of fireplace that had a failure is specifically designed for use with glass pebbles as the internal decorative media.  Glass pebbles were removed from the fireplace by a licensed gas contractor and replaced with a log set, small stones, copper glass and lava rock. These items were			
		not only installed inside the fireplace, but directly on top of the gas burner and ignitor.  A call for heat was made which opened the gas valve and energized the ignitor. With unapproved items installed directly on top of the burner and ignitor, the gas being released from the burner was unable to immediately ignite.  Natural gas built up inside the sealed fireplace unit until it found a source of ignition, most likely the ignitor, and the pressure from the explosion shattered the glass into the living area.

Fireplace manufactures certified installation instructions

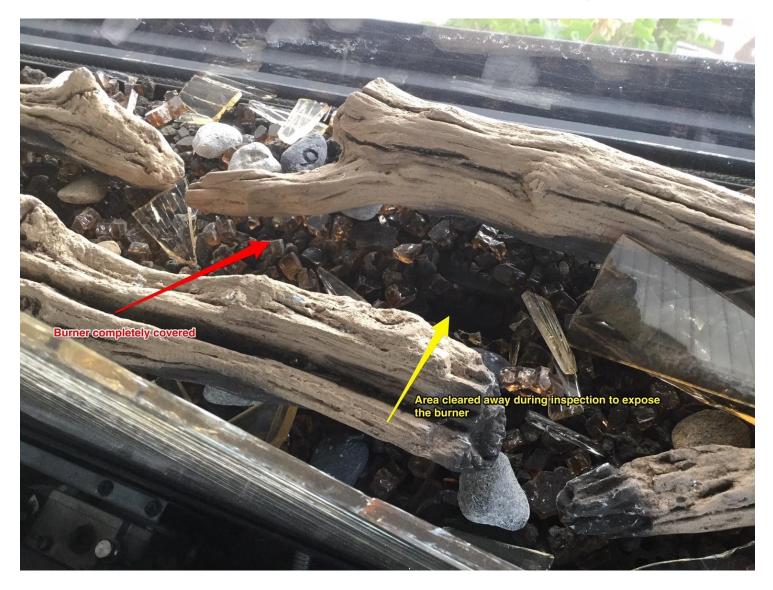
Causes and contributing factors	It is highly probable that the placement and use of the unapproved materials inside the fireplace is what led to the delayed ignition, causing damage to the appliance.

Inside the damaged fireplace
