## Incident Summary (II-899454-2019)(ID#14969) (FINAL)

SUPPORTING INFORMATION	Incident Date		August 24, 2019	
	Location		Interior	
	Regulated industry sector		Passenger Ropeways - Above surface ropeway	
	Impact	Injury	Qty injuries	0
			Injury description	Not Applicable
			Injury rating	None
	Damage	Damage	Damage description	Rupture of sheave, inconsiderable wear on assembly frame.
			Damage rating	Insignificant
	Incident rating		Insignificant	
Incident overview		During operation for summer activities there was unusual noise coming from a tower sheave assembly. Upon investigation it was discovered that there was a cracked sheave.		
INVESTIGATION CONCLUSIONS	Site, system and components		Circulating passenger ropeways transport passengers from the load station to an unload station by carriers (chair) attached to the main cable (haul rope). The haul rope is supported by towers along the length of the ropeway between stations. Towers are equipped with sheave assemblies, which allow travel of the haul rope. Sheave assemblies are comprised of a frame, suspension to tower and sheaves. See Figure 1 & 2. The sheave assemblies are designed and adjusted to have the haul rope travel along the

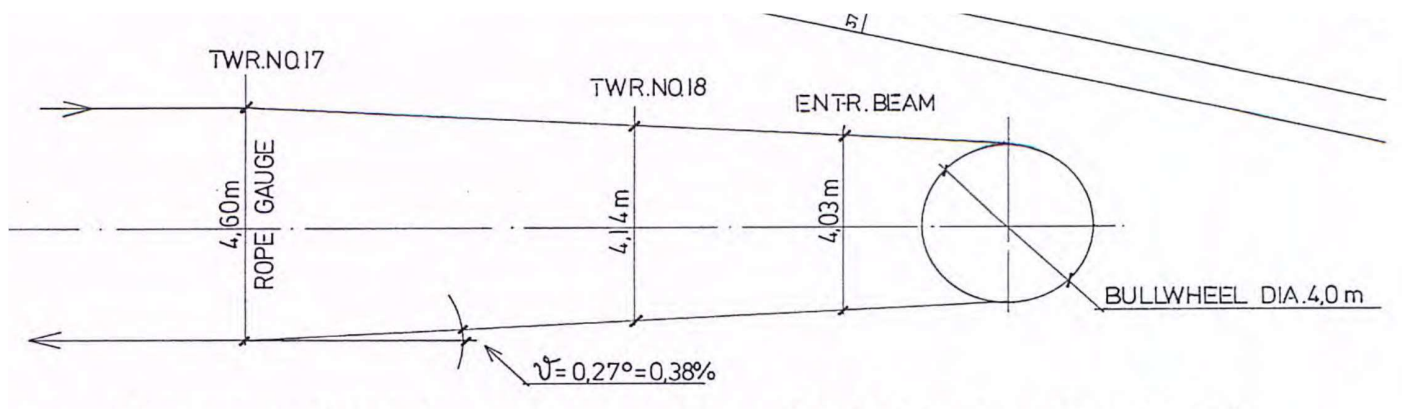
Figure 3, Sheave Assembly tilt Angle

<ul style="list-style-type: none"> <li>• Tower sheave assemblies must have tilt angle alignment to accommodate fleeting gauge. See figure 3</li> <li>• Sheave installed in June 2015 – 6740 hours of operating time – confirmed by contractor maintenance records</li> <li>• Tower was designed to accommodate a heavy load with an 8 wheel assembly on the uphill side and 6 wheel assembly on the downhill side</li> <li>• Contractor has other vintage of ropeways of the same manufacturer – sheave components may have been intermixed</li> </ul> <p>Manufacturer Documents - Sheave Service Bulletin:</p> <ul style="list-style-type: none"> <li>• Issued September 2002 as a result of growing experience and technical developments combined with aging of components. Revision of the sheave operation and maintenance manual for ropeways built before 2002</li> <li>• Issued July 2016 requires all owner/operators that were in compliance of the previous service bulletin to perform any subsequent sheave rebuild according to sheave Inspection Specification dated July 2016. If not in compliance of the 2002 Service bulletin owner/operators must embark on a schedule to assure all sheaves are in compliance with the 2016 Sheave Inspection Specification. Manufacturer allows owner/operators 6 years (until July 2022) to complete.</li> </ul> <p>Manufacturer Inspection Report of sheave:</p> <ul style="list-style-type: none"> <li>• Older side plates (pre-1982) – no ID markings</li> <li>• Hub manufacturing year pre-1989</li> <li>• Inner side plate poor condition of outside diameter</li> <li>• Liner wear – 4mm excessive lateral to the inside – depth ok – indicates incorrect adjustment of sheave assembly.</li> <li>• Recommend all tower uphill sheaves be replaced, as sheaves may have been solicited to unknown lateral loads</li> <li>• Check and correct sheave assembly alignment accordingly – tilt angle alignment</li> </ul>

<p><b>Causes and contributing factors</b></p>	<p>It is possible that inadequate sheave assembly alignment created unknown lateral load on the sheave and caused the sheave hub to rupture.</p> <p>The sheave not being assembled according to the manufacturers most recent Inspection Specifications may be a contributing factor.</p>

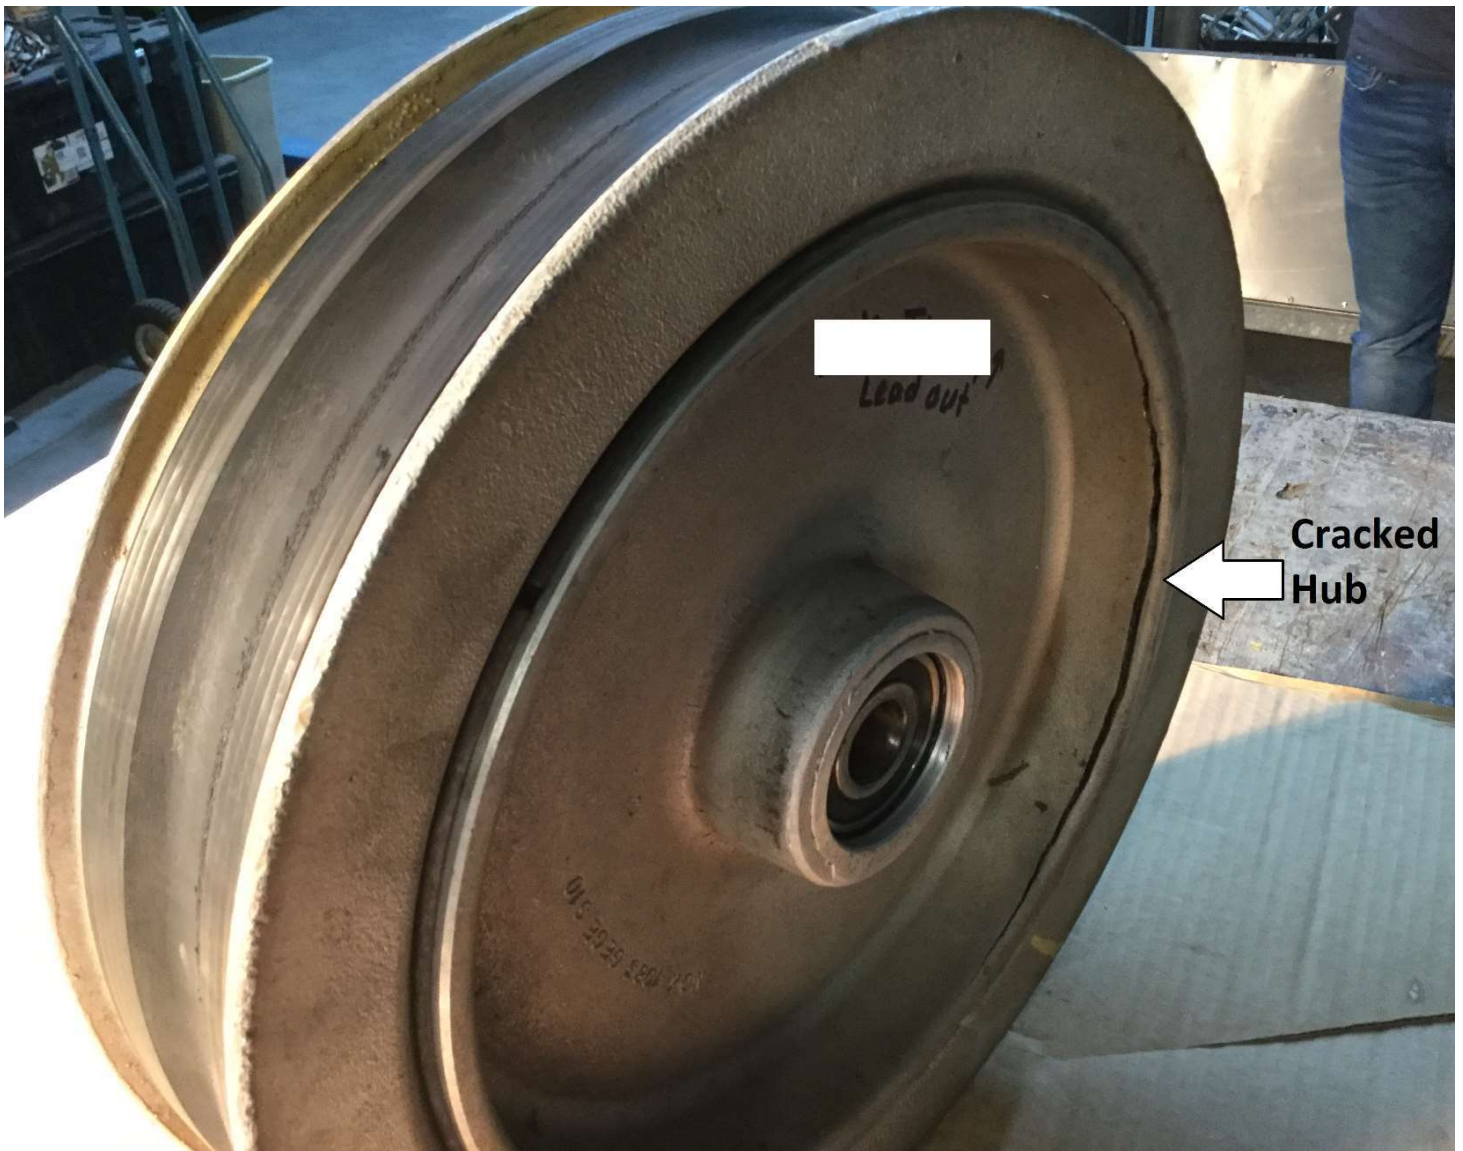
Figure 4, Ruptured Sheave

Failure scenario(s)		There was unusual noise coming from a tower sheave assembly during operation. Upon investigation a cracked sheave was identified.	
	Facts and evidence		<p>Ropeway Summer Operation:</p> <ul style="list-style-type: none"><li>• Ropeway was operating for foot passengers and transporting bikes uphill</li><li>• Operation speed for foot passengers does not exceed 1.3 m/s</li><li>• Date of Incident weather was a high 22C</li></ul> <p>Location of sheave failure:</p> <ul style="list-style-type: none"><li>• Second tower from top drive station</li><li>• Uphill side ropeway travel</li><li>• Lead out – last sheave of an 8 wheel assembly</li><li>• Cracked on the inward facing side</li></ul> <p>Technical Data of ropeway:</p> <ul style="list-style-type: none"><li>• Ropeway installed in 1989</li><li>• Ropeway has fleeting line gauge at incident tower location. – Distance between uphill and downhill haul rope is 4.6m on towers and drive (top) bullwheel is 4.0m</li></ul>
