Incident Summary #II-1411128-2022 (#28895) (FINAL)

SUPPORTING INFORMATION	Incident Date		July 25, 2022	
	Location		Salmon Arm	
	Regulated industry sector		Electrical - Low voltage electrical system (30V to 750V)	
	Impact	Injury	Qty injuries	0
			Injury description	N/A
			Injury rating	None
		Damage	Damage description	The underground service cable of a private electrical system was damaged during an excavation.
			Damage rating	Minor
		Incident rating		Minor
Incident overview		When excavating a trench for a new underground sub distribution cable and water line for a new single-family dwelling under construction, a previously buried underground cable providing the main electrical services for the existing single-family dwelling was hooked by the bucket of the excavator causing damage to the cable.		
INVESTIGATION CONCLUSIONS	Site, system and components		<p>Approved underground electrical cables and raceways installed to the requirements of the Canadian Electrical Code allow electrical systems to operate to their full potential while providing secure and reliable operation.</p> <p>Ground conditions and location in which the underground cables and raceways are to be buried in are impo

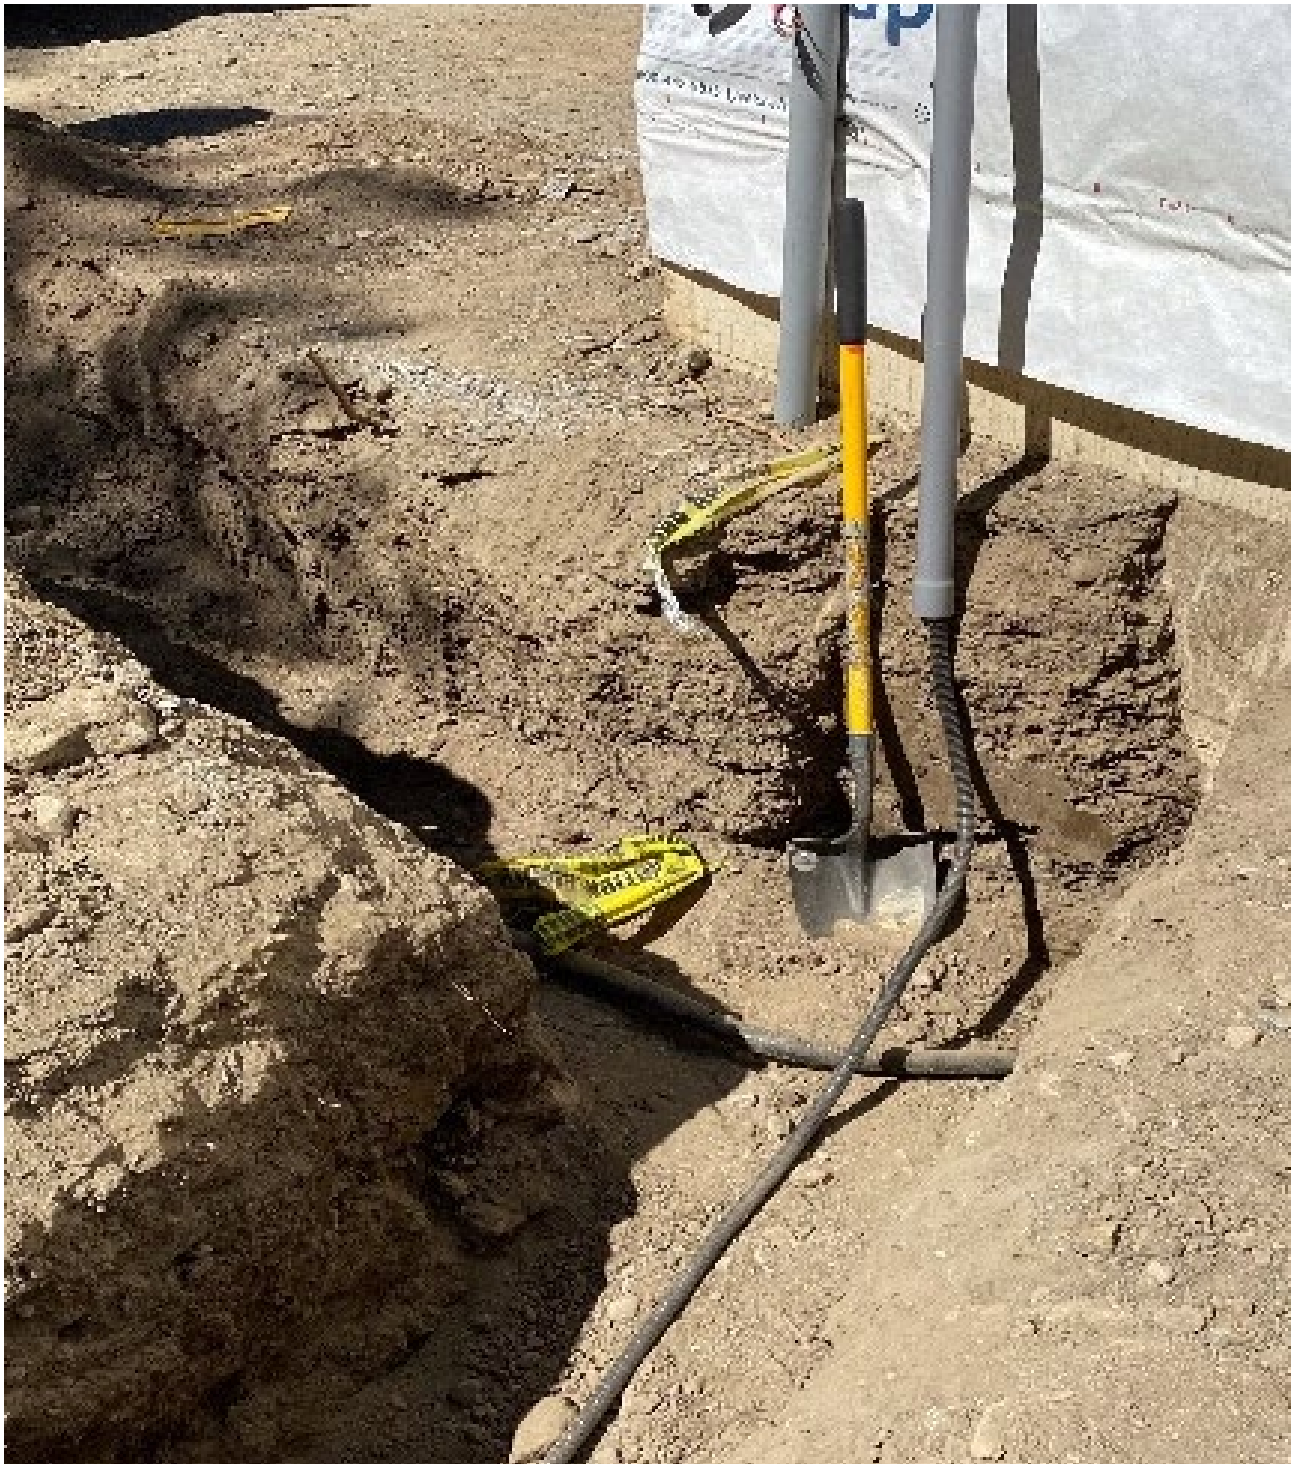
<p>Causes and contributing factors</p>	<p>The failure was likely caused by the burial tape not being placed directly over the buried cable near the building and not located halfway between the installation and grade.</p>

Photo 1 - Burial tape installed at time of original installation. Burial tape coming away from building and protruding from grade

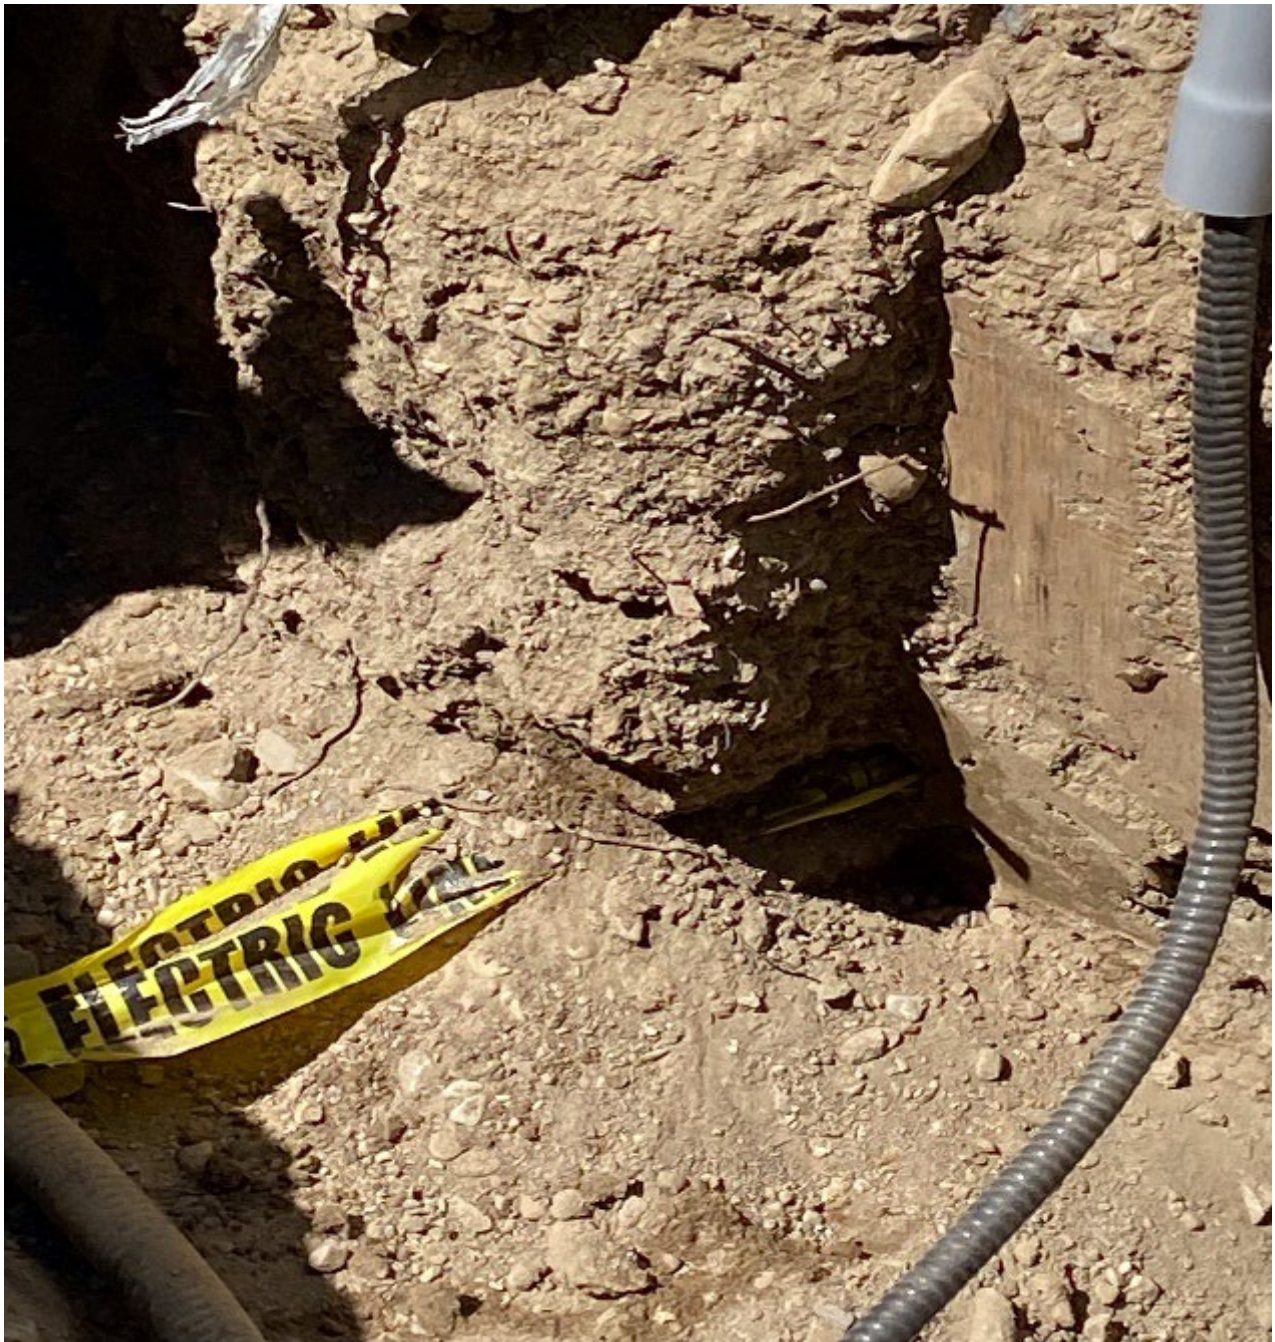
Photo 2 - Existing buried cable and burial tape coming away from building. Burial tape not installed at proper depth.

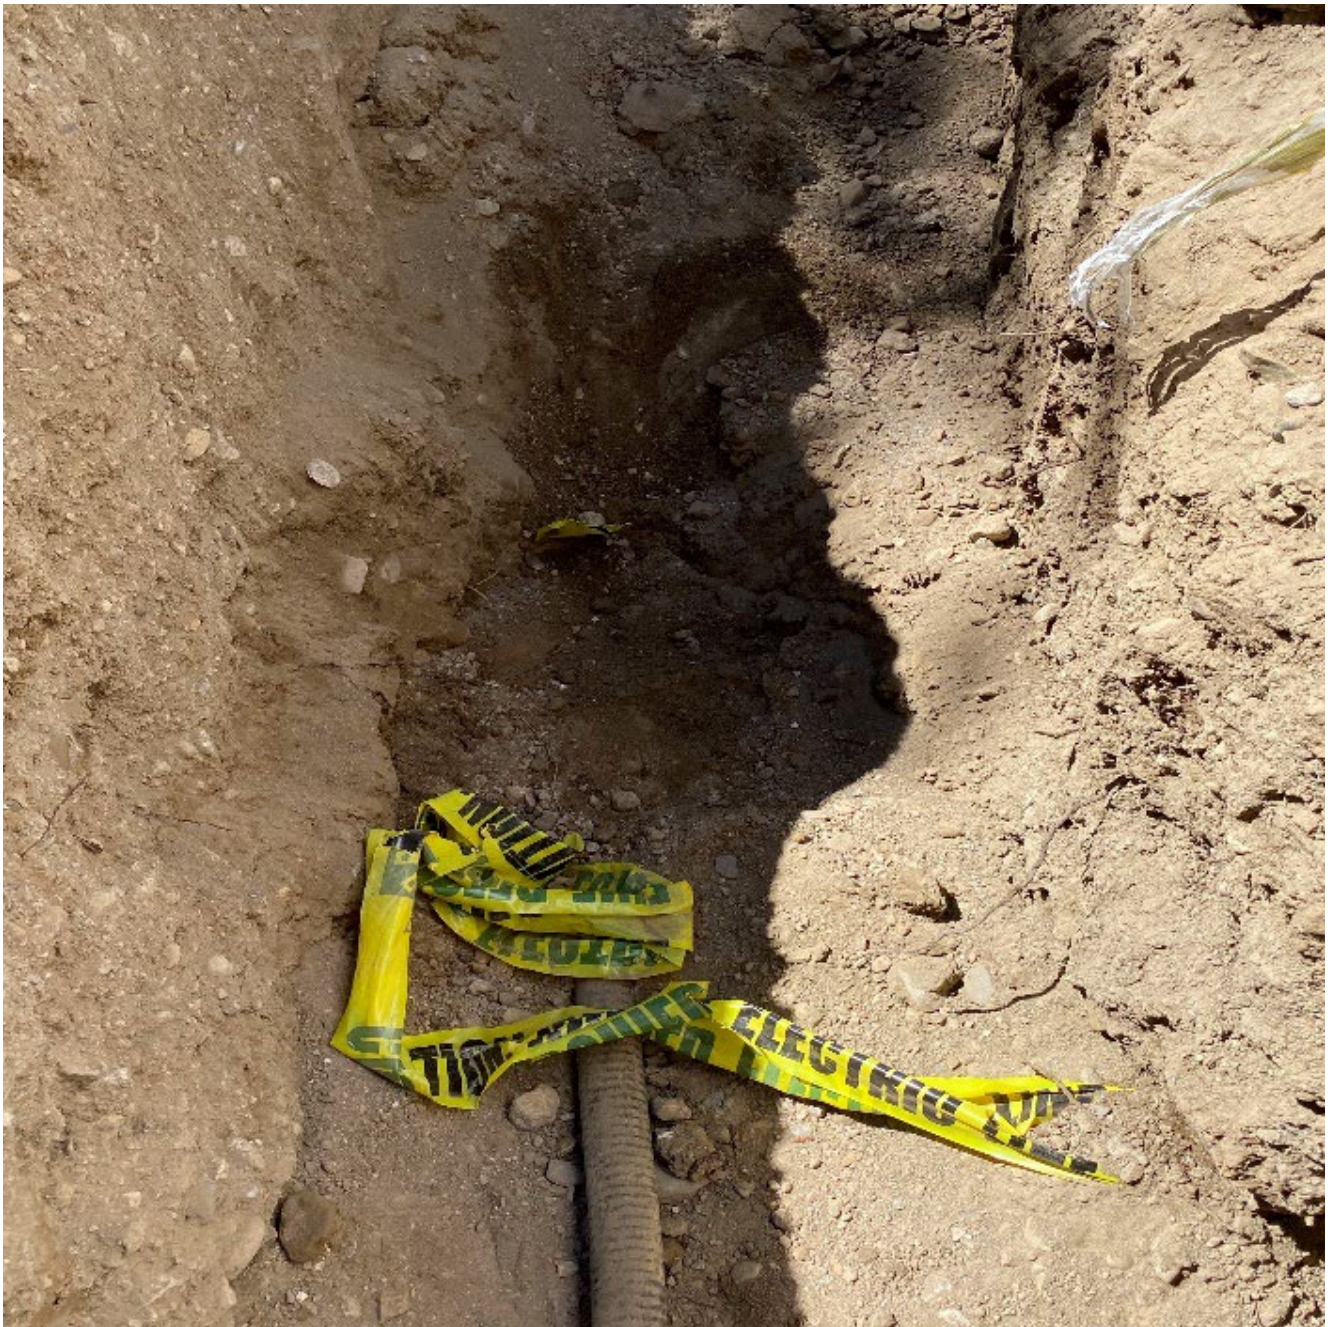
Photo 3 - Burial tape installed on top of sand and not half way between installation and grade.

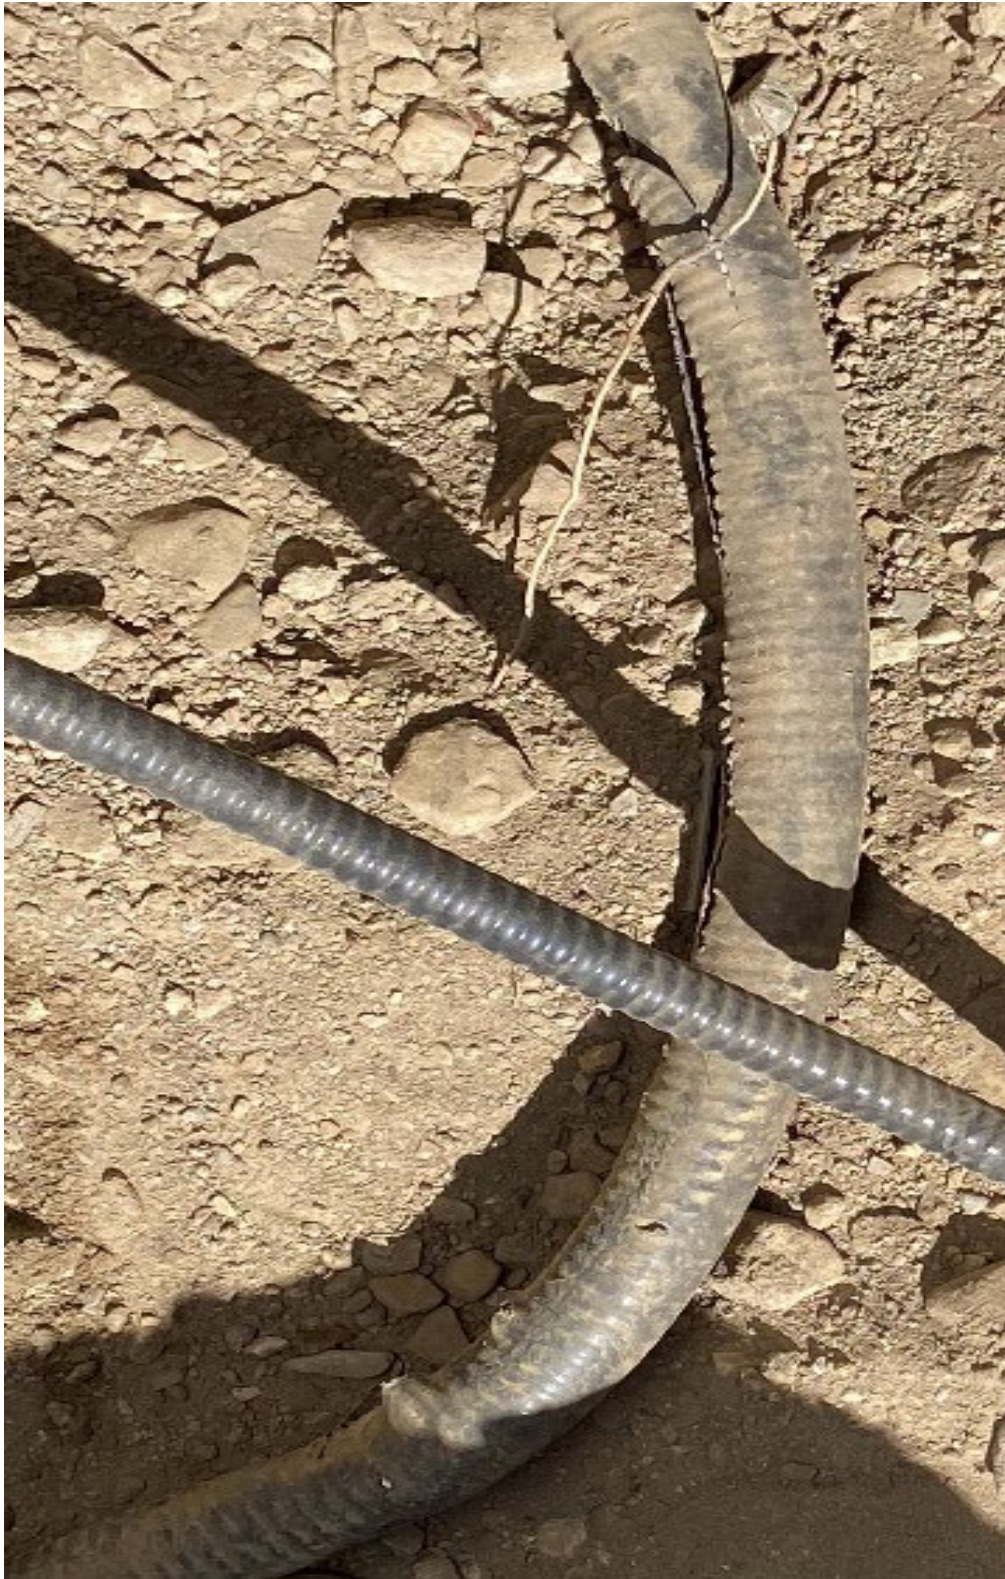
Photo 4 - Damage to outer jacket of cable where bucket came in contact with cable.

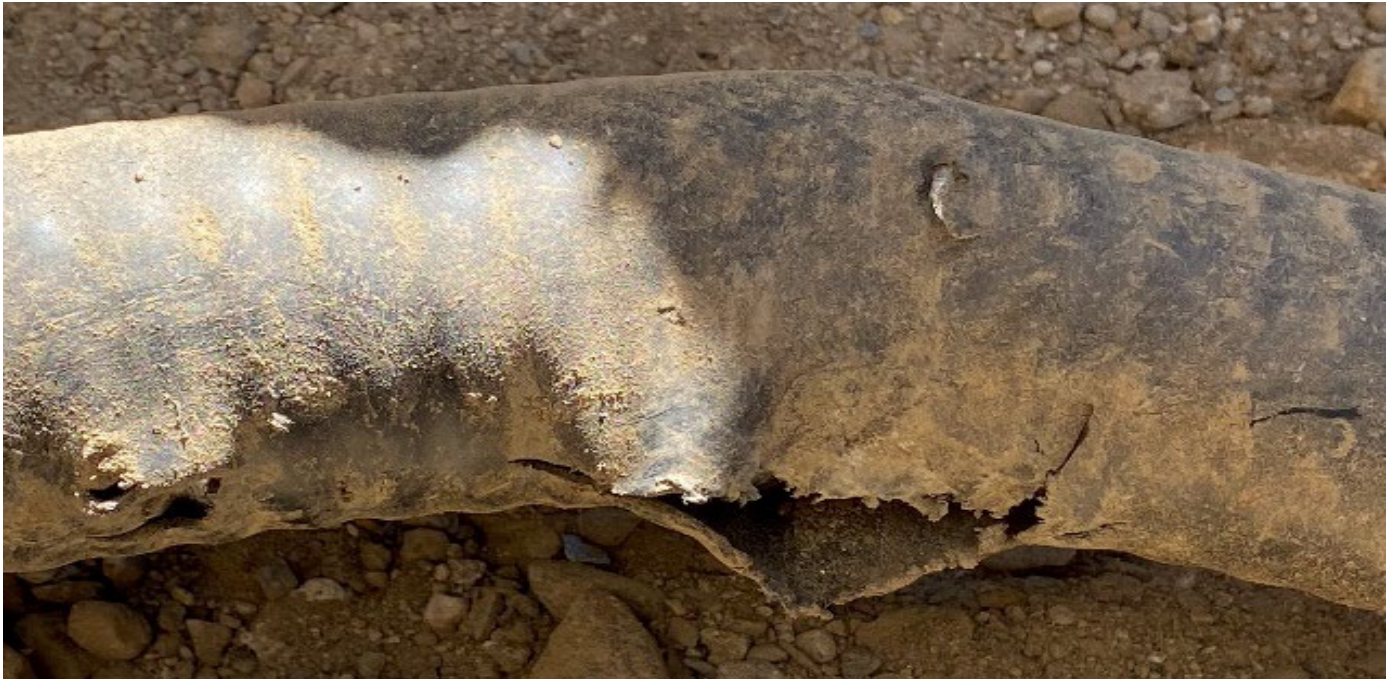
Photo 5 - Damage to outer jacket of cable where bucket came in contact with cable.

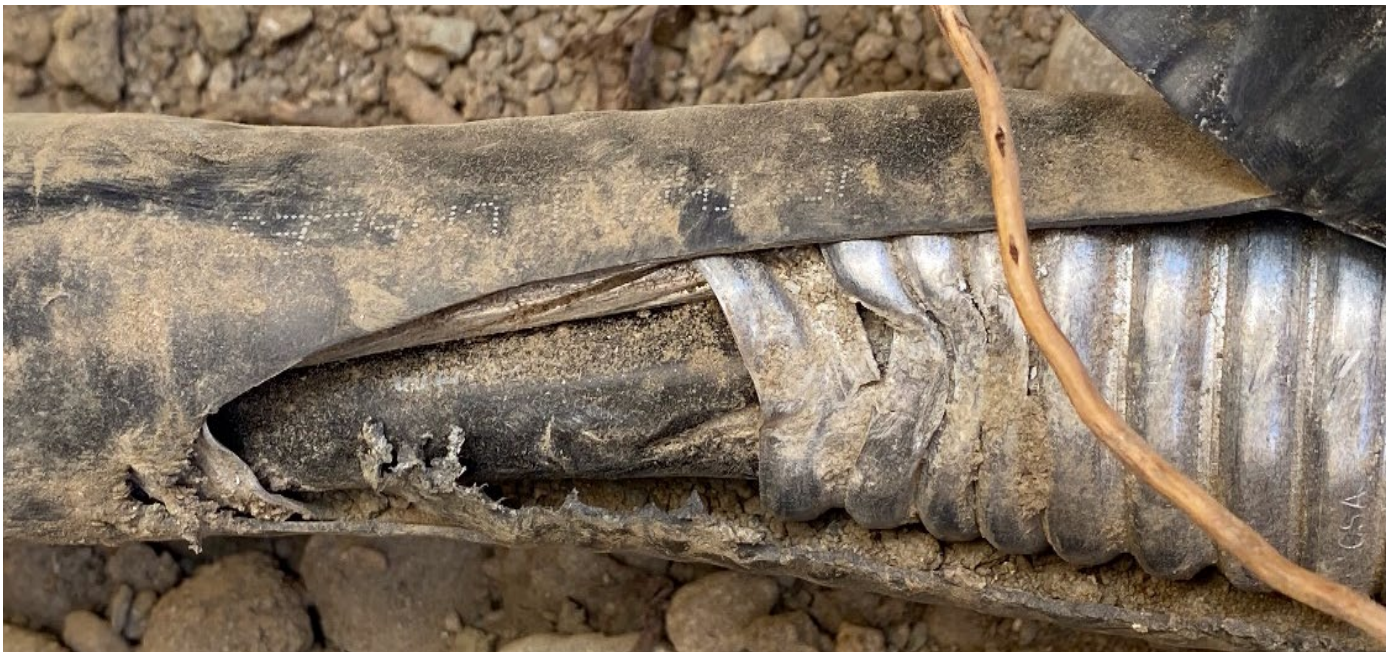
Photo 6 - Damage to outer jacket and armour of cable where bucket came in contact with cable.
