Incident Summary #II-1087124-2020 (#19499) (FINAL)

SUPPORTING INFORMATION	Incident Date		October 17, 2020
	Location		Peace River Region
	Regulated industry sector		Boilers, PV & refrigeration - Refrigeration system
	Impact Injury	Qty injuries	0
		Injury description	Not Applicable
		Injury rating	None
	Damage	Damage description	Failure of a pressure vessel releasing Freon into a machinery room.
		Damage rating	Major
	Incident rating		Major
Incident overview		While staff attempted to start a recreational facility's refrigeration plant for their cooling season, an uncontrolled release of Freon filled a machinery room to an extremely high concentration of 1200 Parts Per Million.	
INVESTIGATION CONCLUSIONS	Site, system and components		<p>During the cooling season, this recreational facility maintains its ice at sub-zero temperatures by circulating cooled brine throughout a piping system called the brine cycle. The brine cycle (Image 1) is made up of six main components: brine pump, expansion tank, chiller, Normally Open valve, the brine, and the substance to be cooled.</p> <p>At this facility the brine cycle begins at the brine pump, where brine is drawn from the cooling floor piping a

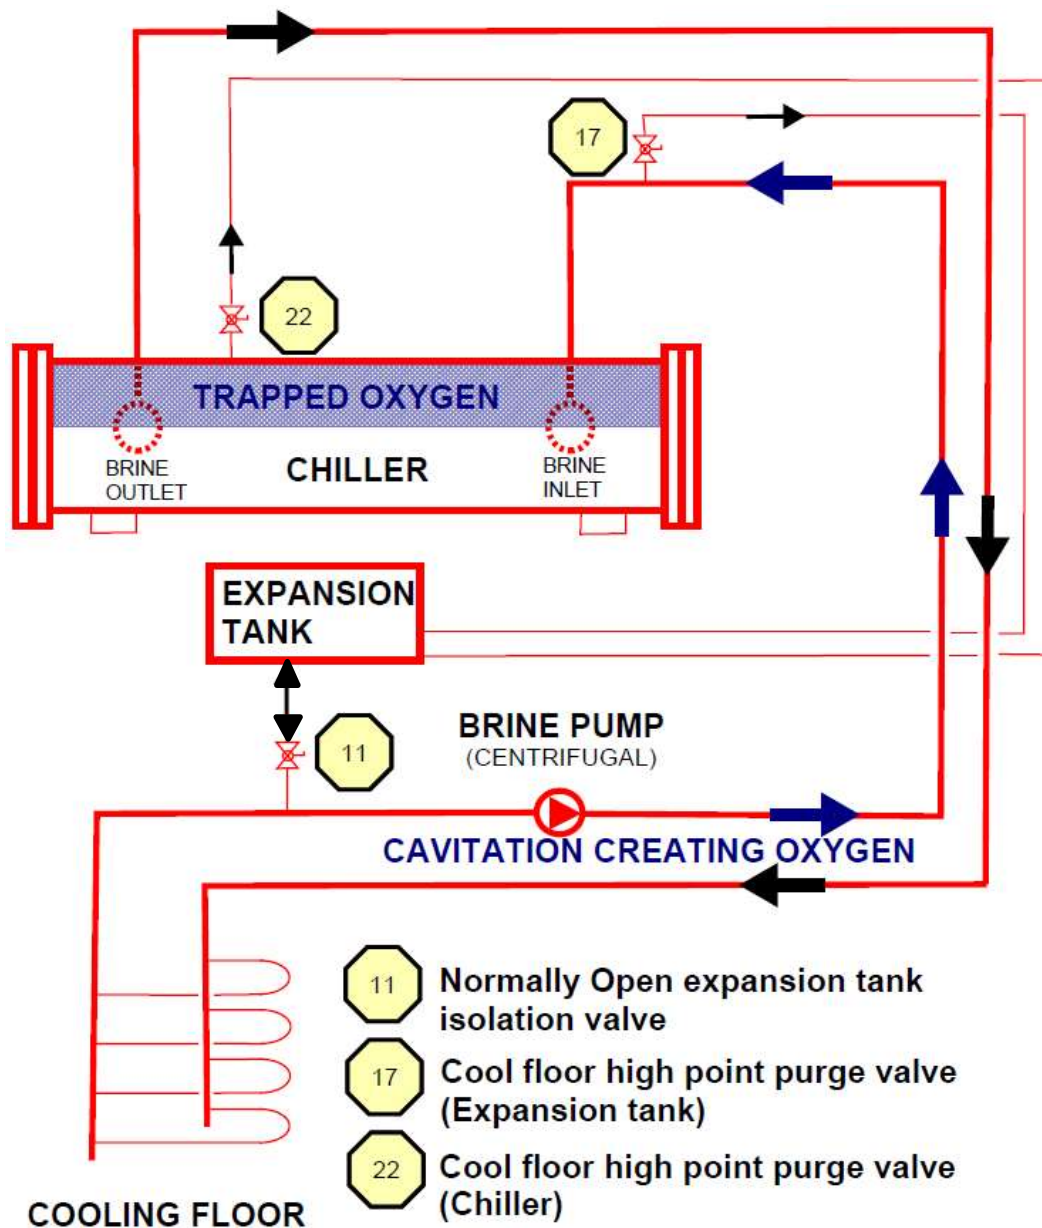
<ul style="list-style-type: none"> Staff reported that when opening the chillers purge valve (number 22 Image 1) to relieve the system of oxygen, Freon escaped into the machinery room.
Causes and contributing factors	<p>It is likely that the imbalanced brine solution, episodes of significant loss of brine, and trapped oxygen led to premature corrosion and thinning of the chillers inner tubes. This allowed Freon to enter the brine side of the chiller. So that when staff opened the chillers purge valve (number 22 Image 1) Freon entered the expansion tank and escaped into the machinery room.</p>

Image 1 Diagram highlighting brine pump cavitation, trapped oxygen in the Chiller, Normally Open valve, and purge valves.

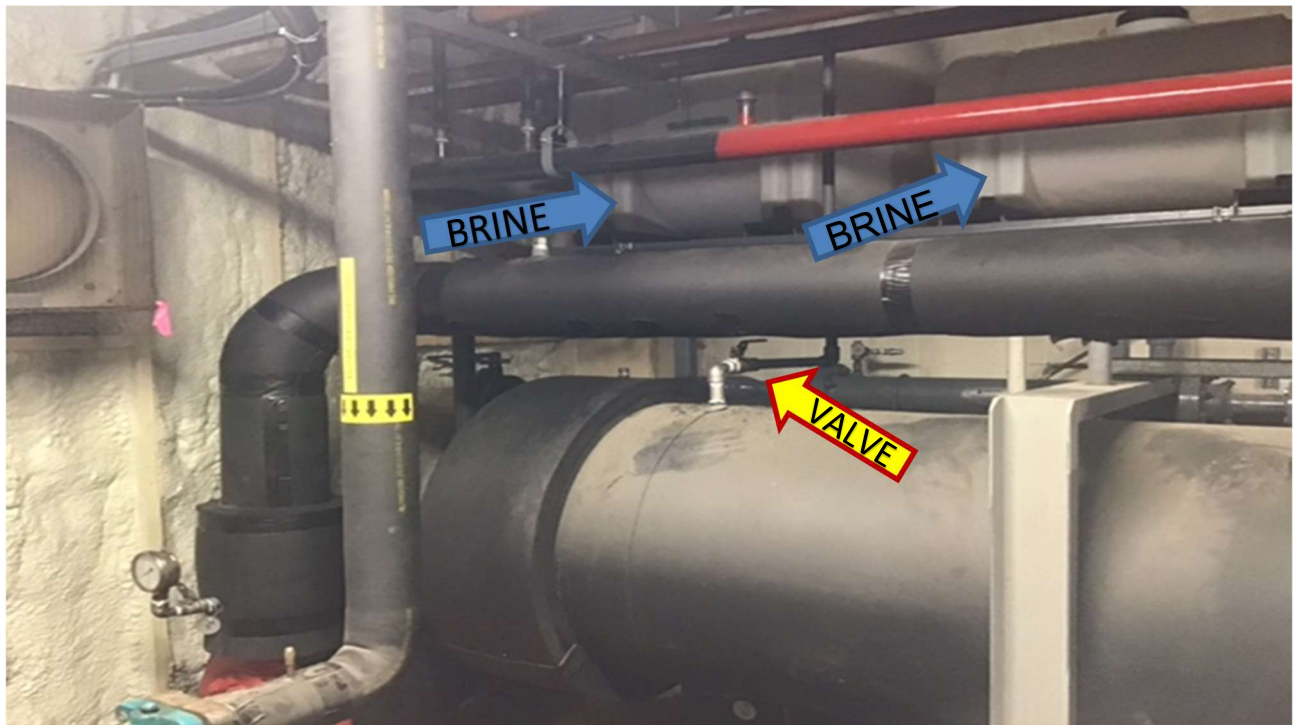
Image 3 **Existing Chiller highlighting location of cool floor high point purge valve item number 22 and brine expansion tanks.**

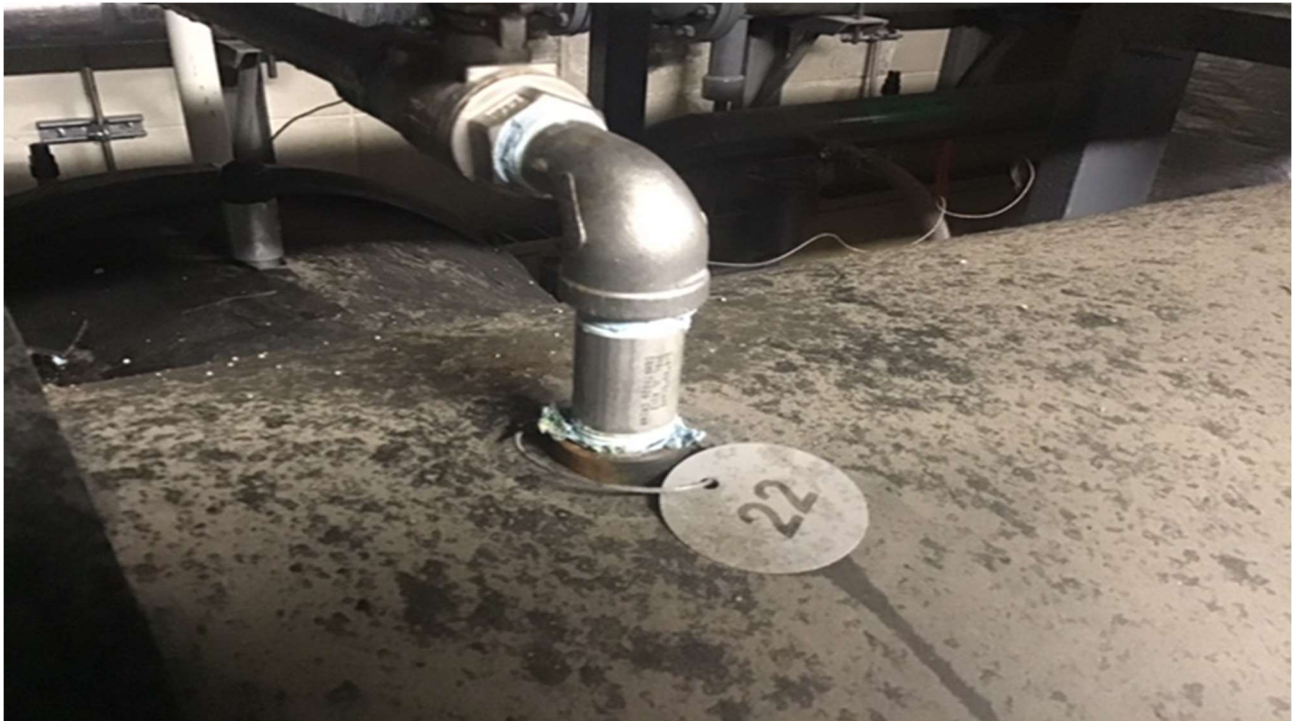
Image 4 Item number 22. Cool floor high point purge valve.

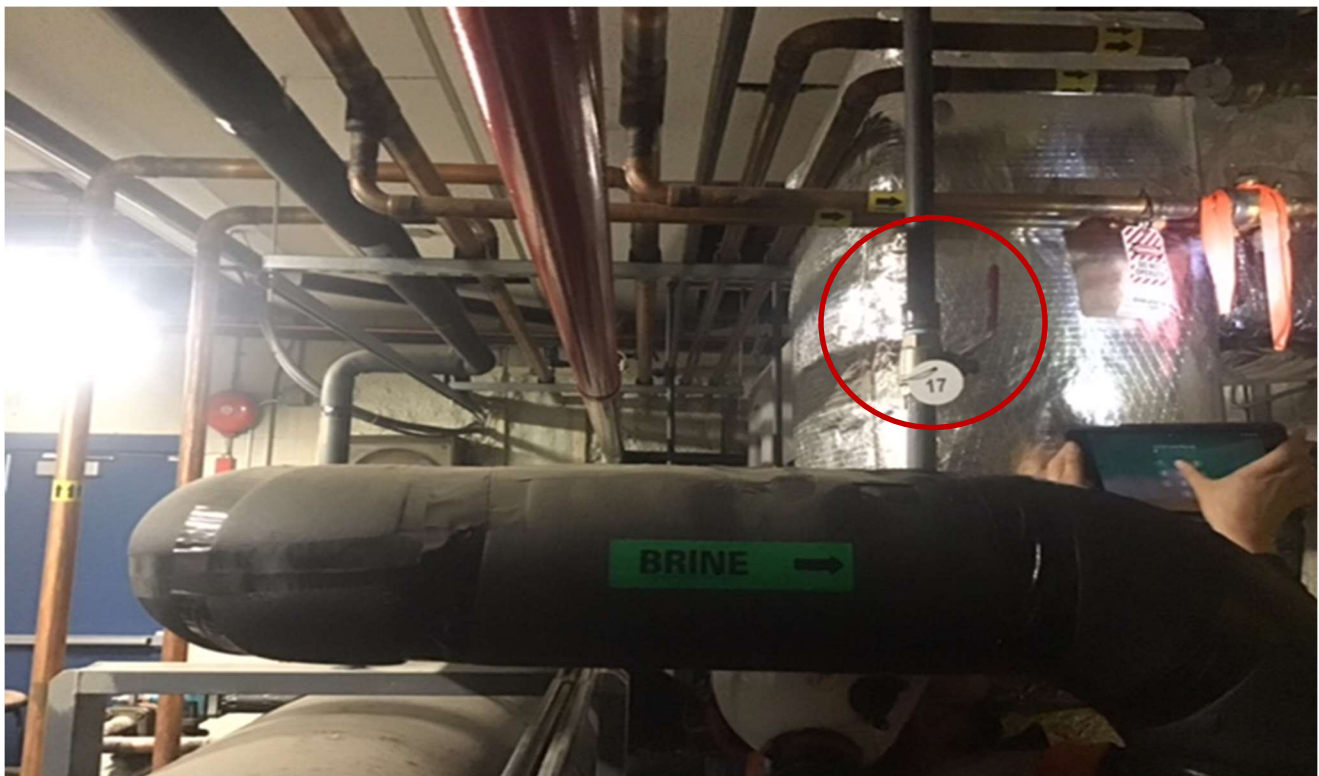
Image 5 Item number 17. Cool floor high point purge valve.

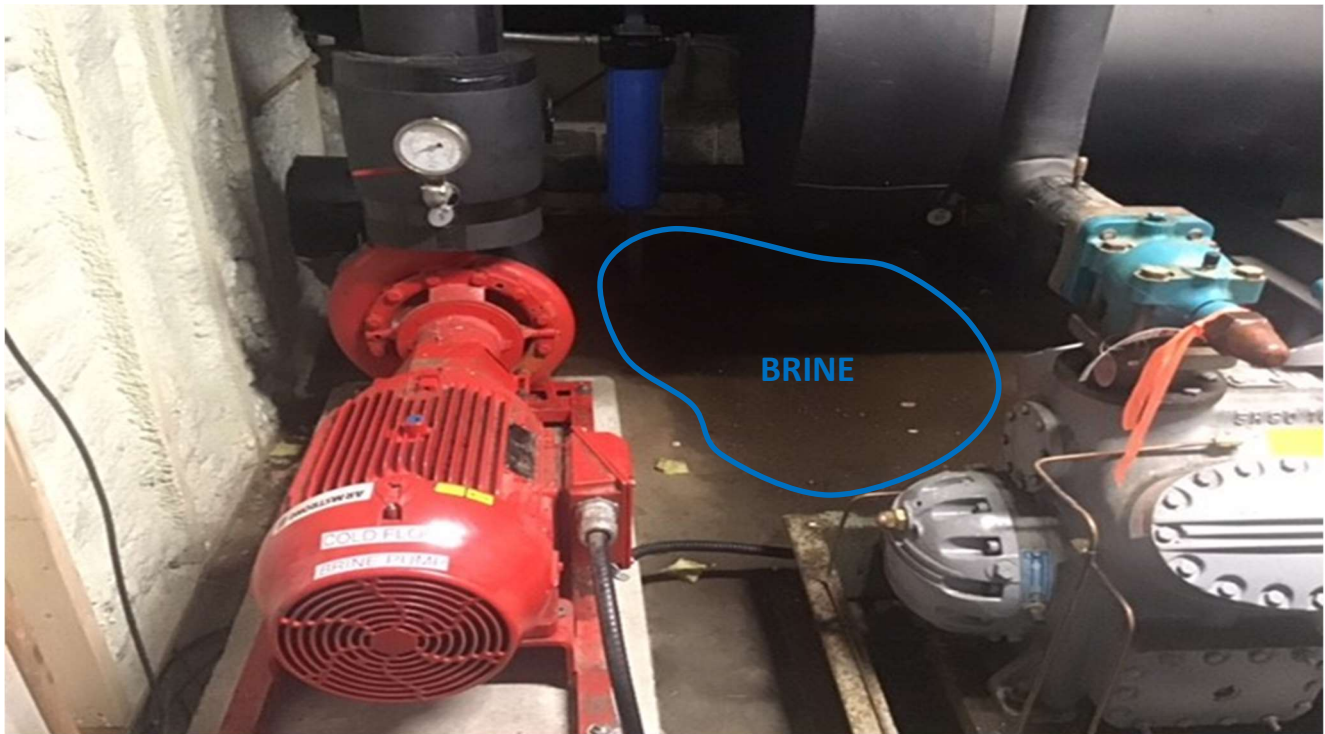
Image 6 **Existing centrifugal pump and pooled brine.**

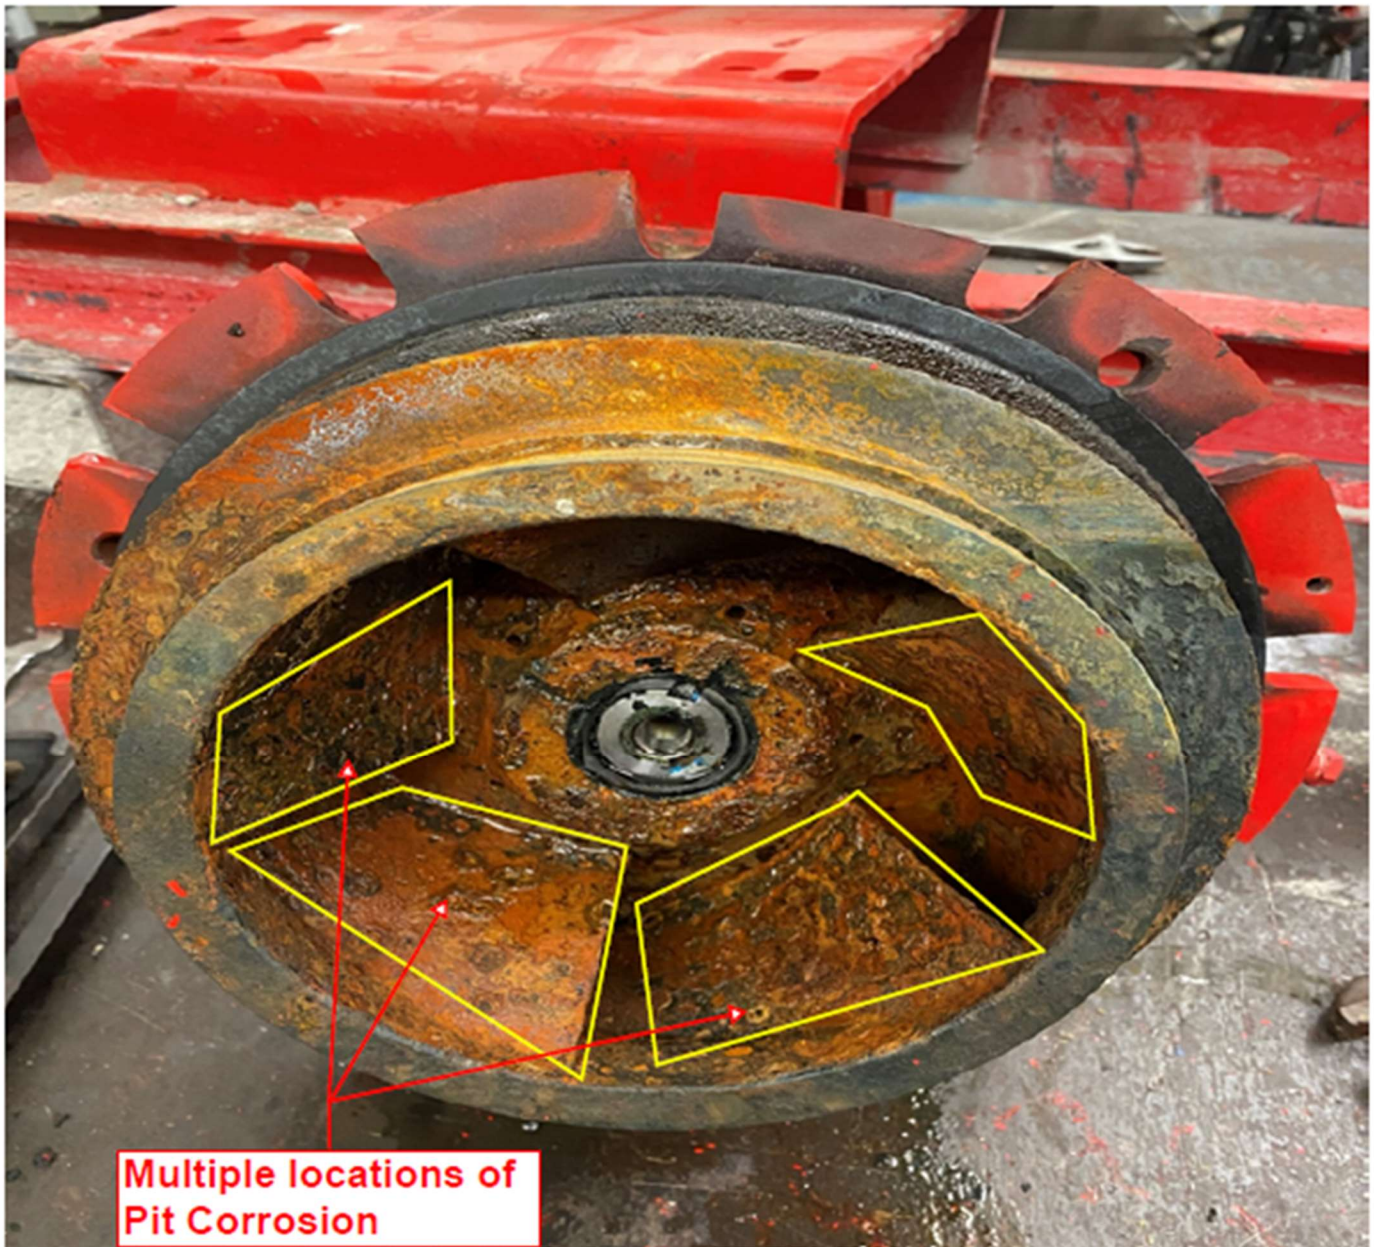
Image 10 **Pitted corrosion on existing brine pump impeller.**

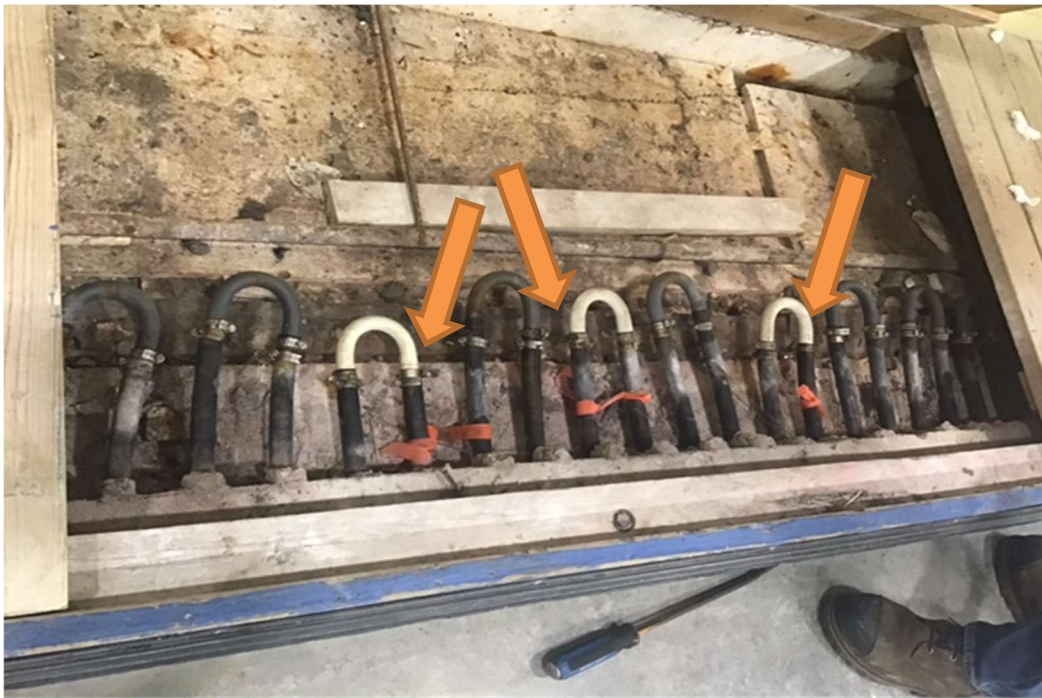
Image 11 **Brine leaks off Brine Cycle at 1" 180° turns of ice sheet.**

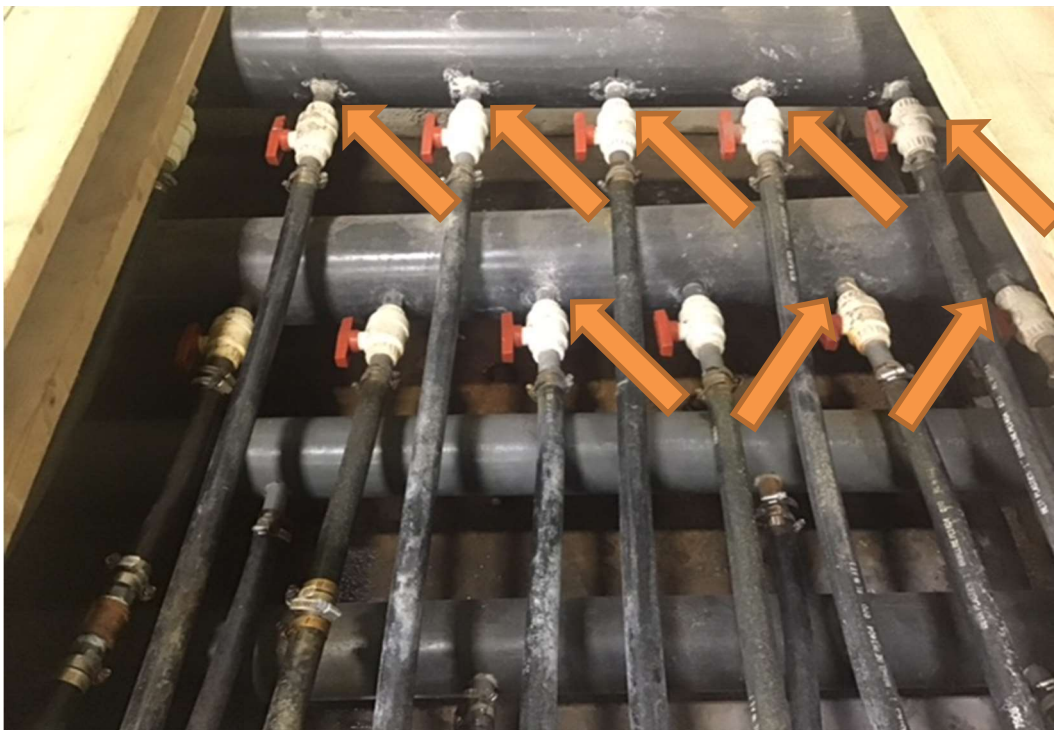
Image 12 **Brine leaks off Brine Cycle at 1" outlets off 6" supply and return piping**
