## Incident Summary #II-875227-2019 (#14105) (FINAL)

SUPPORTING INFORMATION	Incident Date		July 4, 2019	
	Location		Abbotsford	
	Regulated industry sector		Boilers, PV & refrigeration - Refrigeration system	
	Impact	Injury	Qty injuries	0
			Injury description	No injury reported
			Injury rating	None
		Damage	Damage description	A safety feature (flanged connection) failure in a refrigeration system released 10 to 20 lbs of ammonia intended to be contained.
			Damage rating	Minor
Incident rating			Minor	
Incident overview		An ammonia release resulted in the evacuation and temporary shutdown of an ammonia plant in an Industrial food processing facility.		
INVESTIGATION CONCLUSIONS	Site, system and components		Ammonia refrigeration system is designed to operate at 250 Psig. The system uses welded or flanged connections to connect components such as compressors, condenser, evaporators, and liquid receivers. Piping and fittings including flanges, different types of valves, elbows, tee's etc., makes the system complete. Gaskets are installed between the mating surfaces of the fittings to ensure a proper seal so that the refrigerant will not leak out into the atmosphere. When bolts on fla

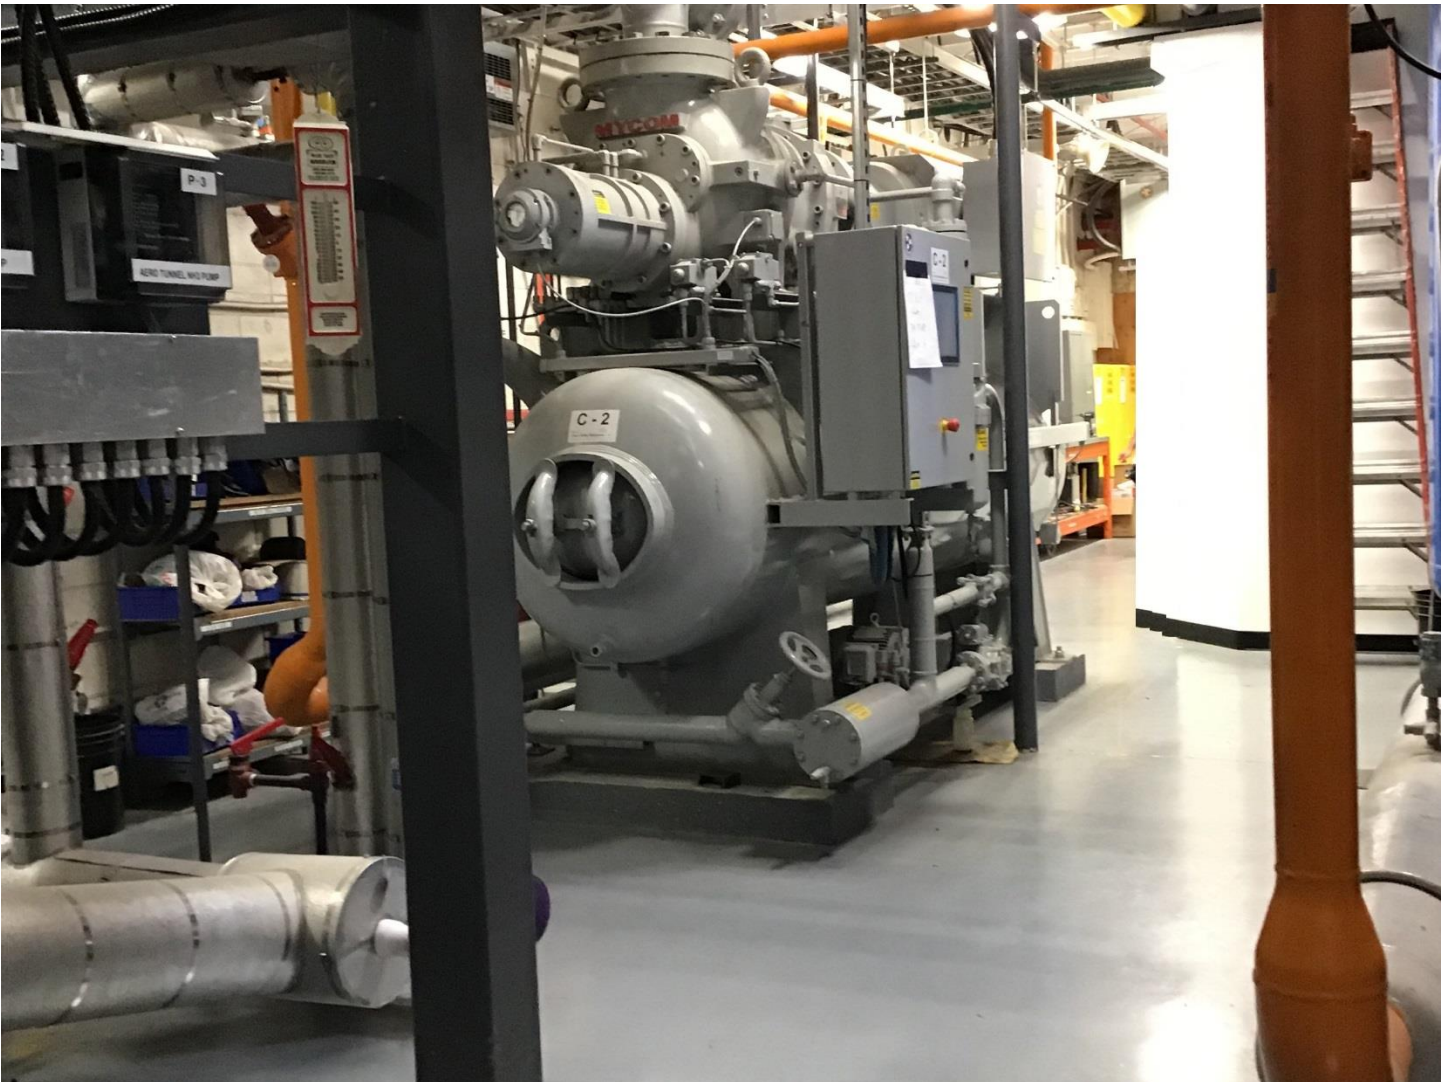
**COMPRESSOR**

<p>Leak detections:</p> <ul style="list-style-type: none"><li>• Maintenance contractor detected ammonia leak through litmus test</li><li>• The leak was found on flanged connection of 10" check valve at the suction side of compressor</li><li>• Maintenance contractor tightened the flange bolts which stopped the leak</li><li>• The ammonia concentration came down to zero in the room</li><li>• The compressor was shut down and isolated for inspection of flanged connection</li></ul> <p>Assessment of Flanged connection:</p> <ul style="list-style-type: none"><li>• The flanged connections were dismantled to assess the condition of the gasket and faces of the flanges.</li><li>• The Gasket was found a little off centered but had no signs of physical damage</li><li>• Flange faces were normal</li><li>• Gasket was replaced</li></ul>
<b>Causes and contributing factors</b>	<p>It is very likely that frequent start-up and shutdown of the plant caused thermal expansion and contraction of the piping, flange, and bolts. This combined with vibration occurring while the compressor is running caused the nuts on the bolts of the suction check valve flange to loosen which resulted in an ammonia release.</p>

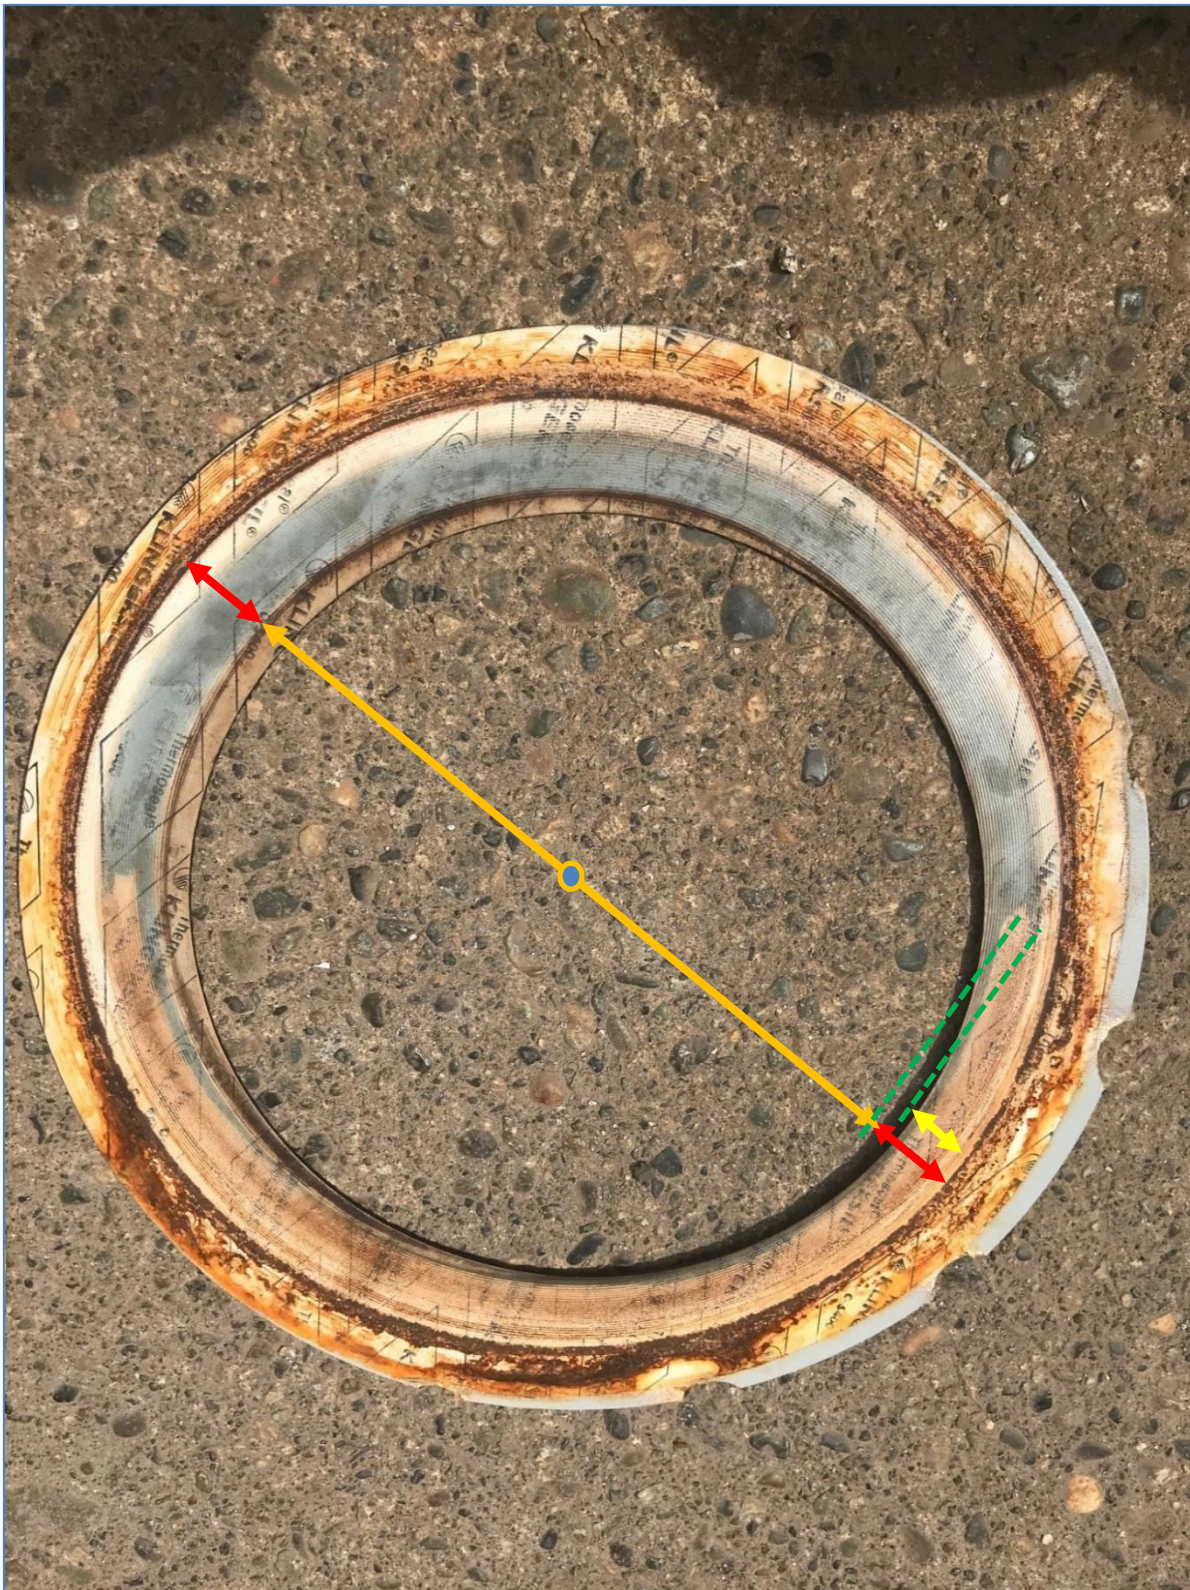
**Gasket picture** (arrows and dotted lines shows the gasket was a little bit off centered)
