## Incident Investigation Report

# Carbon Monoxide Release From Boiler Exhaust Venting

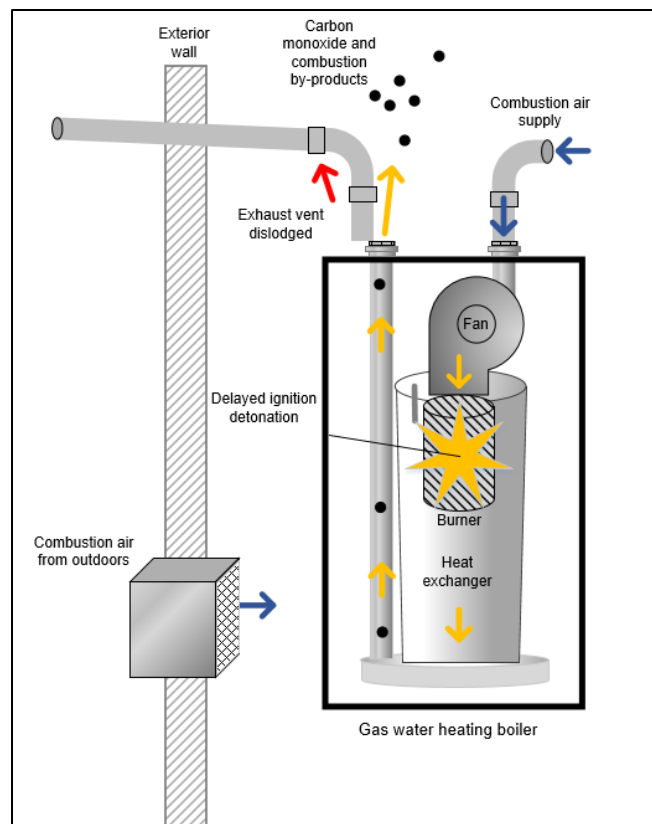
Figure 1 - Boiler delayed ignition damaging attached venting system and continuing to operate spilling flue products including CO into an indoor space.

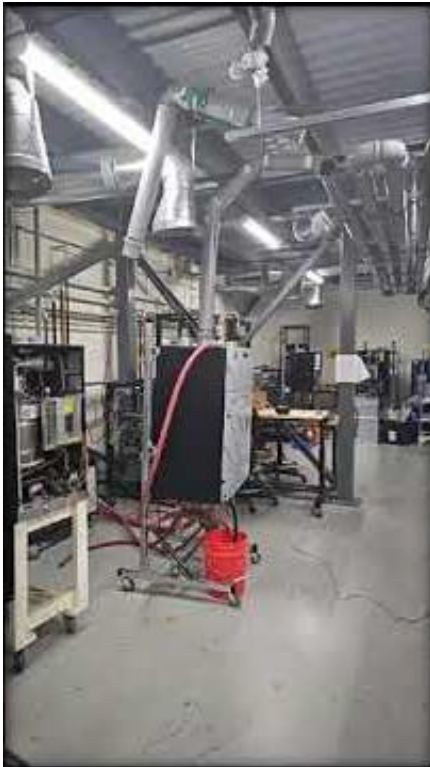
The testing showed that approved venting attached to a CSA 4.9-certified boiler could experience catastrophic failure during delayed ignition events that remained within the standard's permitted four second ignition timing. At certain intervals, between one and 2.5 seconds of delay, the venting was catastrophically damaged and, in several cases, dislodged from the boiler vent connector.

Video 1 - Catastrophic venting failure with a 1.0 second ignition delay.

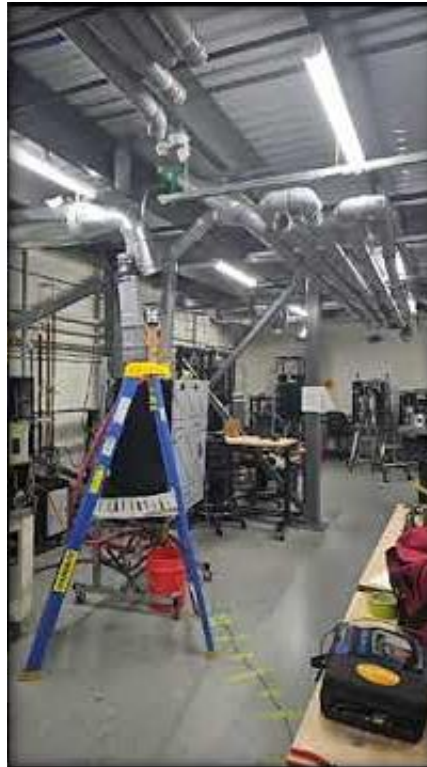
Video 2 - Catastrophic venting failure with a 2.5 second ignition delay.

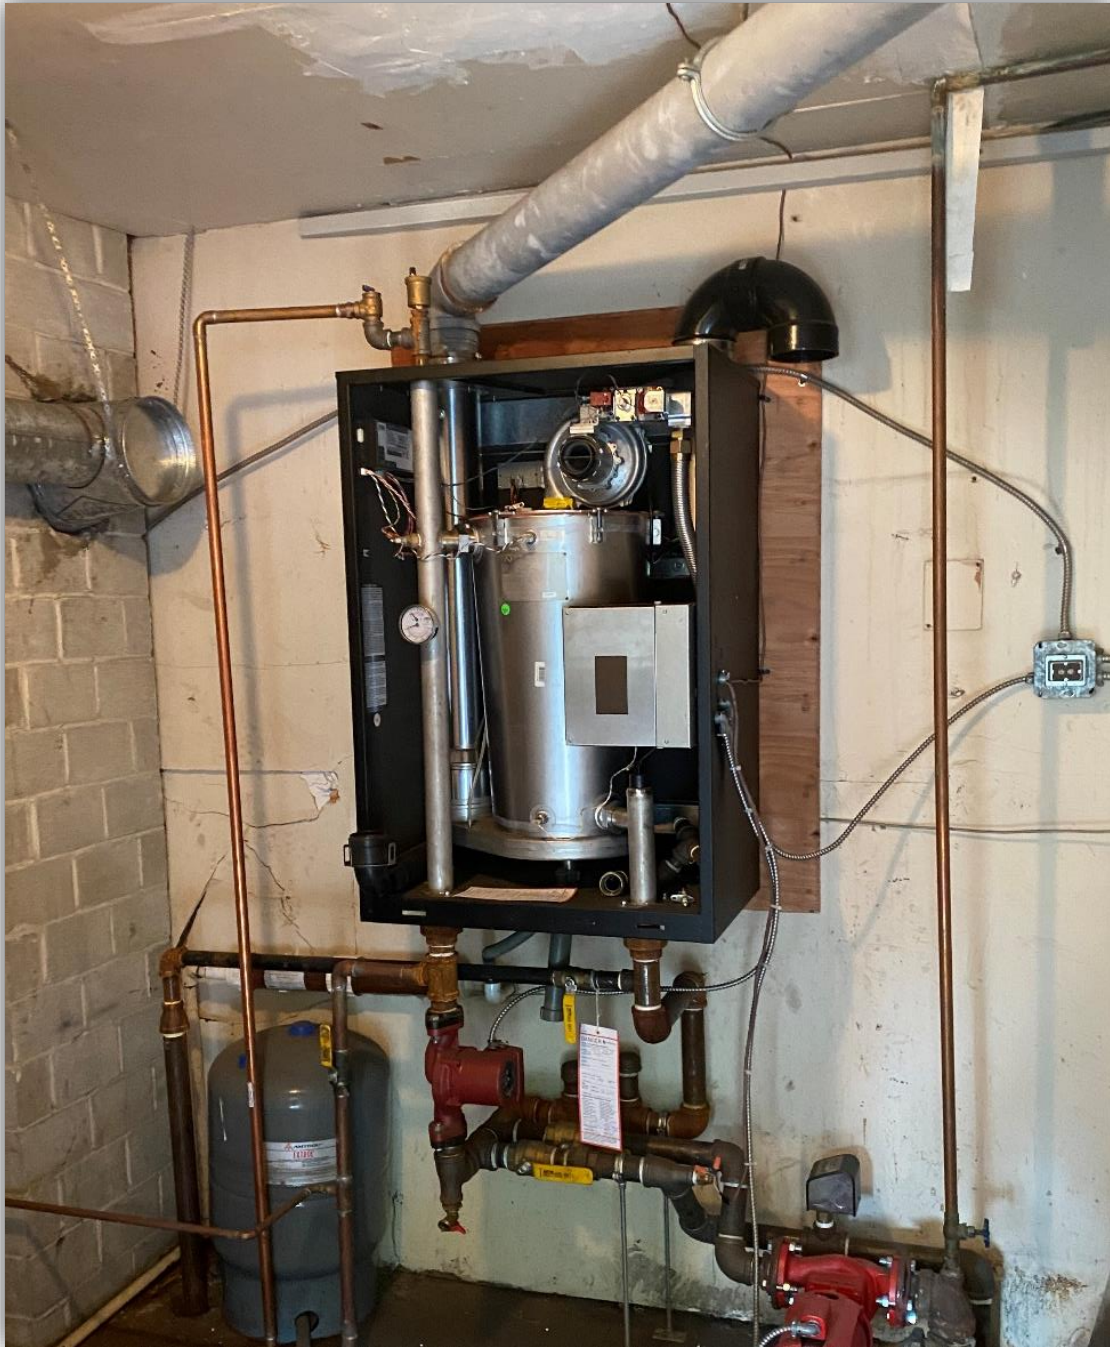
Image 1 – (Maple Ridge incident) Wall hung Boiler in the building mechanical room.

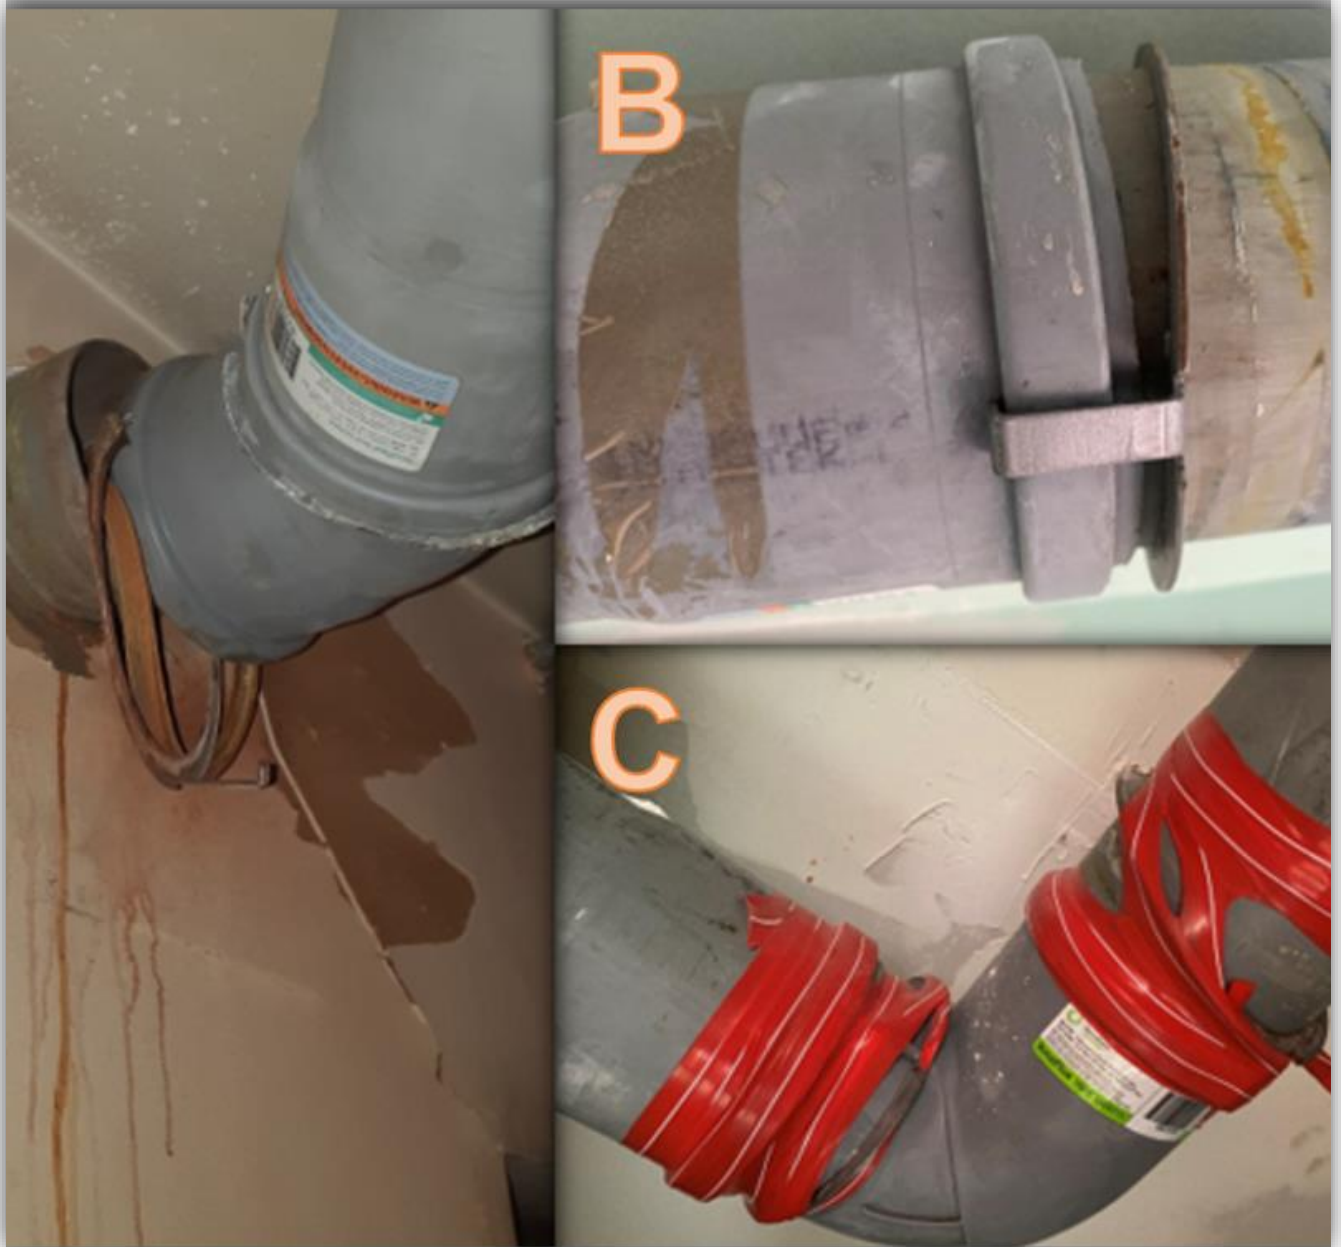
TSBC's investigation revealed that the Boiler had a history of delayed ignitions and the venting system had been damaged multiple times previously. The venting had been previously repaired incorrectly, indicating that delayed ignition occurrences had been an ongoing issue from the time of the Boiler's installation. Escaping products of combustion, including corrosive condensate, moisture, and CO, had infiltrated multiple interior spaces, causing corrosion to electrical distribution equipment, disintegration of the electrical room ceiling drywall, and bowing and splitting of the wood flooring in the dwelling above due to moisture buildup.

Image 2 – (Maple Ridge incident) Multiple locations of damaged venting showing a dislodged elbow [A], a backed-out connection with an intact retaining ring [B], and a previously repaired elbow with the addition of red tape to help keep the connection together [C]. The red taped connection [C] shows stretching and tearing from a subsequent delayed ignition after its repair.

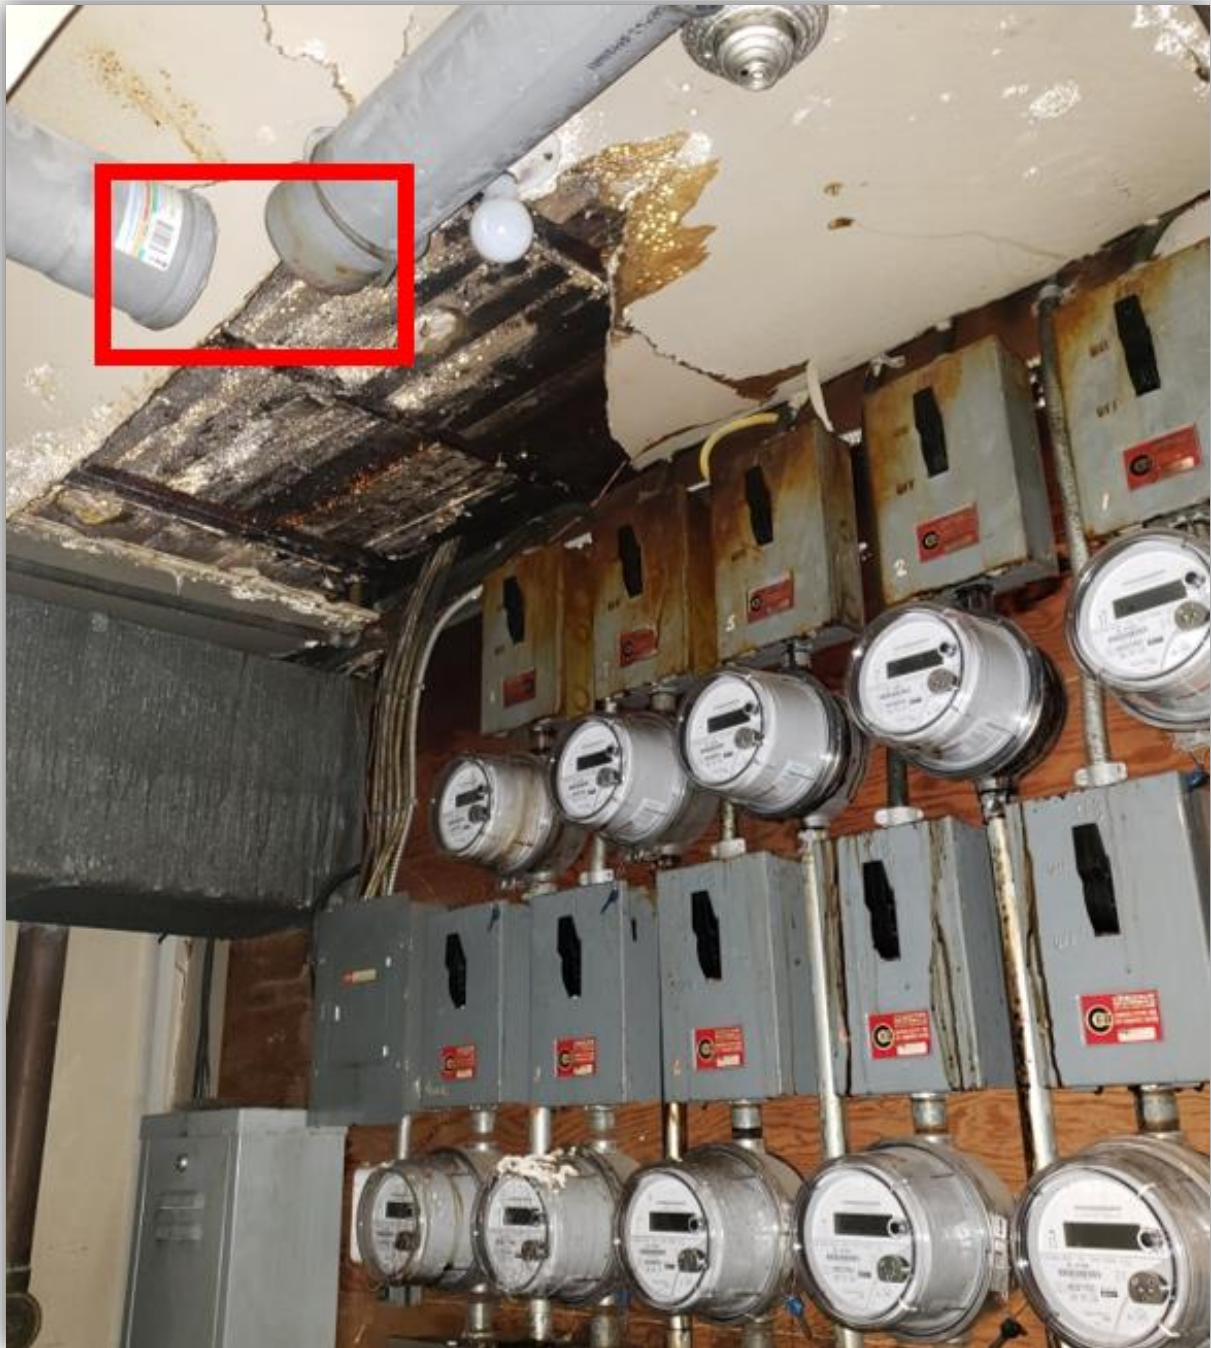
Image 3 – (Maple Ridge incident) Tenant captured image of a missing vent elbow along with the damaged and mouldy drywall above the electrical meters from the sustained operation of the boiler after a delayed ignition damaged the venting.

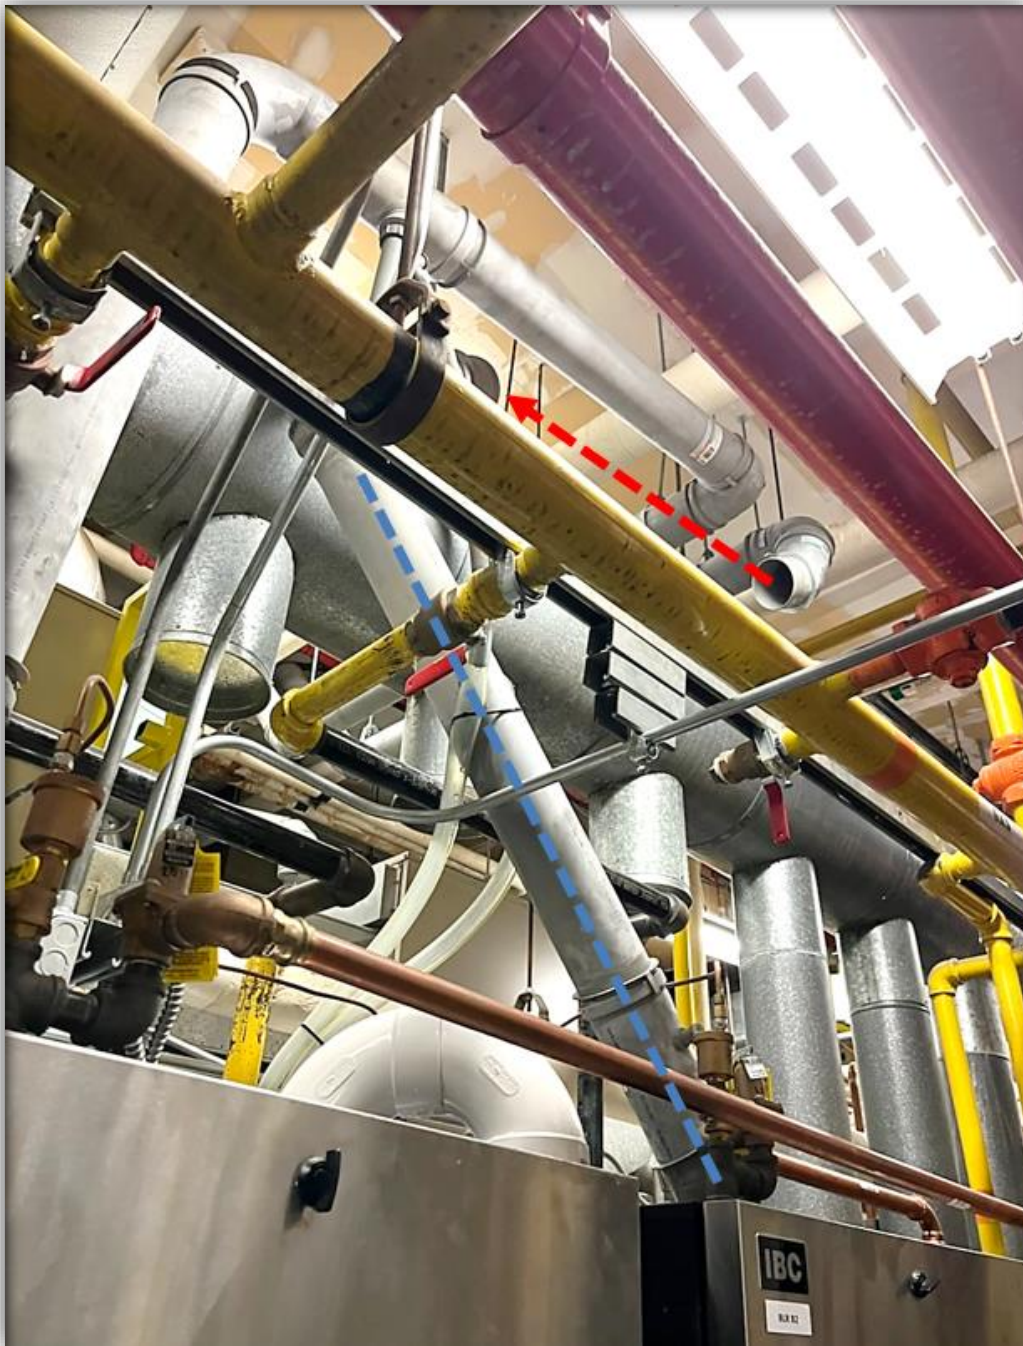
Image 4 – Additional incident ([Appendix A](#) - #4) showing dislodged polypropylene venting from delayed ignitions.

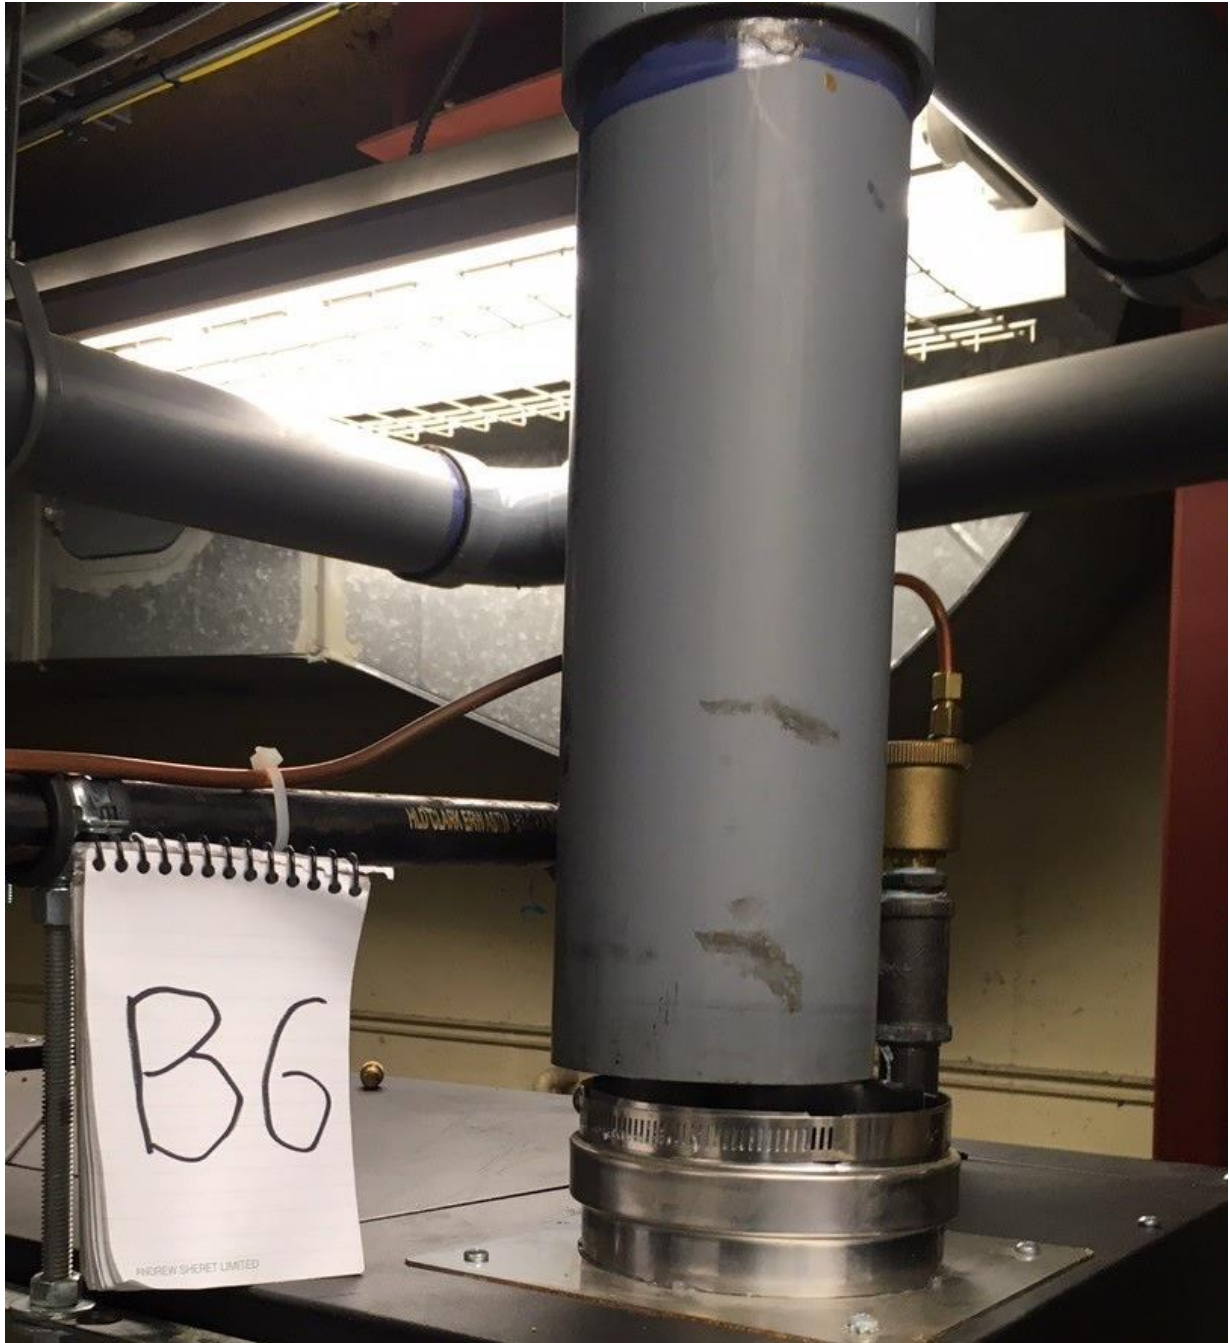
Image 5 - Additional incident ([Appendix A](#) - #1) showing CPVC venting dislodged from boiler vent connection from delayed ignitions.

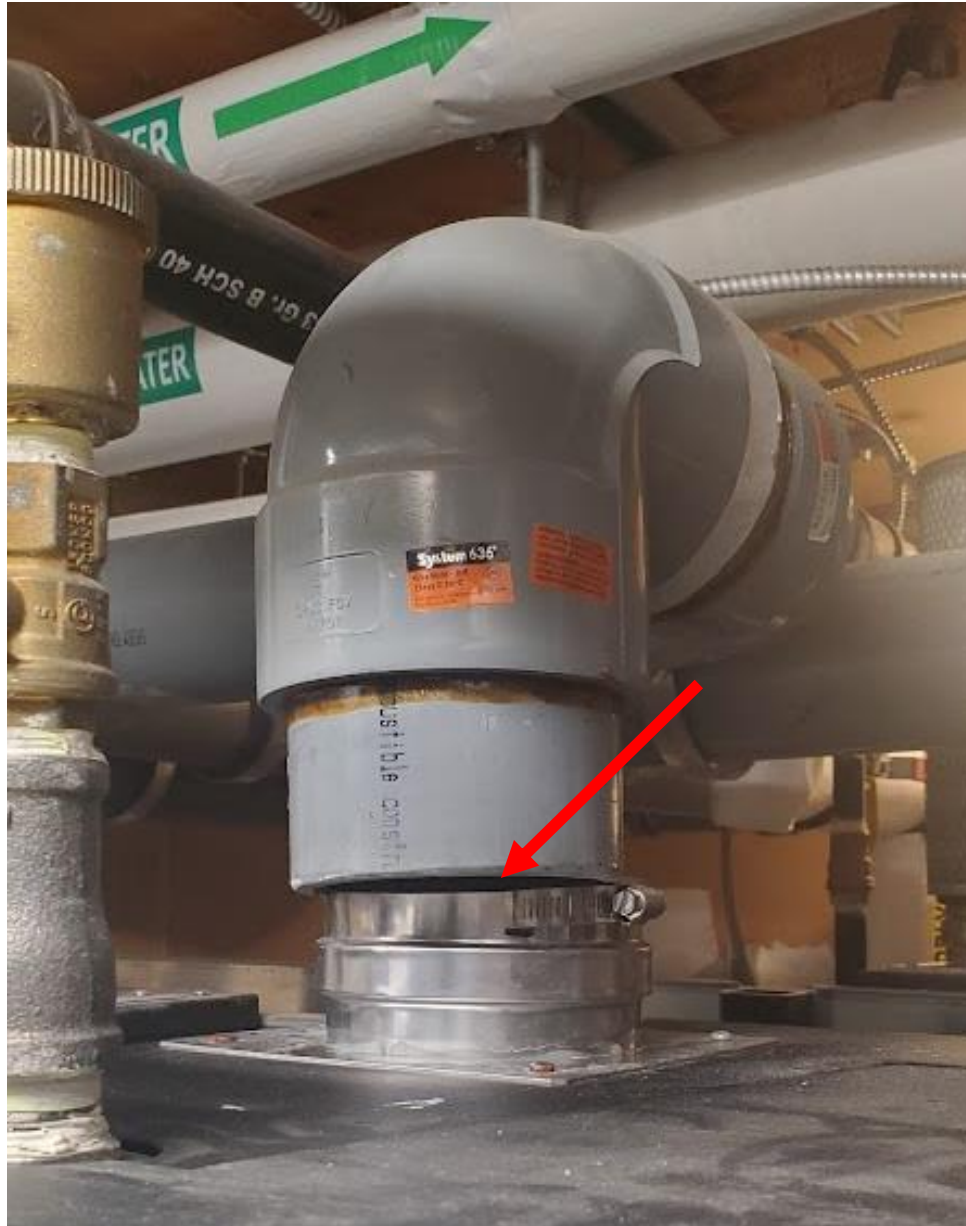
Image 6 - Additional incident ([Appendix A](#) - #5) showing CPVC venting dislodged from boiler vent connection from delayed ignitions.

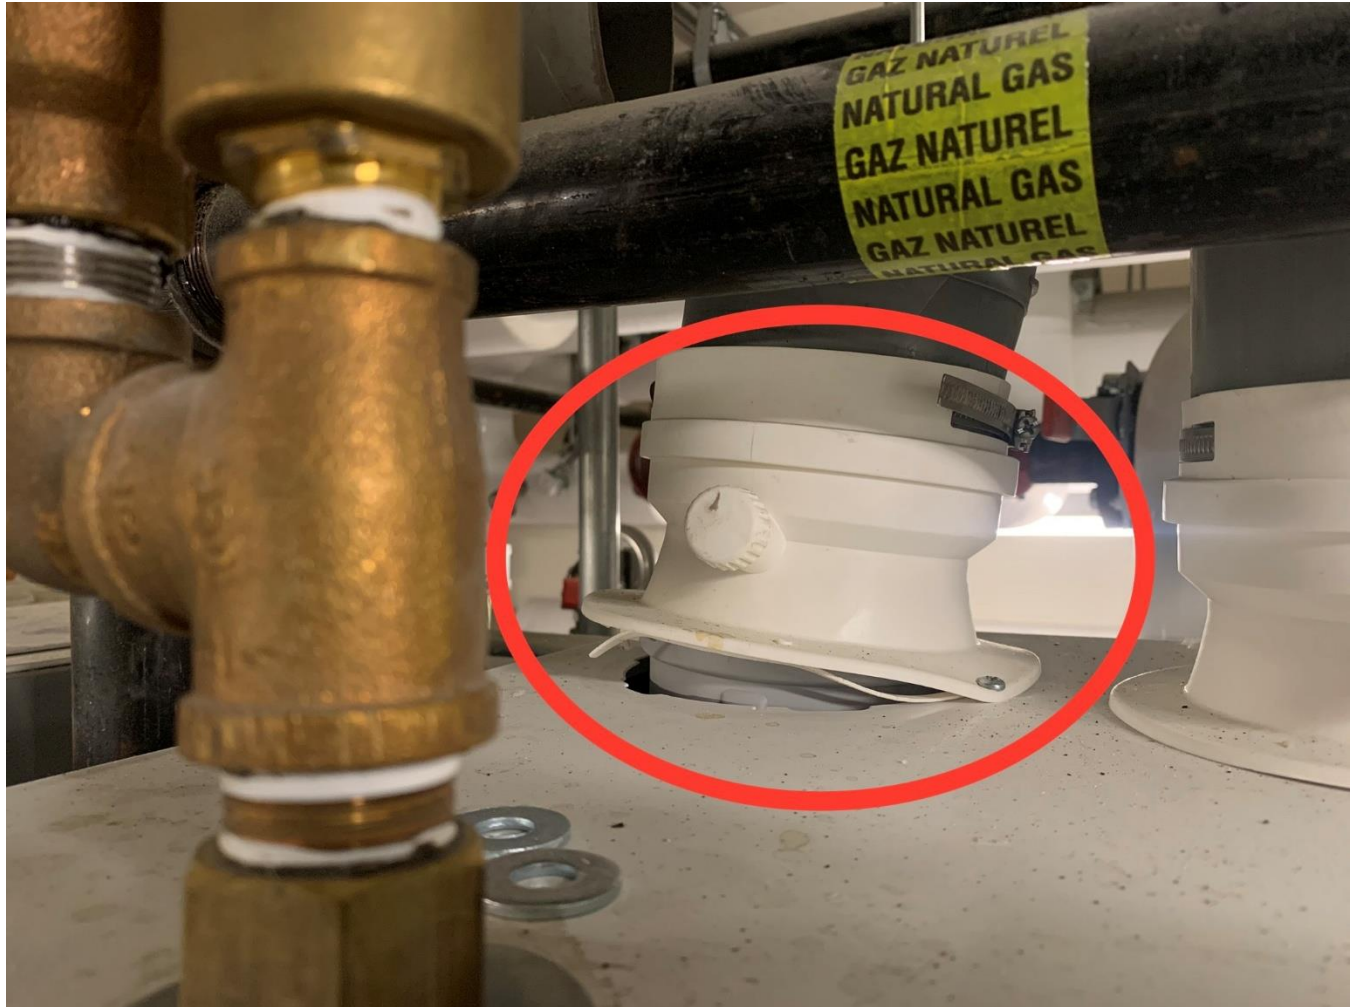
Image 7 - Additional incident ([Appendix A](#) - #7) showing vent output adapter dislodged from the boiler enclosure from delayed ignitions.

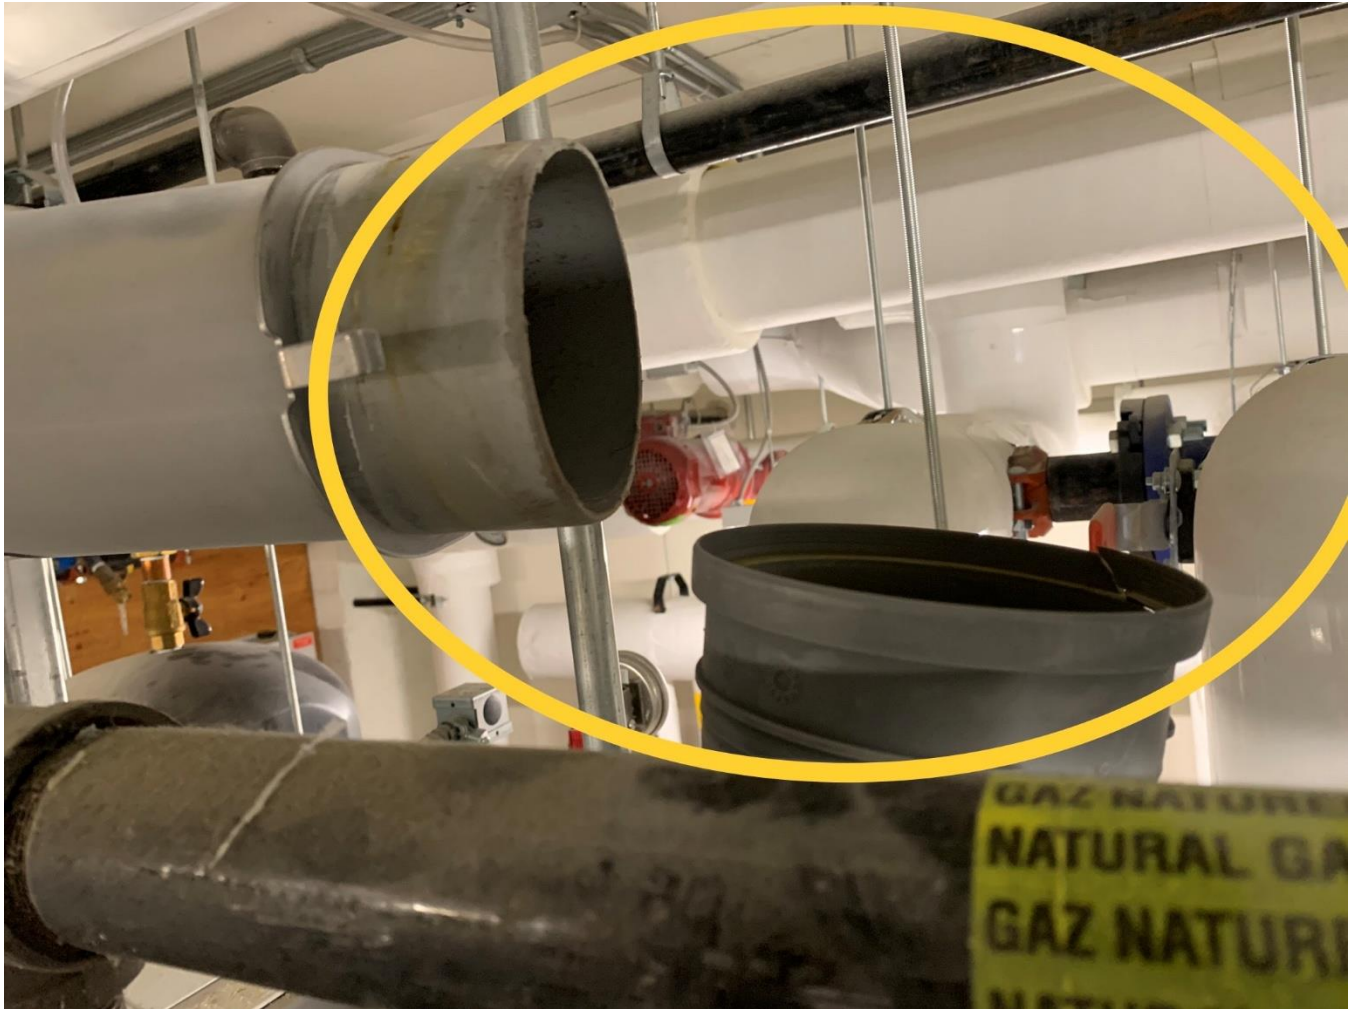
Image 8 - Additional incident ([Appendix A](#) - #7) showing 90-degree polypropylene vent fitting missing from the venting system at the top of the boiler and cracked vent piping from delayed ignitions.

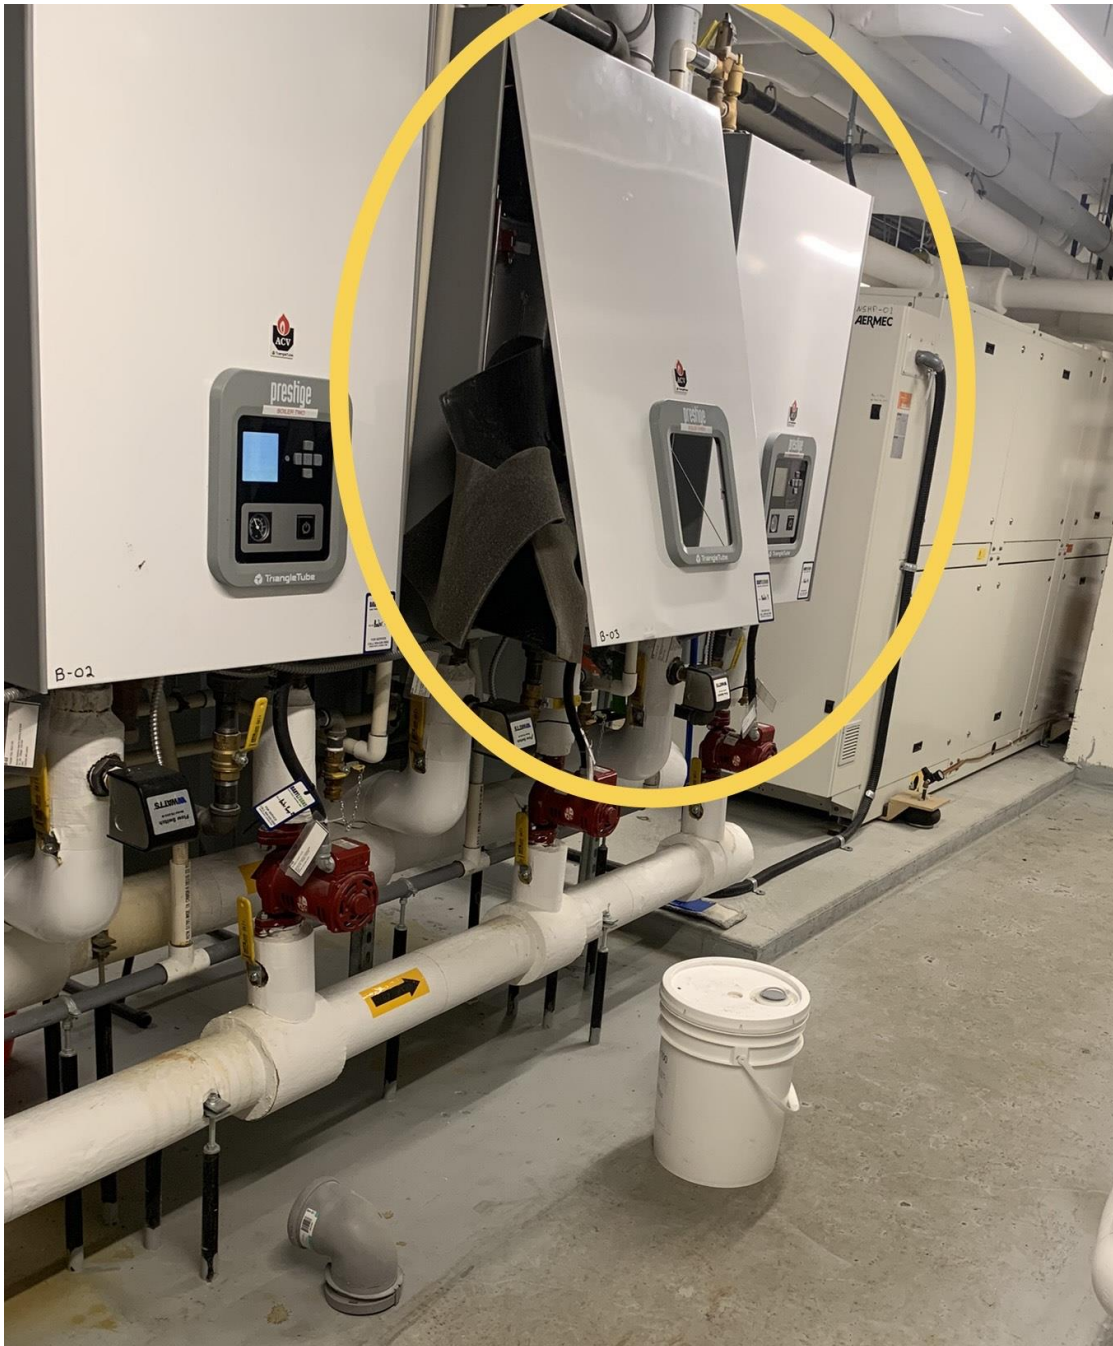
Image 9 - Additional incident ([Appendix A](#) - #7) showing boiler cover blown open from delayed ignitions.

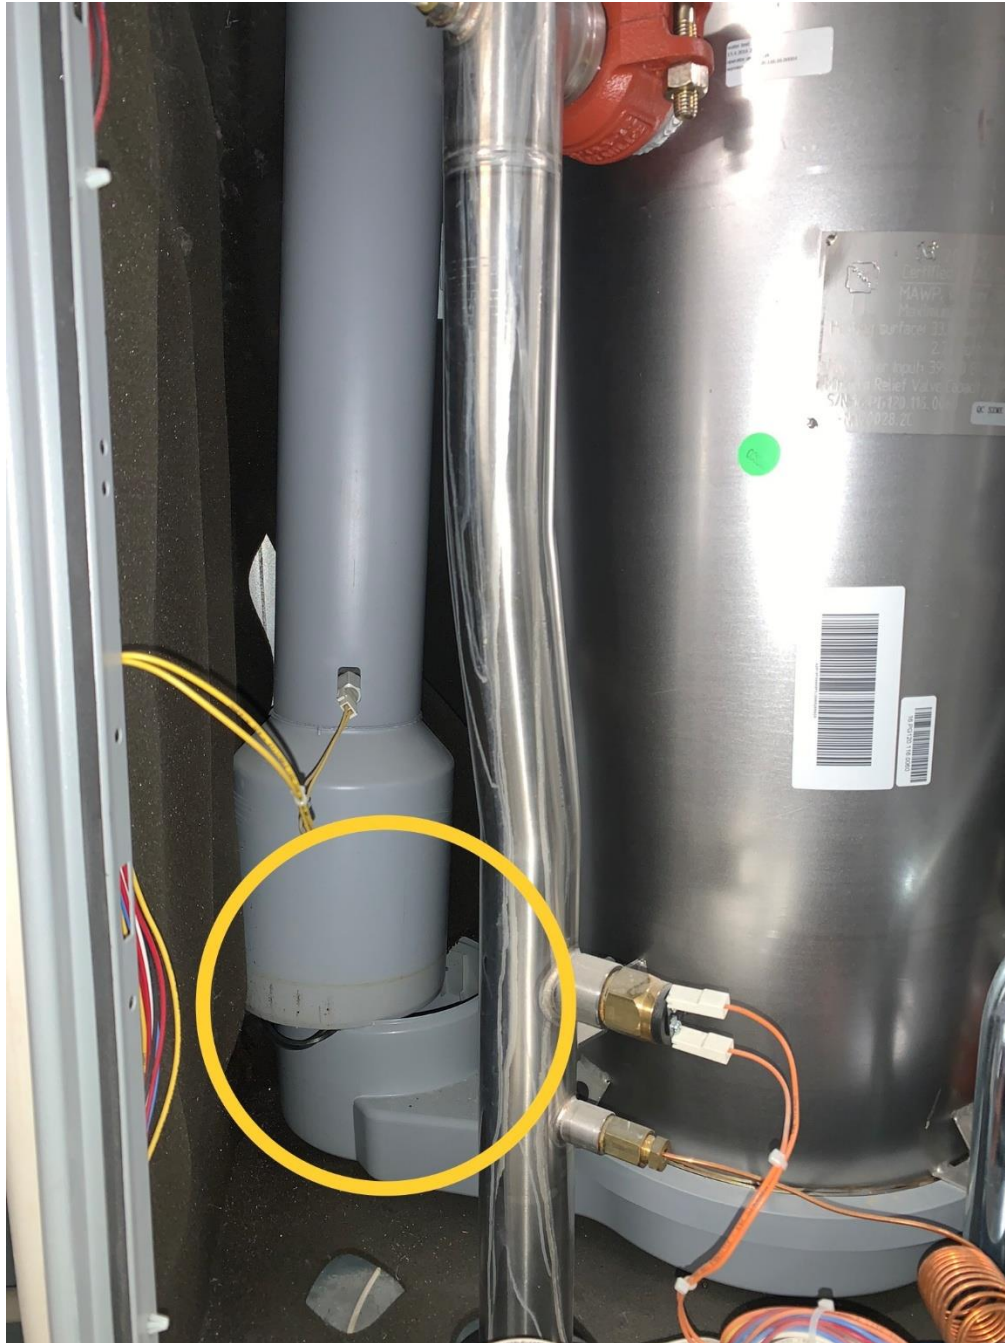
Image 10 - Additional incident ([Appendix A](#) - #7) showing the internal venting output pipe dislodged from the condensate pan from delayed ignitions.

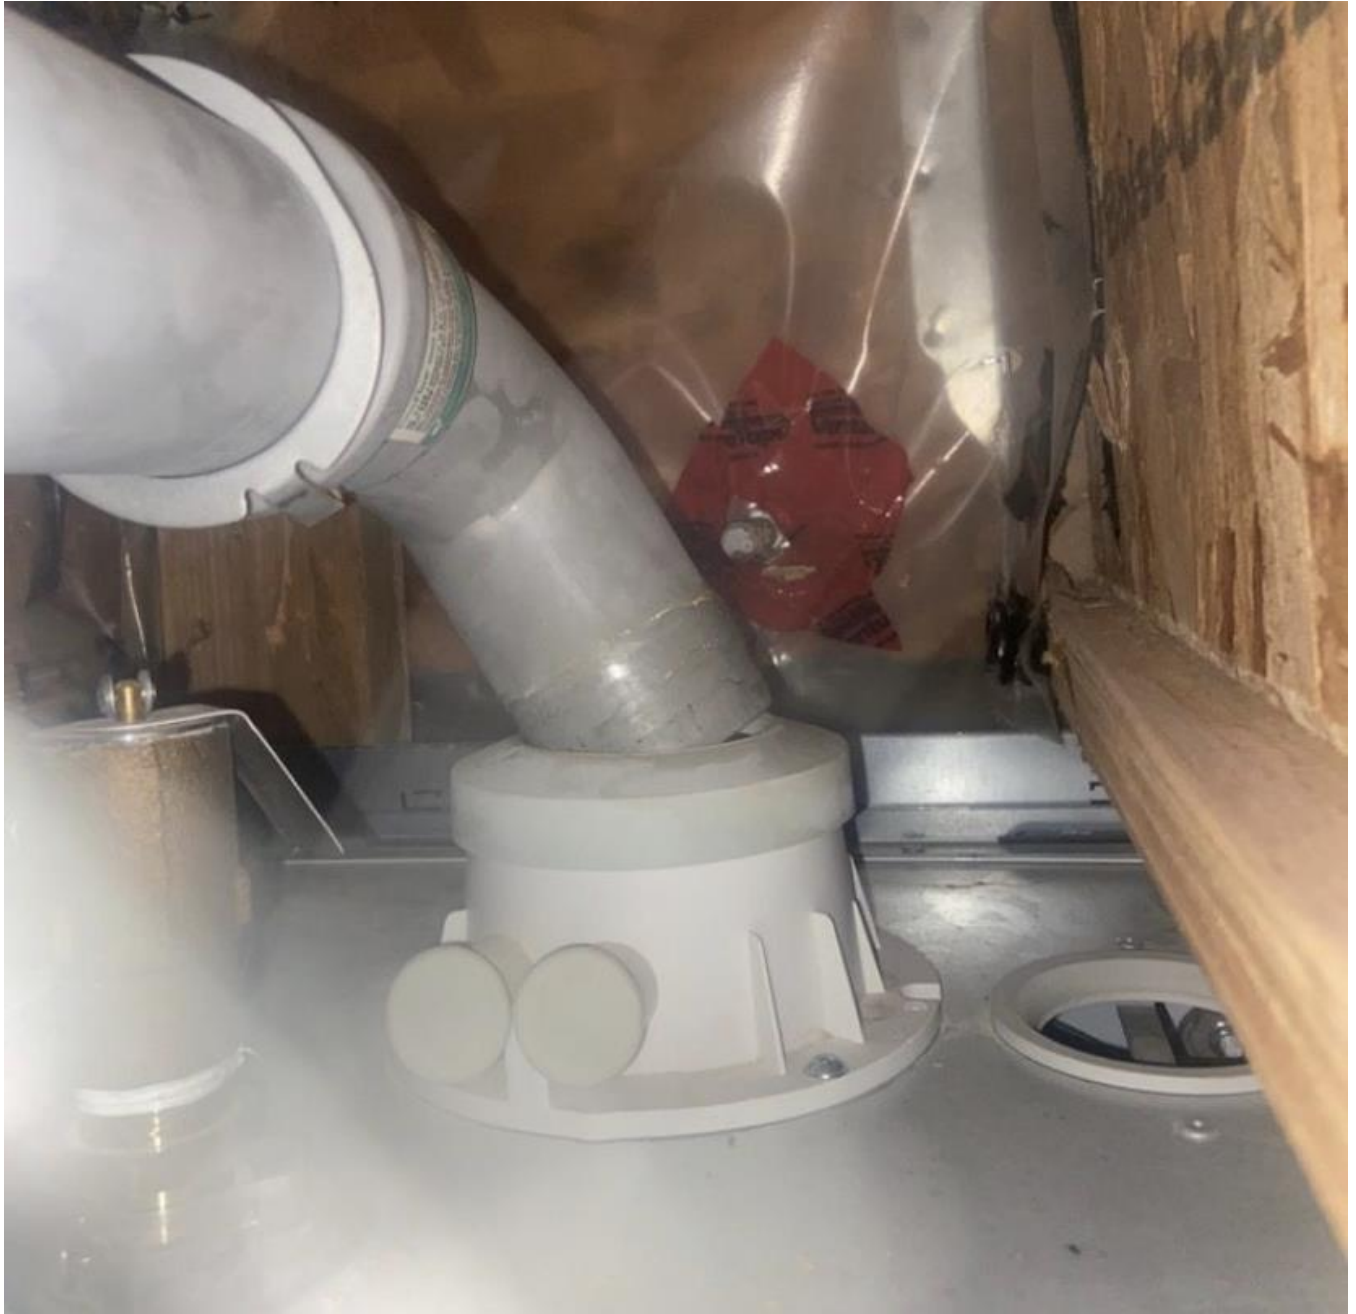
Image 11 - Additional incident ([Appendix A](#) - #9) showing polypropylene venting dislodged from boiler vent connection from delayed ignitions.

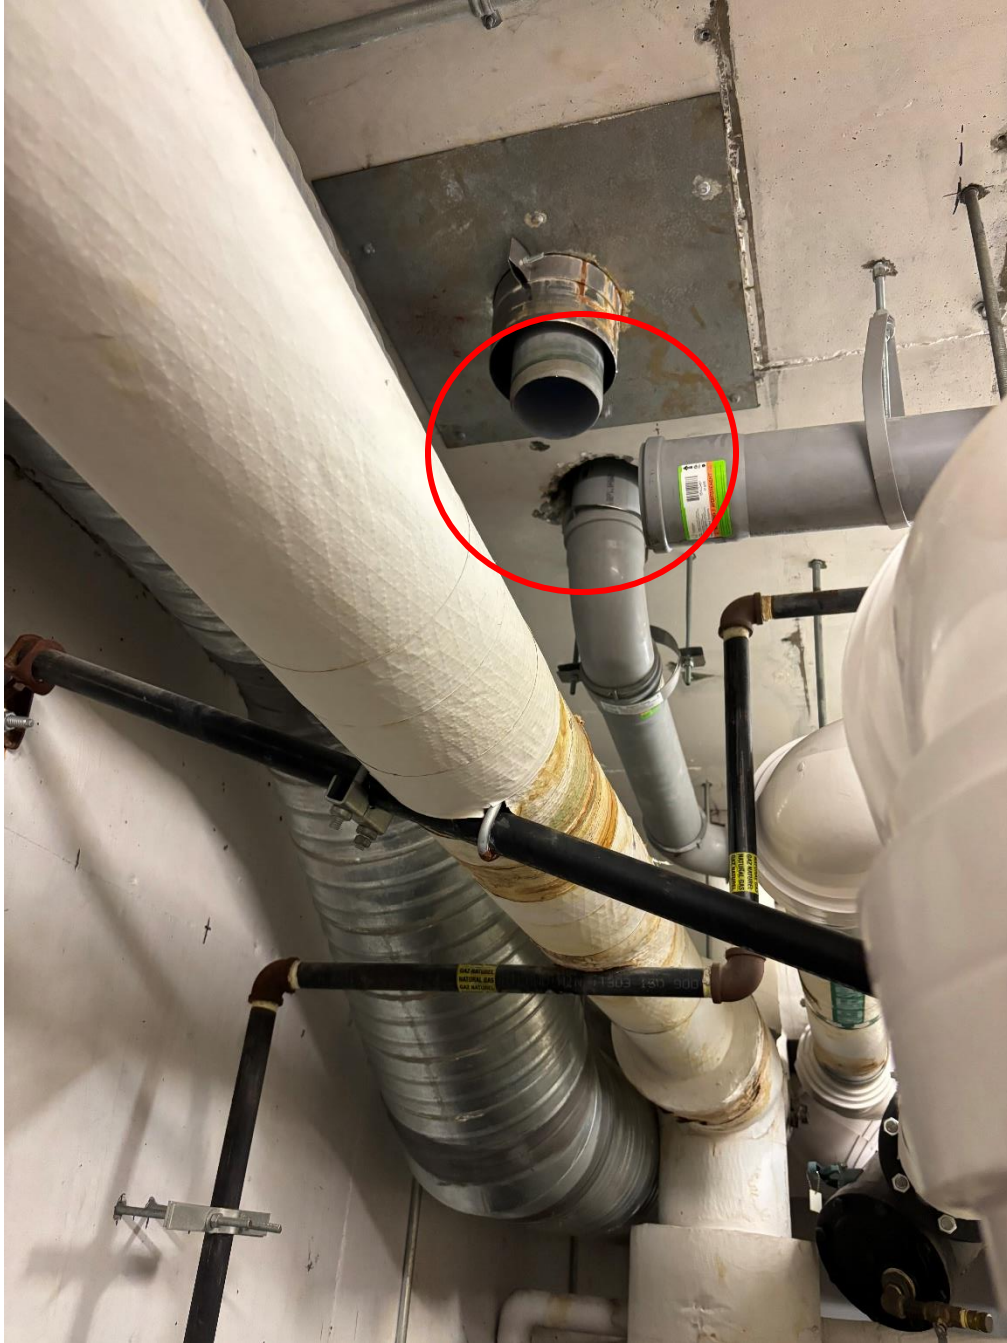
Image 12 - Additional incident ([Appendix A](#) - #11) showing 90-degree polypropylene vent fitting separated from the venting system from delayed ignitions.

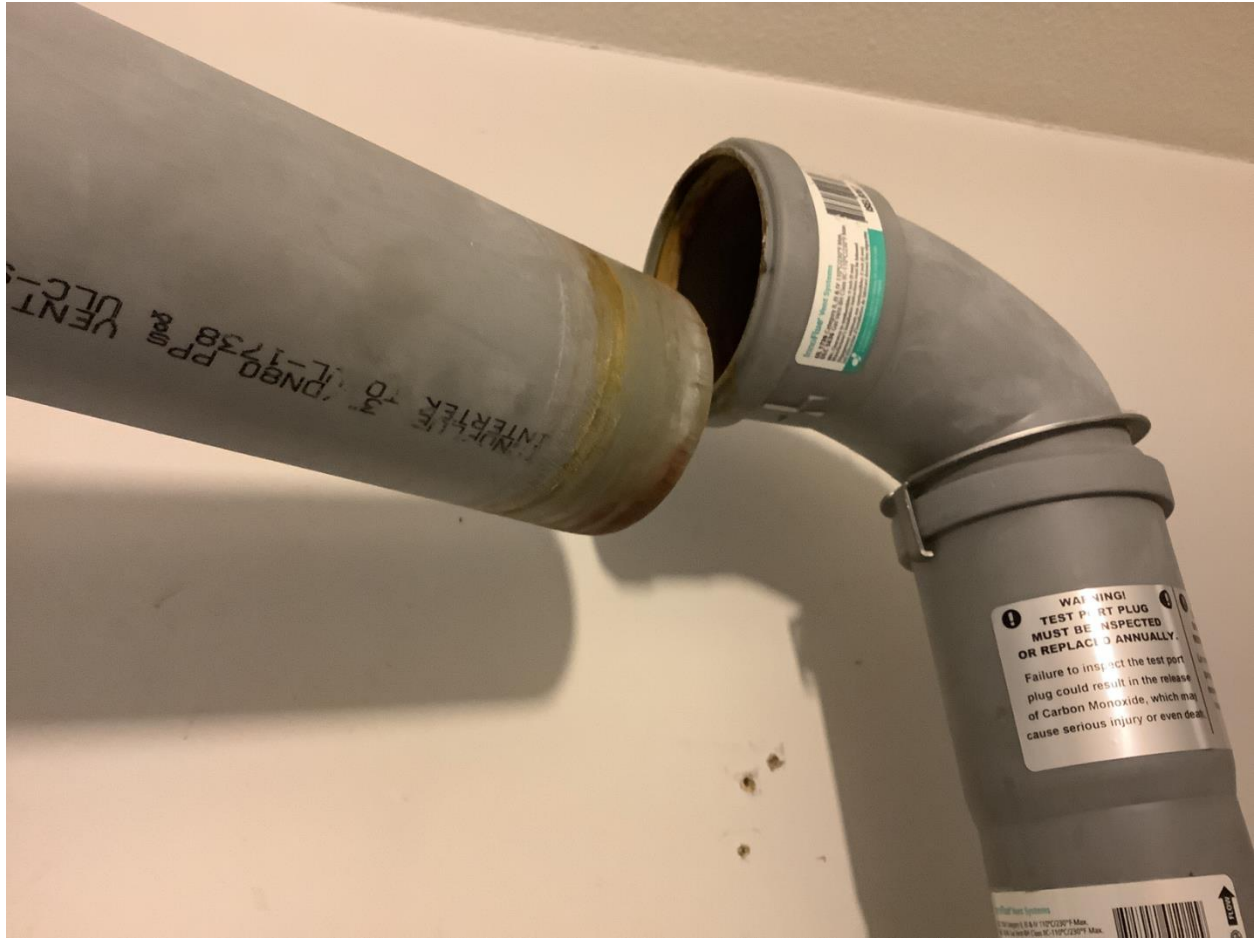
Image 13 - Additional incident ([Appendix A](#) - #10) showing polypropylene venting dislodged from delayed ignitions.
