## Incident Investigation Report

# Carbon Monoxide Release From Boiler Exhaust Venting

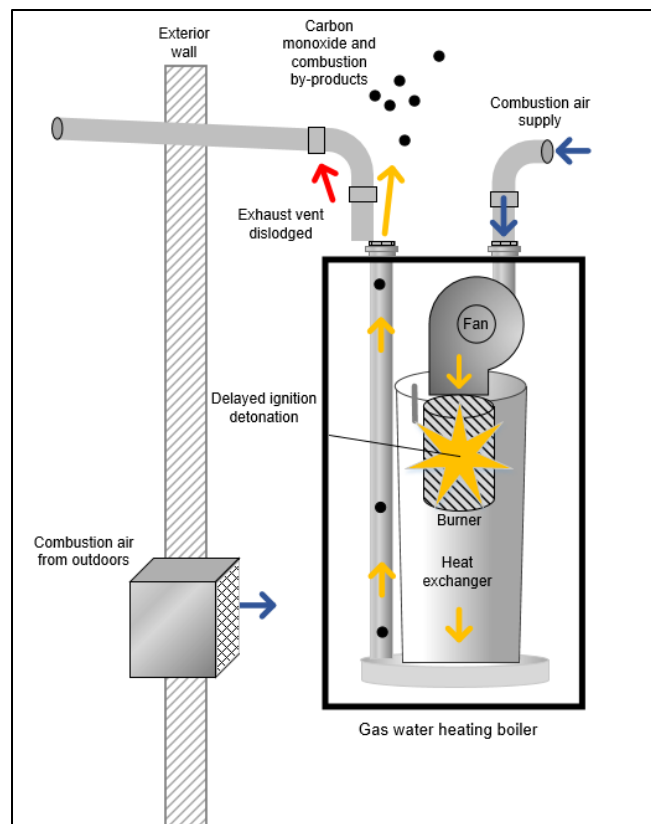
Figure 1 - Boiler delayed ignition damaging attached venting system and continuing to operate spilling flue products including CO into an indoor space.

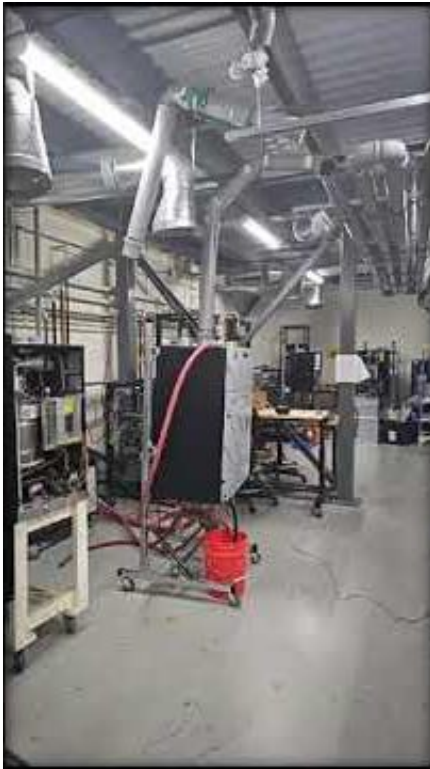
The testing showed that approved venting attached to a CSA 4.9-certified boiler could experience catastrophic failure during delayed ignition events that remained within the standard's permitted four second ignition timing. At certain intervals, between one and 2.5 seconds of delay, the venting was catastrophically damaged and, in several cases, dislodged from the boiler vent connector.

Video 1 - Catastrophic venting failure with a 1.0 second ignition delay.

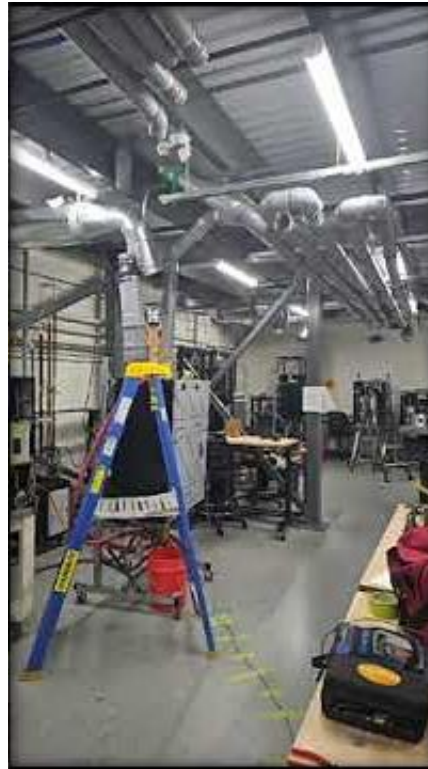
Video 2 - Catastrophic venting failure with a 2.5 second ignition delay.

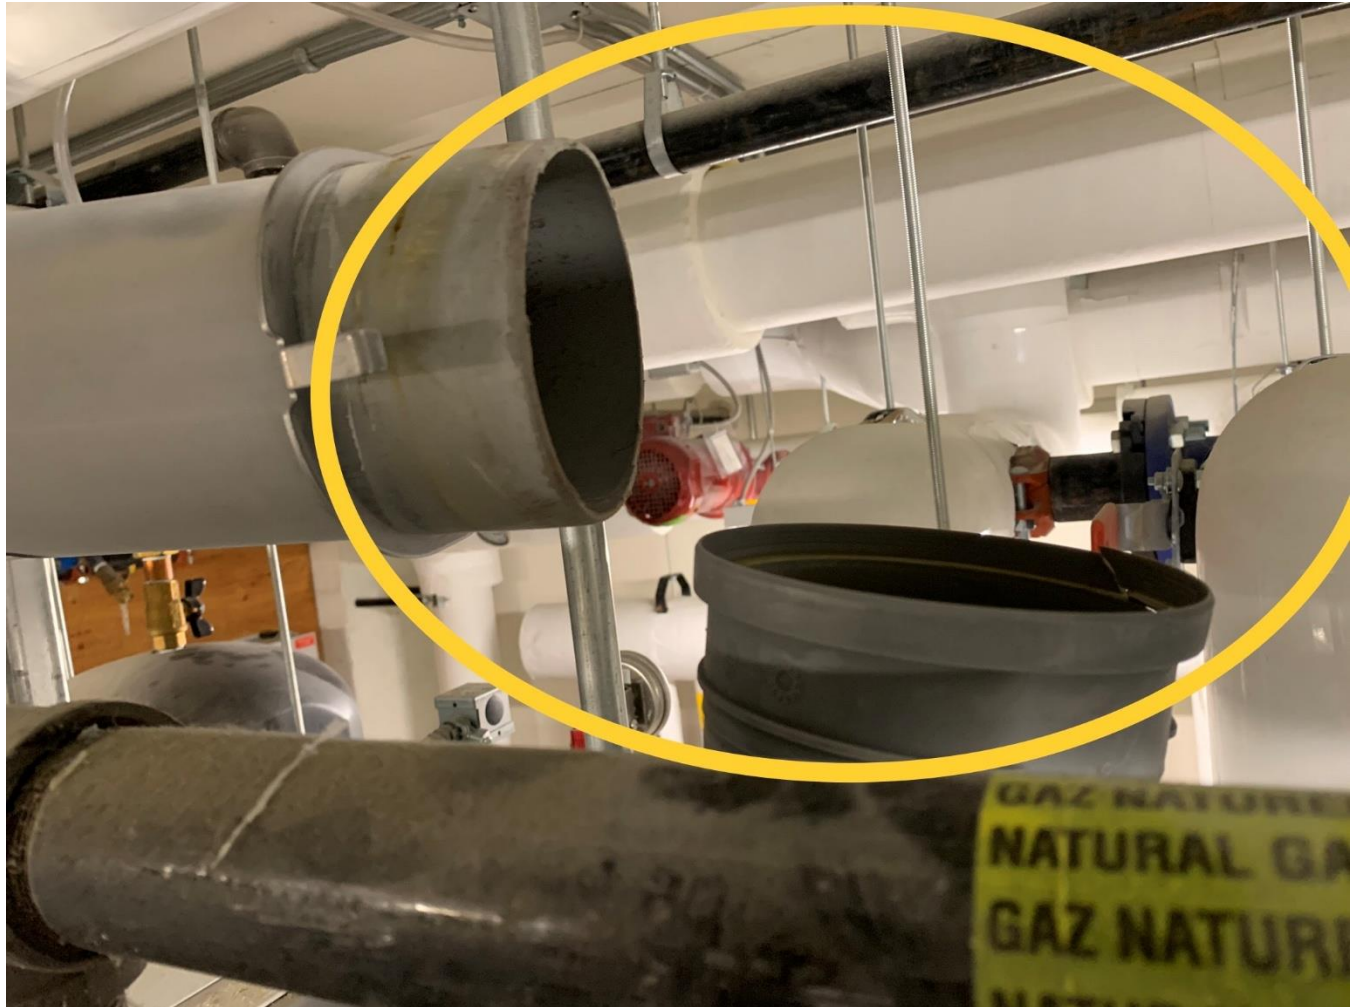
Image 8 - Additional incident ([Appendix A](#) - #7) showing 90-degree polypropylene vent fitting missing from the venting system at the top of the boiler and cracked vent piping from delayed ignitions.
