## Incident Summary #II-1945272-2025 (#58276) (FINAL)

SUPPORTING INFORMATION	Incident Date	July 21, 2025	
	Location	West Vancouver	
	Regulated industry sector	Elevating devices - Elevator	
	Impact	Qty injuries	1
		Injury description	A patient experiencing a serious medical emergency was not transported by emergency medical services to the hospital in a timely manner due to an elevator entrapment. The patient was trapped inside elevator along with three BC Emergency Health Services (BCEHS) members.
		Injury rating	Moderate
	Damage	Damage description	The elevator car doors were pried open using the jaws of life by the responding fire department bending and breaking the door latch and track components.
		Damage rating	Major
	Incident rating	Major	
	Incident overview	BCEHS members responding to an emergency medical call at an apartment building got trapped in the elevator with a patient while descending to the ambulance from the patient's apartment. They were trapped in the elevator for 25 minutes until the fire department responded with the jaws of life and pried the door open releasing the trapped occupants.

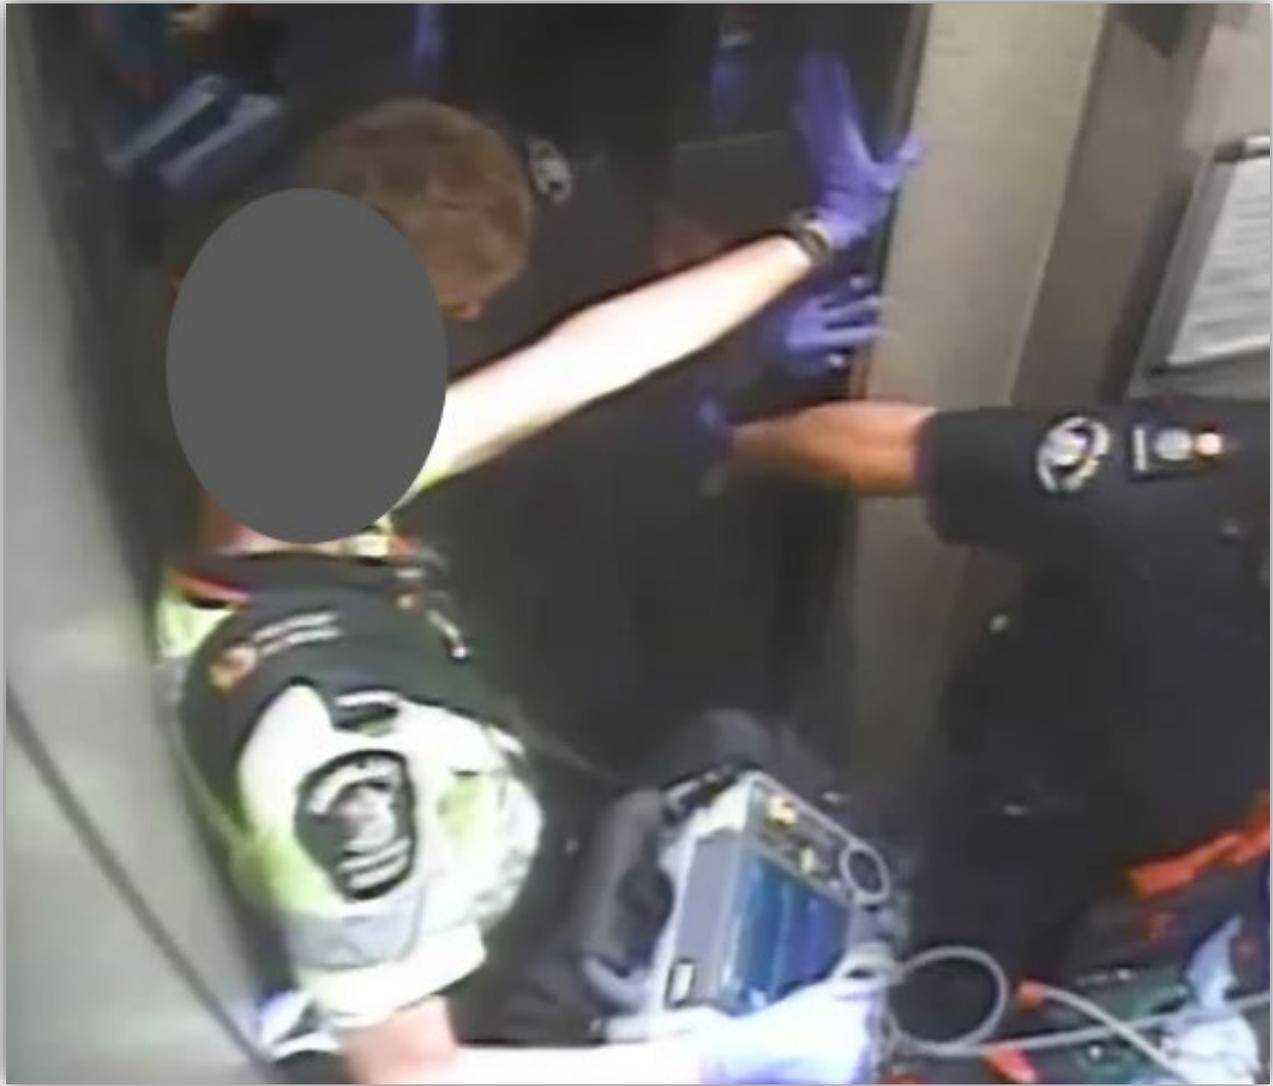
The manual forcing open of the elevator door as it was attempting to close resulted in the door derailing from the door track. High use, age and wear made the door more susceptible to coming off the track while in nudging mode. The manual closing of the jammed door by the occupants caused the entrapment in the elevator.

Image 1 – Surveillance video still of BCEH members pushing on the top of the door as it was attempting to close for the third time.

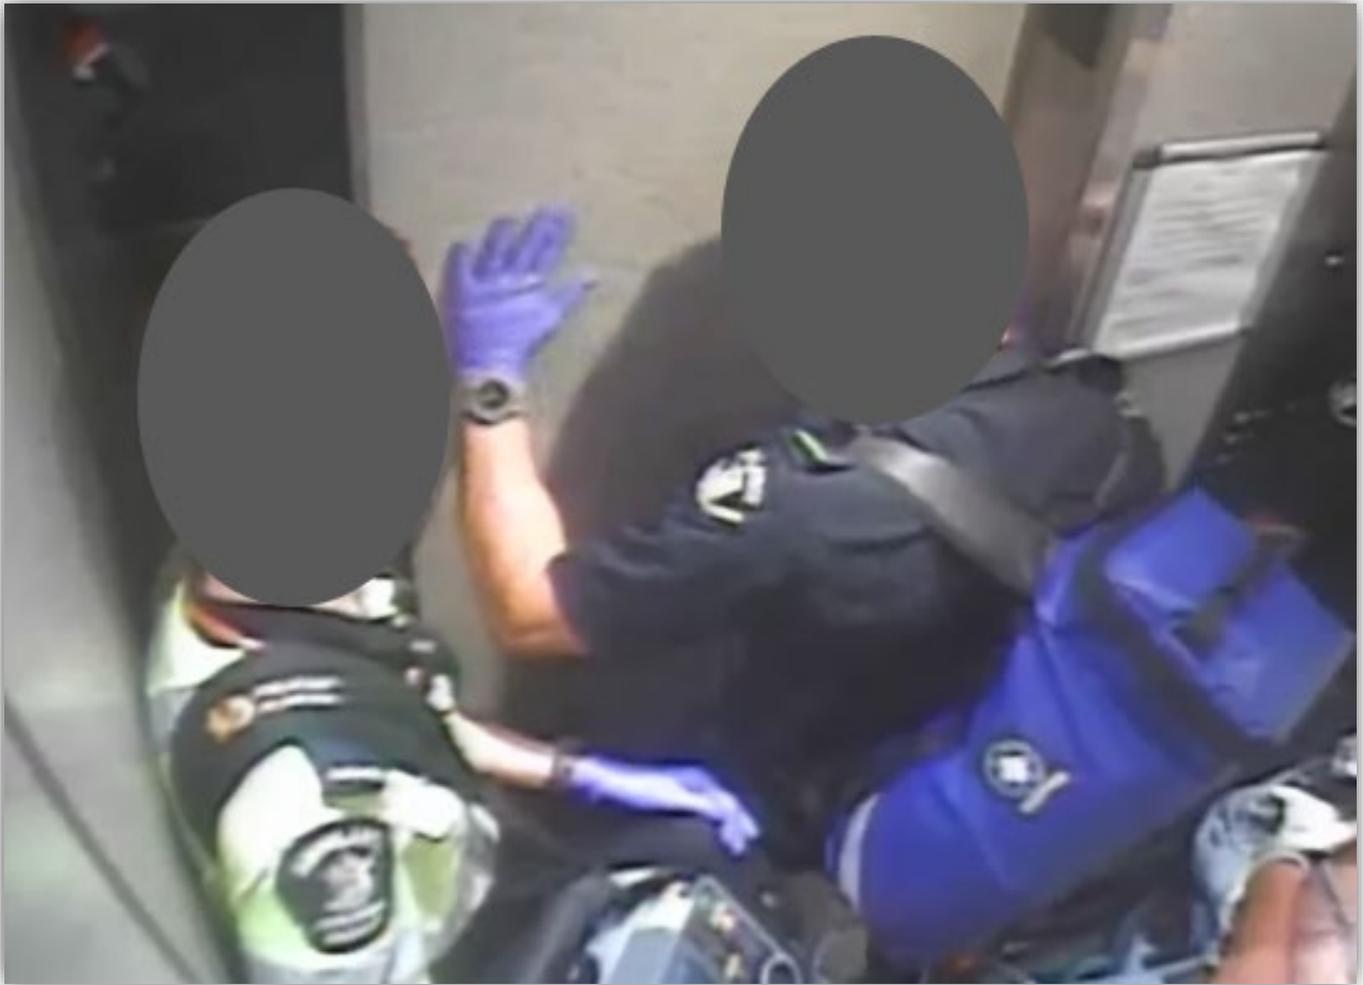
Image 2 - Surveillance video still of BCEH members manually pushing the door closed after it jammed while automatically attempting to close.

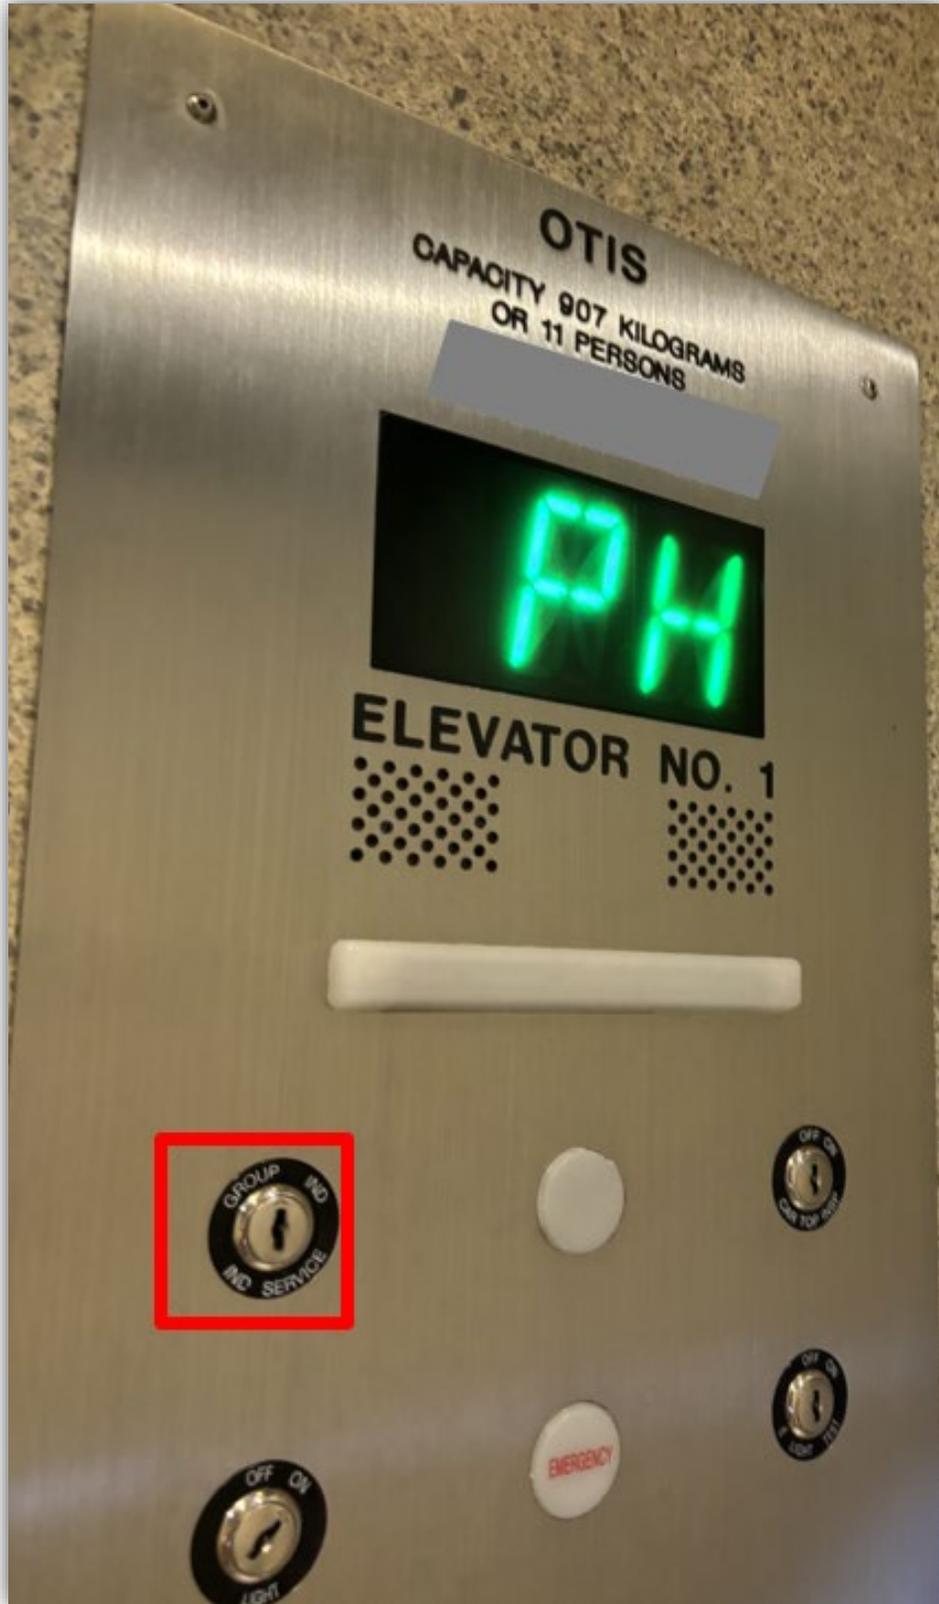
The elevator has an independent mode that is accessed with a key that allows the elevator to only be used by the operator and will not respond to elevator calls ([Image 3](#)). It will not close the door unless the “close door” button is pushed and held. The building manager always has a copy of the key.

- The elevator was in general operation mode while it was used to transport a patient during an emergency. Alternatively, the elevator could have been used in independent mode if paramedics had been provided with a key available from the building manager. This would have prevented the elevator doors from continuing to attempt to close and nudge which resulted in the eventual jamming of the door.

Image 3 – The panel inside elevator #1. The key switch to place the elevator into independent mode.

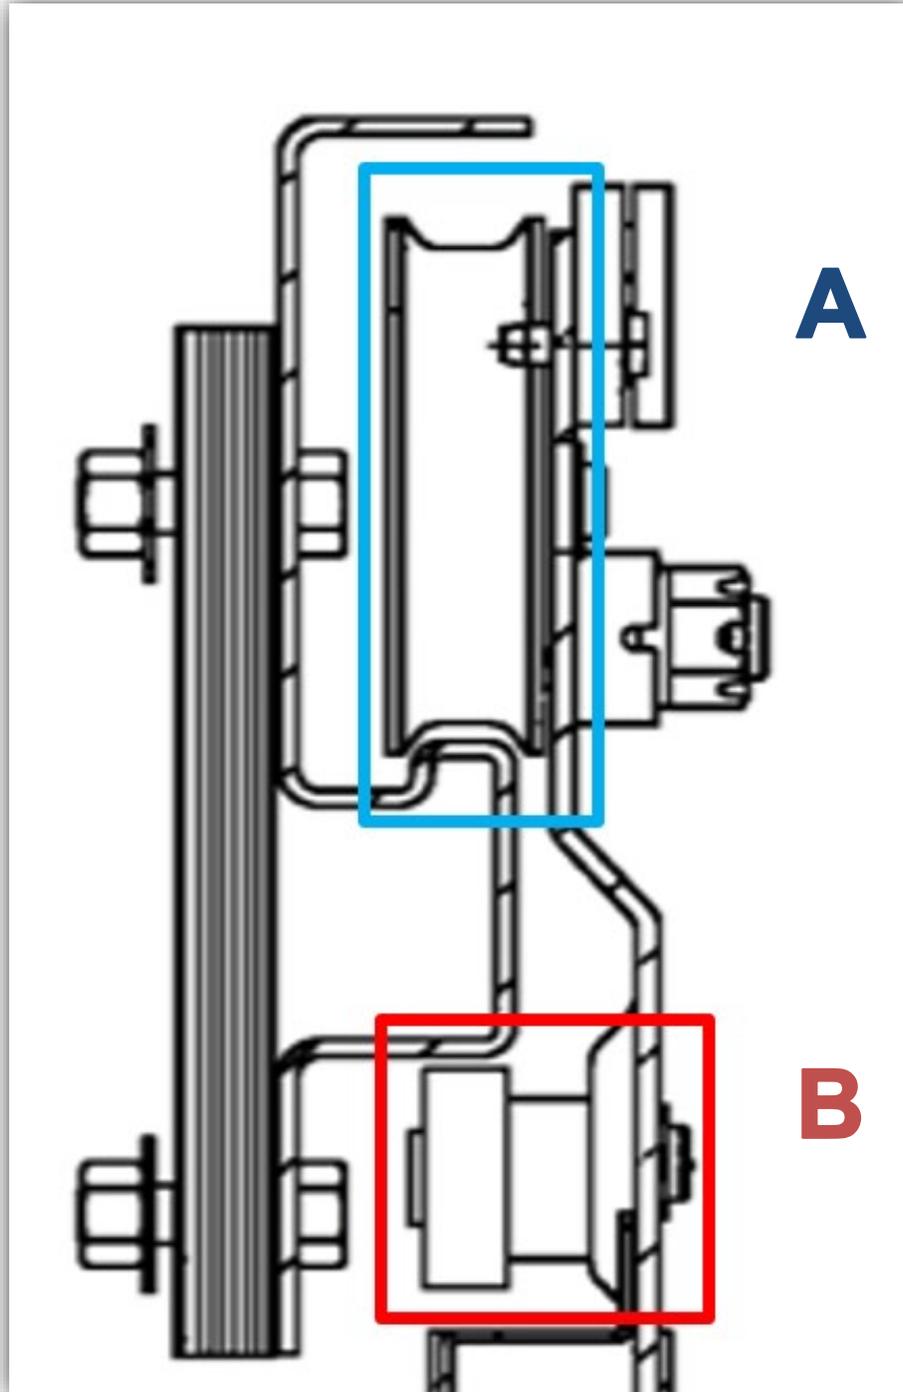
- Wear of the components resulted in the upthrust rollers being maxed out without any further available adjustability to keep the clearances in spec.
- Blocking the elevator car door can make it come off the tracks when the upthrust clearances are not set up correctly, which makes it too hard for the motor to physically move it back and forth.

- The worn door track components being left in service and not identified during recent documented maintenance inspections allowed excessive gaps that made the door more susceptible to derailment during normal expected operation.

Image 4 – Example of a car door track system. [A] Roller on top rail. [B] Eccentric adjustable roller on bottom of rail.
