## Incident Summary #II-674065-2018-2018 (#6585) (FINAL)

SUPPORTING INFORMATION	Incident Date	April 1, 2018	
	Location	Burnaby	
	Regulated industry sector	Elevating devices - Escalator or moving walkway	
	Impact	Qty injuries	0
		Injury description	None
		Injury rating	None
	Damage	Damage description	3 damaged steps, step axial, upper comb plates, up thrust track, hold down track upper landing plate and step chain.
		Damage rating	Major
	Incident rating	Major	
Incident overview	Escalator pile up, steps piled into combplates at the top end.		
INVESTIGATION CONCLUSIONS	Site, system and components	Inside an escalator, a pair of chains wraps around two pairs of gears that are driven by an electric motor. The motor and chains sit within a metal structure known as the truss, which extends between the floors served by the escalator. Within the truss the escalator houses steps and tracks, which allows the conveyer like rotation to travel through the truss with precise alignment and precision.

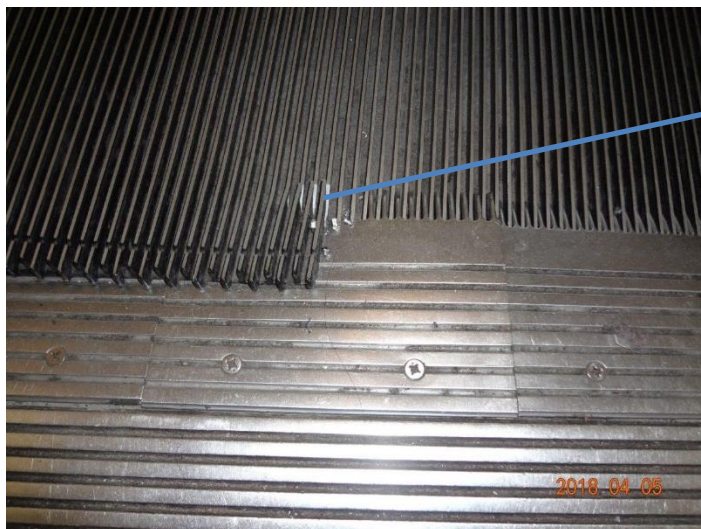
Fig. 1

Territory Number : FV 50		Bldg Name : METRO		Machine # : 981964	
Contract Number : FV 05591		Address : 4700 KI		Daily Usage : 12	
Building ID : FV 313702		City, St, Zip : BURNV		Government # : 10956	
Product Group : ESCALAIRE		Customer Desig : 112 LUK			
Date	Performed E Type	Task	Description	Comments / Reference	
3/5/2018	██████ Callback	ADJUSTED	Escalator Skirt	"NOISE" 112 LUGARO UP ESC IS OOS, CUST S/D B/C IT MKG A GRINDING NOISE ON UPPER FLR- RTCB MONDAY	
3/29/2018	██████ Callback	CHECKED OPERATION	Escalator Step	ESC 112 LUGARO UP, MKG LOUD GRINDING NOISE, CUST S/D, RTCB MONDAY

Showing the service call backs regarding noise.

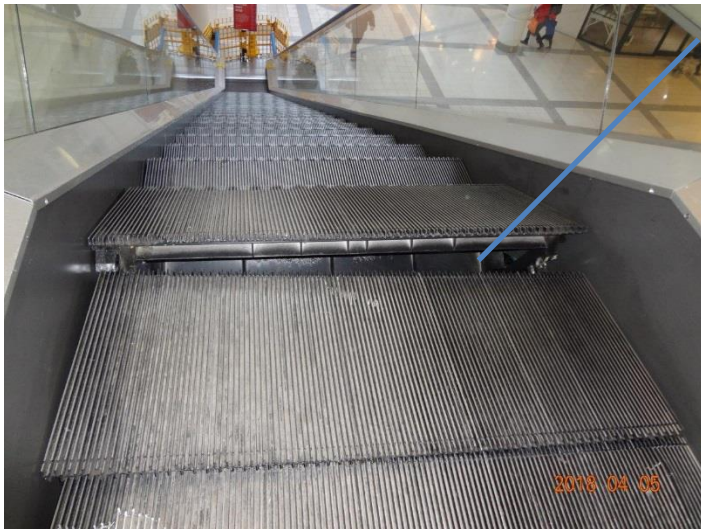
Failure scenario(s)	<p>Licensed mechanic failed to properly investigate grinding noise.</p> <p>Upthrust track was not set to the correct specification which could allow the step rollers to ride higher before entering into the combplates.</p> <p>The hold down track uses a clip on the step roller to hold the step down. When the track is not set to the correct specifications, this could allow the step to rise more than 1mm. The combination of the hold down track and the upthrust track outside of specifications could allow the step to rise and come into contact with the combplates and upper landing deck.</p>	
	Facts and evidence	<p>Onsite investigation:</p> <ul style="list-style-type: none"> <li>Unit had two service call backs prior to the escalator pile up. See figure 1.</li> <li>The proper adjustment for the upthrust track is 1mm. This escalator had the upthrust track set to 6mm. (5mm above maximum allowance)</li> <li>The hold down track was allowing the steps to rise 4mm. (3mm above maximum allowance)</li> <li>Through conversation the Field Mechanic made the Safety Officer aware that he did not have the upthrust track specifications for allowances. Field Mechanic was not provided the documentation to maintain those specifications.</li> </ul>

Steps tread risen above the combplates

<ul style="list-style-type: none"> <li>Licensed contractor after discussion would be providing training and documentation to maintain specifications.</li> <li>Field Mechanic was not trained or checking for these allowances at this time as they were not provided the specifications.</li> </ul>
<p>Causes and contributing factors</p>	<p>It is highly likely that the upthrust track and the hold down track were not set to the correct specification after a recent step chain and step replacement, which led to incorrect tolerances causing the pile up.</p> <p>The contributing factor was that the Licensed contractor failed to provide field mechanics with the escalator specifications and tolerances therefore leading to the mechanics not setting the tracks to proper OEM specifications.</p>

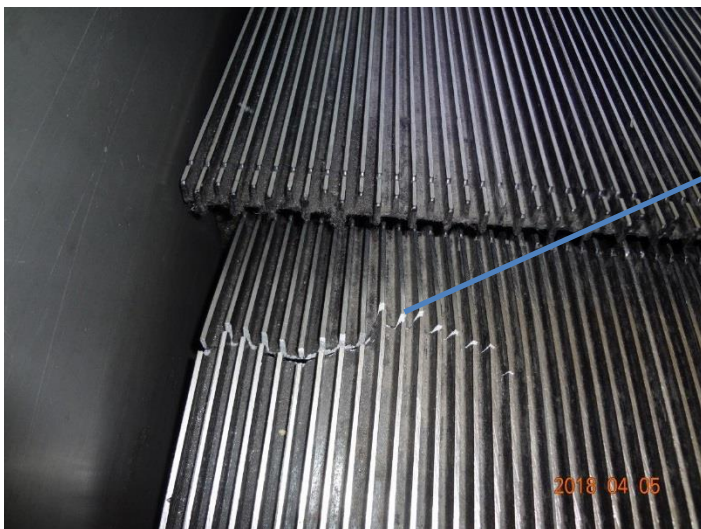
Pile up of the steps
