## Incident Summary #II-1327439-2022 (#26178) (FINAL)

| SUPPORTING INFORMATION | Incident Date | | February 6, 2022 | |
| | Location | | Fruitvale, BC | |
| | Regulated industry sector | | Electrical - Low voltage electrical system (30V to 750V) | |

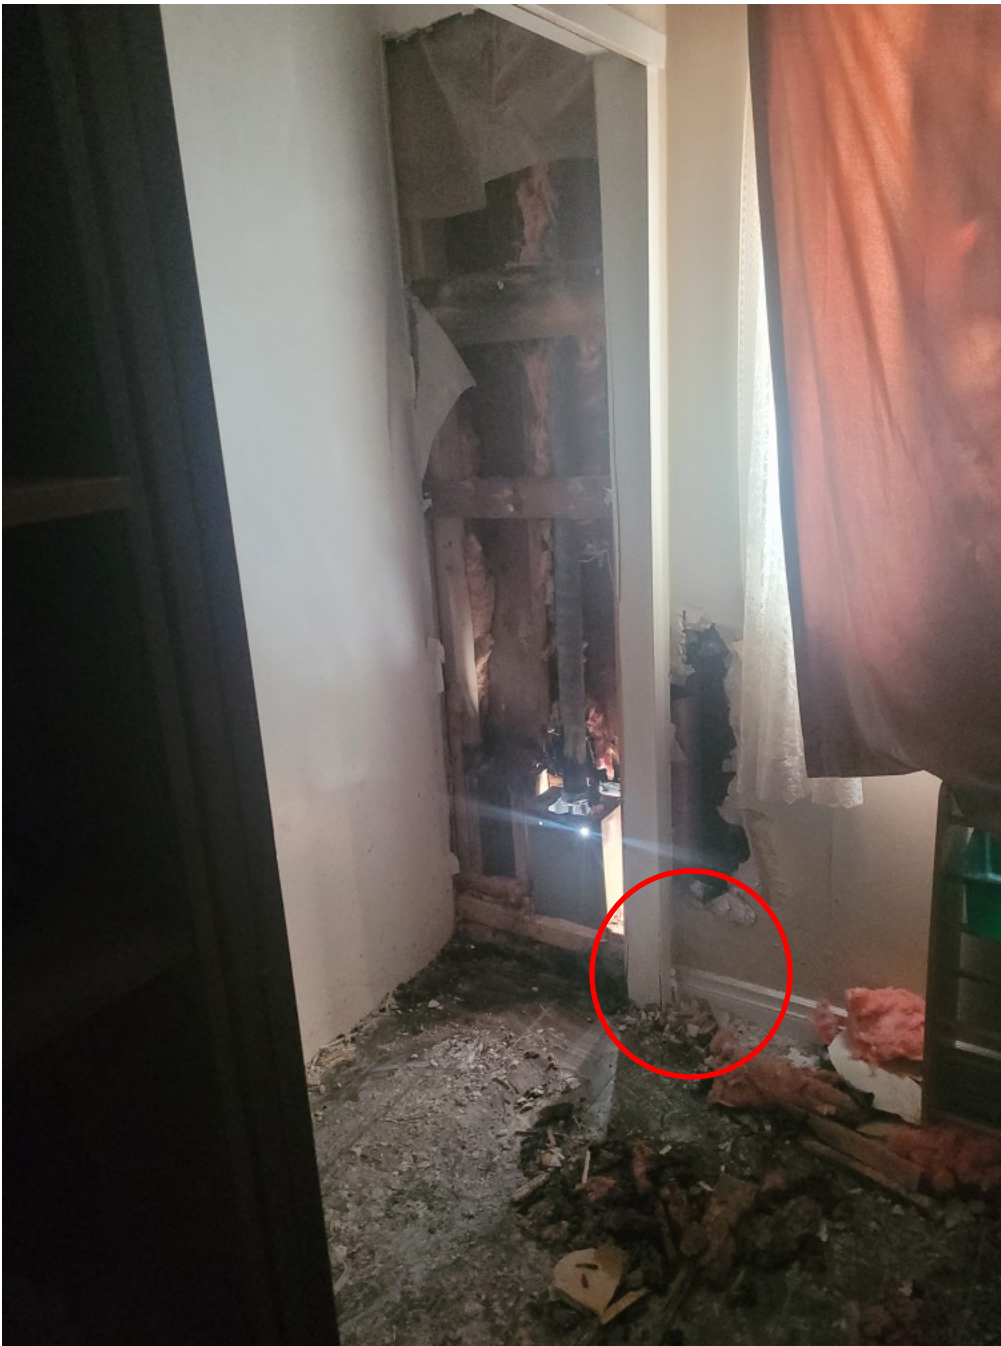
| | <p>The service conductors drawn into the mast pipe were compromised and stretched by the falling snow. As a result, the service conductor insulation was damaged and created multiple conductor short circuits, conductor faults to ground, intermittent electrical arcing in and around the area where the mast pipe secures to the meter mount enclosure. The intermittent arcing was sustained until utility overcurrent protection operated and de-energized the electric supply to the structure. The high temperatures at the electrical arcing area charred adjacent combustible materials. No resulting fire damage occurred.</p> |

Image 1 - Mast pipe and meter mount prior to removal. Note the electric arcing damage, evidenced by ambient light, where the mast pipe is secured to the meter mount (circled).

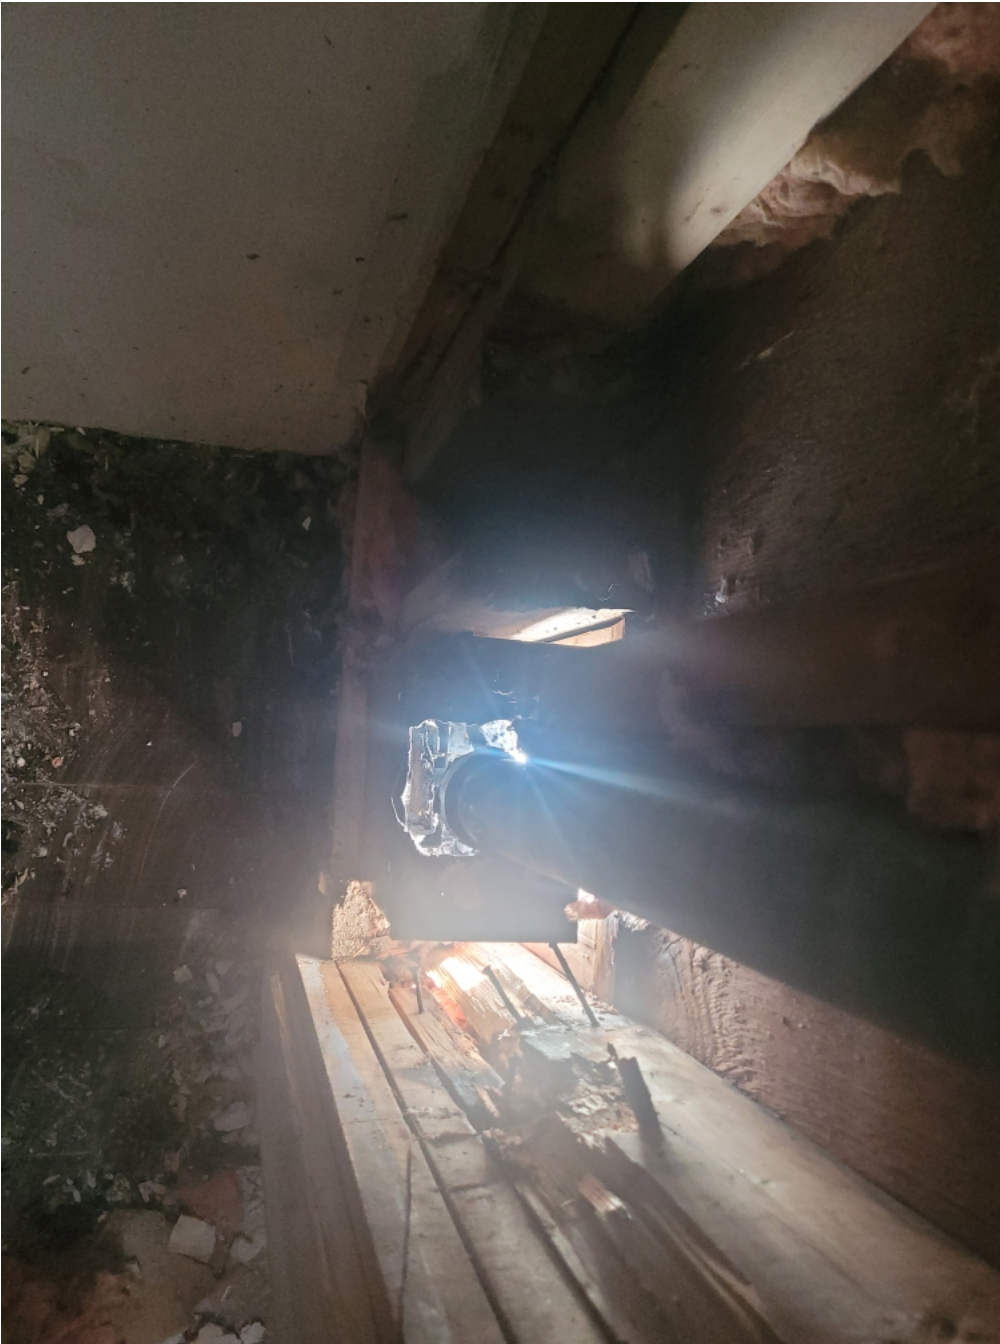
Image 2 - Mast pipe and meter mount prior to removal – top view of arcing damage and charred adjacent combustible material.

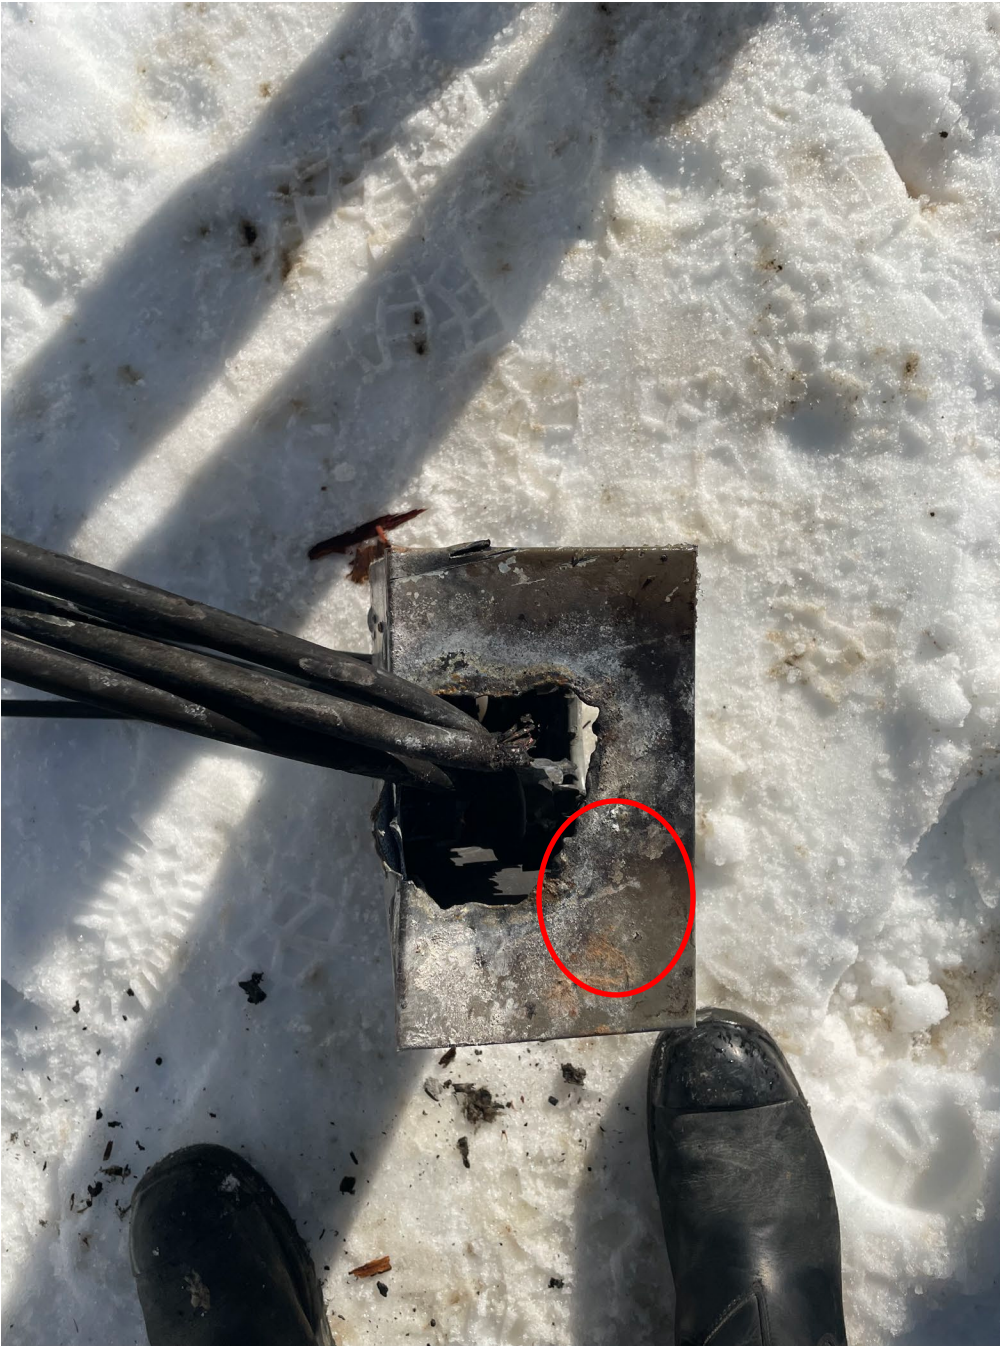
Image 3 - Roof Line: Electric arcing damage to the meter mount enclosure. Circled area indicates the compromised service conductor insulation.
