Incident Summary #II-1512003-2023 (#32273) (FINAL)

SUPPORTING INFORMATION	Incident Date	February 20, 2023	
	Location	Peace River South	
	Regulated industry sector	Boilers, PV & refrigeration - Boiler and pressure vessel system	
	Impact	Qty injuries	1
		Injury description	One person sustained bruising and contusions to the right-side torso and leg.
		Injury rating	Minor
	Damage	Damage description	Metal on metal scrape to a pressure vessels access hatch and destroyed light fixture.
		Damage rating	Minor
	Incident rating	Minor	
Incident overview	During a filter replacement at a natural gas processing plant a release of trapped pressure forced a pressure vessel 54" access hatch open. Injuring a worker and destroyed a light fixture.		
INVESTIGATION CONCLUSIONS	Site, system and components	<p>A natural gas processing plant is a facility designed to clean raw natural gas by separating impurities and various non-methane hydrocarbons and fluids to produce dry natural gas.</p> <p>Processing raw natural gas begins at the inlet gas piping or gas stream of a natural gas processing plant and this piping delivers the raw natural gas to each processing vessel. Two of these processing vessels are a

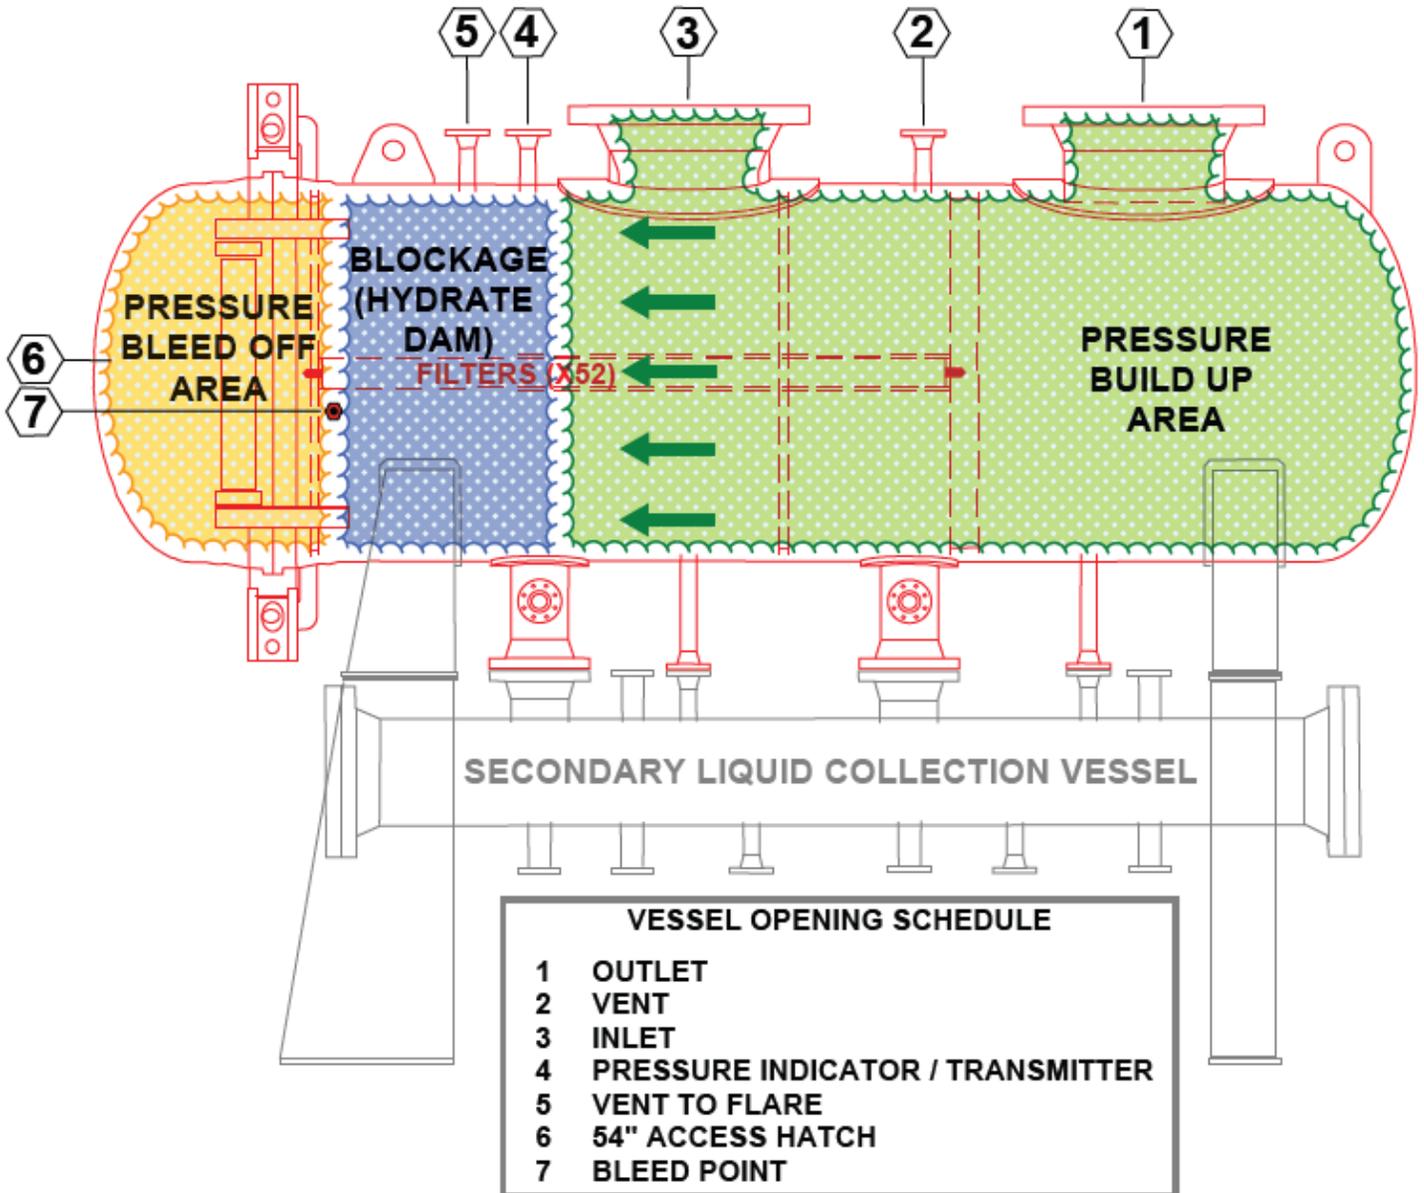
FAILURE SCENARIO DIAGRAM

<p>procedure would be utilized to ensure a safe opening. However, as the operators went through the steps of the LOTO they failed to confirm zero pressure inside the vessel with the control room. They also failed to consider the presence of a blockage inside the inlet filter vessel.</p> <p>Once the operators reached the last step of the LOTO and removed a bleed plug to verify complete depressurisation. They witnessed a normal amount of pressure released from the vessel that quickly ended. However, this release of pressure only came from a section downstream of the blockage. So, believing there was zero pressure in the vessel. The operators proceeded with loosening the clamp holding the 54" access hatch closed. Once the final bolt holding the access hatch closed was loose the access hatch unexpectedly opened. Releasing the filters, ice, and hydrate from the vessel striking one operator on the torso and leg. See failure scenario diagram and aerial diagram.</p>

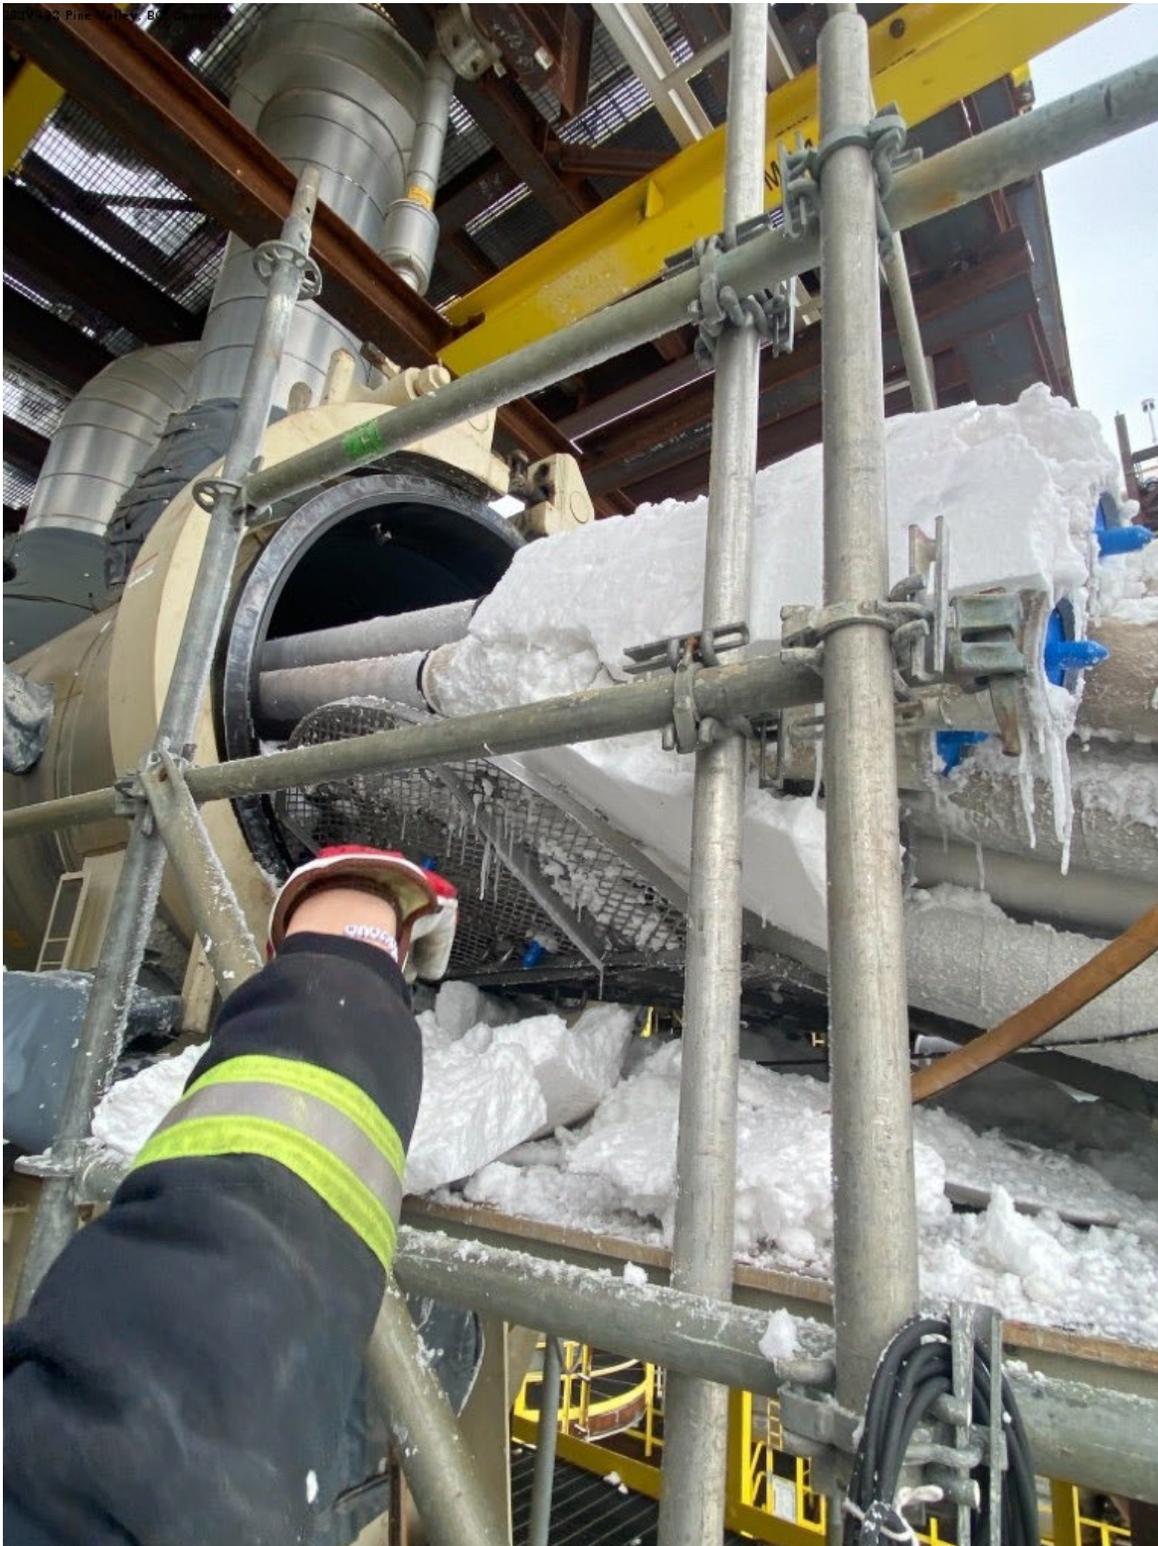
BLOCKAGE (HYDRATE DAM)

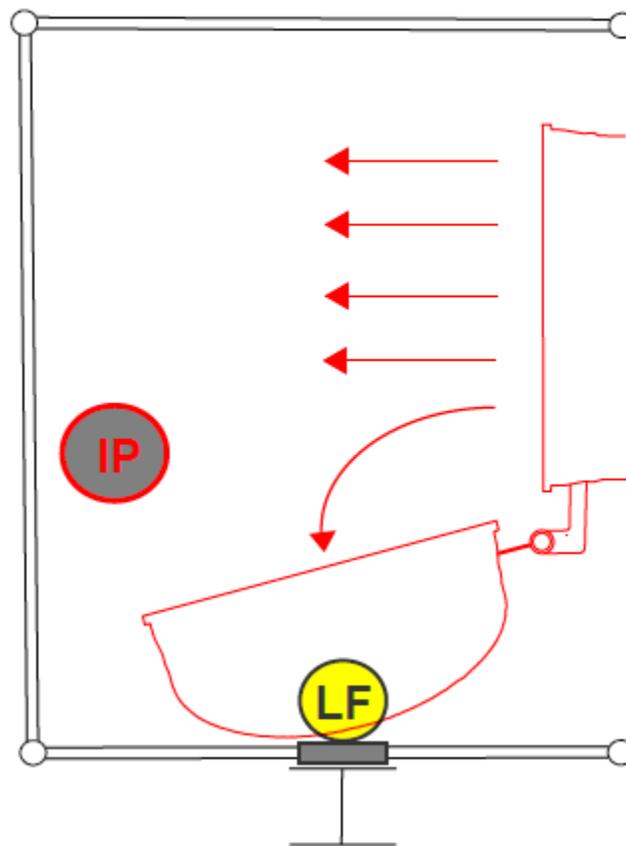
**AERIAL DIAGRAM OF OPEN ACCESS HATCH,
SCAFFOLDING, LOCATION OF LIGHT FIXTURE, AND
POSITION OF INJURED PERSON**

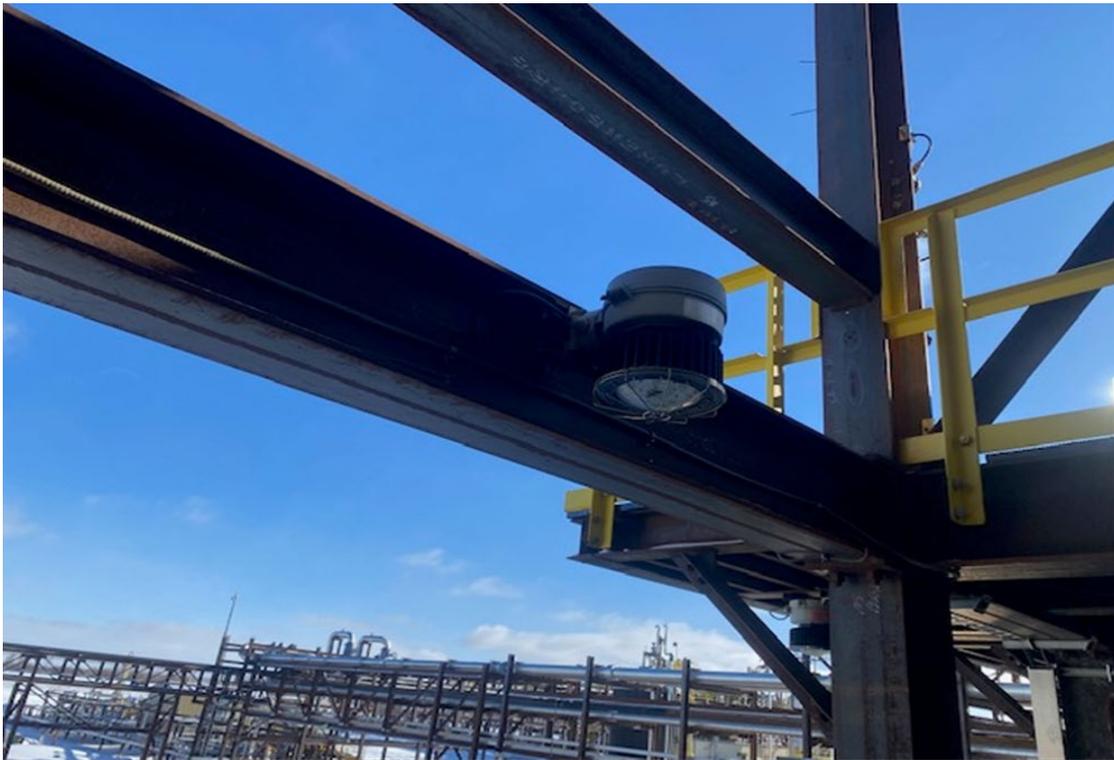
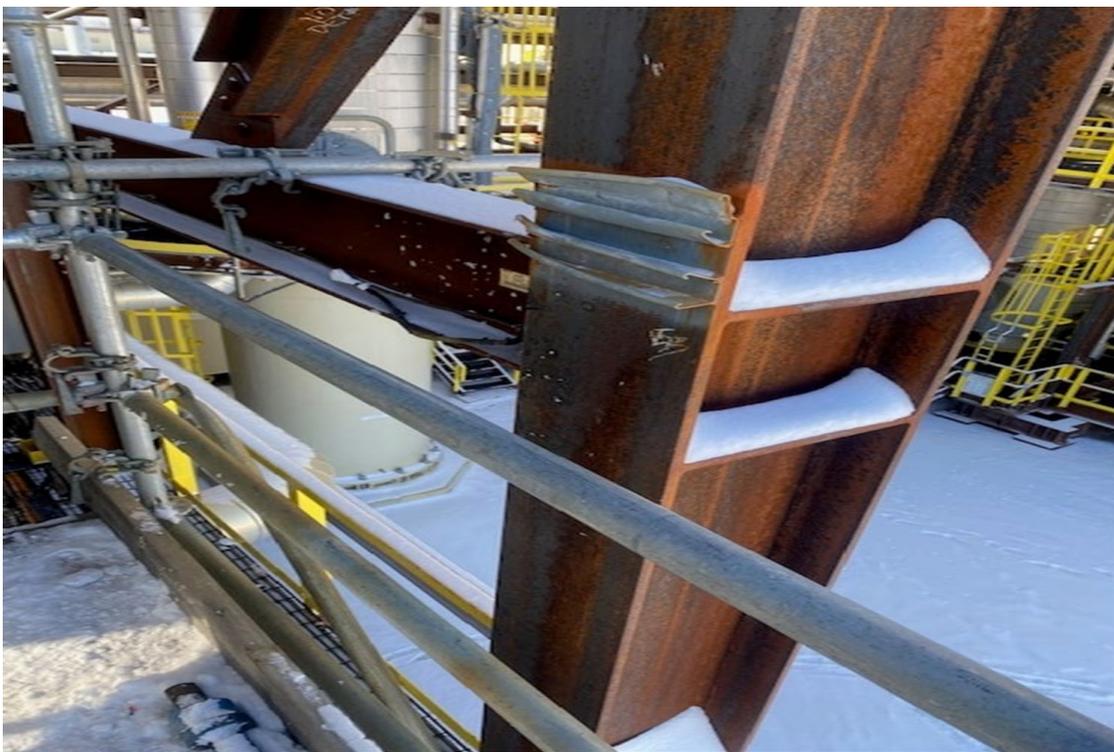
EXAMPLE LIGHT FIXTURE & LOCATION OF DESTROYED LIGHT FIXTURE

<p>Facts and evidence</p>	<ul style="list-style-type: none"> • Owner reported that procedure was not followed. Personnel did not confirm zero pressure inside the vessel prior to loosening access hatch door. • Owner reported that procedure was inadequate. Procedure did not allow for additional pressure venting away from blockage if a blockage was present. • Photographic evidence was taken of the blockage. Blockage was observed to be approximately 1 meter in length and through all 52 filters.
<p>Causes and contributing factors</p>	<p>It is highly probable that since the operators did not confirm zero pressure inside the vessel prior to loosening the access hatch. The trapped pressure forced the access hatch open releasing the filters, ice, and hydrate from the vessel striking one operator and destroying a light fixture.</p>
