## Incident Summary Report # II-641646-2018) (#5105)

SUPPORTING INFORMATION	Incident Date		January 18, 2018
	Location		Burnaby
	Regulated industry sector		Elevating Devices, Escalator or Moving Walk way
	Impact Injury	Qty injuries	1
		Injury description	Child sustained bruising and swelling to their right foot.
		Injury rating	Minor
	Damage	Damage description	No damage to regulated equipment
		Damage rating	None
	Incident rating		Minor
Incident overview		<p>The user was stepping up onto the escalator skirt decking and back down onto the step.</p> <p>The escalator users right rubber boot became entrapped between the escalator step and stationary skirt panel.</p> <p>It was reported that the user was stepping up onto the stationary skirt decking and then back down on to the step at the time of the entrapment.</p>	
INVESTIGATION CONCLUSIONS	Site, system and components		<p>Escalators have design features to prevent users from getting their foot wear and clothing articles from being entrapped.</p> <p>This entrapment mainly occurs between the moving step and stationary skirt panel on down escalators.</p> <p>The escalator steps are designed and required to have a maximum running clearance

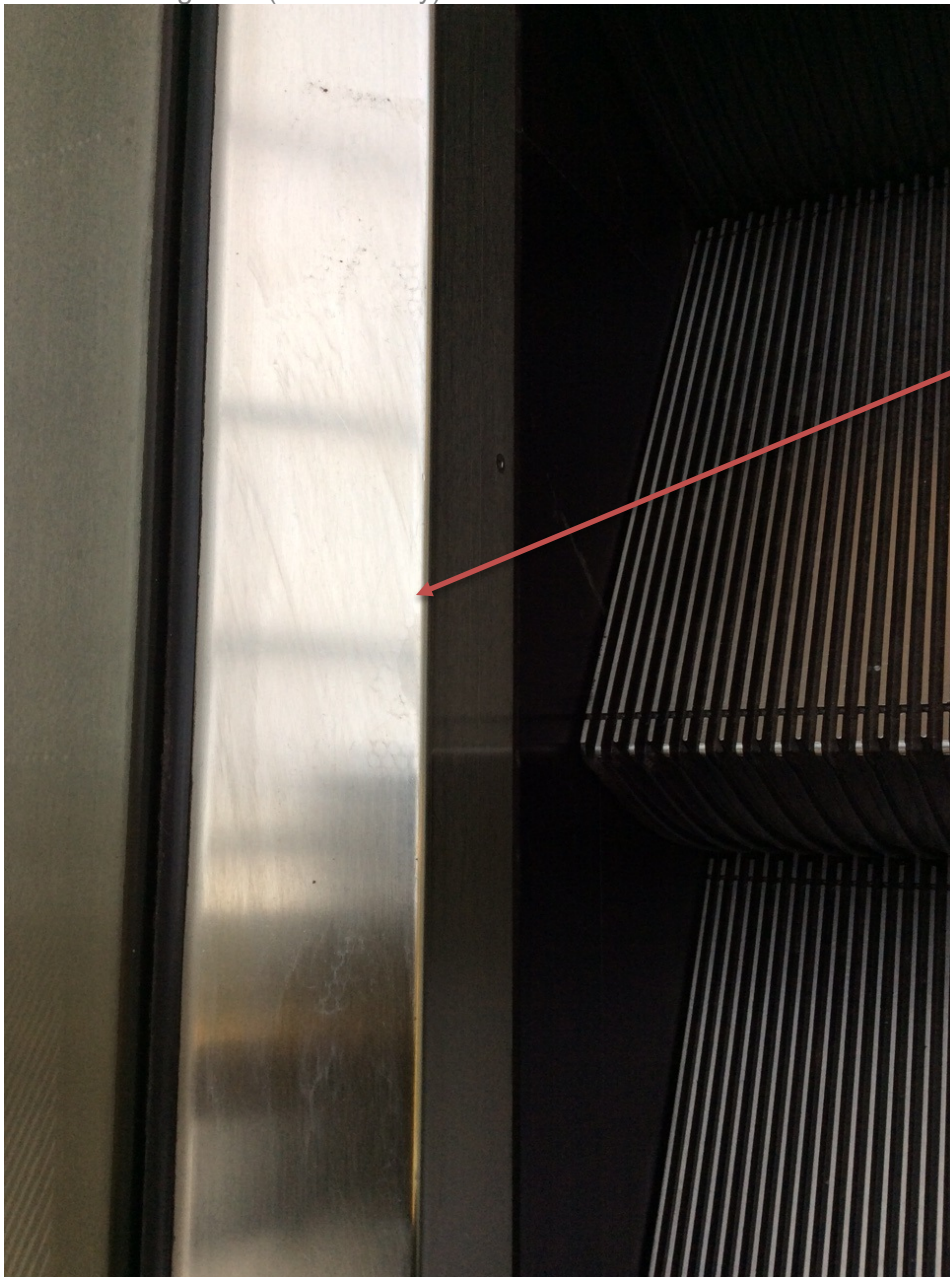
Foot print markings on the skirt from the 7-9th steps from the top.

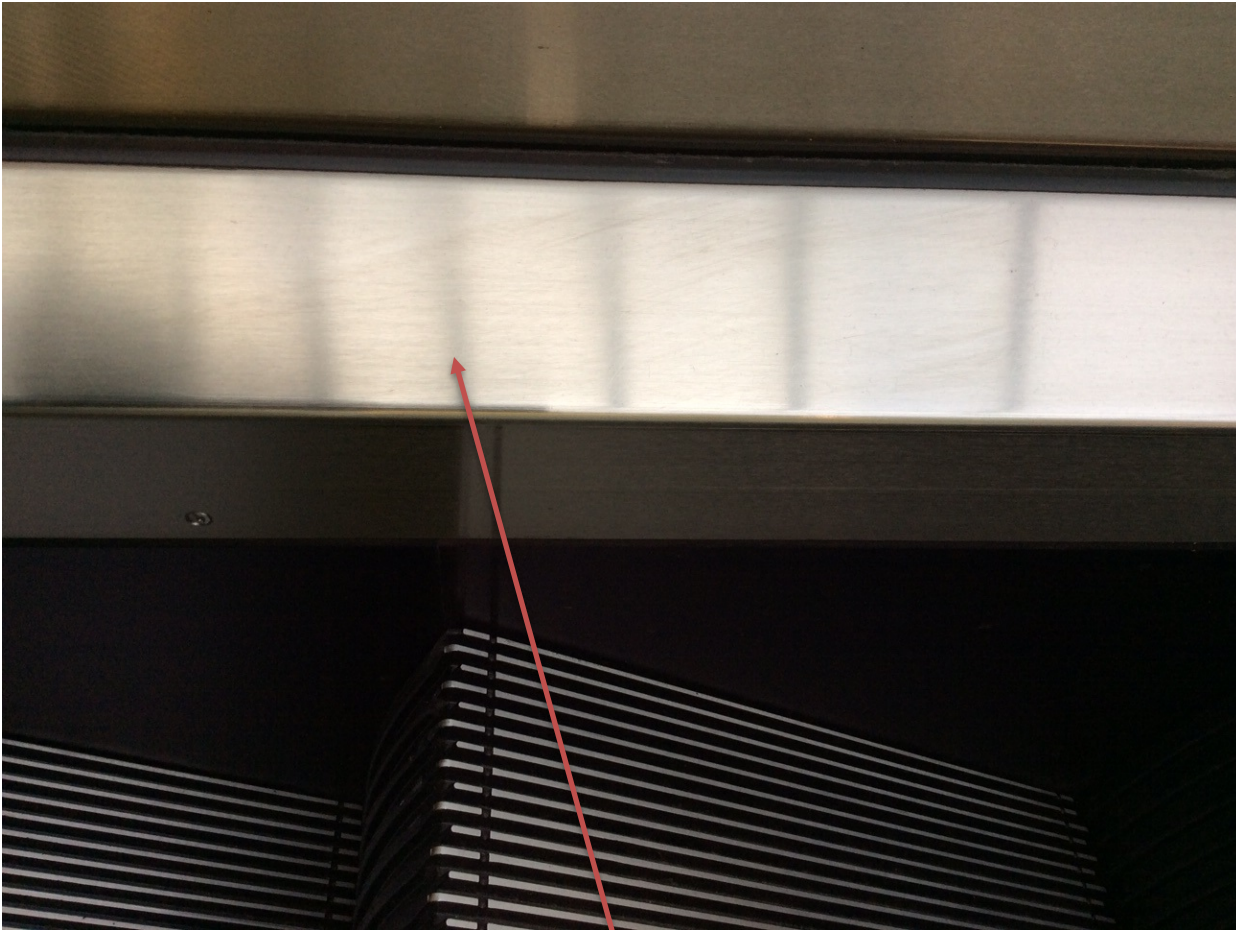
Foot print markings on the 12-13th  
steps from top.

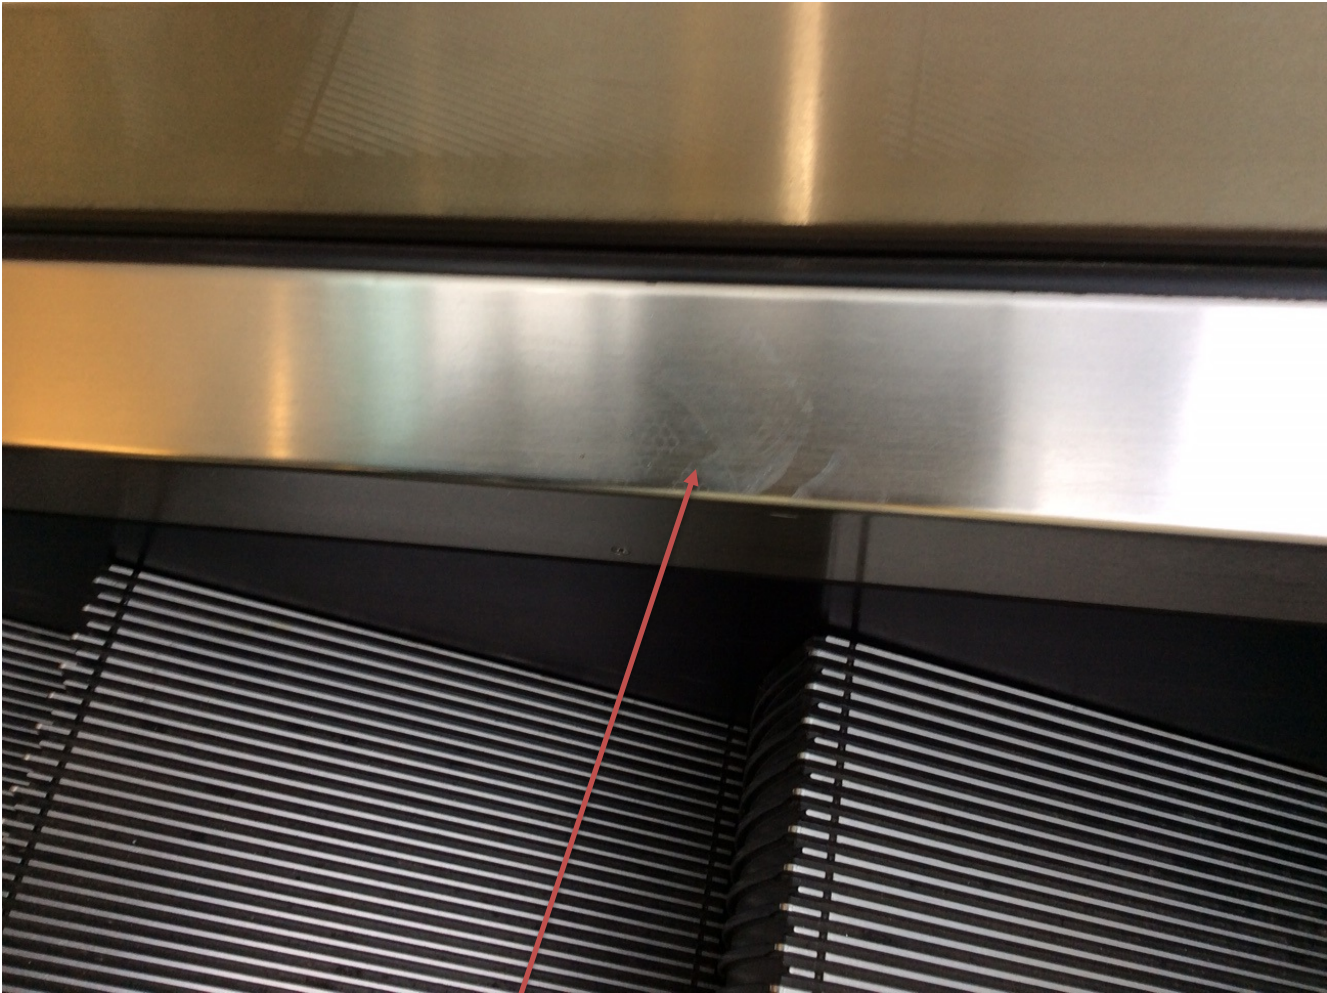
Foot print markings 19-20th step from top.

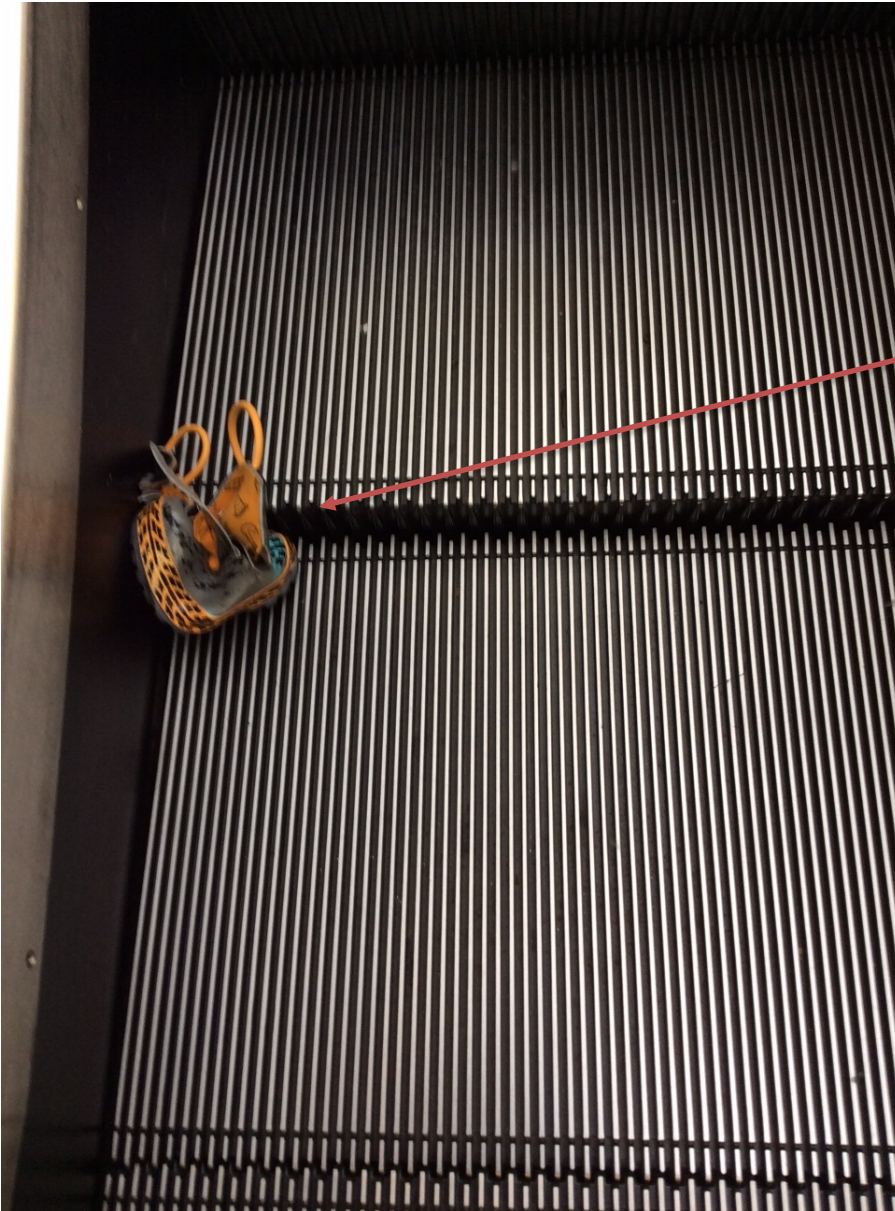
Each side was missing 10 skirt stiffening brackets for this rise of escalator.
Causes and contributing factors	Highly likely that the interaction of the soft rubber boot with the high friction step/skirt panels allowed the boot to become entrapped. Missing skirt brackets allowed the flexing of the skirt panels , this likely contributed to the entrapment.

Entrapped rubber boot between the steps  
and skirt panel.
