## Incident Summary #II-1624875-2023 (#40684) (FINAL)

SUPPORTING INFORMATION	Incident Date		October 23, 2023		
	Location		Manning Park		
	Regulated industry sector		Electrical - Low Voltage electrical system (30V to 1000V)		
	Impact	Injury	Qty injuries	0	
			Injury description	N/A	
			Injury rating	None	
		Damage	Damage description	Two (2) conductor #12 American Wire Guage (AWG) non-metallic sheathed cable (NMSC) was severely damaged inside of the wall in the basement of a cabin, as well as other NMSC that were in contact with that #12 NMSC. There was also damage to a tv, a wireless speaker adaptor, an air cleaner, coffee machine, electric range controls, and light bulbs.	
			Damage rating	Moderate	
Incident rating		Moderate			
Incident overview		A hot conductor and a neutral conductor were crossed in an electrical system, causing an electrical fault that resulted in severely damaged non-metallic sheathed cable, and damaged electronic appliances.			
INVESTIGATION CONCLUSIONS	Site, system and components		<p>The property has a 200-amp (A), 120/240-volt (V) utility service that provides power to an existing cabin and a new detached shop. The utility meter has an integral 200A main br

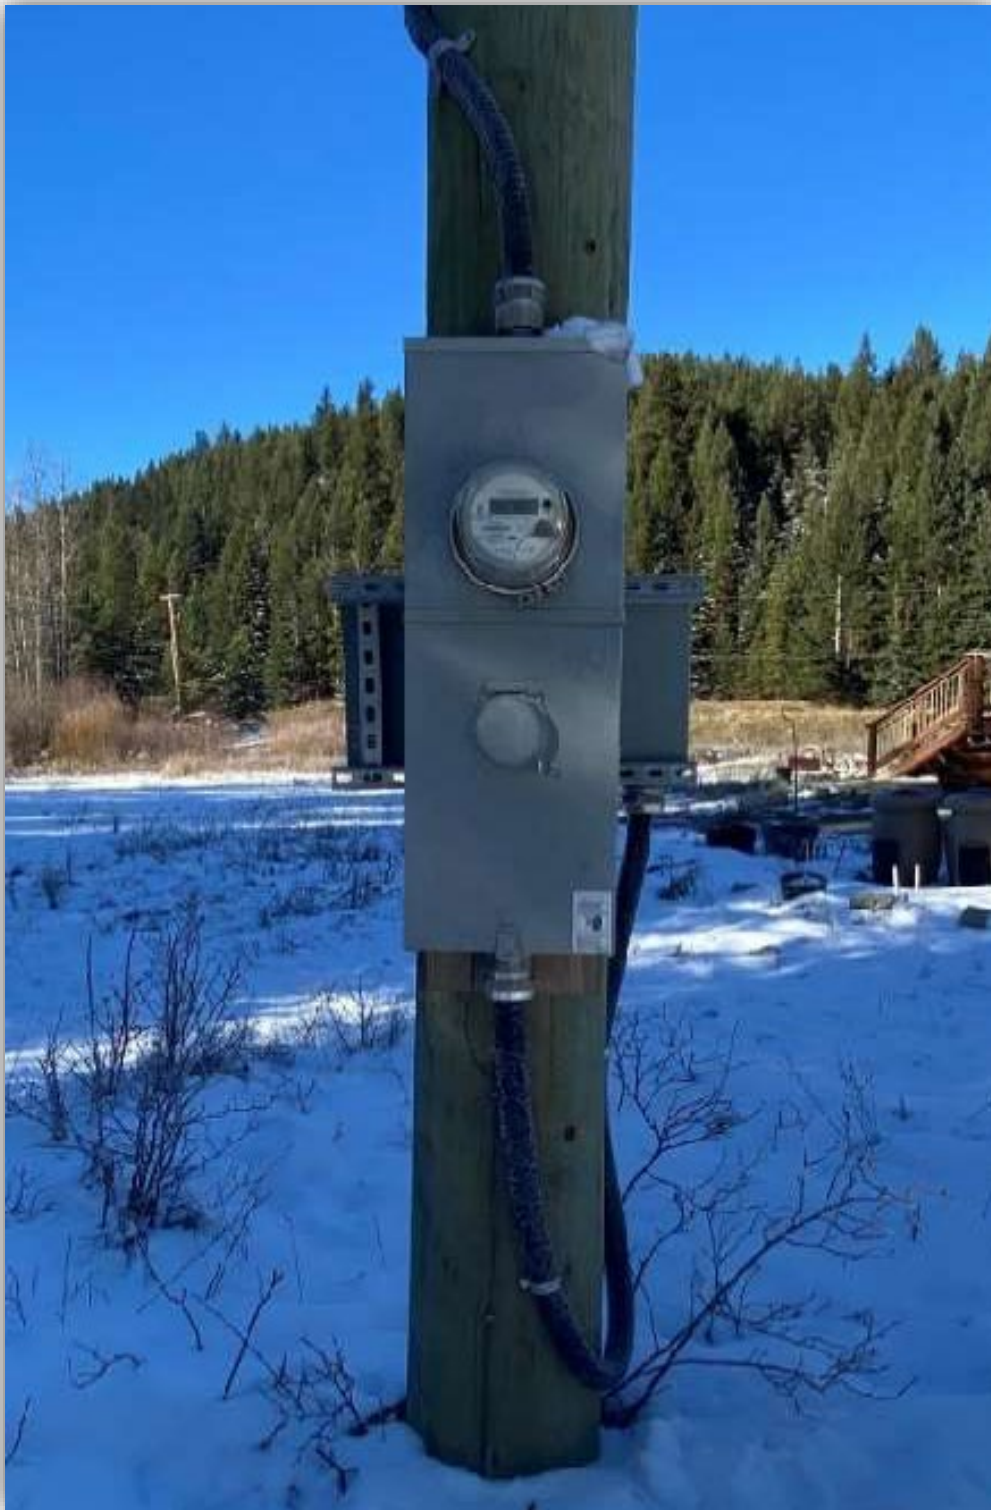
Image 1 - 200A combination meter with main breaker mounted to private pole.

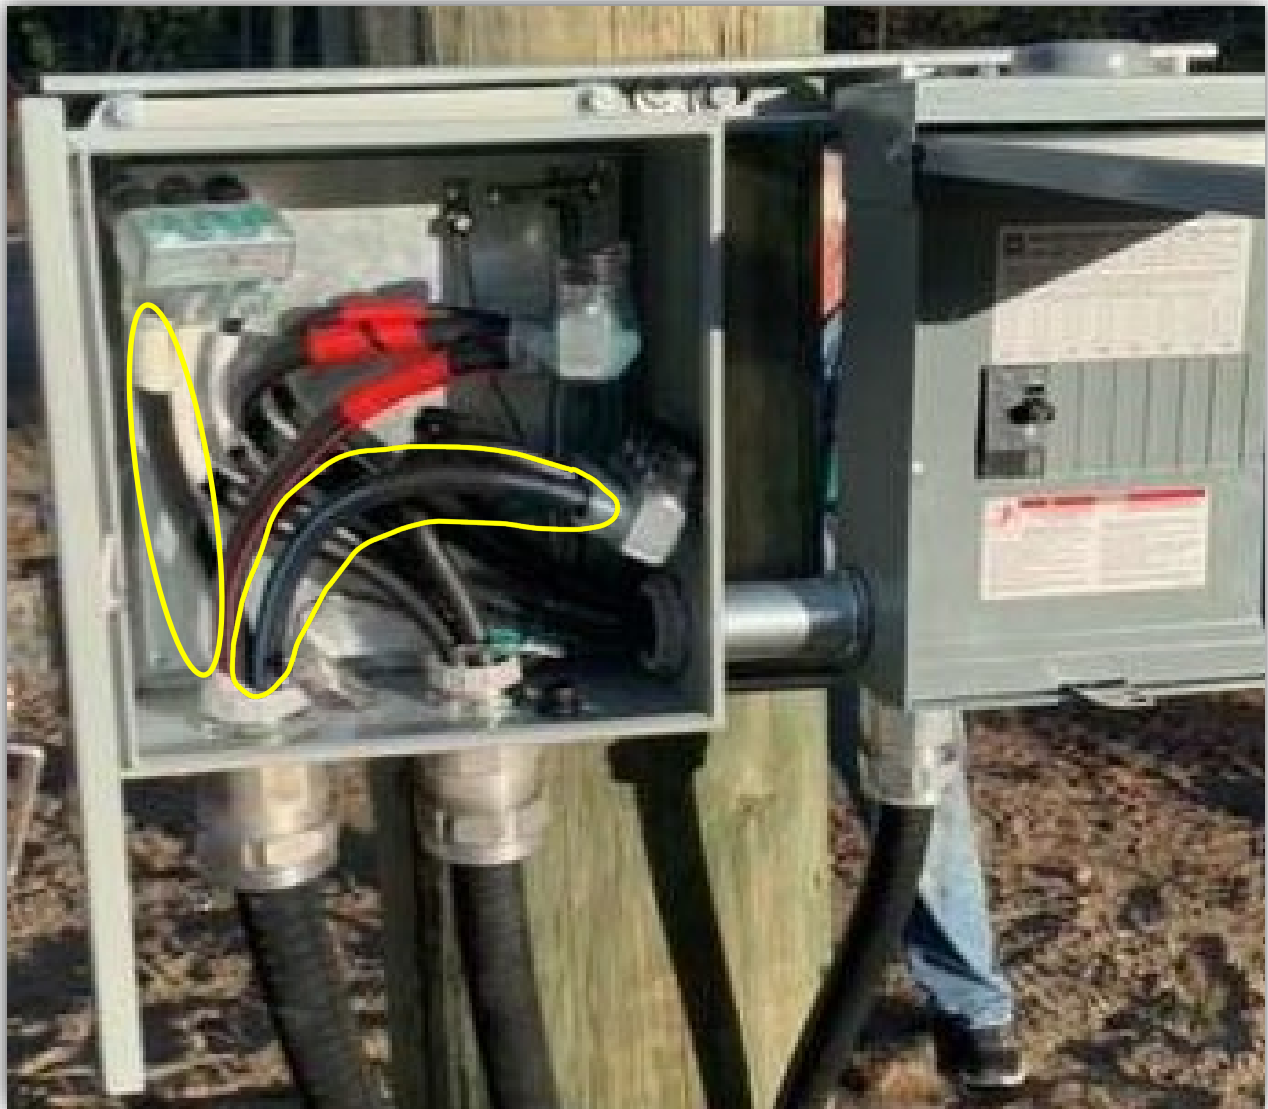
Failure scenario(s)		<p>Originally the 250KCMil ACWU cable ran underground straight from the utility meter 200A breaker to the 200A panel in the cabin. An electrician added the junction box on the pole to accommodate the addition of the 100A panel on the pole, as well as maintaining the 200A power feed to the cabin. When this was done a new 250KCMil ACWU was installed between the combination meter and the junction box, due to the original cable being too short. There are three conductors inside each of the ACWU cables. In a 120/240V electrical system the three conductors are used for two hot wires and a neutral, with the hots identified black and red, and the neutral identified white. 120V is measured between each hot conductor and neutral, and 240V is measured between the red and black hot conductors.</p> <p>In the new 250KCMil ACWU cable, the conductors are factory colour coded black, red, and blue. The typical color coding for the neutral conductor is white, but since the cable was factory coded with black, red, and blue, the neutral had to be identified with white tape. Identification of the neutral conductor was inconsistent (<a href="#">Image 2</a>).</p> <p>One end of the cable the black conductor was identified as the neutral with white tape, and on the other end of the cable the blue conductor was identified with white</p>

<p>tape. Because of this mislabeling the black hot conductor and the neutral conductor were crossed. When the power was turned on there was now 240V between the red-hot conductor and neutral, 120V between the black hot conductor and neutral, and 120V between the red and the black hot conductors.</p> <p>The existing cabin had several household items plugged into 120V receptacles, as well as 120V light fixtures with light bulbs that were now damaged due to 240V being present.</p>
Failure scenario(s)	<p>Originally the 250 KCMil ACWU cable was ran underground straight from the utility meter 200A breaker to the 200A panel in the cabin. An electrician added the junction box on the pole to accommodate the addition of the 100A panel on the pole, as well as maintaining the 200A power feed to the cabin. When this was done a new 250 KCMil ACWU was installed between the combination meter and the junction box, due to the original cable being too short. There are three conductors inside each of the ACWU cables. In a 120/240V electrical system the three conductors are used for two hot wires and a neutral, with the hots identified black and red, and the neutral identified white. 120V is measured between each hot conductor and neutral, and 240V is measured between the red and black hot conductors.</p> <p>In the new 250 KCMil ACWU cable, the conductors are factory colour coded black, red, and blue. The typical color coding for the neutral conductor is white, but since the cable was factory coded with black, red, and blue, the neutral had to be identified with white tape.</p> <p>Identification of the neutral conductor was inconsistent (<a href="#">Image 2</a>). One end of the cable the black conductor was identified as the neutral with white tape, and on the other end of the cable the blue conductor was identified with white tape. Because of this mislabeling the black hot conductor and the neutral conductor were crossed. When the power was turned on there was now 240V between the red-hot conductor and neutral, 120V between the black hot conductor and neutral, and 120V between the red and the black hot conductors. The existing cabin had several household items plugged into 120V receptacles, as well as 120V light fixtures with light bulbs that were now damaged due to 240V being present.</p> <p>In the basement of the cabin there was a circuit that had a fault on it due to the hot and neutral being swapped. Neutral conductors do not have over current protection installed on them, and with the hot and neutral being swapped there was no over current to protect that circuit from sustaining damage from instantaneous high current and high heat (<a href="#">Image 3</a>).</p>

Image 2 - Junction box with splice to accommodate 100A panel on pole. [Circled] Misidentified conductors.

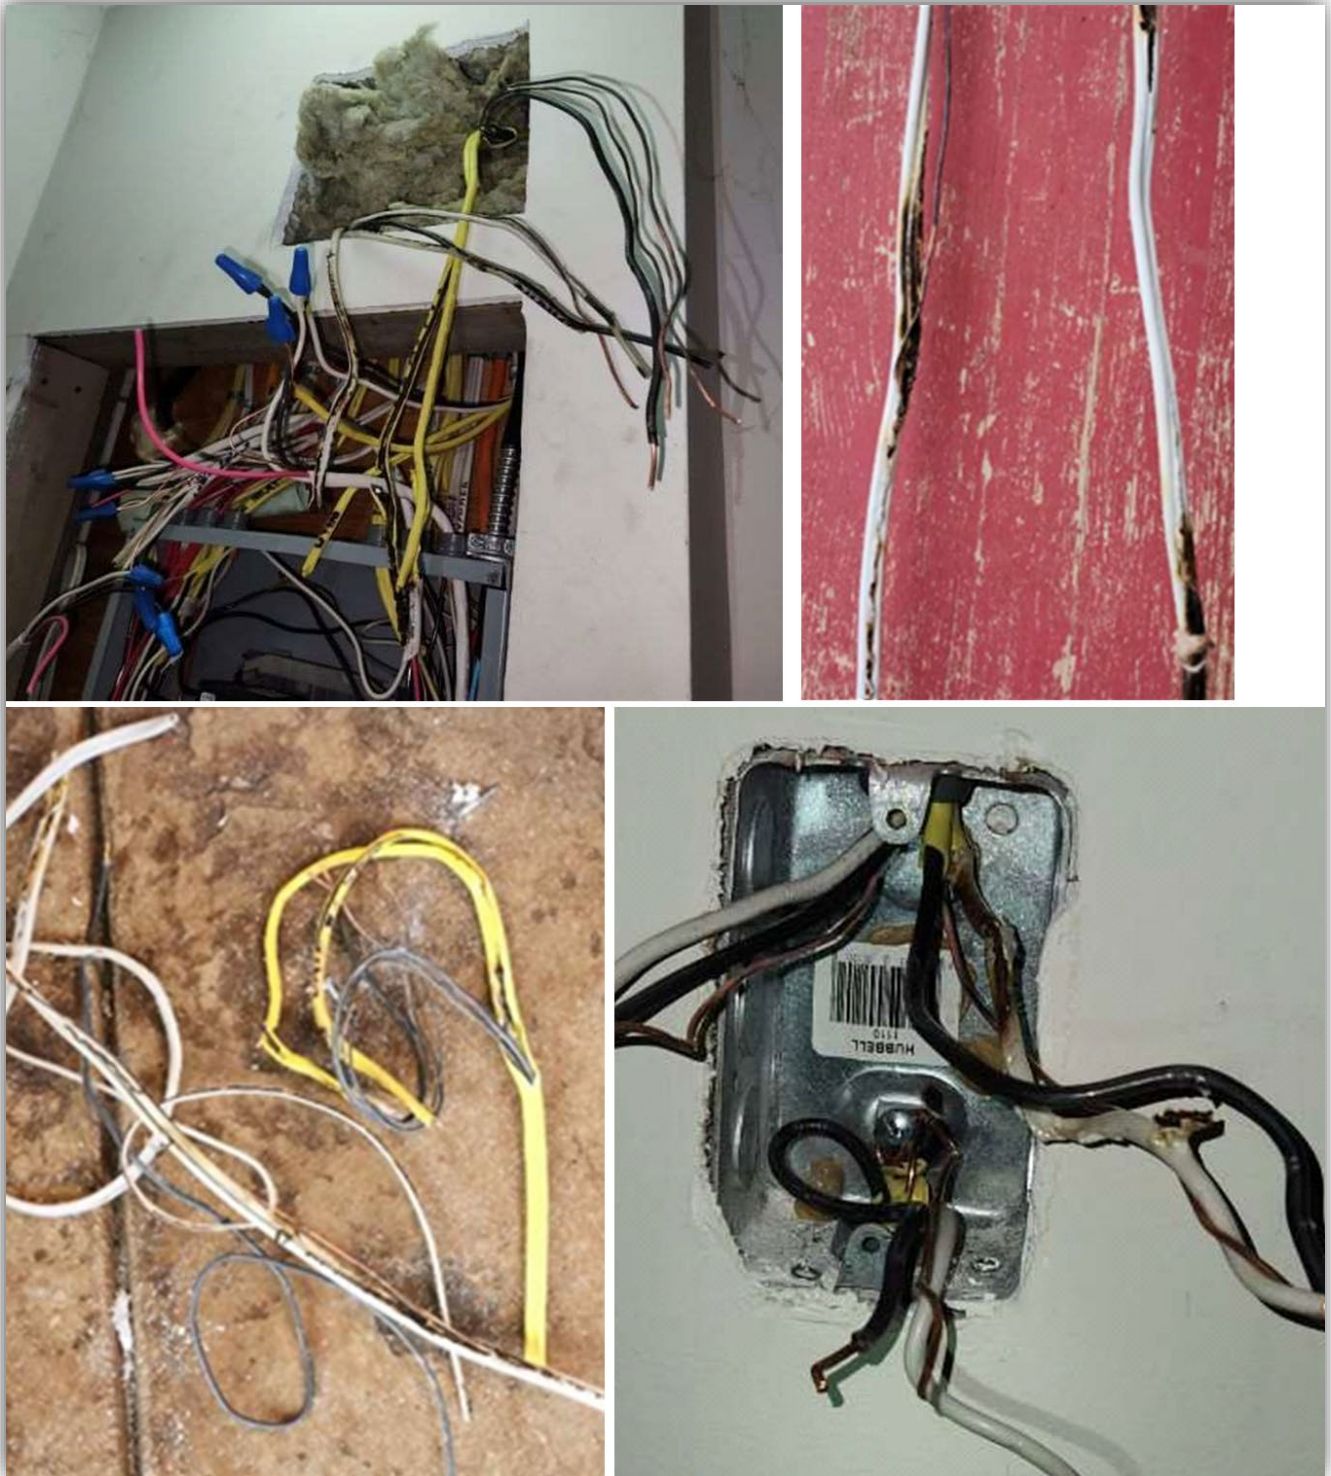
<p>Causes and contributing factors</p>	<p>It is highly likely that the heat damage and damage to appliances occurred when the black hot conductor and the neutral conductor were misidentified and crossed in the electrical system.</p> <p>Contributing factors are:</p> <ul style="list-style-type: none"> <li>• Sensitive electronic appliances rated for 120V that were plugged into wall receptacles where 240V was present.</li> <li>• The neutral conductor that became a hot conductor did not have overcurrent protection on it, and that led to the physically damaged wiring in the cabin before the power was turned off.</li> </ul>

Image 3 - Damaged wiring inside the cabin.
