## Incident Summary #II-978382-2020 (#16593) (FINAL)

| | Regulated industry sector | | Elevating devices - Construction / personnel hoist/ man lift | |
| Incident overview | | As the construction hoist traveled down, the cab struck the tower causing significant damage to the tower. Other components of the cab were also scraping the tower as the cab traveled up and down. | | |

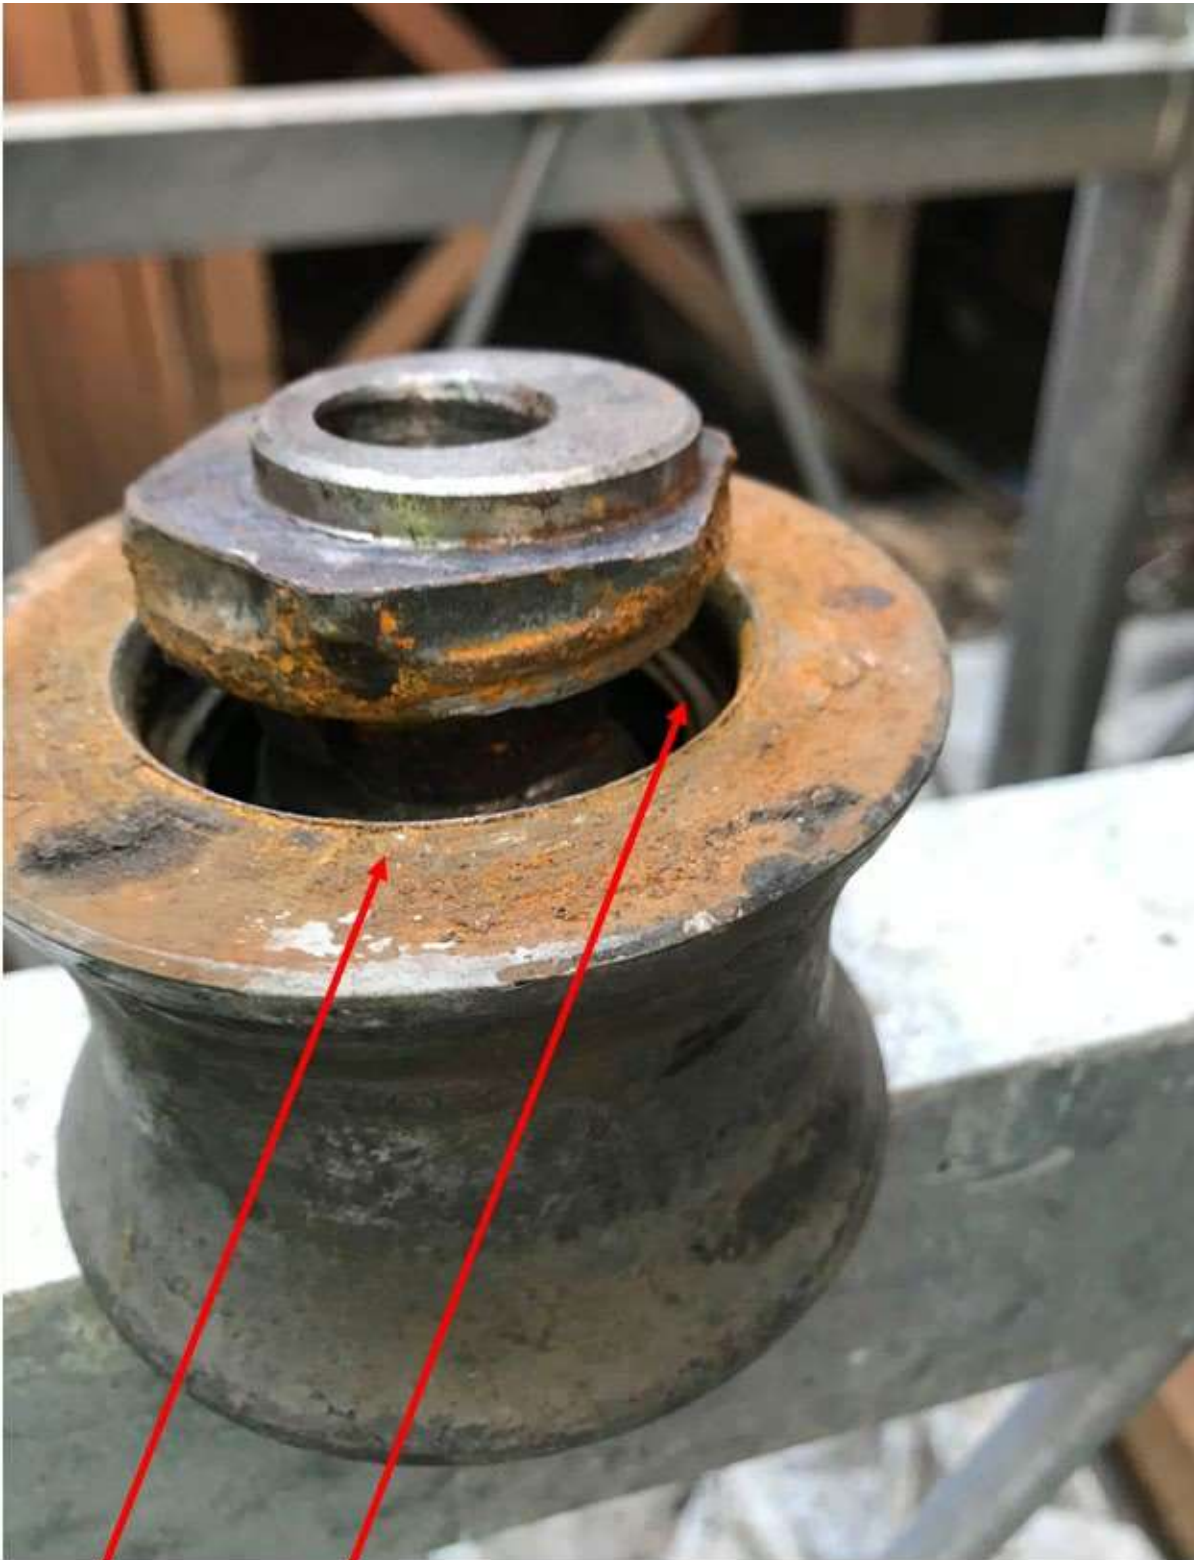
Picture #1

| <b>Causes and contributing factors</b> | It is highly probable that failure of one of the guide rollers caused the cab to sway excessively causing the truck assembly to come into contact with the tower resulting in damage to the tower sections. |

Failed Guide Roller – Bearing Failure

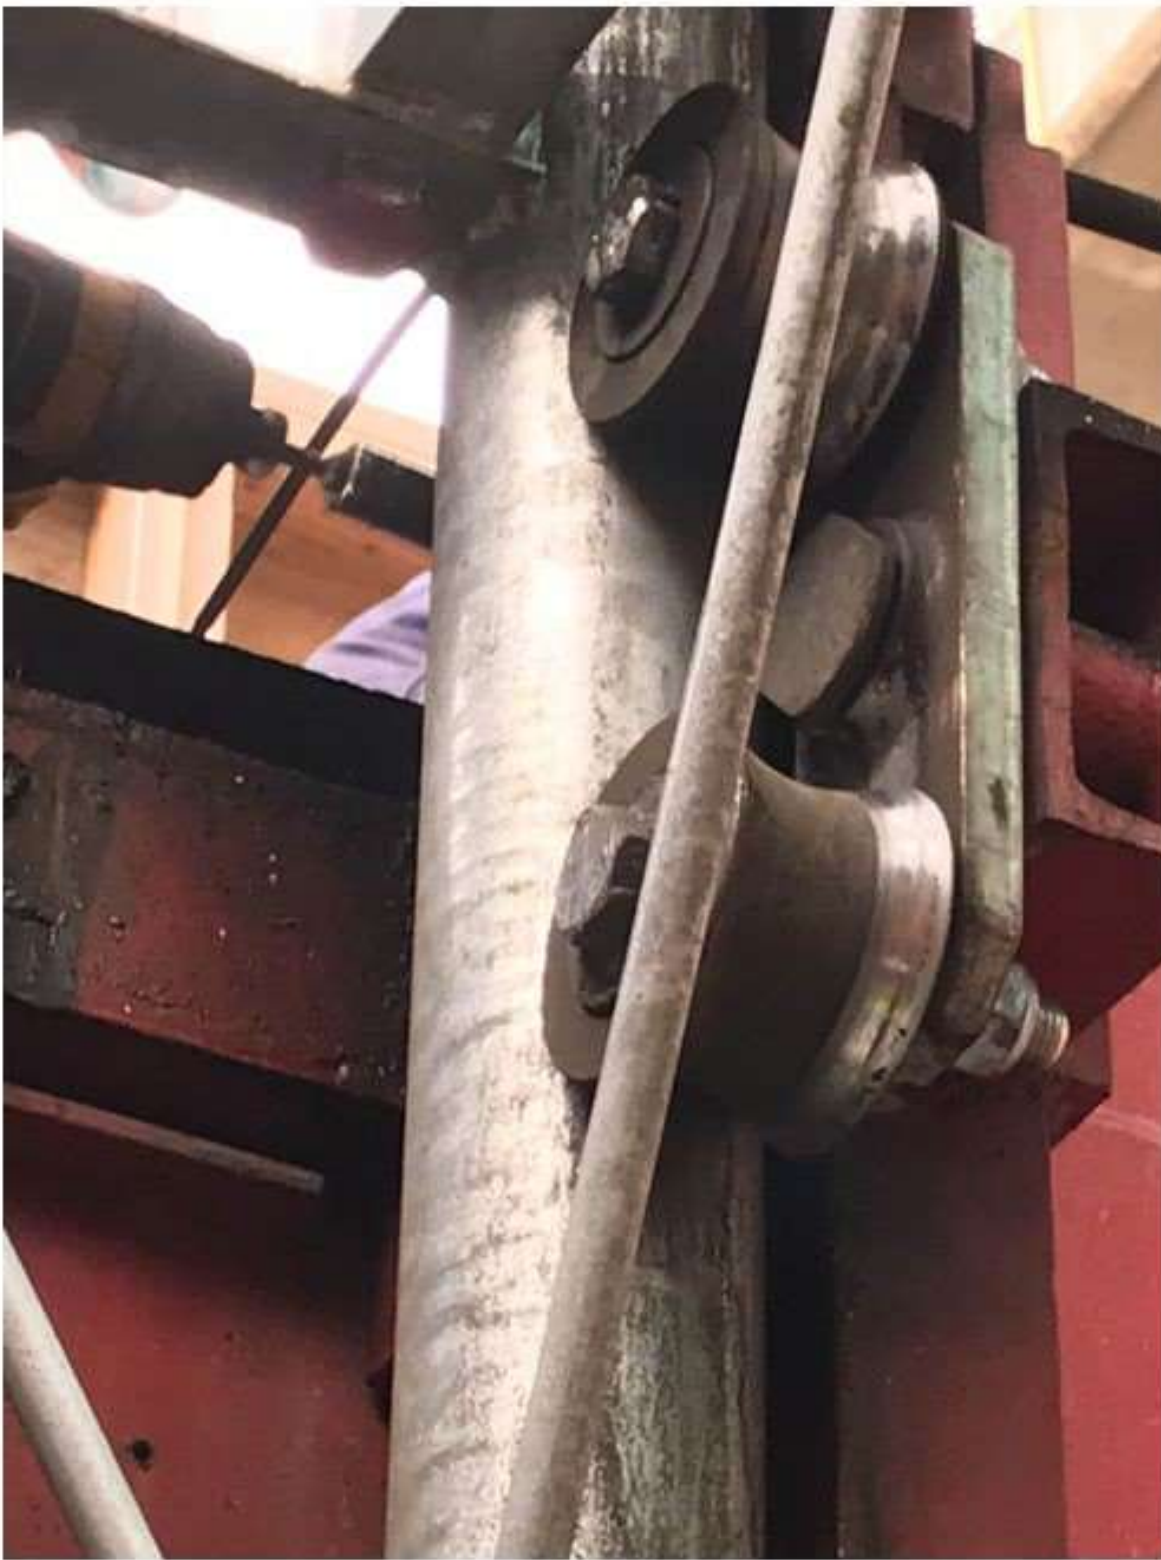
Picture #2

Upper Truck Assembly – Building Side

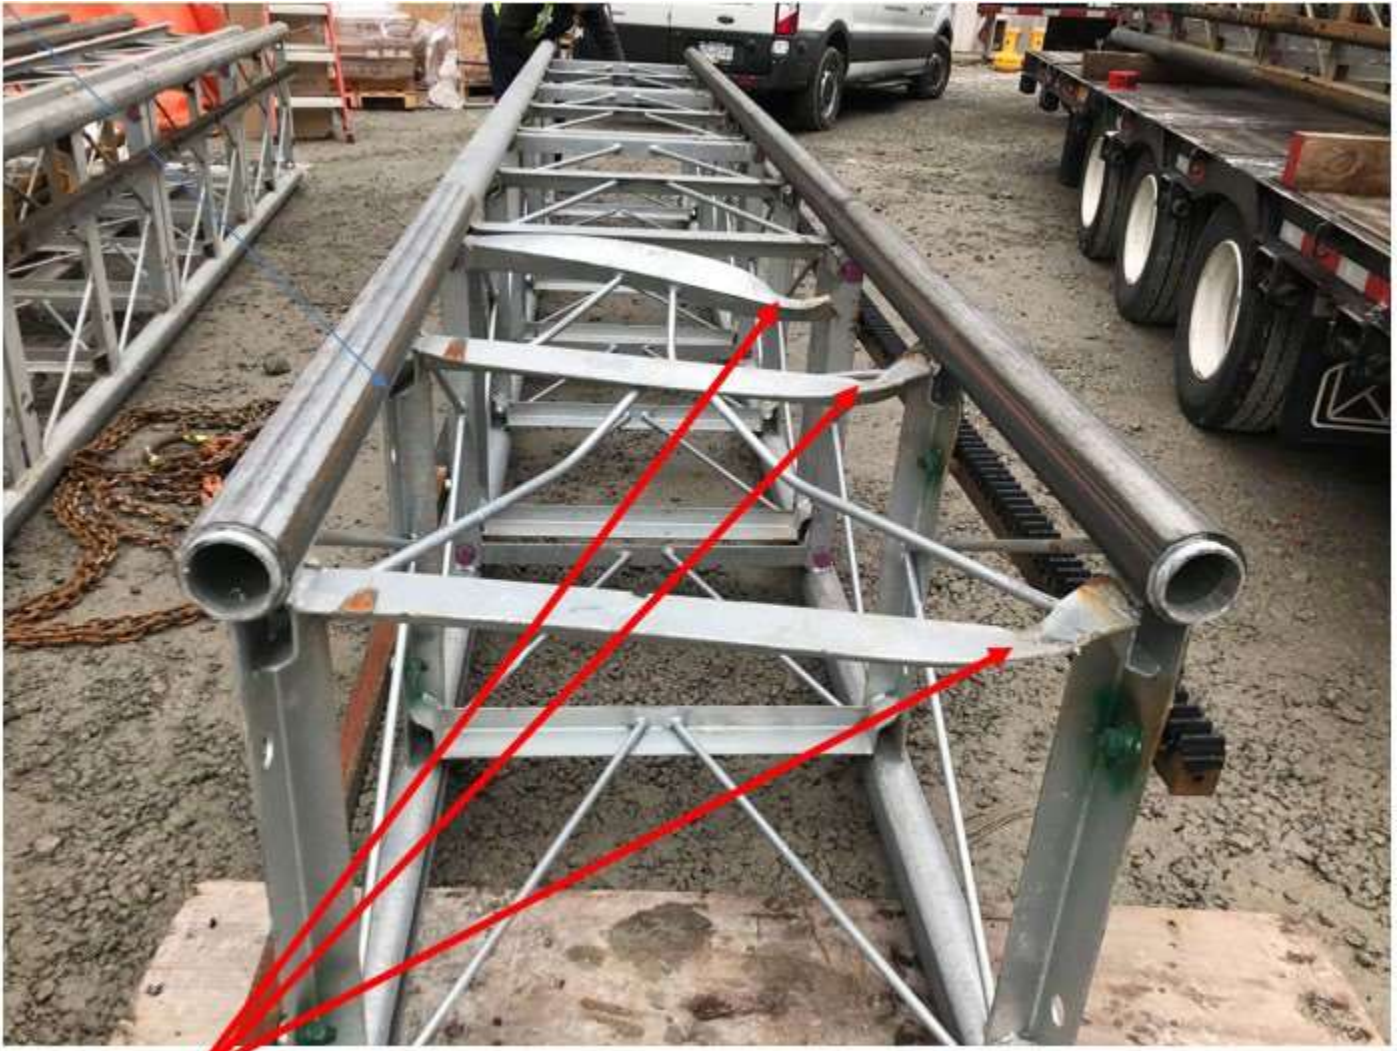
Picture #3

| | Failure scenario(s) | | Due to the tight tolerance of the truck roller assembly to the tower, the failure of a bearing in the guide roller in the lower truck assembly caused the cab to sway/rock excessively which resulted in the upper truck assembly to make contact with the tower causing the damage (See pictures 3-4). | |

Damaged Tower Section

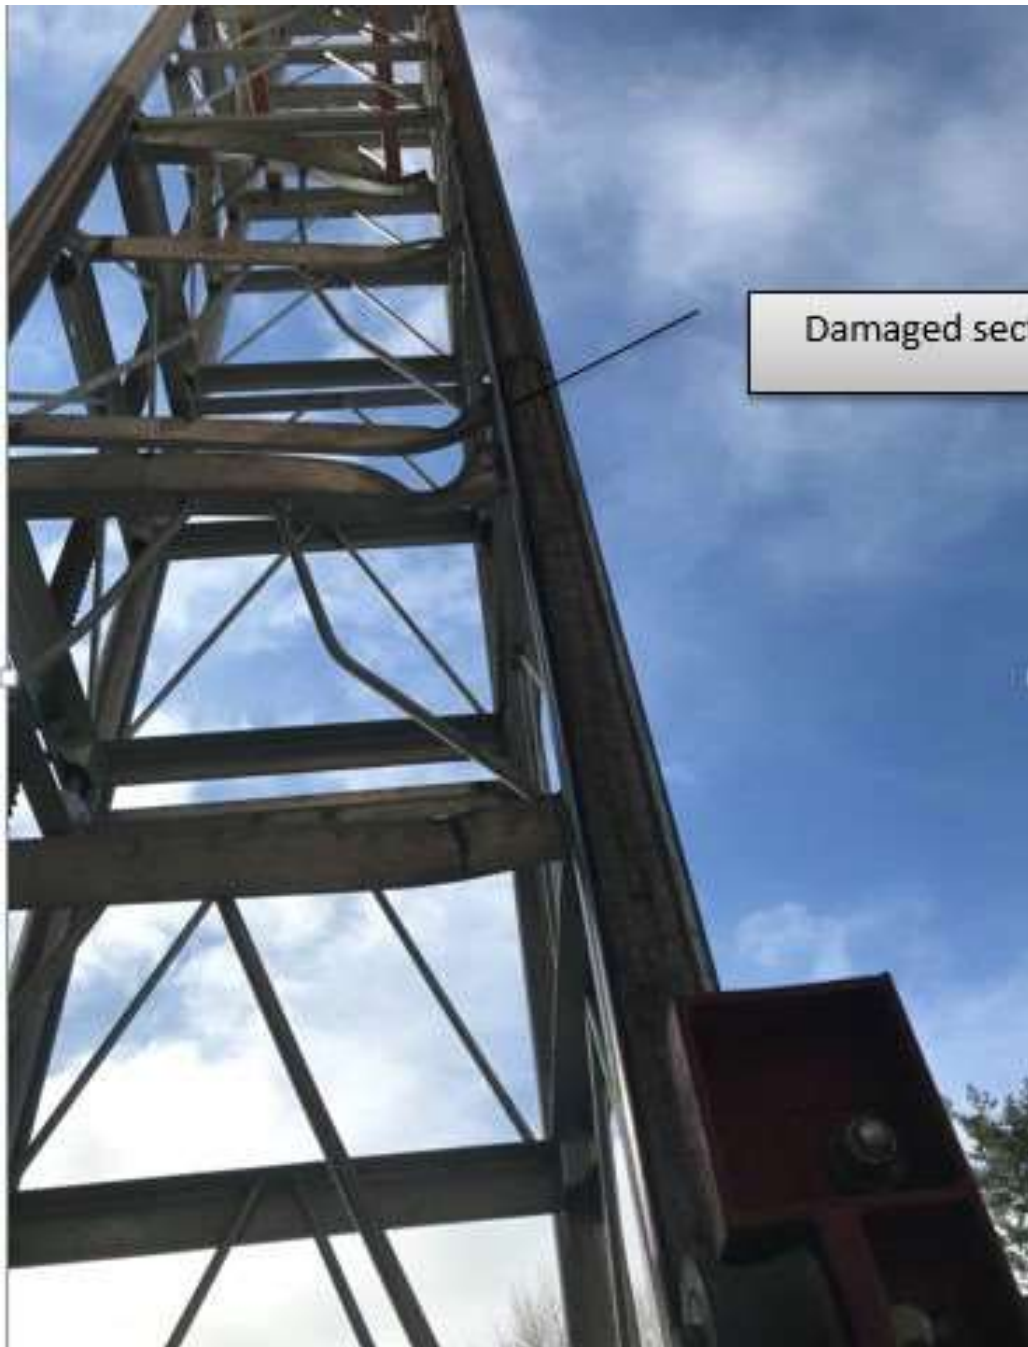
Picture #4

Damaged section of the tower

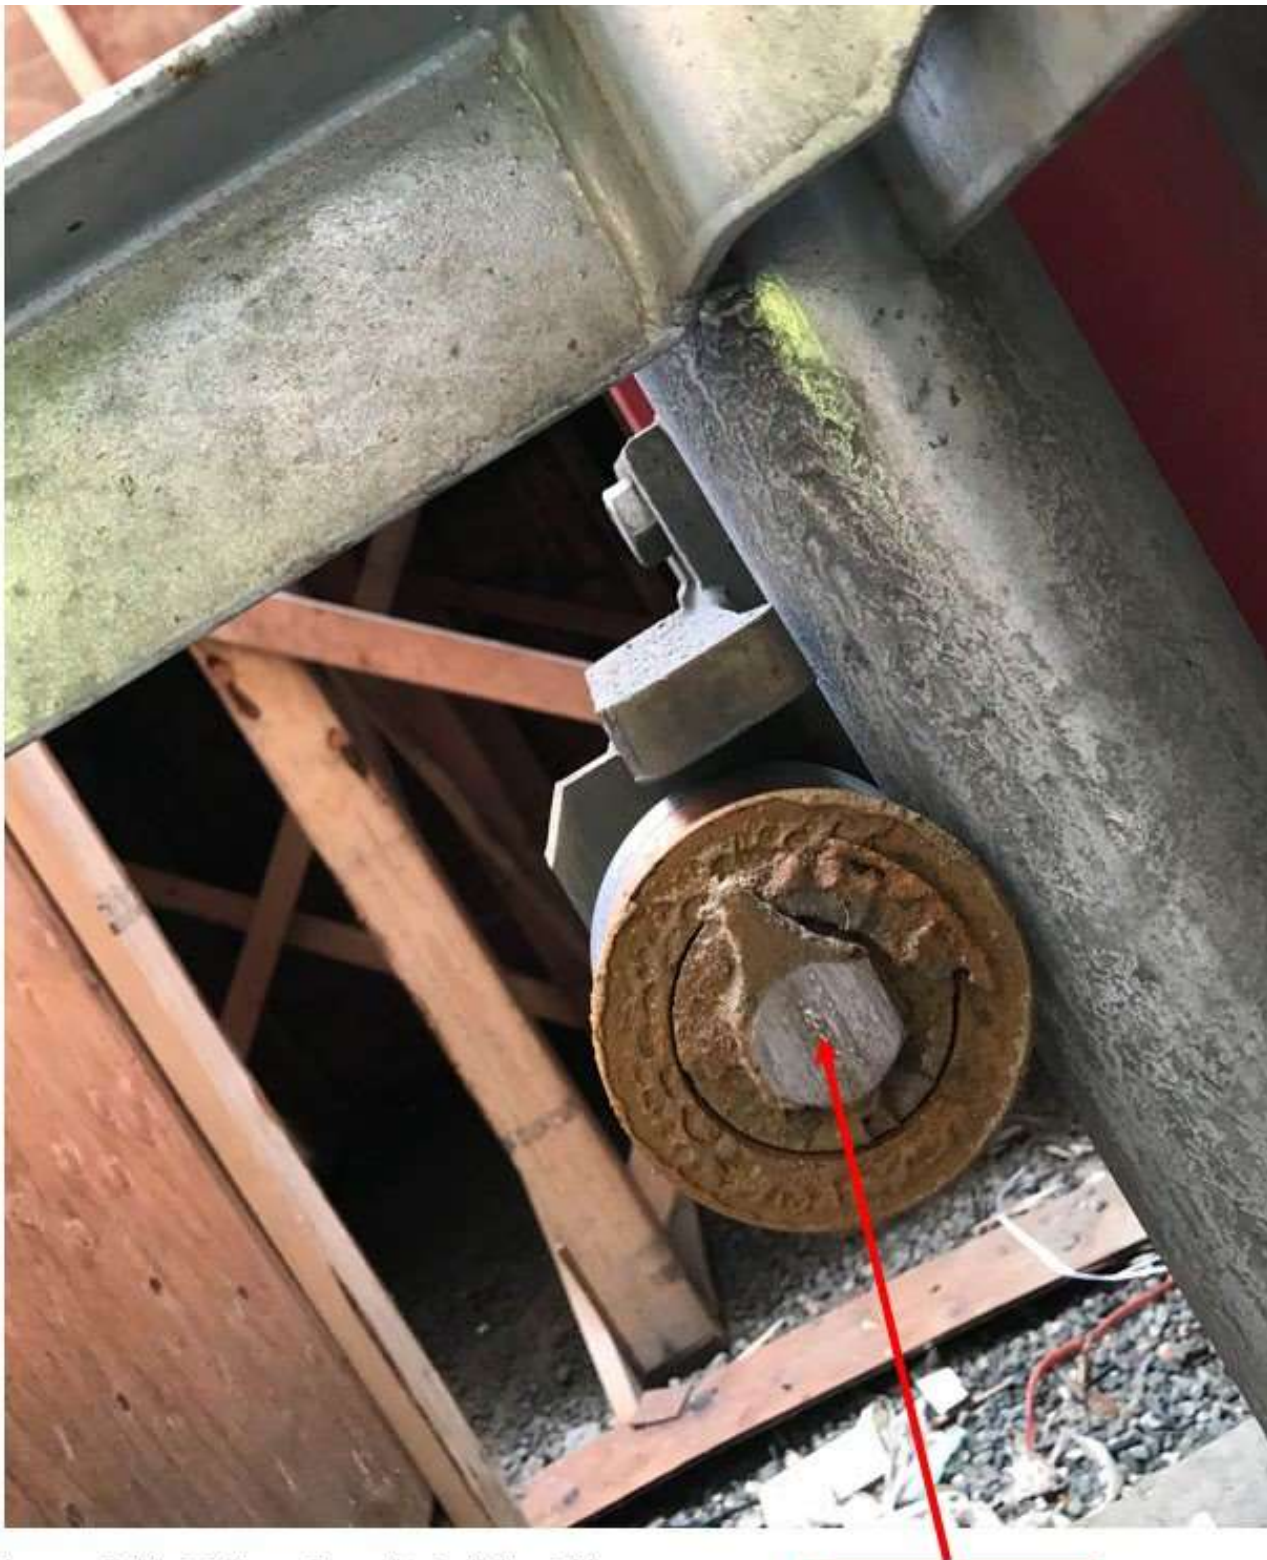
Picture #5

Lower Guide Roller – Opposite Building Side

Contact with tower

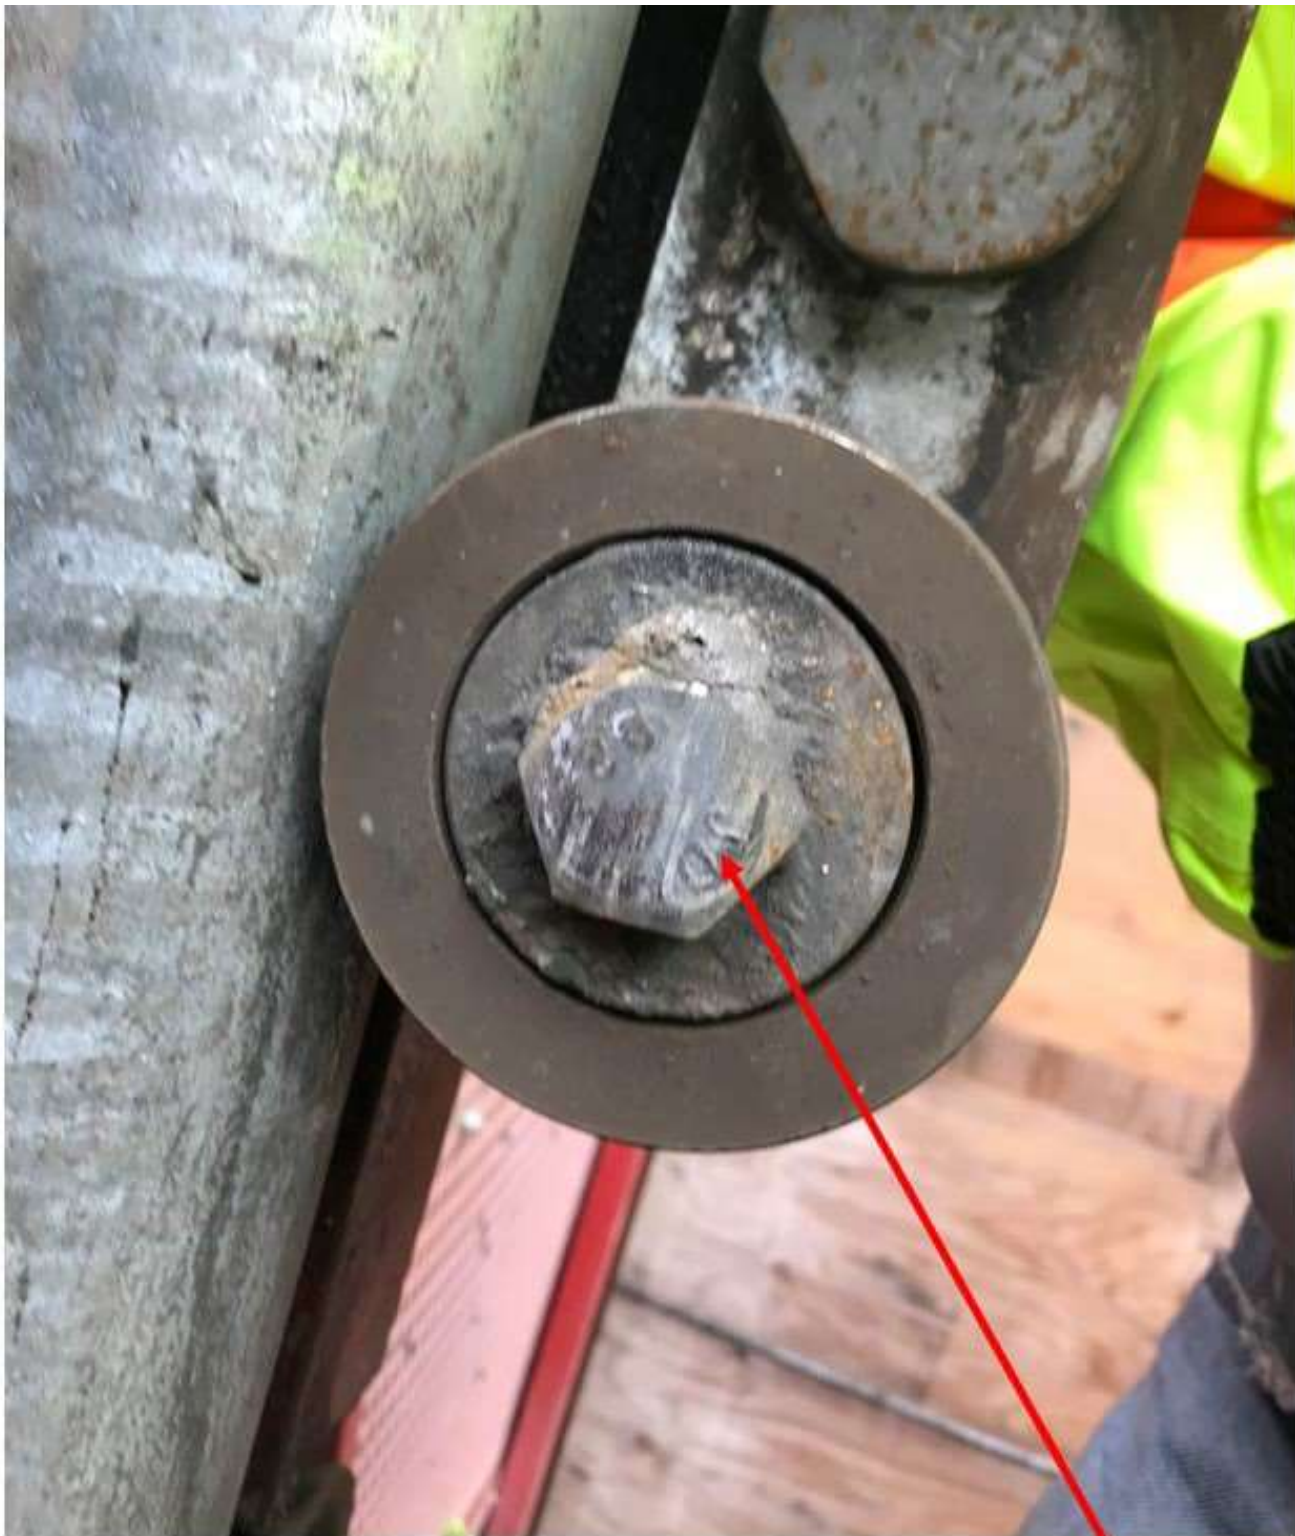
Picture #6

| | Facts and evidence | | <p>During the removal process the tower more closely inspected to ascertain components contacted the tower. It was found that the bolts that secured the guide rollers on the truck assembly had struck the tower based on the damage on the bolt head (See picture 6). It was also found that the bolts of the truck assembly on the opposite site of the cab were scraping the tower on the opposite side of the tower as the cab traveled up and down the tower (See picture 5).</p> <p><b>On-site investigation and interviews with Mechanic:</b></p> <ul style="list-style-type: none"><li>• Mechanic replaced a roller on the lower truck assembly (building side)</li><li>• Mechanic went on top of the car to perform an inspection to ensure the unit was operating as per manufacturer's specifications. This is when damage to the tower was discovered</li></ul> | |

Upper Truck Assembly – Building Side

Contact with tower
