## Incident Summary II-1738757-2024 (#49429) (Final)

SUPPORTING INFORMATION	Incident Date	July 24, 2024
	Location	Armstrong
	Regulated industry sector	Electrical
	Qty injuries	1
	Impact Injury	Injury description
		A qualified electrical maintenance technician came into contact with 1500volts AC connected to an electronic card on a piece of equipment during a routine maintenance process. Resulting in injuries that included a laceration on the right thumb and 2 burn marks on the right ring finger and right wrist.
		Injury rating
	Damage	Damage description
		Damage rating
	Incident rating	Minor
INVESTIGATION CONCLUSIONS	Incident overview	<p>The incident occurred on a veneer 'moisture detection' machine while regular maintenance adjustments were being performed to the sensing cards located behind a clear plastic plexiglass barrier.</p> <p>It was noted that one card was neither seated nor secured in its bracket. As a result of this it did not allow the maintenance personnel to access the adjustment screw or metering terminals as per the manufacturer's instructions.</p> <p>The qualified electrical maintenance technician removed the plexiglass barrier to re-seat the card while the equipm

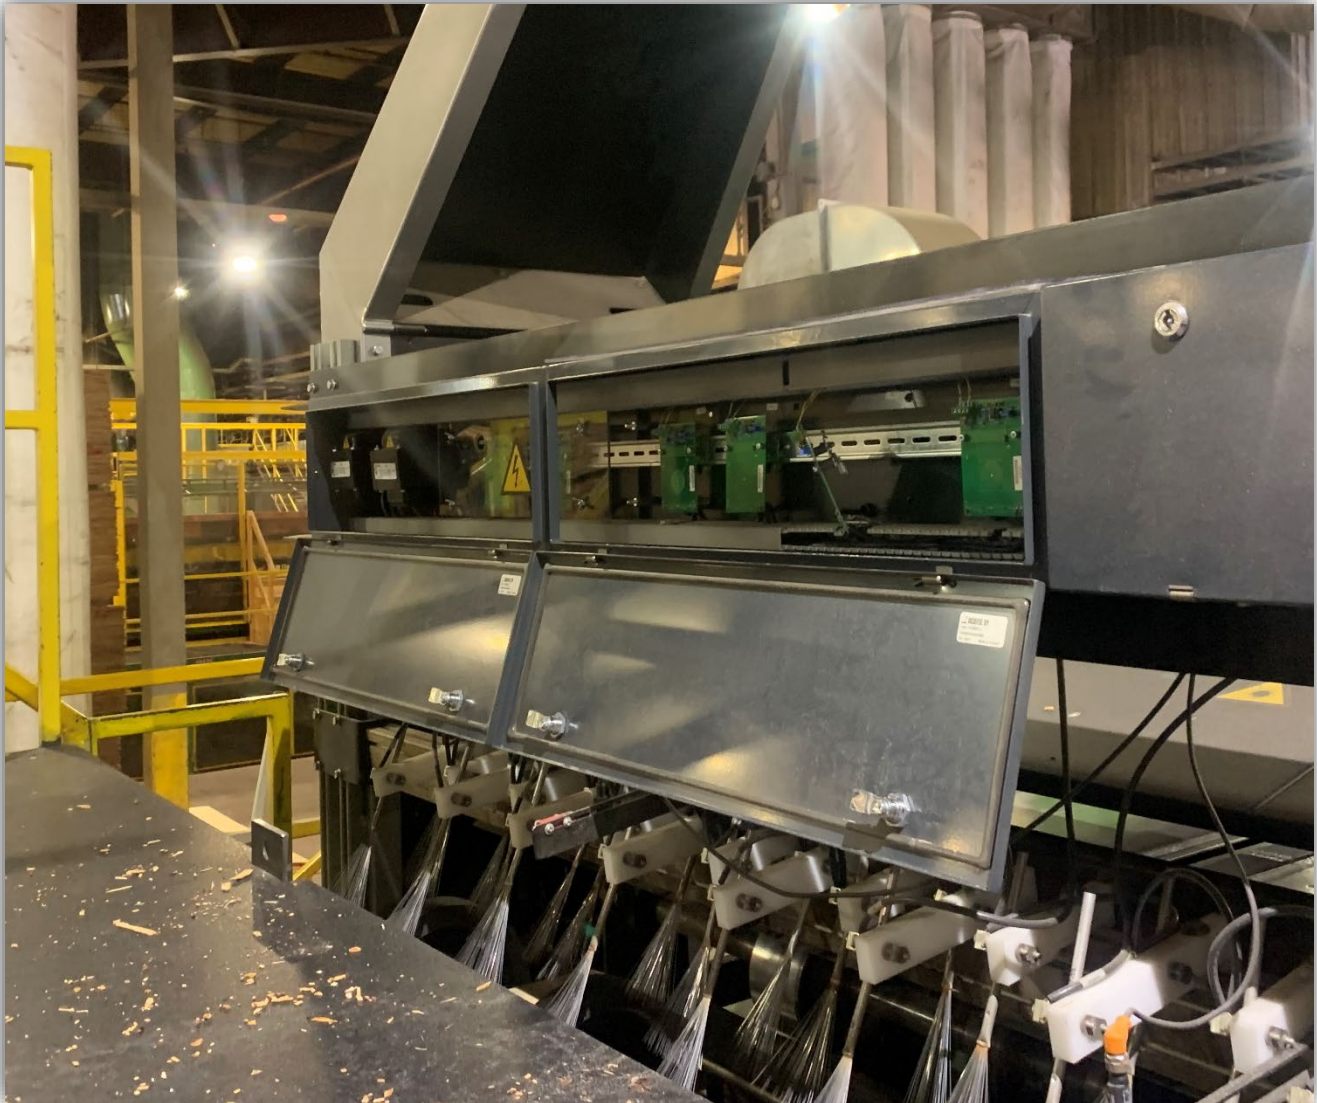
Image 1 - Sideview of maintenance platform to access the machine components for adjustments and testing.

- Plywood veneer sheets run through the machine and under the platform during operation, the brushes viewed have 7Vac applied to multiple metal brushes with a 0-volt grounded reference point to complete the circuit.
- These brushes are accessible to maintenance personnel during operation.
- Loose card noted in mid-open panel.
- Transformers viewed in far open panel.

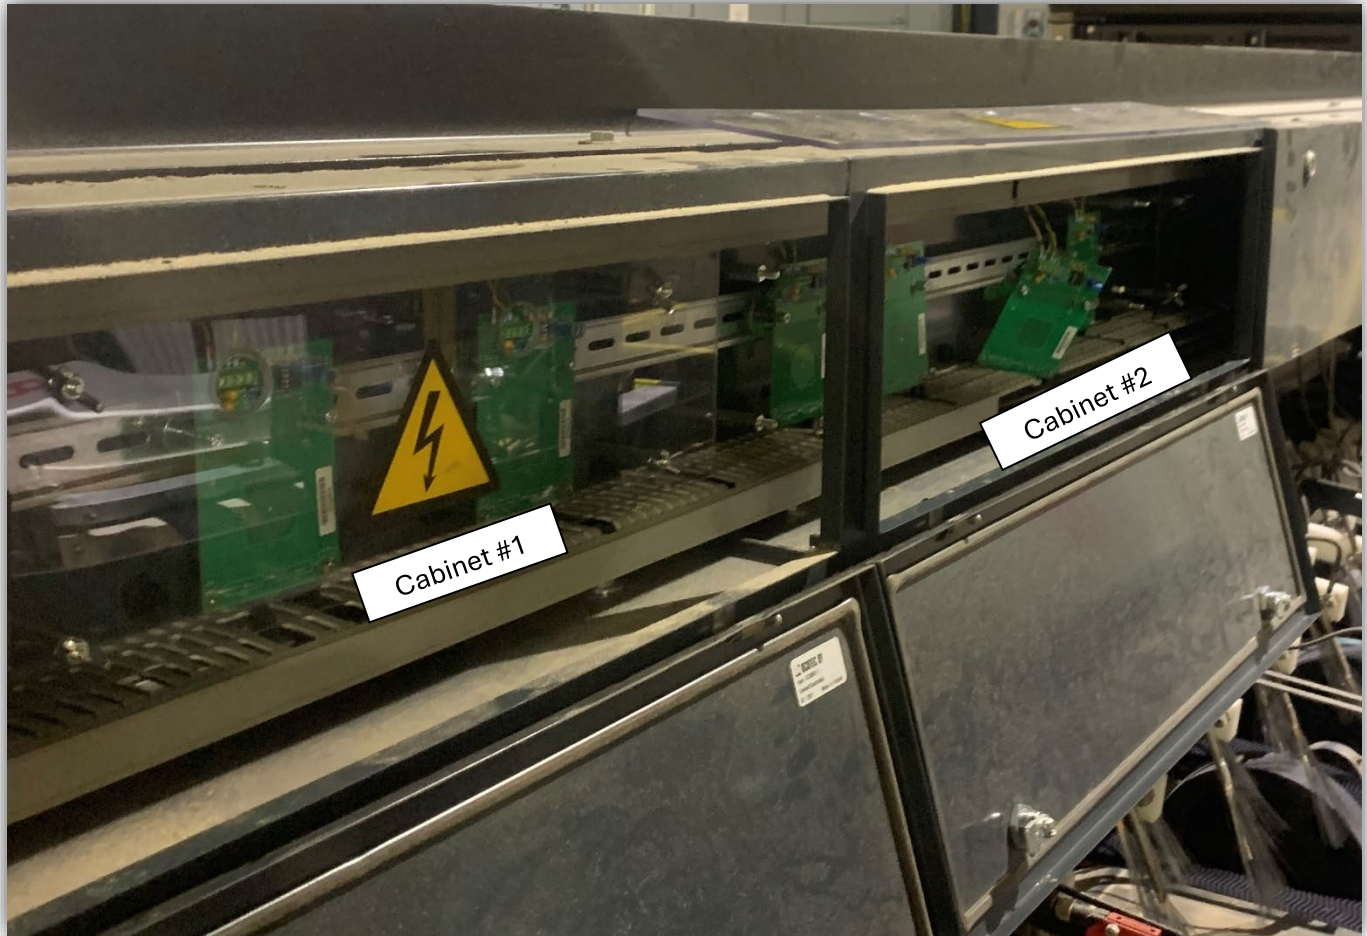
Image 2 - Close up view of the open cabinets after the incident occurred:

- Cabinet #1 with 1500volt transformers and 2 sensing cards located behind plexiglass cover installed 'Electric Warning' label.
- Cabinet #2 with sensing cards, plexiglass cover removed and laying on top of cabinet, loose sensing card where incident occurred is viewed.

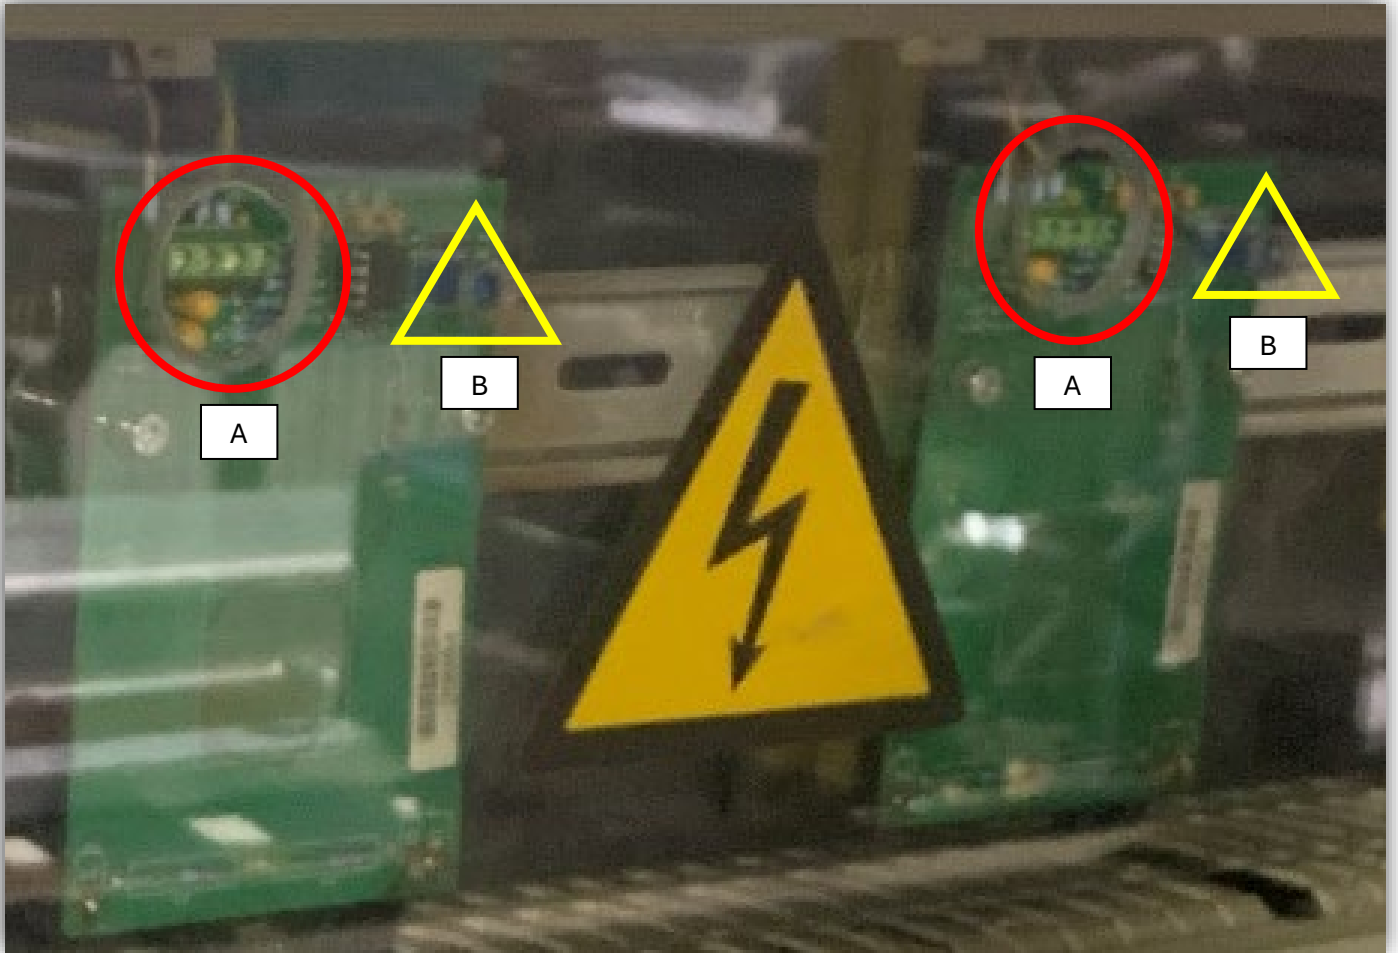
Image 3 – [A] Close up of manufacturers voltage measurement access through plexiglass cover. [B] And access points for maintenance personnel to measure voltages (0-10volts, 7 volts target) with screwdriver access holes.

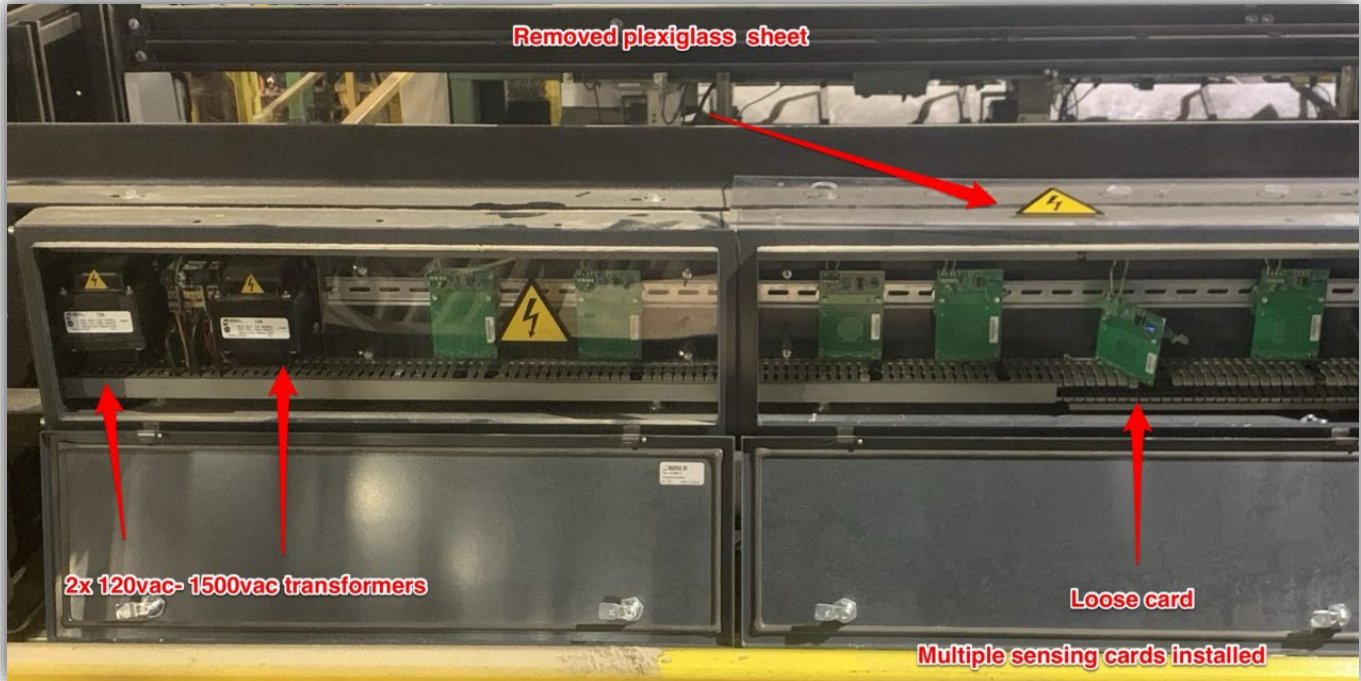
Image 4 - Front view of the machine - Locations of transformers, various sensing cards and exposed metal brushes that make contact with veneer sheets during process.

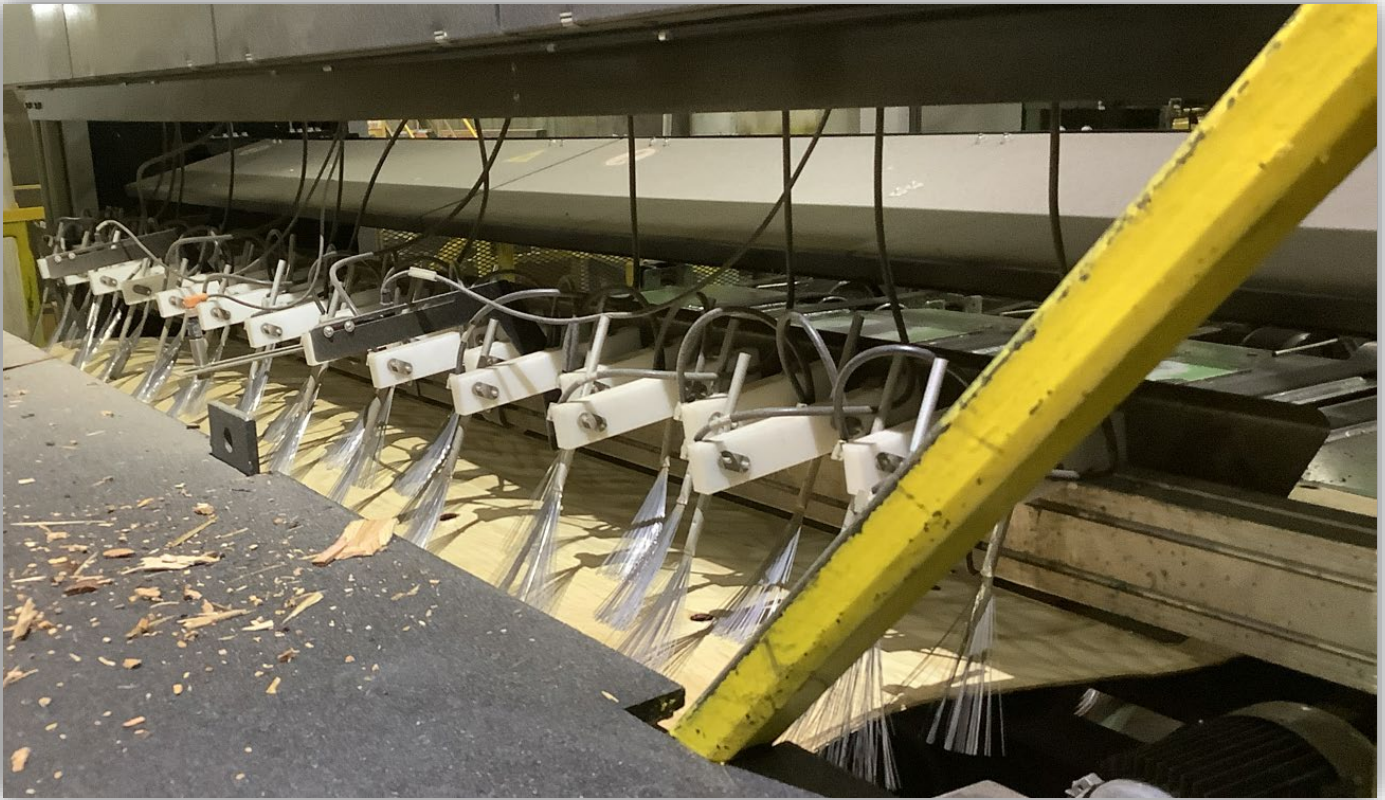
Image 5 - Sensing brushes below with 7Vac sensing circuits measuring moisture in sheets as they cross the brushes to 0-volt sensing brushes.

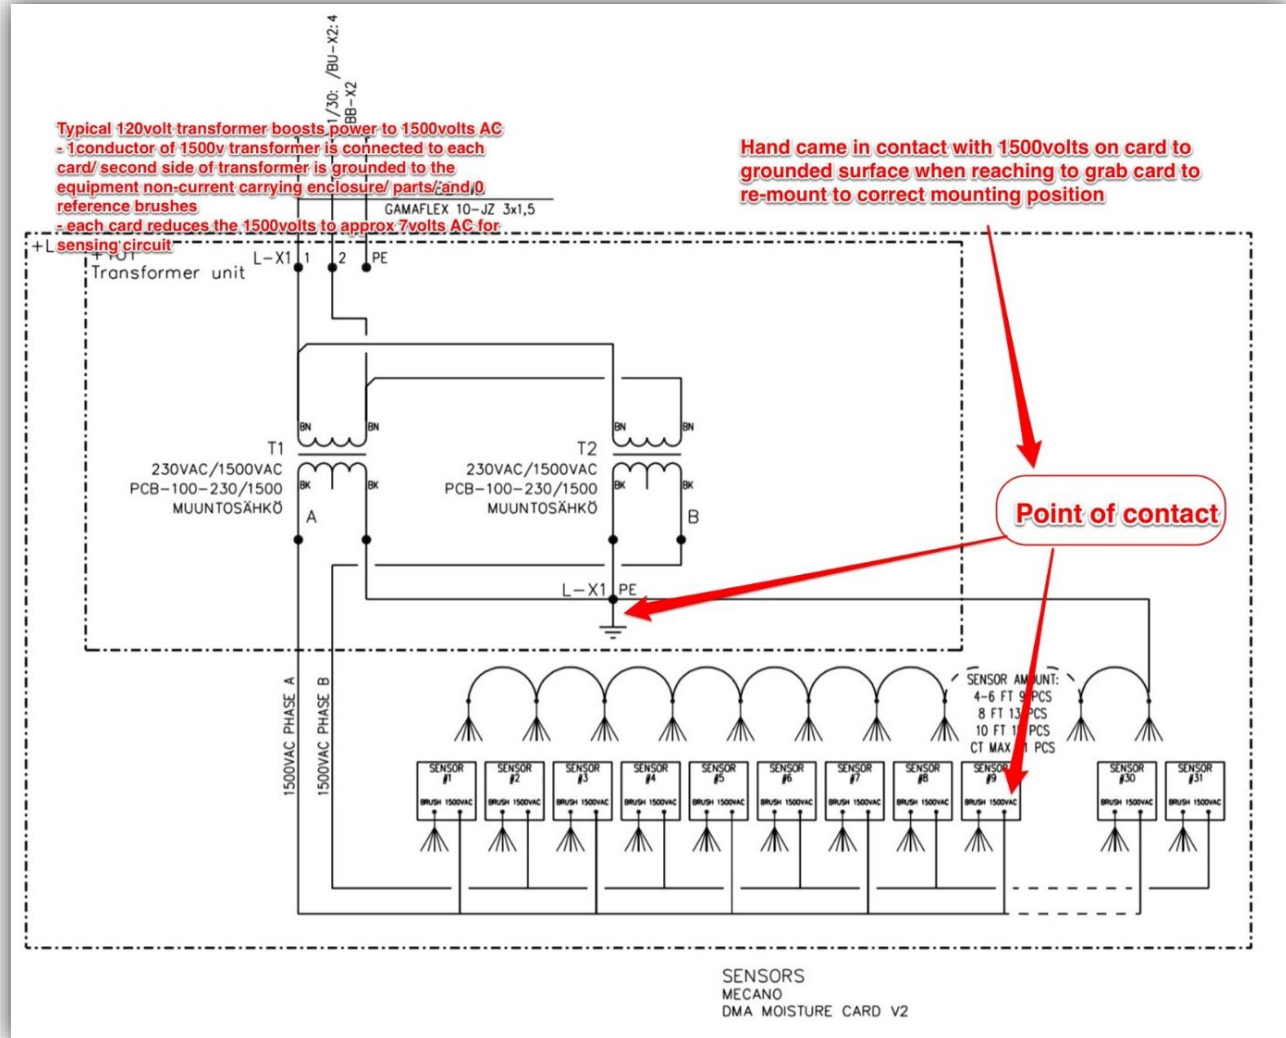
Image 6 - Copy of 1-line diagram retrieved from manual obtained by duty holder after the incident notes:

- 1500volt connections to sensing cards.
- Cards reduce 1500volts to 0-10volts to complete circuit.
- Communications are sent from cards to PLC.
- Point of Contact was created by physical contact with card at the point where 1500volt conductor is applied to any grounded surface.
