Incident Summary #II-1200230-2021 (#22172) (FINAL)

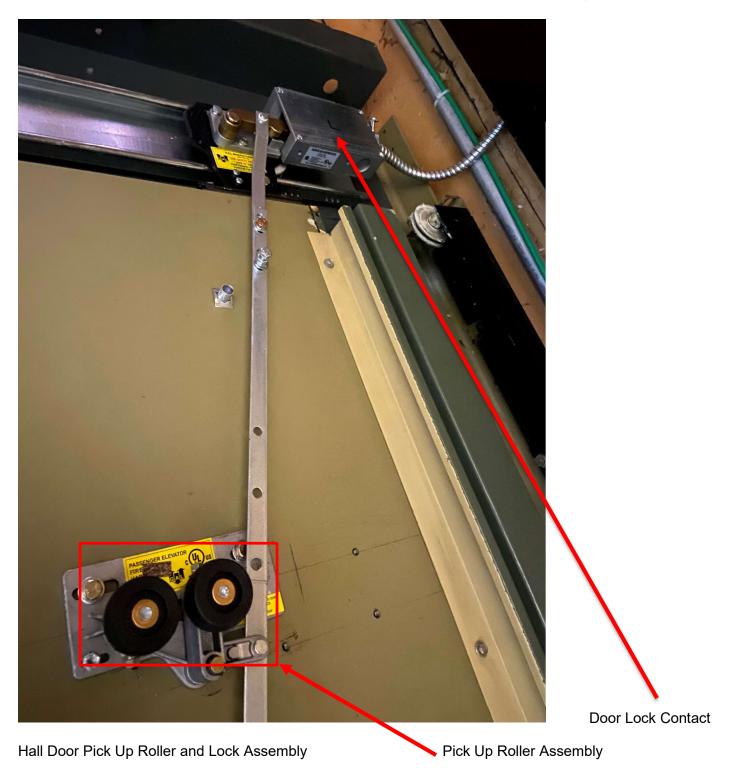
Failure scenario(s)		After reviewing the fault logs that were generated by the controller, it was determined that during the elevator travel to P2, the door clutch clipped the hall door lock at the third floor. This caused the controller to initiate an emergency stop.
	Facts and evidence		After reviewing the controller fault log, the fault log showed that the safety circuit opened and caused the controller to initiate an emergency stop,
	Causes and contributing factors		It is highly likely that due to the tight adjustment and the settling of the building, the car door clutch and hall door lock clearances became so tight that as the car passed the third floor, the car door clutch clipped the hall door lock causing the controller to initiate an emergency stop.

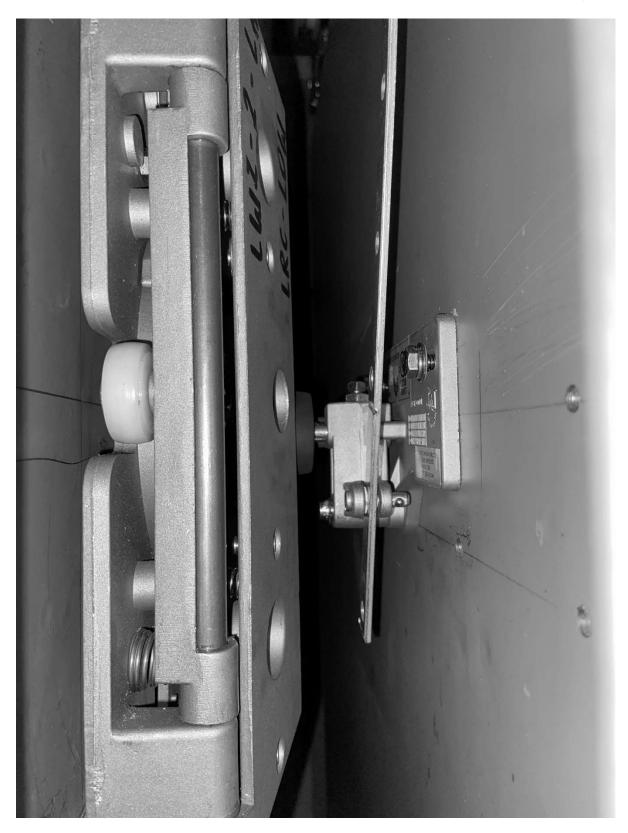
Hall Door Lock and Car Door Clutch
