#### Incident Summary #II-871224-2019 (#13788) (FINAL) Revised August 6, 2020

| | Incident Date | May 11, 2019 (#13788) (FINAL) Revised August 6, 2020 |
|---|---|---|
| | Regulated industry sector | Amusement Devices - Zip line |
| | Incident overview | The active dynamic primary brake system for the zip line became fixed in place causing an instantaneous stop of the rider. |

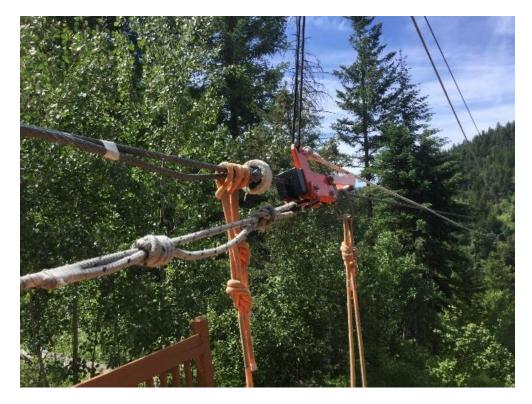
# Brake System at Arrival Platform

| | Incident Date | May 11, 2019 (#13788) (FINAL) Revised August 6, 2020 |
|---|---|---|
| | Failure scenario(s) | The normally dynamic primary braking system became fixed. The zip line participants trolley impacted the now immovable brake block. The rider swung up and hit the zip line cable and rebounded away from the arrival platform, settling at the lowest point of the zip line. |
| | Facts and evidence | <ul> <li><u>As reported by the arrival quide:</u></li> <li>Rope for controlling primary brake system became locked</li> <li>Rider came in backwards</li> <li>Rider came to an abrupt stop and swung upwards as their trolley contacted the brake block</li> </ul> |

| Incident Summary #II-871224-2019 (#13788) (FINAL) | | |
|---|--|--|
| Causes and contributing factors | The immobility of the primary brake system caused the participant to impact zip line components resulting in rider injuries. The arrival guide instructing the departure guide to launch zip line riders prior to ensuring the brake is set in position and actively functional is likely a contributing factor. | |

| Incident Summary #II-871224-2019 (#13788) (FINAL) | | |
|---|--|--|
| | <ul> <li>Operational best practice - the primary brake system shall be set prior to sending a rider</li> <li>Set position of primary brake shall be where the internal friction of the system shall slow the rider prior to contacting the emergency brake if arrival guide becomes incapacitated</li> <li>Additional guarding to be added to "brake block" to help prevent rope lock</li> </ul> | |

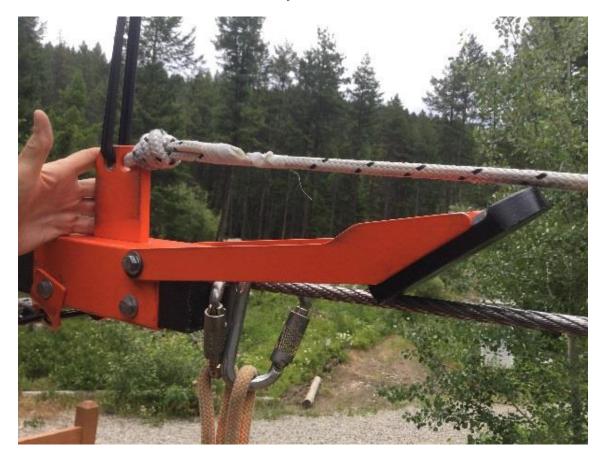
#### Brake Block that catches Riders Trolley

| Incident Summary #II-871224-2019 (#13788) (FINAL) | | |
|---|--|--|
| | <ul> <li>Rider was travelling down zip line cable prior to arrival guide re-setting the primary brake system</li> <li>Arrival guide realized brake system was jammed and tried to free brake equipment before rider arrived</li> <li>Rider came in backwards to an immobile brake block, Rider swung up, rebounded away from brake system and rolled back away from arrival platform</li> <li>Rider came to a stop away from arrival platform</li> <li>Arrival guide retrieved dangling rider</li> </ul> | |
