Incident Summary #II-1998184-2025 (#59269) (FINAL)

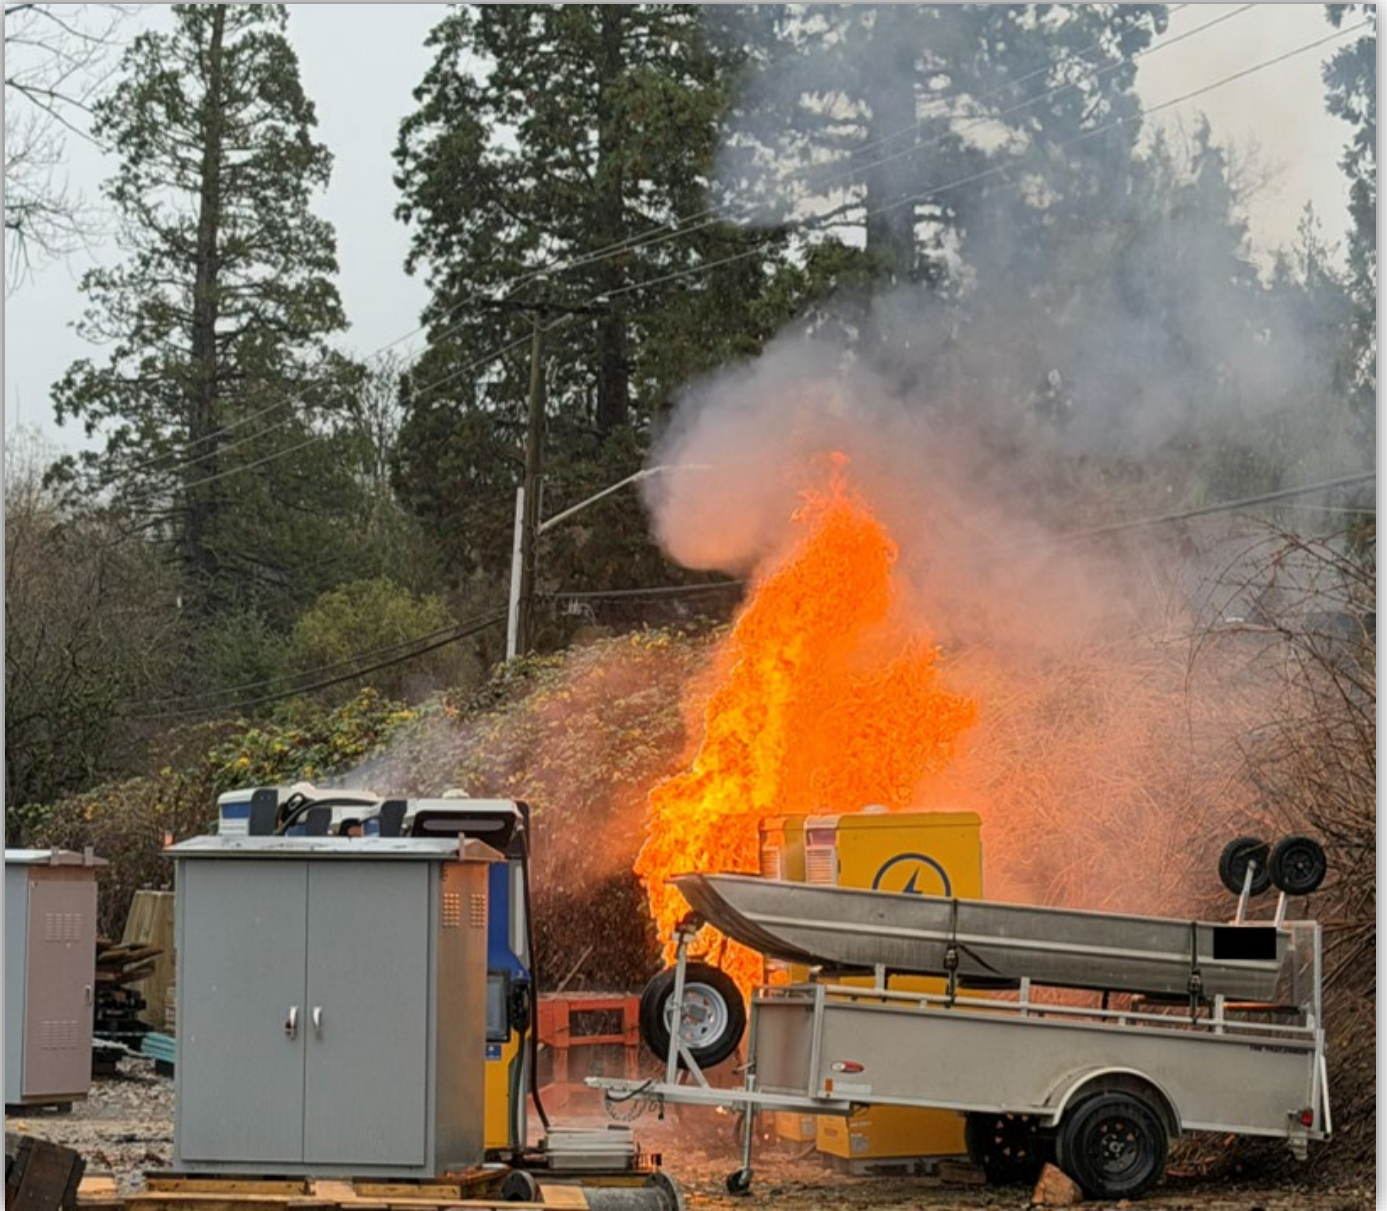
Image 1 – EV Charger on fire surrounded by other chargers in a storage yard.

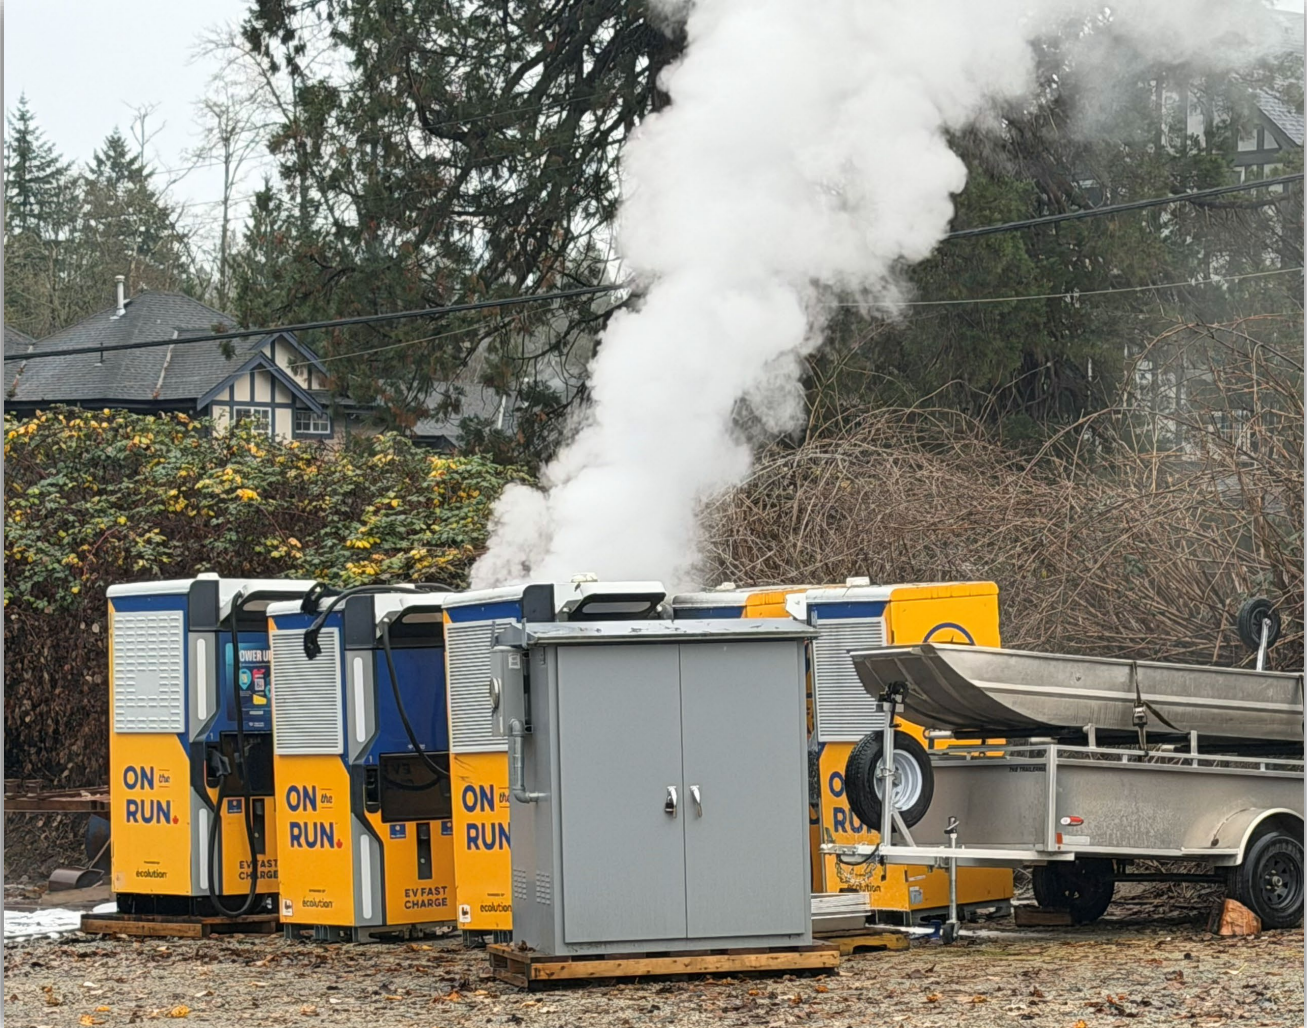
Image 2 – EV charger lithium-ion battery off gassing after flame extinguished by the fire department.

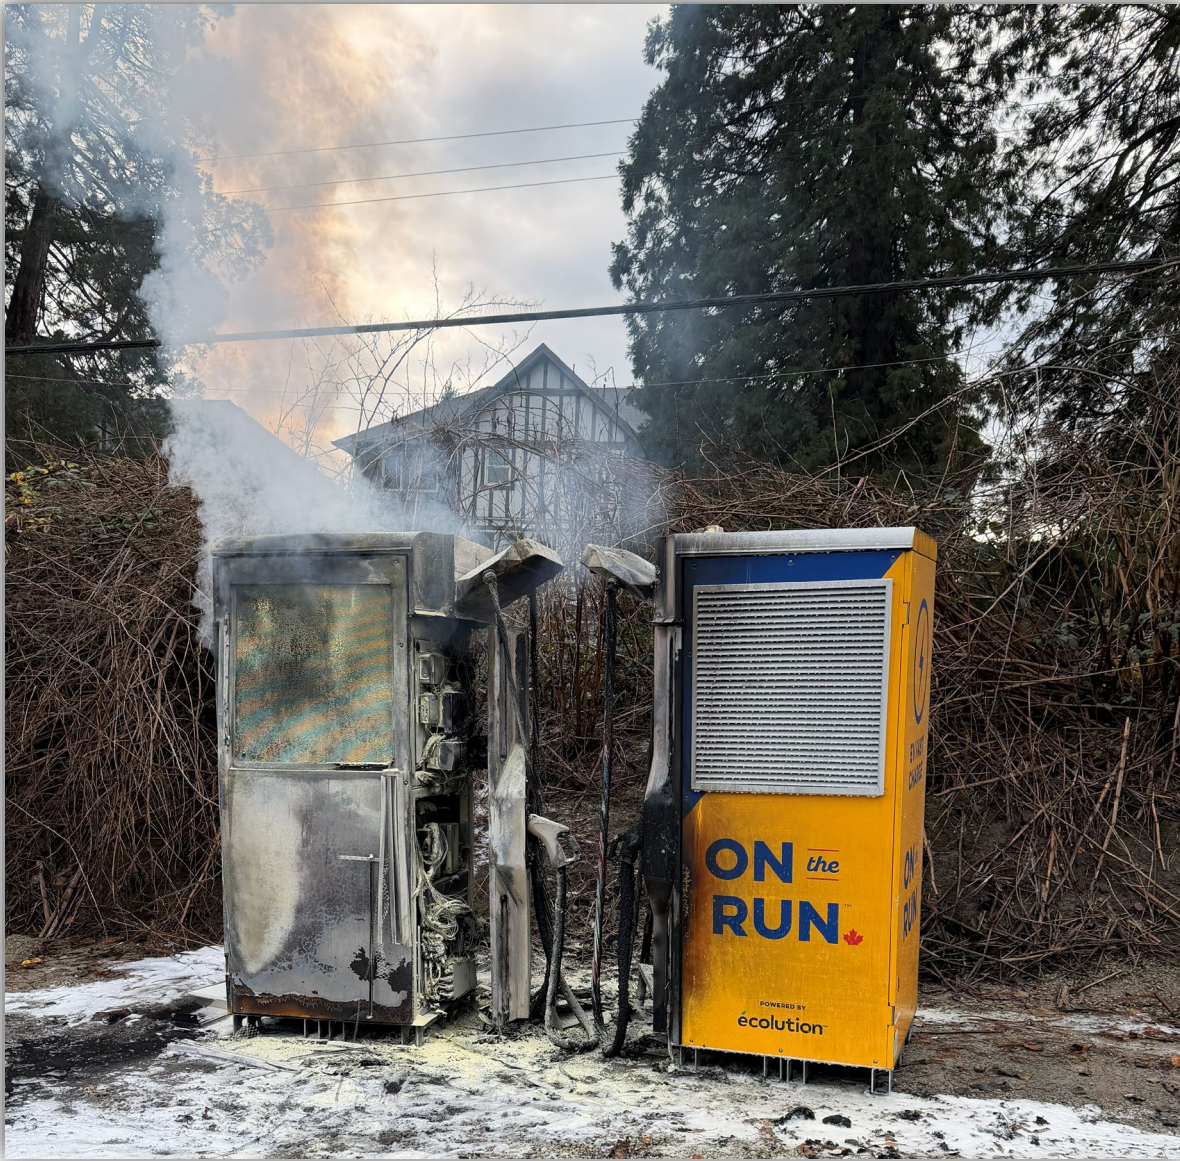
Image 3 – EV charger destroyed by fire next to another charger damaged by the fire.

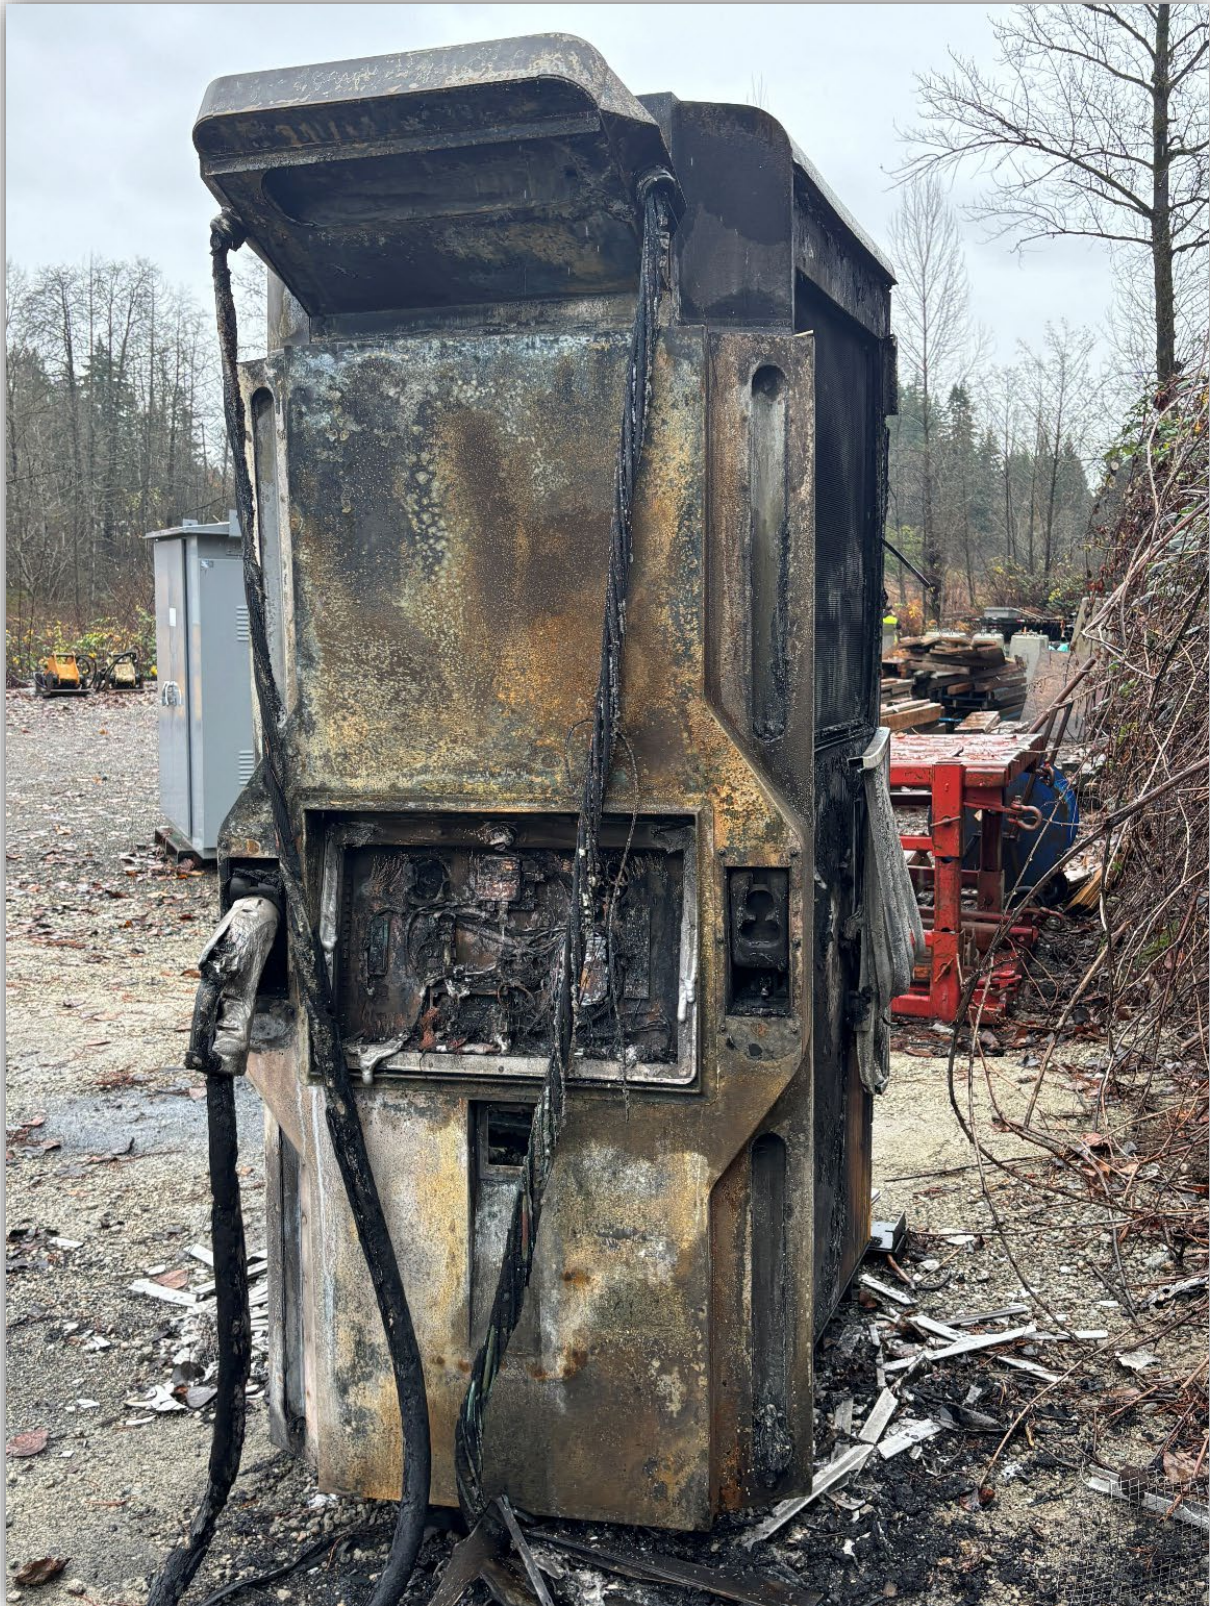
Image 4 – Damaged EV charger after fire extinguished.

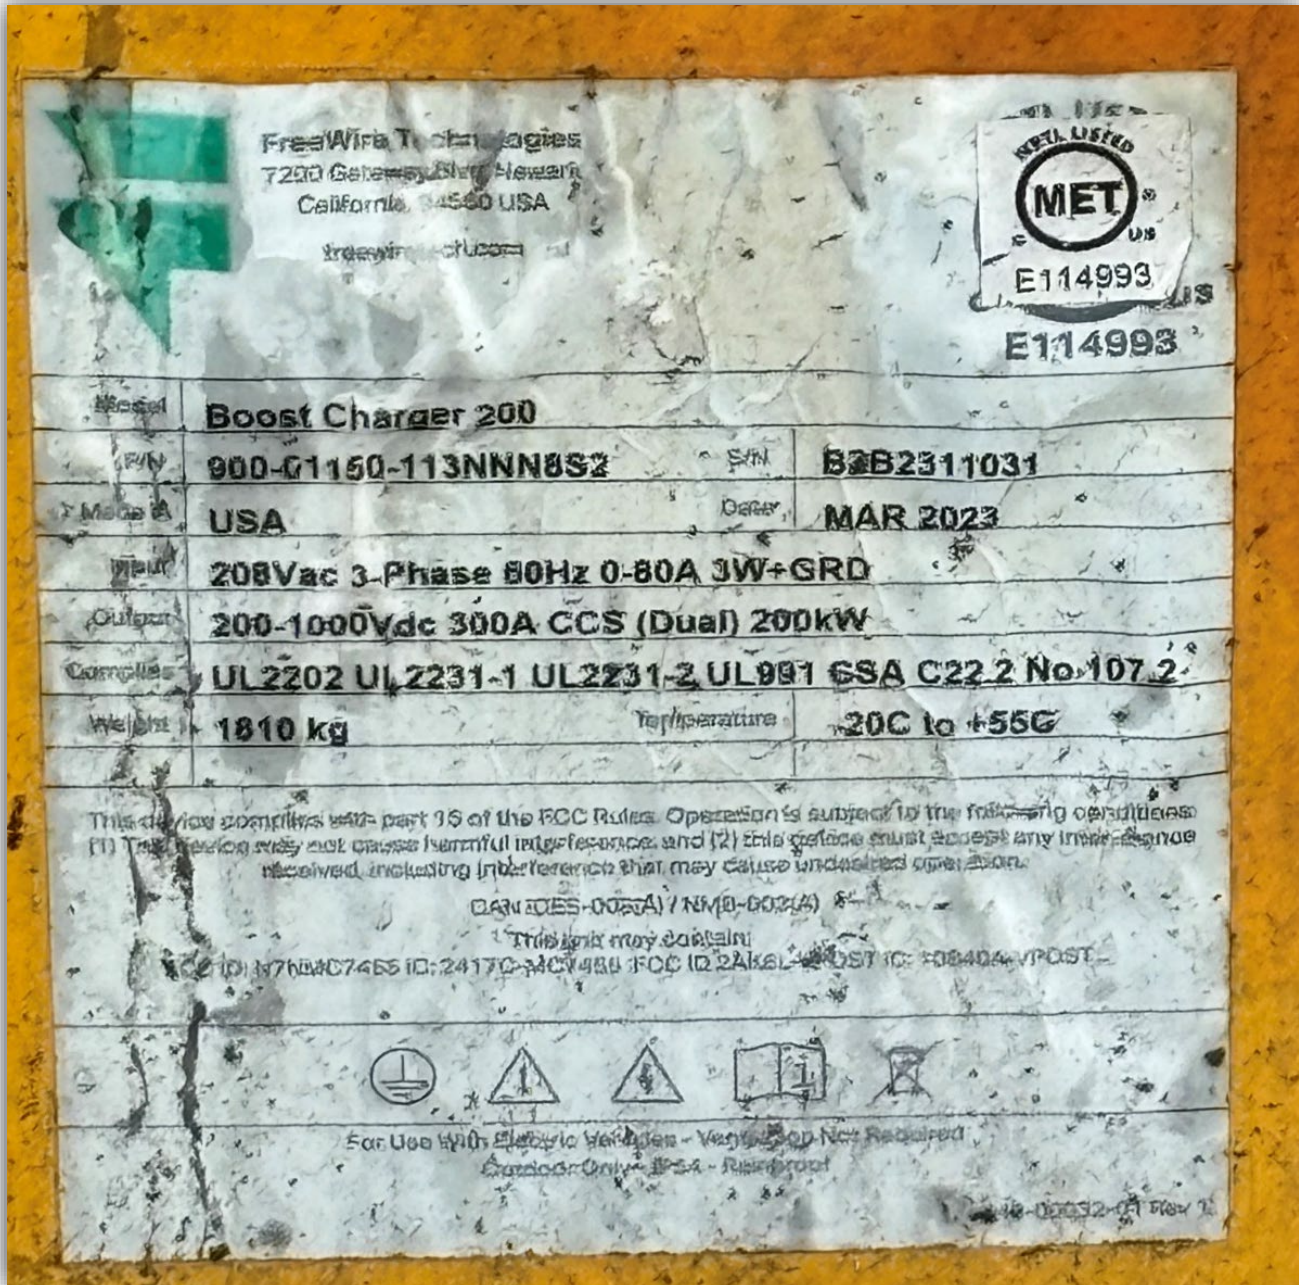
Image 5 – Data tag for EV charger that caught fire.
