Incident Summary #II-1892563-2025 (#57220) (FINAL)

SUPPORTING INFORMATION	Incident Date	April 9, 2025			
	Location	Vancouver			
	Regulated industry sector	Elevating devices - Elevator			
	Impact	Qty injuries	0		
		Injury description	N/A		
		Injury rating	None		
	Damage	Damage description	An elevator collided with the passenger car during the elevator operation. The counterweight guide assembly was bent and broken, and the metal frame of the car was bent and torn. Two 50lb balancing weights from underneath the car dislodged and fell down the elevator shaft into the pit from the 17 th floor.		
		Damage rating	Major		
	Incident rating	Major			
	Incident overview	The counterweight for a freight elevator in a 32-floor high-rise office building came off of the guide tracks. While the elevator was traveling downward without any passengers, the rising free-swinging counterweight collided with the bottom of the passenger car. The collision damaged the counterweight guide wheel assembly and the metal c-channel structure on the bottom of the car. The collision tripped the elevator overspeed safety circuit, stopping the operation of the elevator.

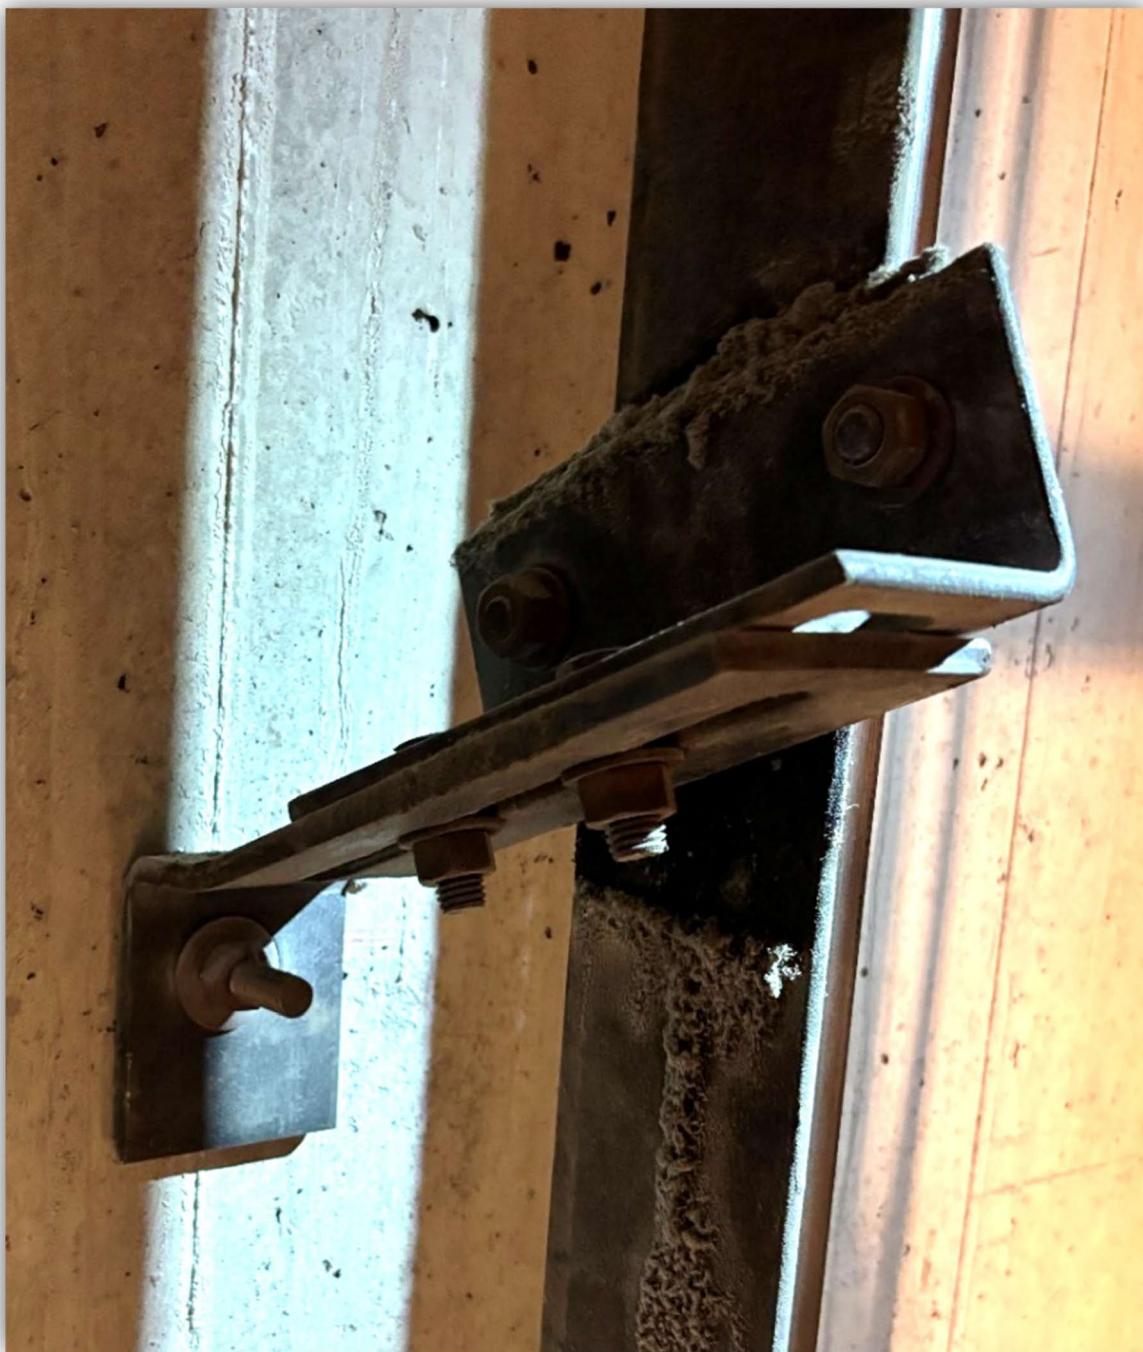
Image 3 - Counterweight guide rail bracket bent up from contact with the traveling counterweight.

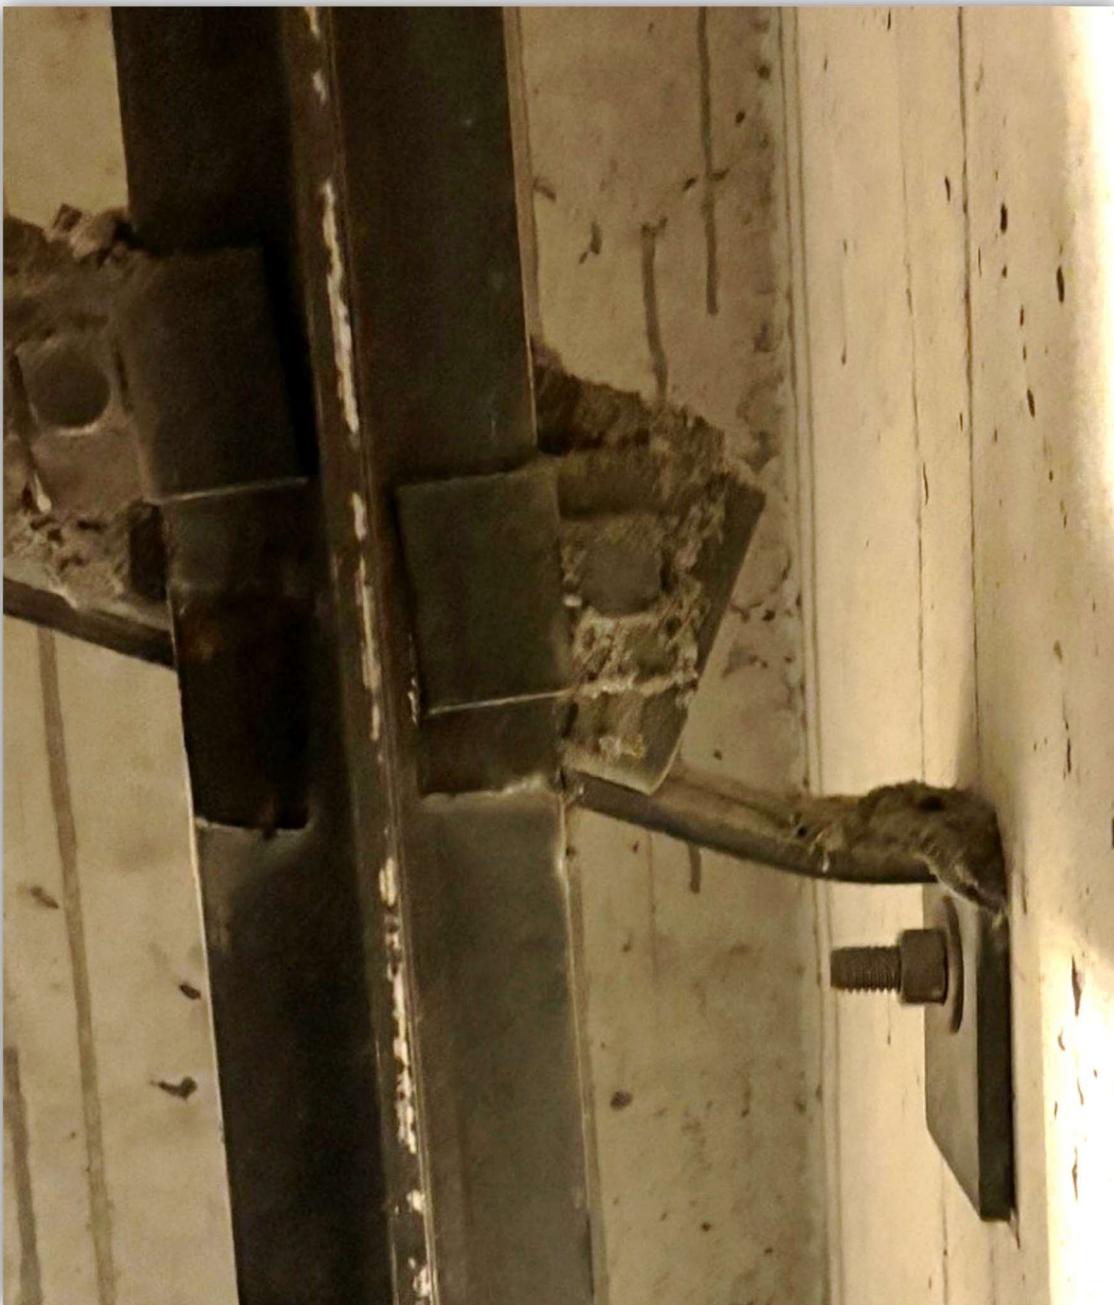
- The clamping force of the inserts on other concrete inserts for other rail brackets remained tight and in place even after the brackets had been struck by the counterweight. Forces from the counterweight strikes were strong enough to bend the brackets holding the rail but failed to pull out the inserts ([Image 4](#)). In one other location the threaded rod sheared off flush with the insert while leaving the insert securely anchored in place ([Image 9](#)).

Image 4 – Another counterweight guide rail bracket bent up from contact with the traveling counterweight.

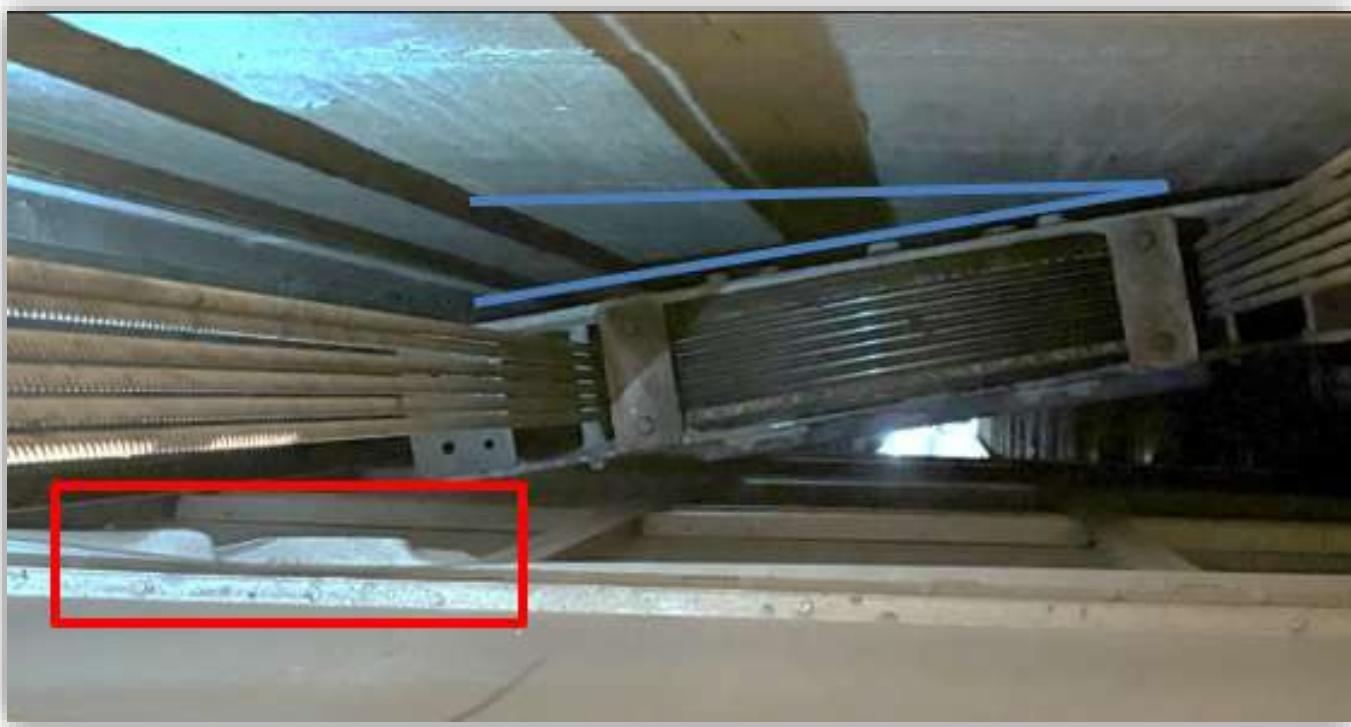
Image 5 – Free hanging elevator counterweight derailed from guide rails showing angle away from wall [lines] and location of damage on elevator car [box].

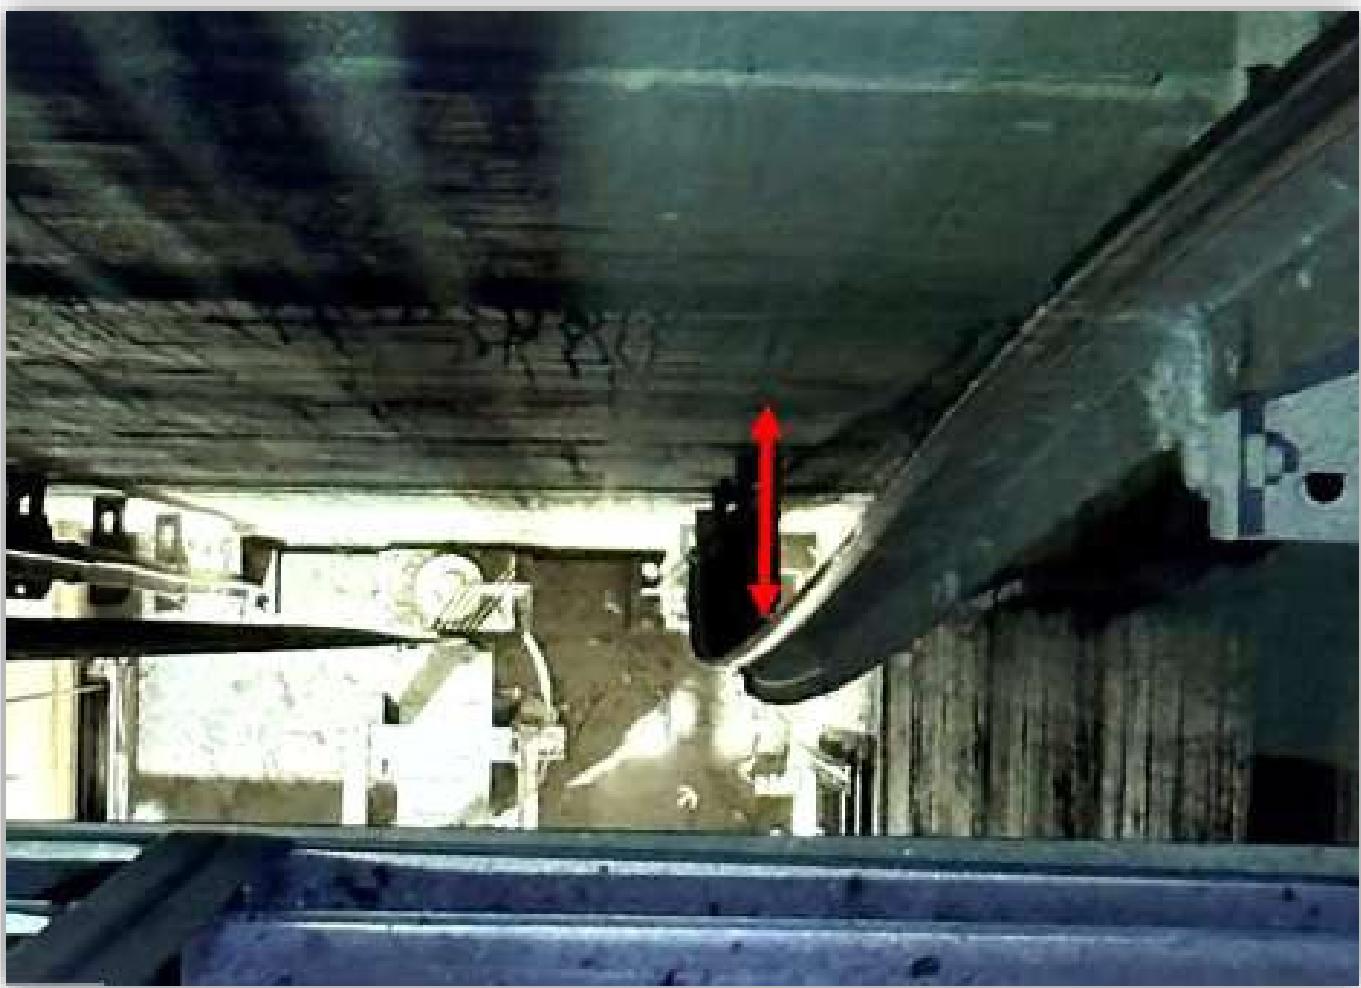
Image 6 - Counterweight guide rail bowed away from the wall.

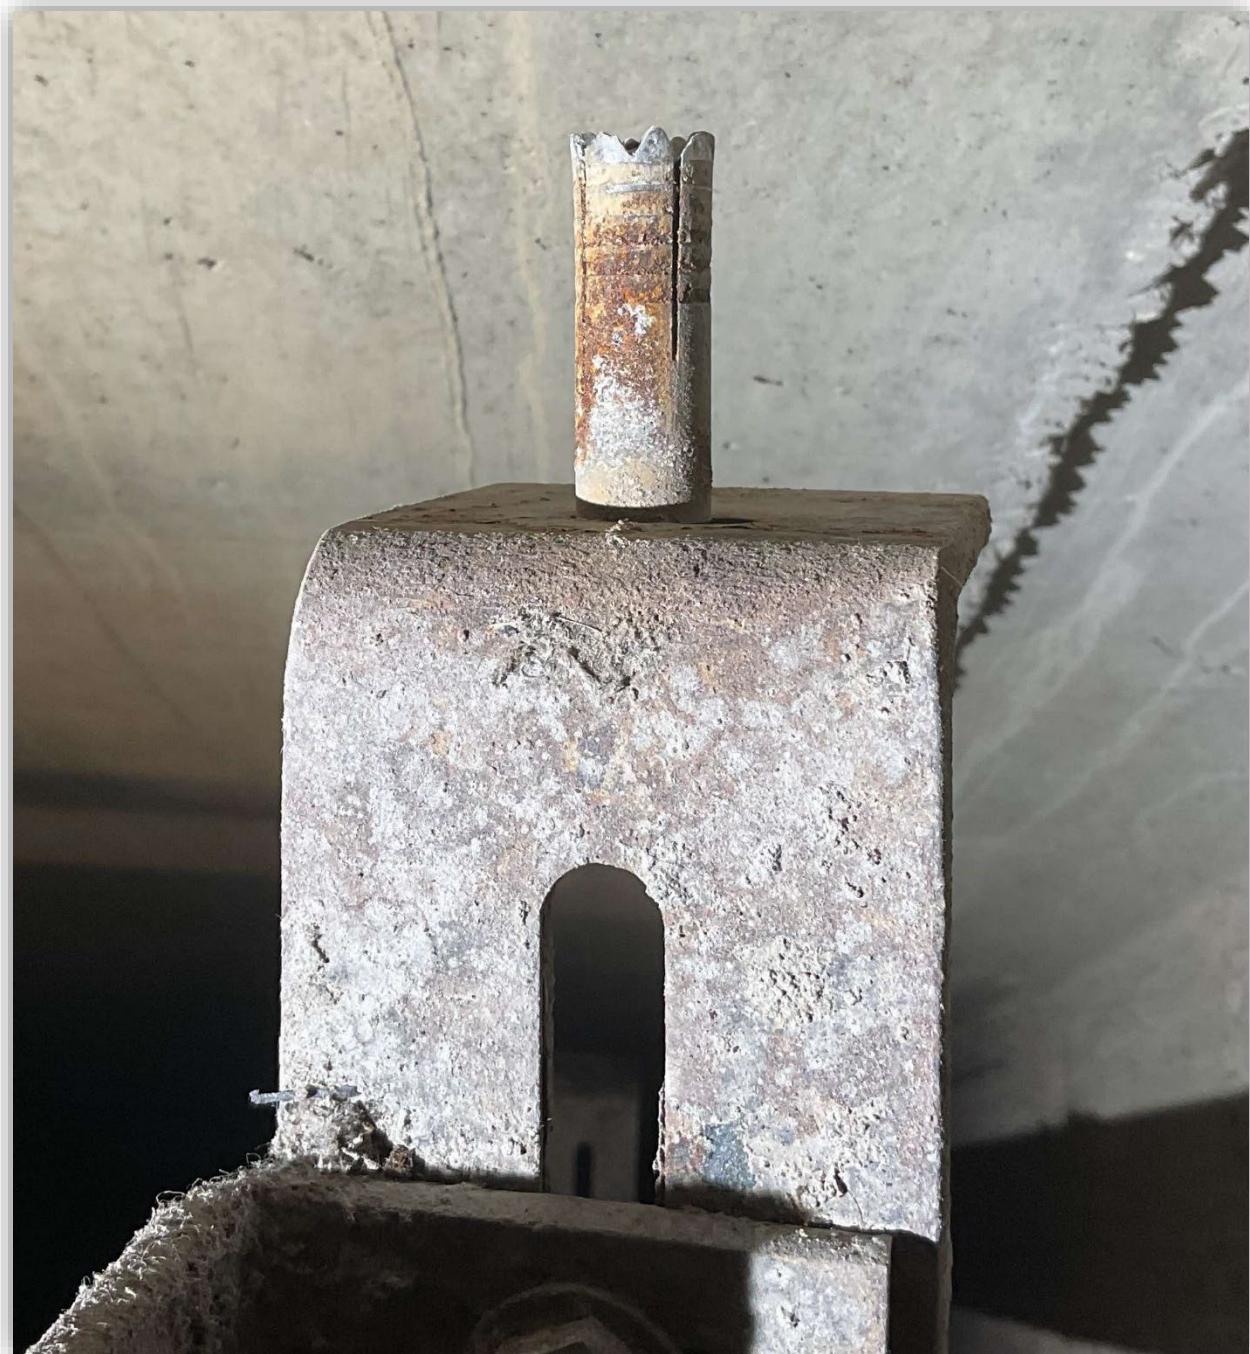
<p>Failure scenario(s)</p>	<p>An insert on one of the brackets at the 5th floor pulled out of the concrete which allowed the guide rail to pull away from the wall. As the counterweight passed over that area, the force of the counterweight eventually broke a second bolt off from the guide bracket below the 4th floor. With two consecutive brackets detached from the wall the guide rail bowed outwards. As the counterweight passed over the bowed-out area, the guide wheels eventually detached from the rail and the counterweight began to hang freely out of the guide in the hoistway. While hanging freely, the counterweight naturally rotated away from the wall into the path of the elevator car. As the elevator car continued to operate, the free hanging counterweight struck and bent seven other counterweight guide rail brackets bending them either upwards or downwards depending on the direction of travel. The elevator continued to operate with the free hanging counterweight until it struck the bottom of the car resulting in the collision and the tripping of the elevator overspeed governor which engaged the safeties and stopped the operation of the elevator.</p> <p>Although Vancouver is in a high seismic risk zone, the requirement for a counterweight displacement device is not a retrofit requirement for elevators unless a major alteration takes place. The elevator had not undergone any major alterations since the requirement came into effect in 2003. As a result, it did not have a counterweight displacement detection device installed and remained compliant with current code because this device was not required at the time of the initial installation. Without the device, the elevator continued to operate once the counterweight came off the rails.</p>

Image 7 – Counterweight guide rail bracket from the 5th floor with concrete anchor insert that had pulled out from the wall.

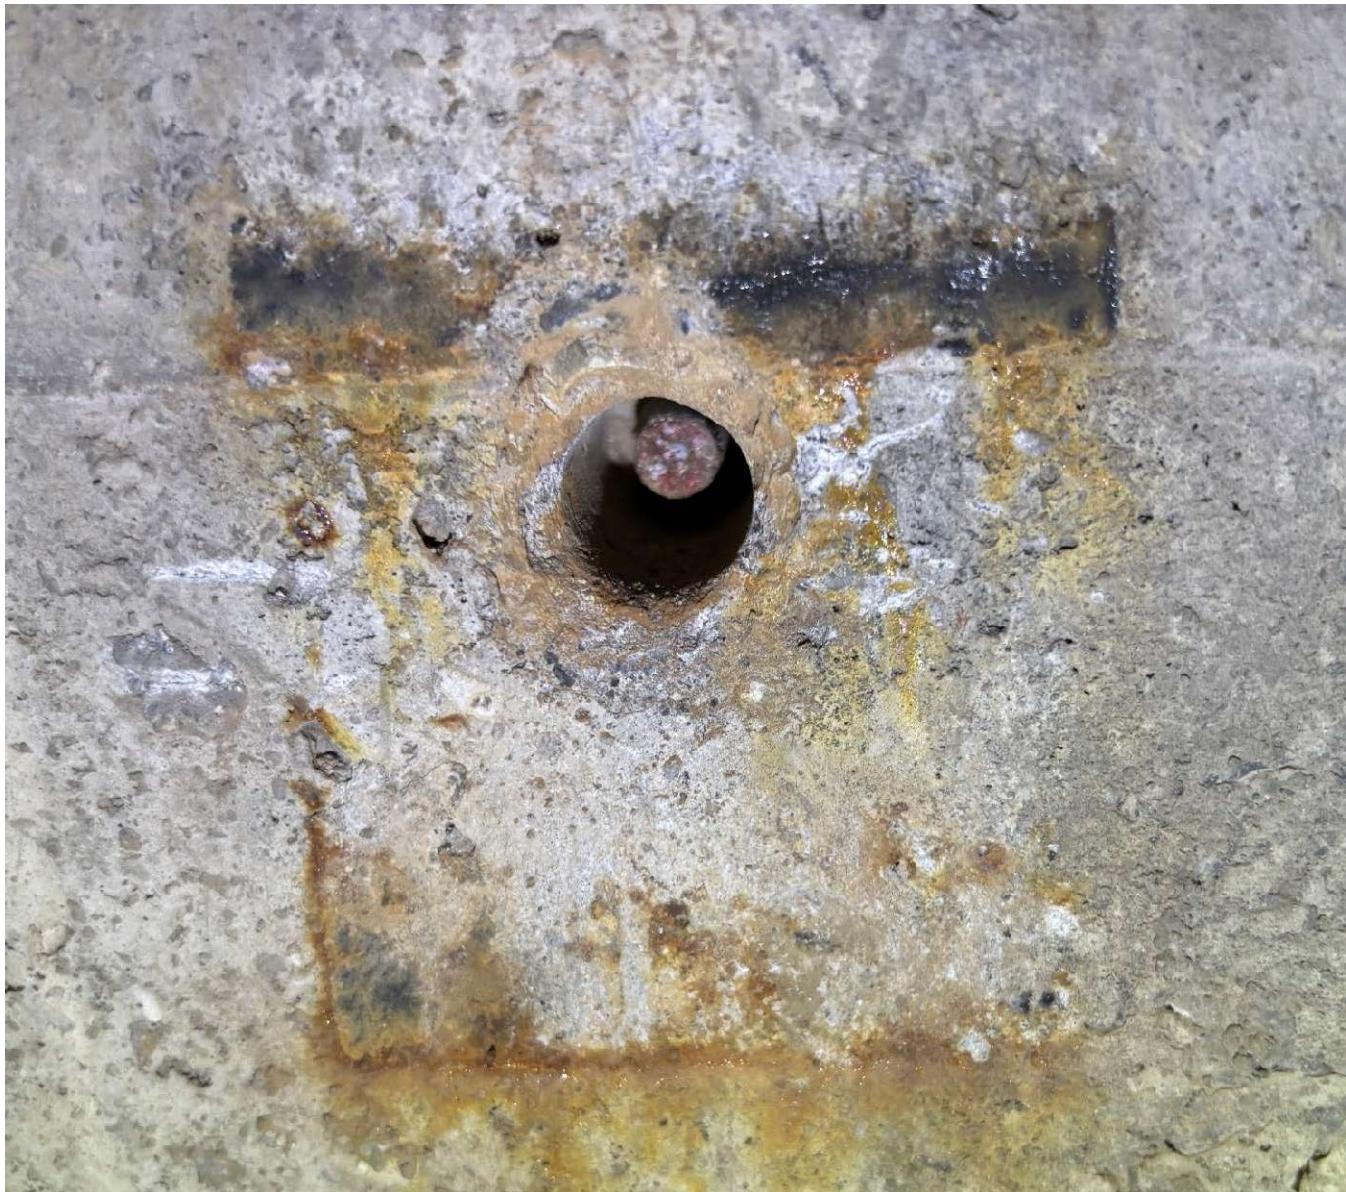
- The pin from the inside of the insert that forces it outward to clamp onto the drilled concrete hole was no longer attached to the insert and was observed remaining on the inside of the drilled hole ([Image 8](#)).

Image 8 – Concrete holed for failed anchor. Anchor set pin shown still attached to the center of the hole.

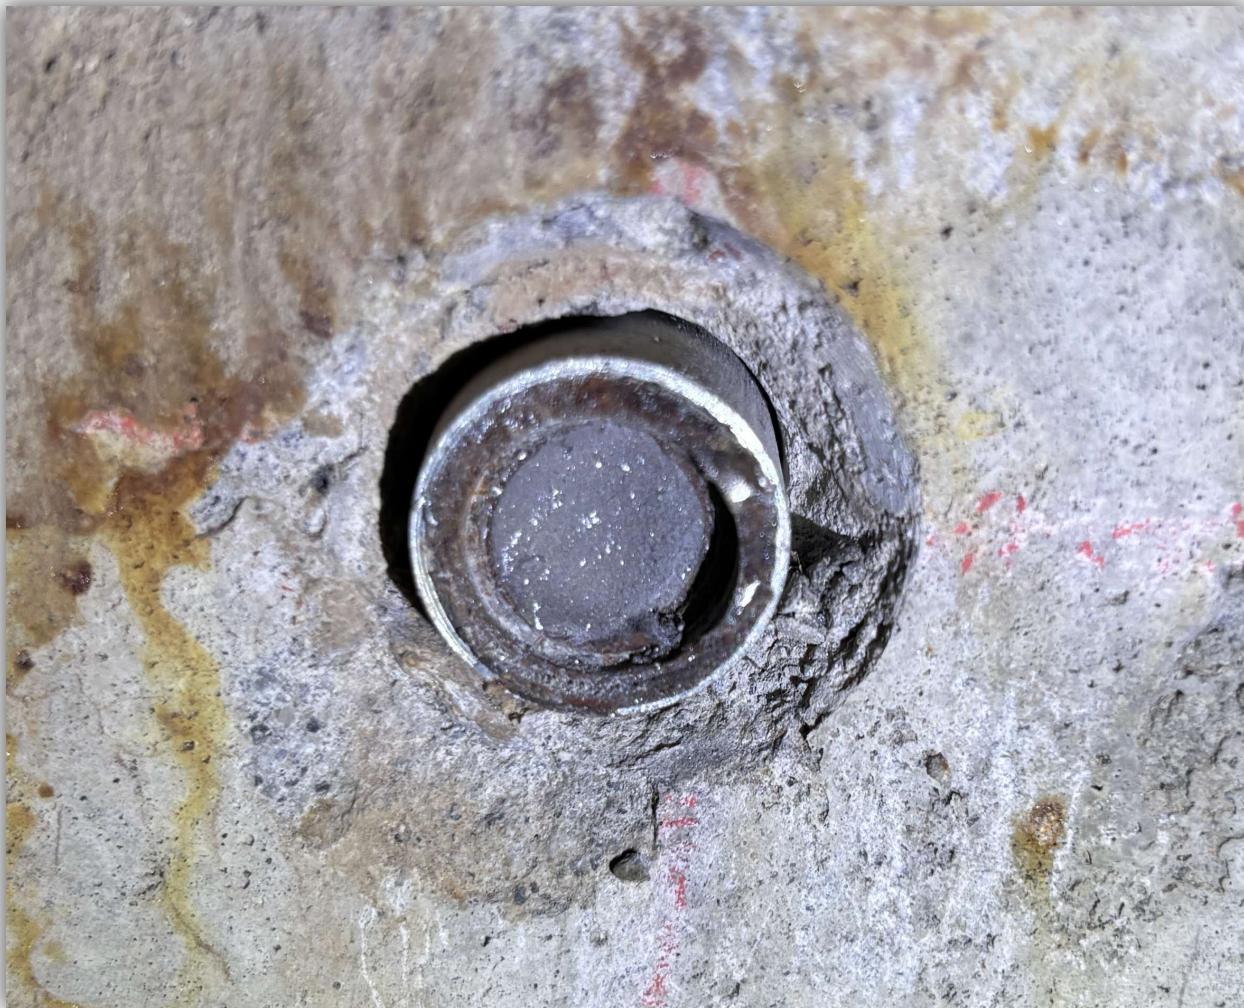
Image 9 – Counterweight guide rail bracket anchor location on the 4th floor with a portion of the broken threaded rod still in the insert.

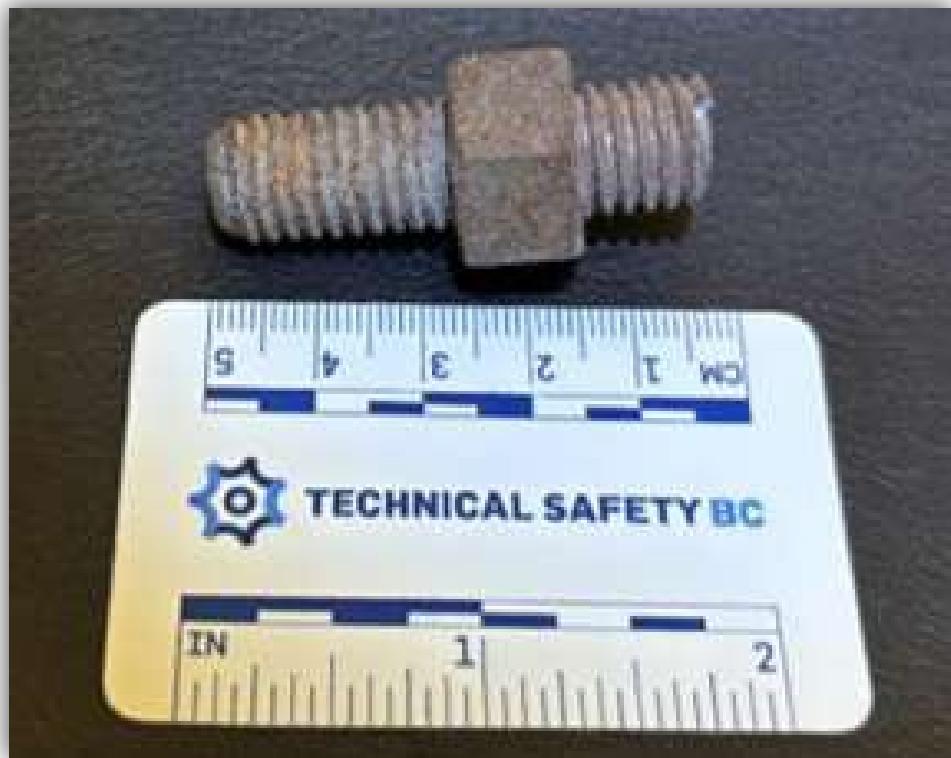
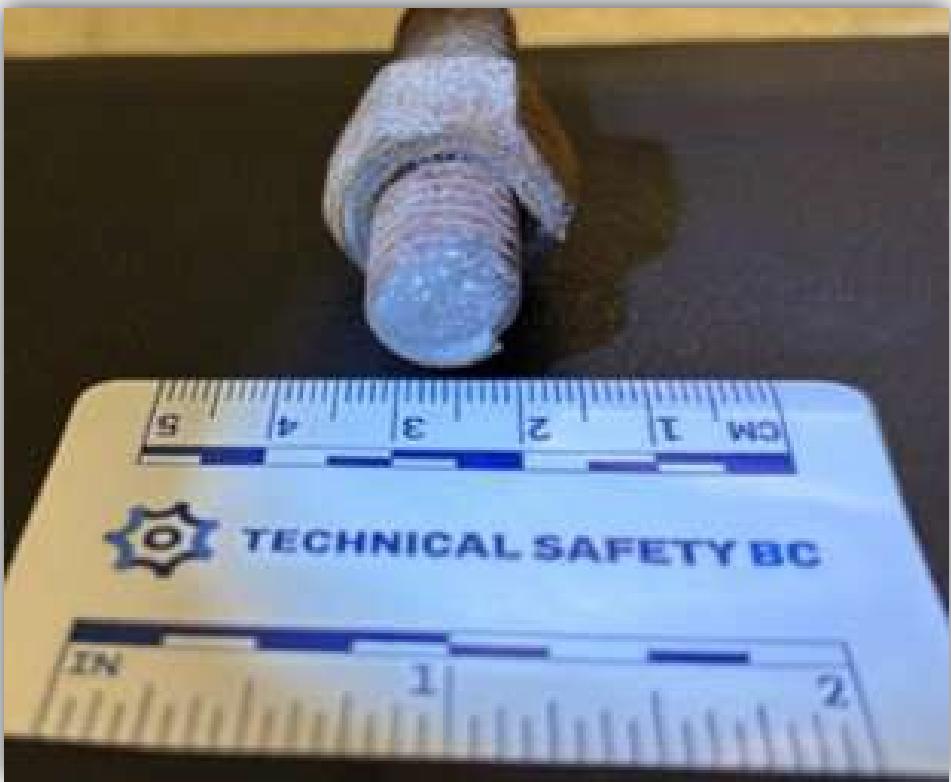
Image 10 – The other half of the broken threaded rod recovered from the elevator pit after the incident.

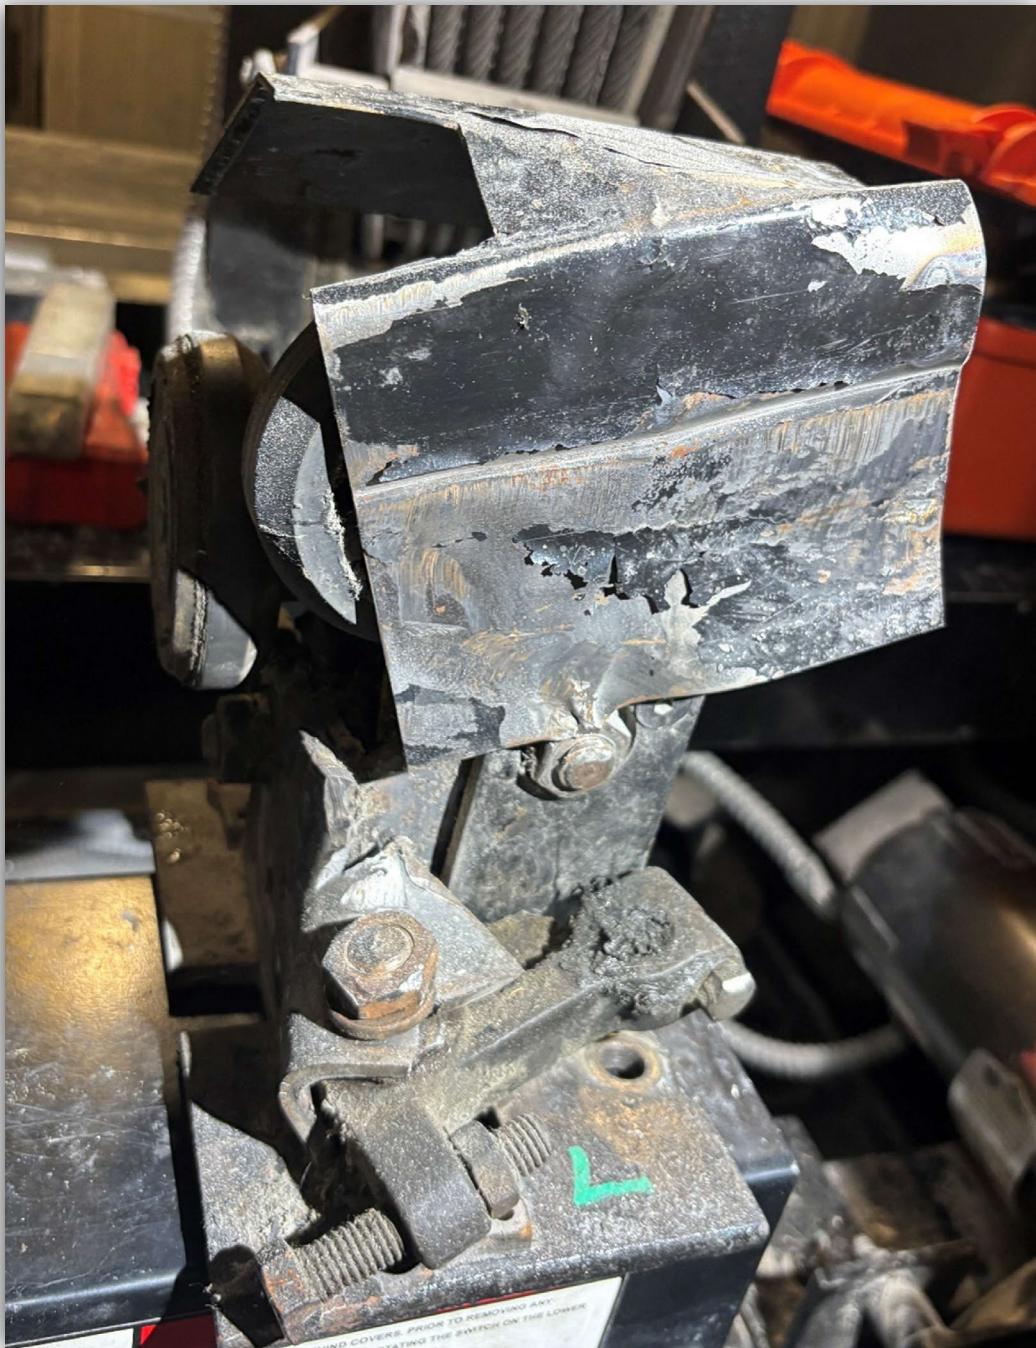
Image 11 – The damaged upper lefthand counterweight guide assembly removed from counterweight after incident.

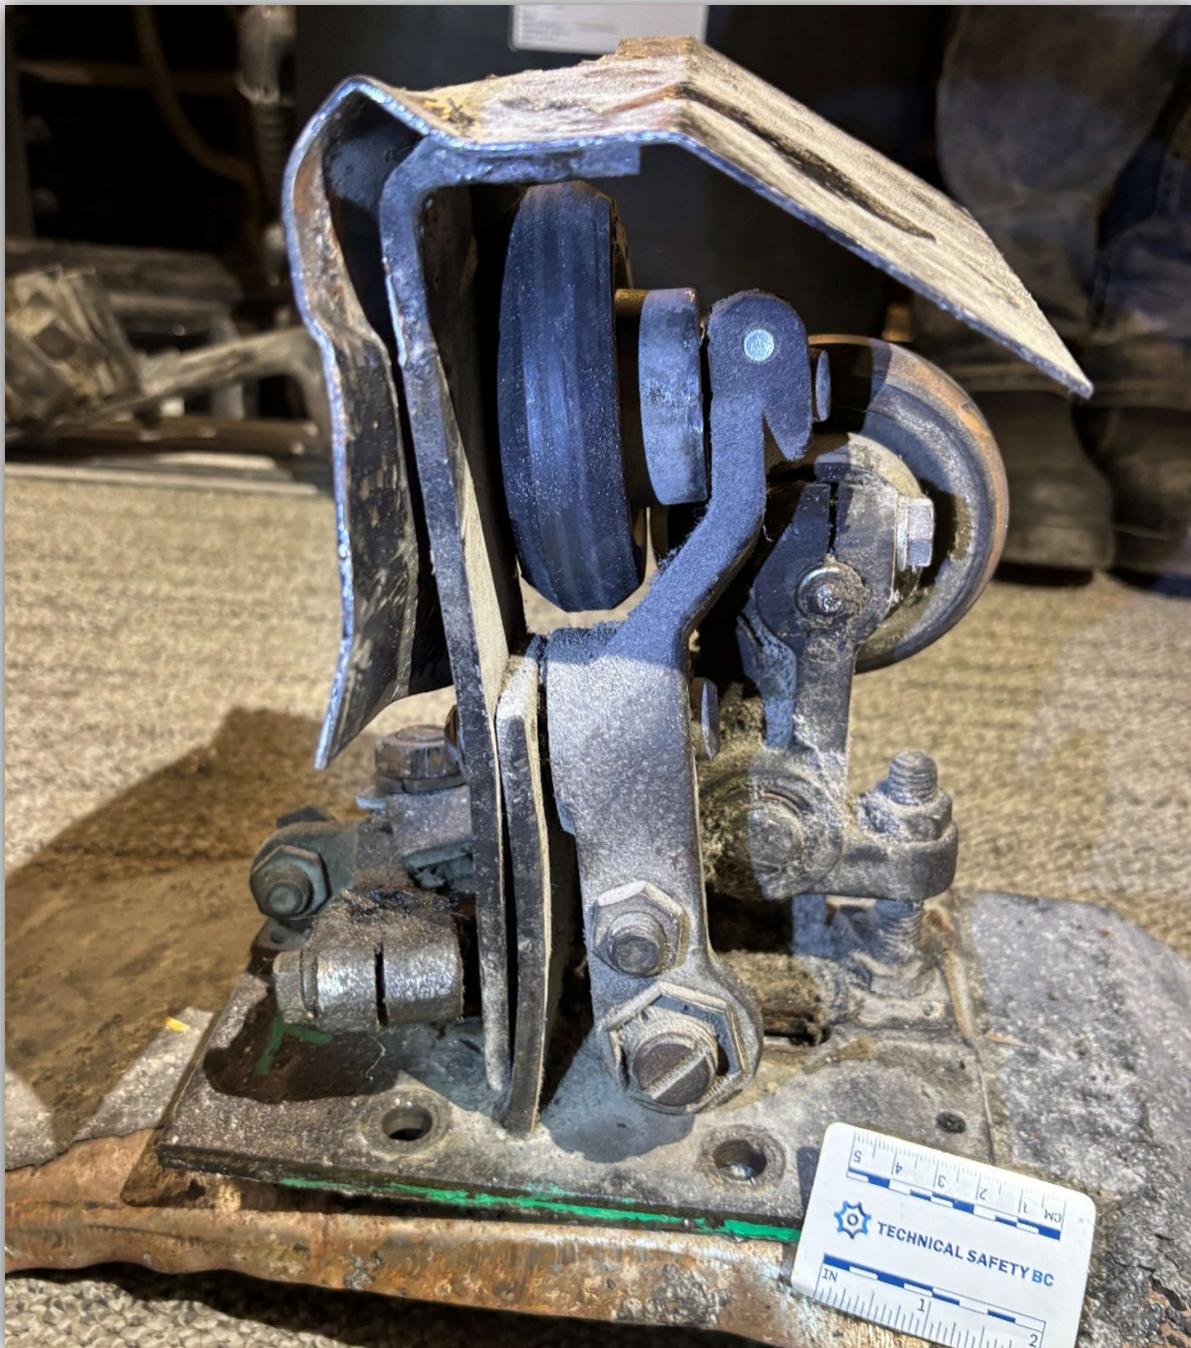
Image 12 – Second view of the damaged counterweight guide assembly.

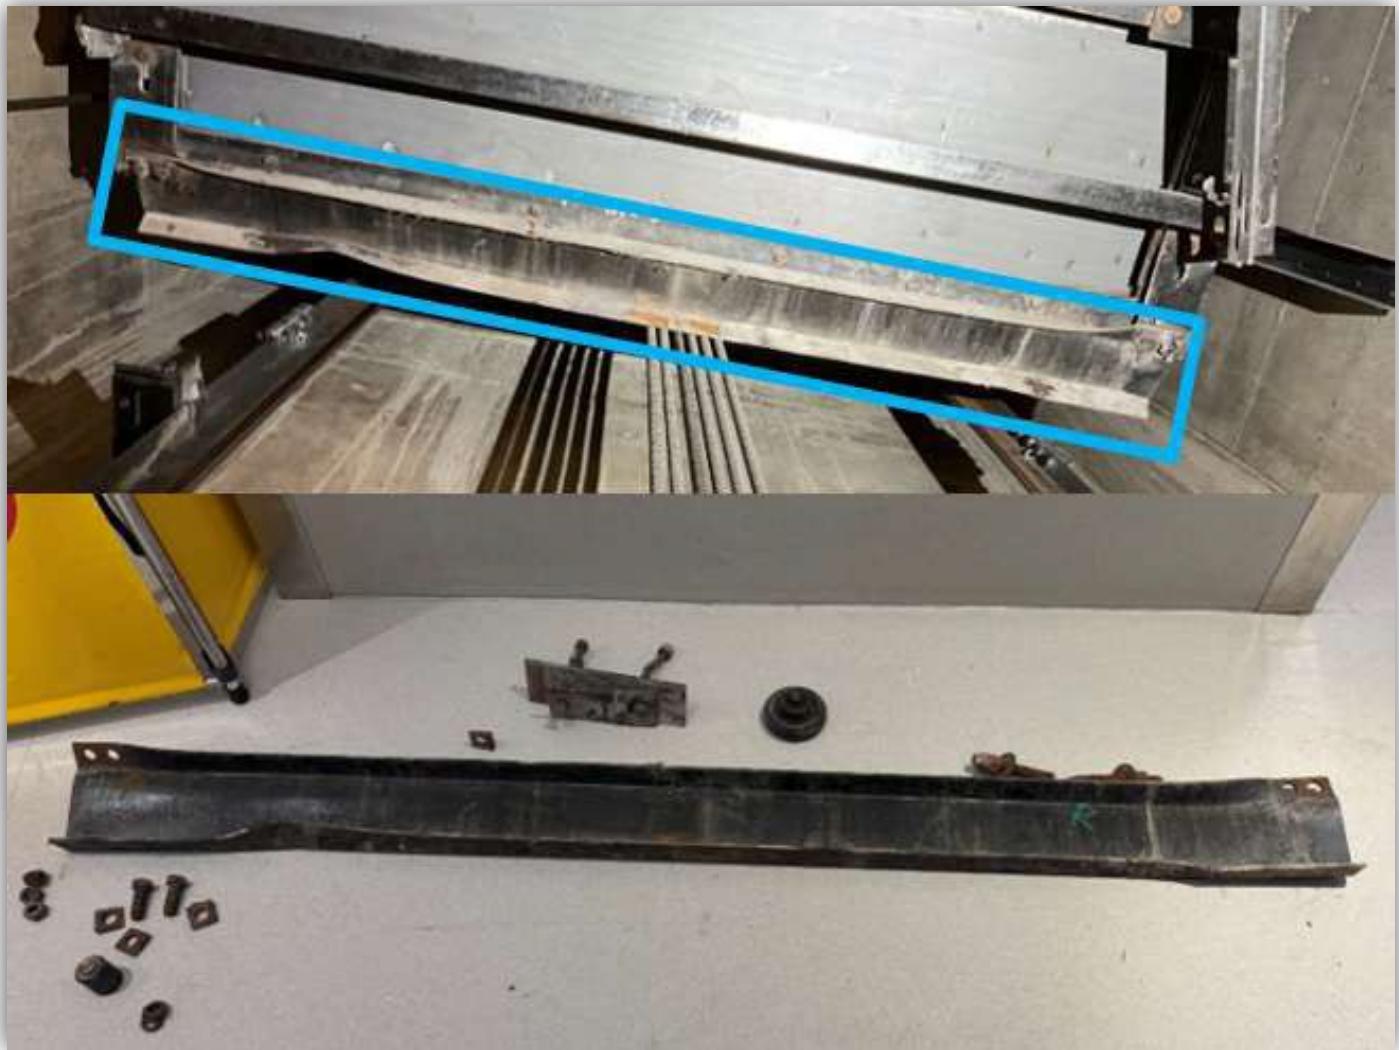
Image 13 – [Top] The bottom of passenger car with bent up c-channel from collision with counterweight. [Bottom] C-channel removed after incident.

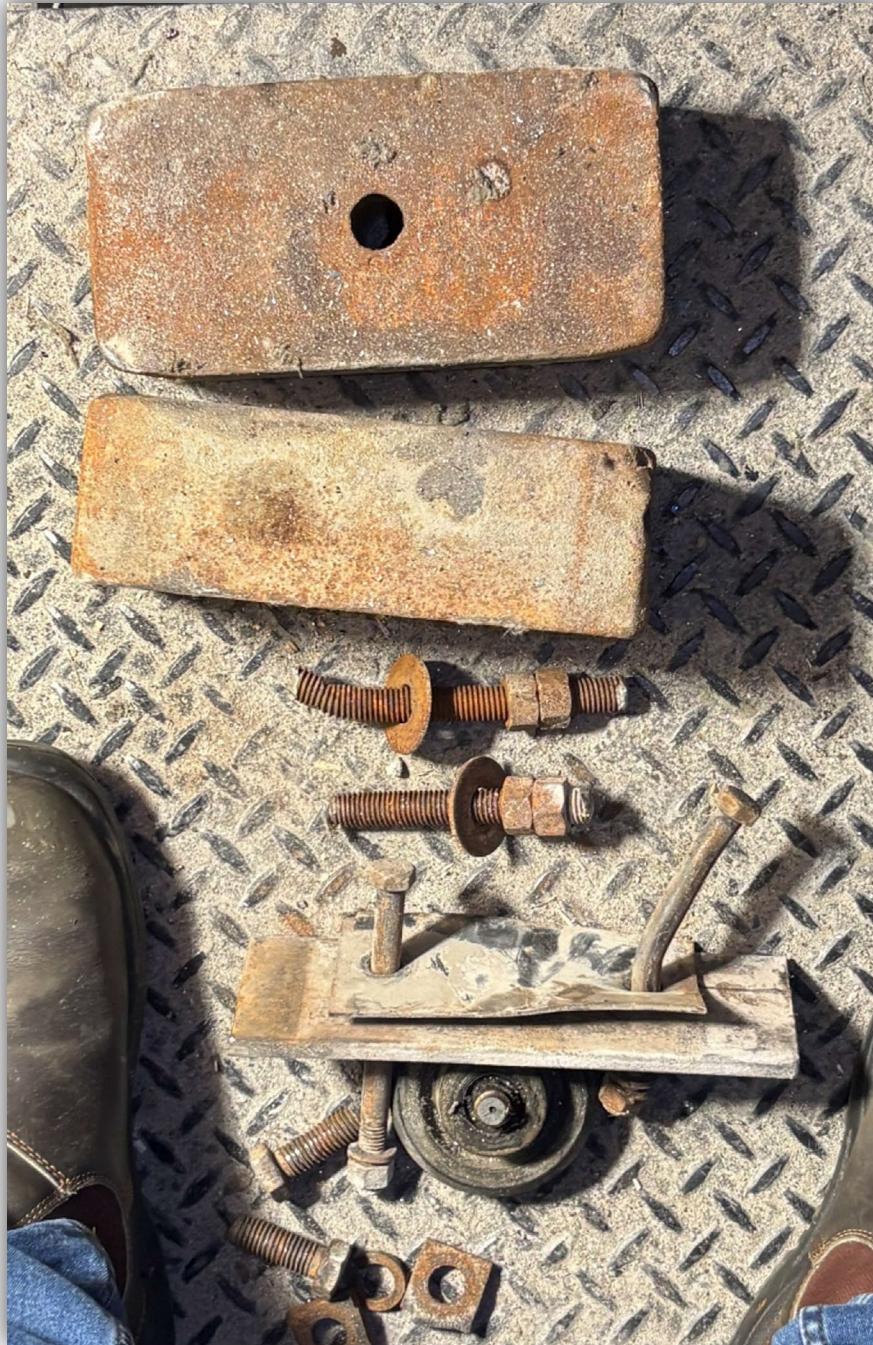
Image 14 – The two 50lb balance weights and damaged hardware that were torn from the bottom of the passenger car and crashed into the bottom of the elevator pit from the 17th floor.

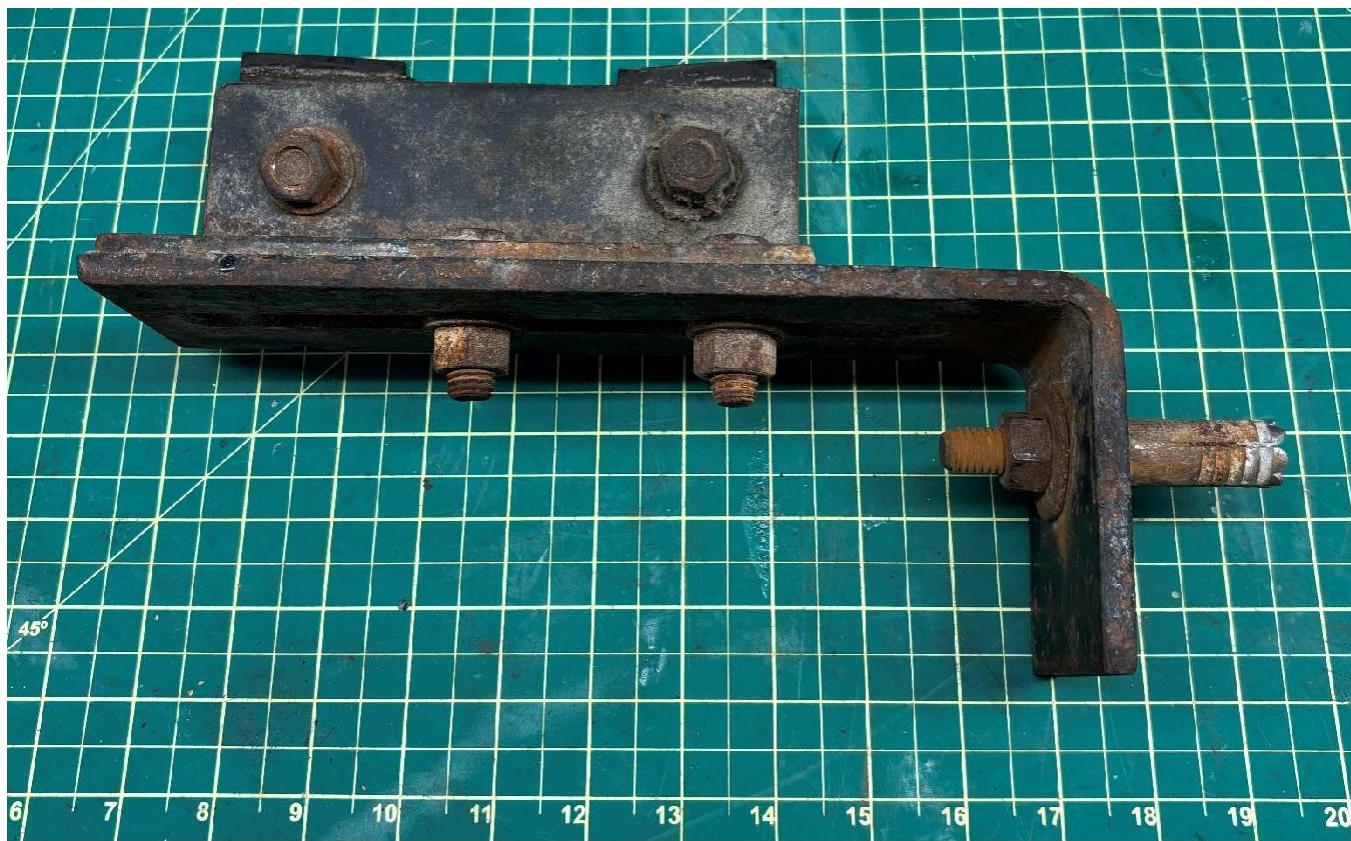
- The treaded rod, washer and nut were still tight clamping the insert against the bracket. The insert was 3.5mm larger in diameter than the width of the slotted hole in the bracket. This allowed the insert to contact the bracket when the threaded rod was tightened. This created a torque force on the nut that did not loosen when the insert came loose from the wall. ([Image 16](#))

Image 16 – Counterweight guide rail bracket with concrete anchor still attached.

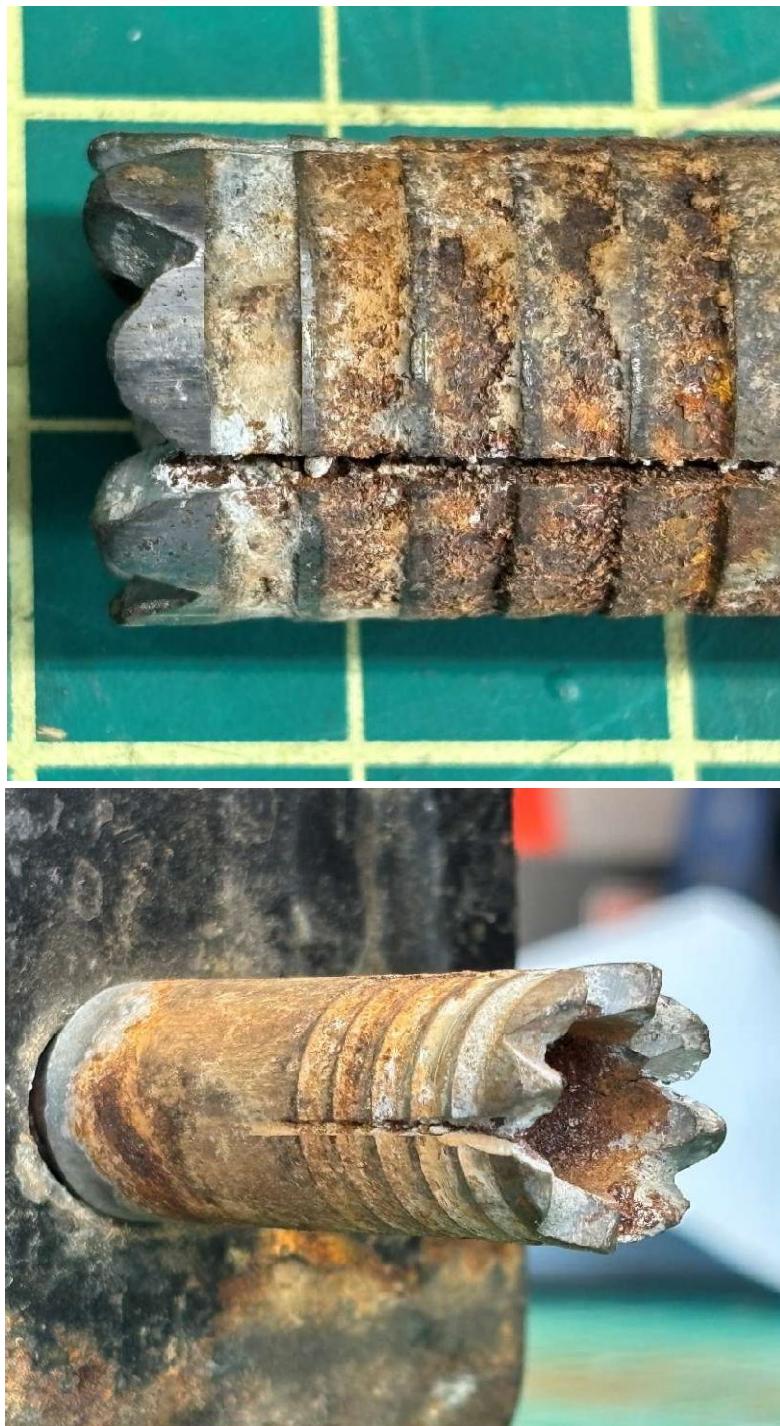
- Visual examination suggests the shiny areas at the end of the insert where it was contacting the inside of the drilled concrete hole. The contact areas were non-consistent around the circumference of the insert and measured 8mm at the end of the insert ([Image 17](#)).

Image 17 – Closeup images of the failed concrete anchor.

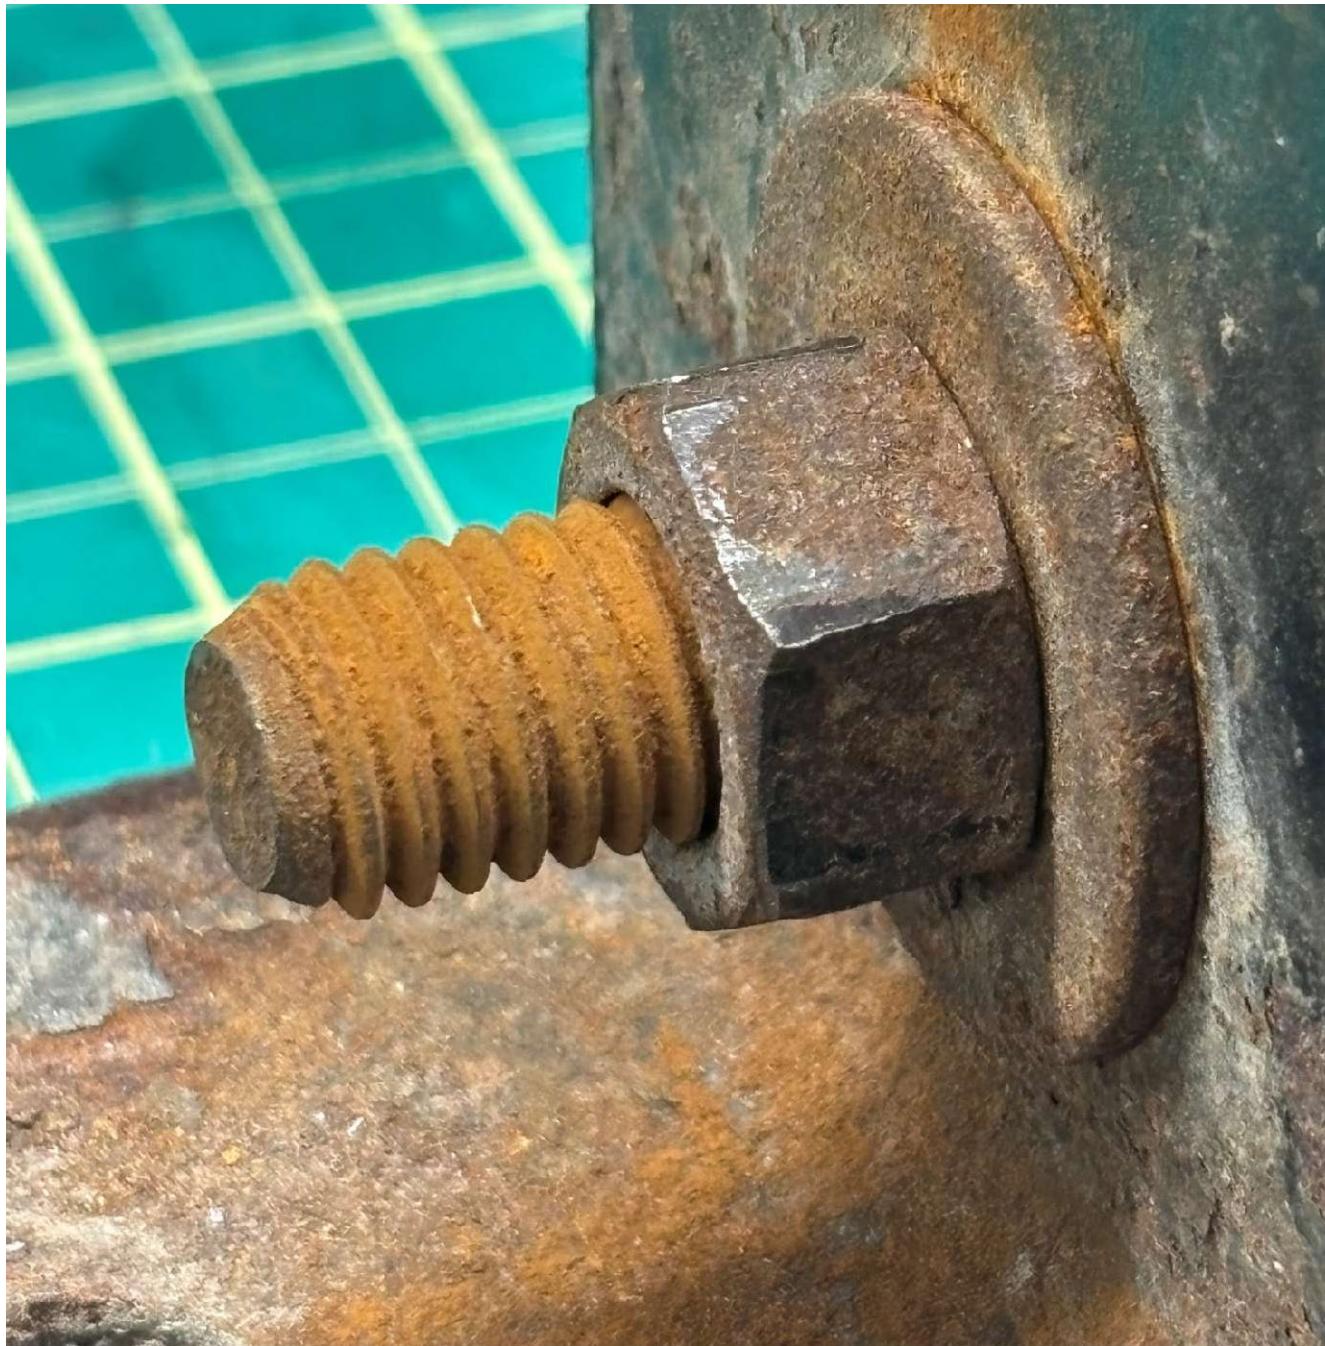
Image 18 – Closeup of threader rod, nut and washer still tight to bracket after concrete insert failure.
