Incident Summary #II-1503013-2023 (#31232) (FINAL)

SUPPORTING INFORMATION	Incident Date	January 31, 2023	
	Location	Vancouver, BC	
	Regulated industry sector	Electrical - Low voltage electrical system (30V to 750V)	
	Impact	Qty injuries	0
		Injury description	N/A
		Injury rating	None
	Damage	Damage description	Electrical baseboard low voltage relay overheated causing smoke and fire.
		Damage rating	Minor
Incident rating	Minor		
Incident overview	A low voltage electronic relay installed in a baseboard heater junction box overheated, failed, and caused a small fire that damaged the relay and associated wiring.		
INVESTIGATION CONCLUSIONS	Site, system and components	<p>The AUBE low voltage (24v) programable thermostat, part #TH140A-28 located on the wall of the student housing concrete tower foyer, provides a voltage that opens or closes the RE153 STELPRO low voltage 15AMP @ 120v-347v electronic relay located in the 1000W baseboard heater. In this installation the low voltage thermostat controls six 1000W baseboards. Each baseboard has its own RE153 low voltage electronic relay located in the baseboard. One 15AMP 208v 2pole breaker supplies power for two 1000W baseboards.</p> <p>It i

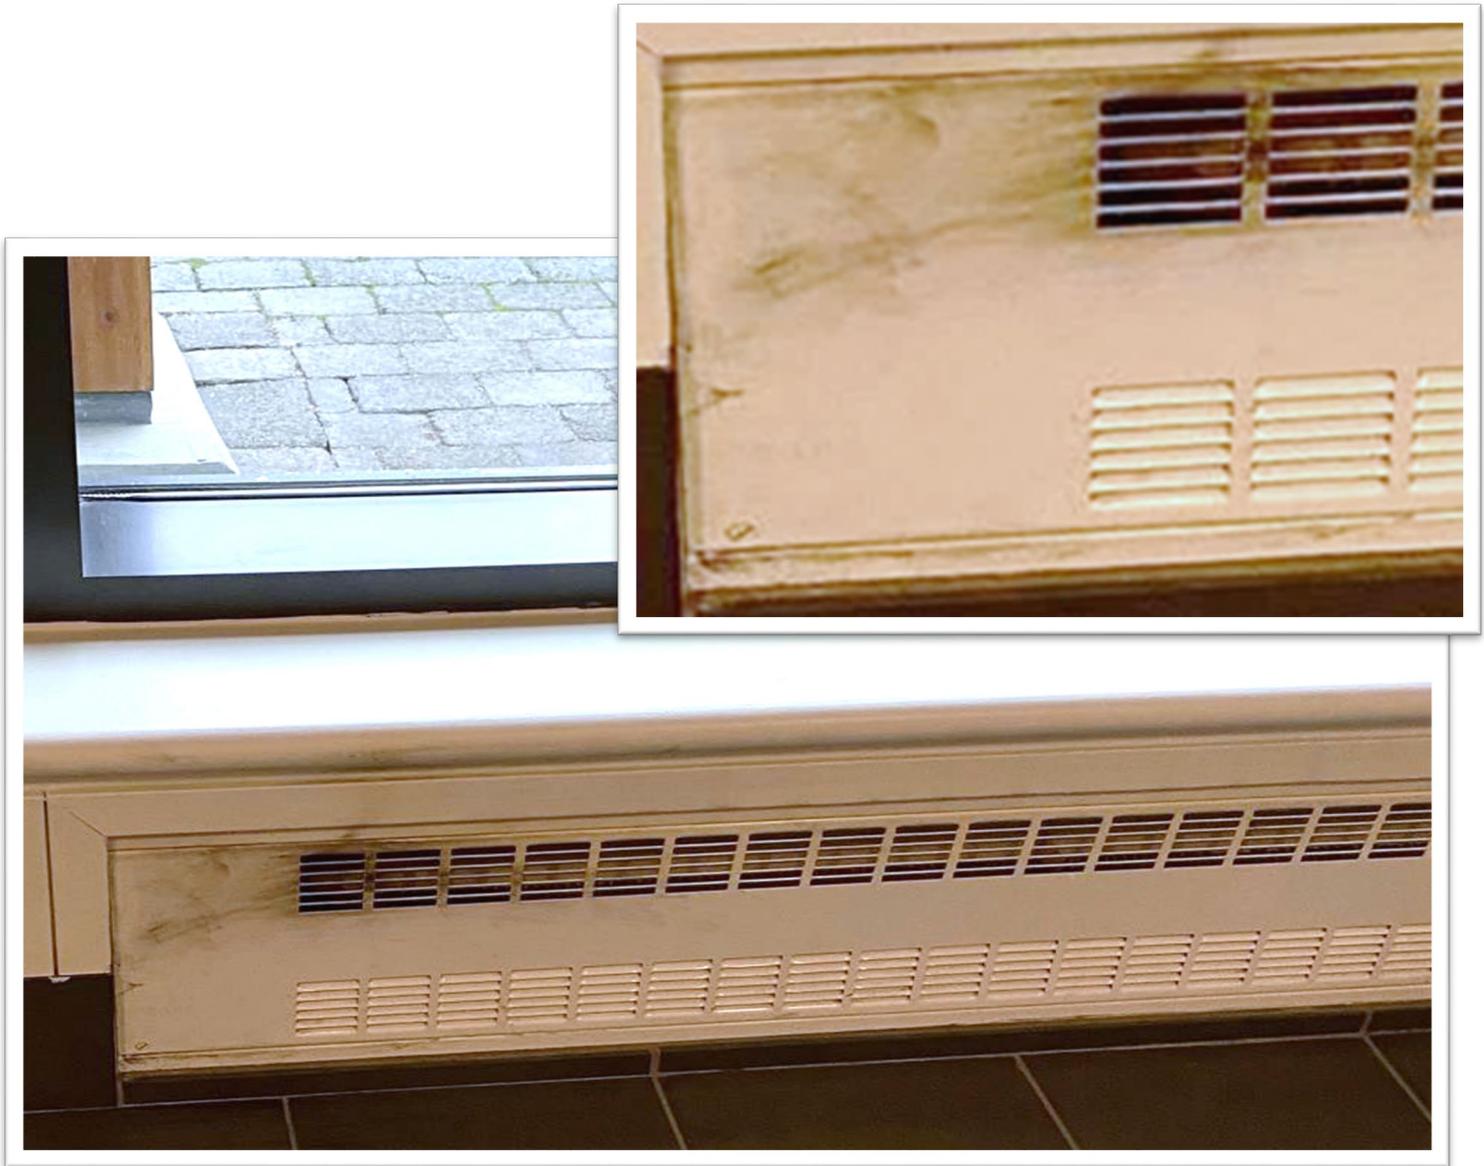
Photo #1

Failure scenario(s)	<p>The Field Service Representative was notified of a small fire and smoke coming out of the STELPRO 1000W baseboard heater located in Building #3 front desk area (Photo #1). Upon arrival the FSR met the fire department that had arrived on site.</p> <p>The smoke had initiated the smoke detectors in the building. The 1ft tall flame that was reported by the front desk attendant, had extinguished itself. The FSR found that all 2pole 15AMP breakers were still engaged. The FSR manually opened all breakers to the six 1000W baseboard heaters. The low voltage relay is not compatible with the installed thermostat and there were more than 4 relays connected to one thermostat.</p>	
	Facts and evidence	<ul style="list-style-type: none"> The FSR removed all Baseboard covers to access the RE153 low voltage relays. The FSR also removed the AUBE low voltage thermostats. <p><u>Visual inspection of all 1000W baseboards & AUBE thermostats showed.</u></p> <ul style="list-style-type: none"> The damage was highly localized and confined to the RE153 STELPRO low voltage electronic relay. (Photo #2)

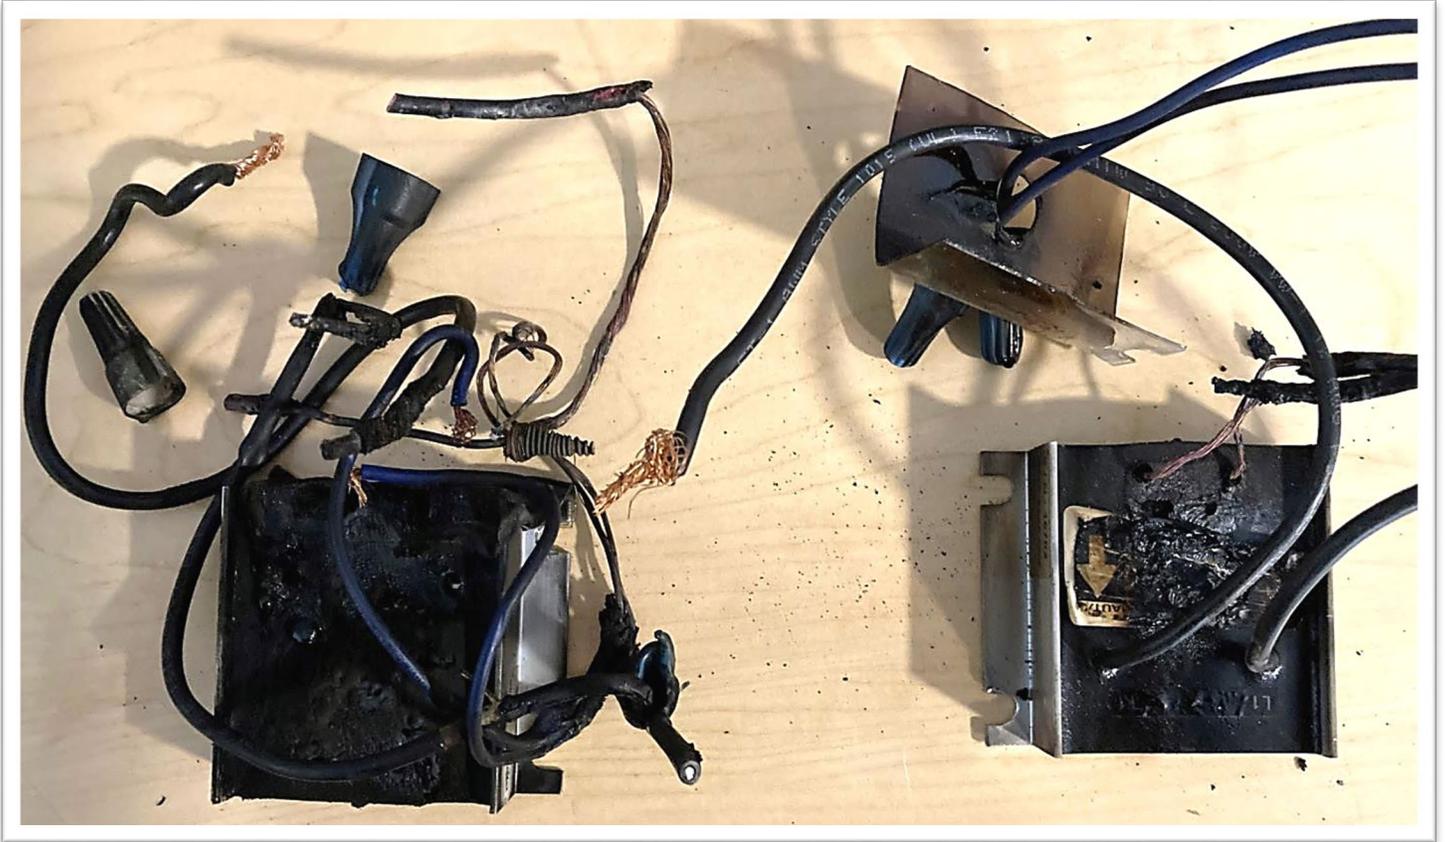
Photo #2

The cause of the relay overheating and catching fire was very likely due to the relay not being installed as per the manufacturer's specifications. This includes the relay not being installed with a thermostat deemed compatible by the manufacturer and that there were more than four low voltage relays connected to one thermostat.

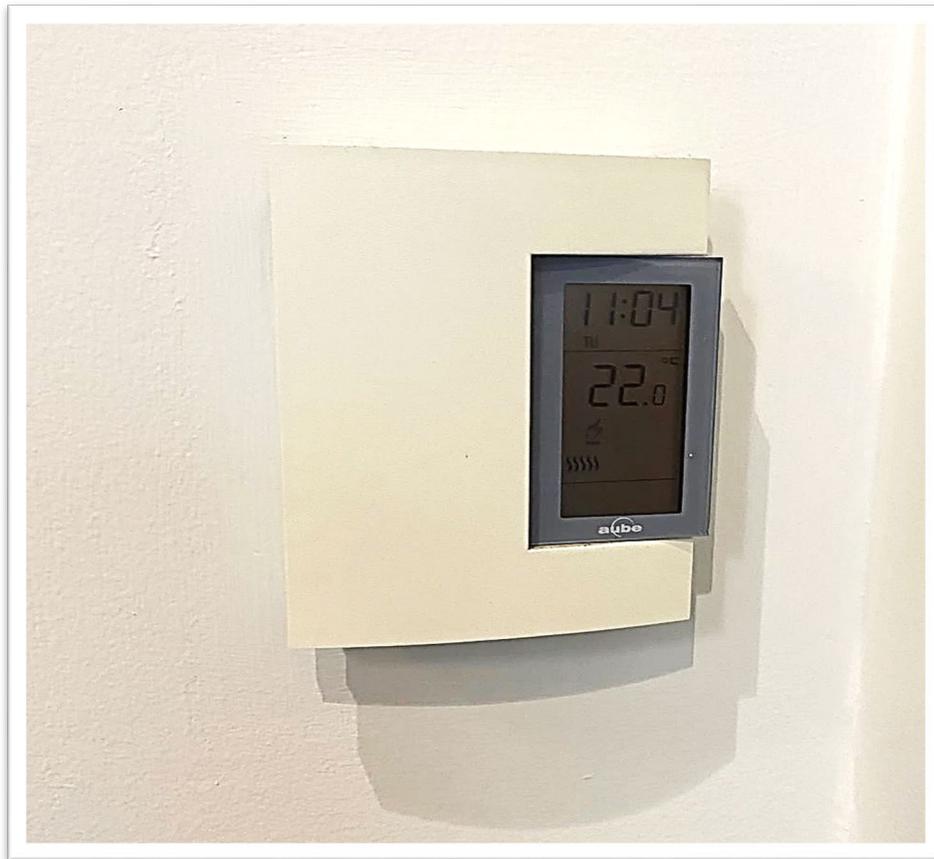
Photo #3

- Manufacturers specifications were not followed. More than 4 low voltage relays on one thermostat and the thermostat part number not listed as compatible with the low voltage relay. ([Photo #4](#))
- An additional damaged RE153 STELPRO was discovered on a different 15AMP 2pole circuit and on a different thermostat. The thermostat was connected to more than 4 low voltage relays and the thermostat part number not listed as compatible with the low voltage relay. ([Photo #4](#)).
- Two AUBE low voltage thermostats discovered to be faulty. Thermostat always in the Normally closed position.

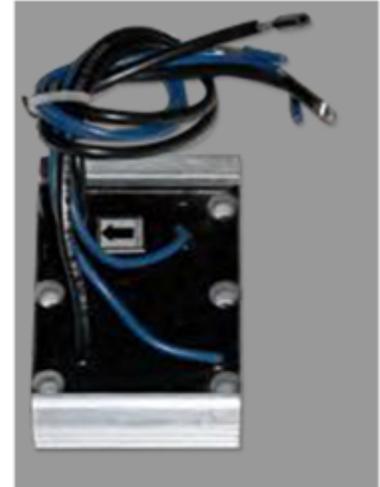
Photo #4

- The thermostat part numbers indicated on manufacturer specification sheet ([Photo #4](#)) are the only thermostats that manufacturer tested the compatibility with the low voltage relay.
