## Incident Summary #II-1039707-2020 (#18815) (FINAL)

SUPPORTING INFORMATION	Incident Date	July 15, 2020	
	Location	Lower Mainland	
	Regulated industry sector	Boilers, PV & refrigeration - Boiler and pressure vessel system	
	Impact	Qty injuries	0
		Injury description	N/A
		Injury rating	None
	Damage	Damage description	Light hydrocarbon was released through a pinhole breach of an insulated process pipe.
		Damage rating	Minor
Incident rating	Minor		
Incident overview	A plant operator detected an abnormal hydrocarbon odor and immediately responded as per site emergency protocol. A localized possible breach was identified, and the process unit was safely shut down for further investigation.		
INVESTIGATION CONCLUSIONS	Site, system and components	A 3-inch insulated pipe connecting process piping to a pressure safety relief valve. The pressure relief valve is designed to open to relieve excess pressure into a Flare system in the event an emergency over pressure occurs.

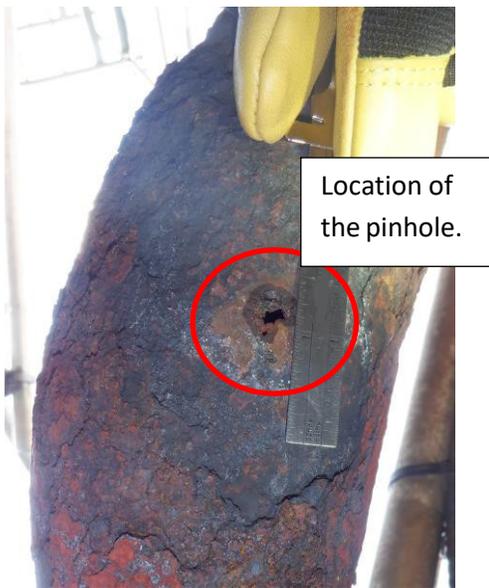
Failure scenario(s)	Corrosion under insulation (CUI) on carbon steel piping resulted in a leak of light hydrocarbon. The process pipe operated within the CUI temperature range (Approximately 115°C) and in a marine environment.	
	Facts and evidence	<p>Upon the removal of the insulation, inspection of the pipe wall verified external thinning of the metal had occurred at the sweep of the elbow, resulting in a pinhole breach.</p> <p>The damage was consistent with corrosion under insulation (CUI) which is an external damage of metallic components and equipment that are insulated. Damage is caused by moisture ingress through the insulation material. Carbon steel and low-alloy steels corrode in the temperature range between -5°C and 175°C (25°F and 350°F).</p> <p>The facility operates in a marine environment which increases susceptibility to CUI damage, the location of external damage was aligned with a low point where moisture would collect if the insulation were damaged, and insulation damage was identified on the piping above the leak location.</p> <p>It was confirmed that the safety relief valve did not lift and operated as designed.</p> <p>It was confirmed that the facility's inspection strategy meets or exceeds industry standards, and that a dedicated maintenance team was in place for repairs.</p>

Causes and contributing factors	<p>Cause: There was an insulation breach creating a location of susceptibility to CUI on process piping.</p> <p>Contributing Factors: It was identified that a more robust prioritization methodology for insulation repairs may have reduced the likelihood of the piping breach.</p>

Image 1 - Pinhole found on the elbow after removing the insulation.

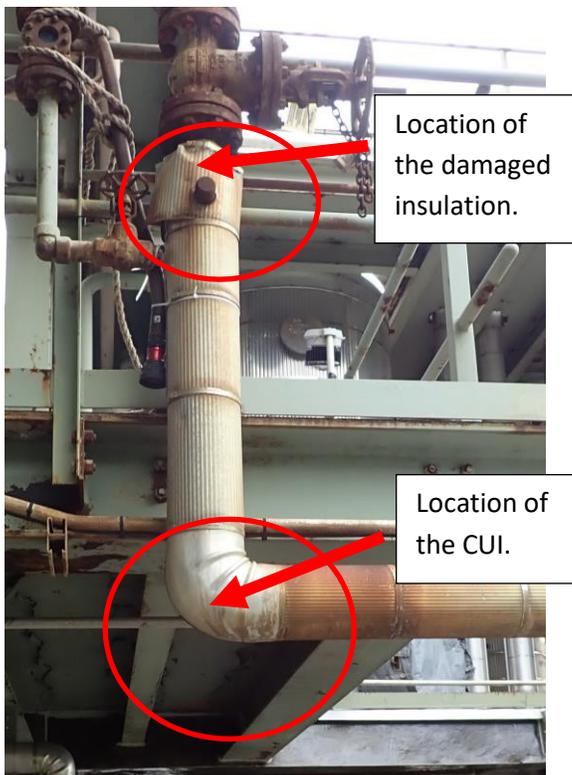
Image 2 - Location of the CUI before removing the insulation.
