## Incident Summary #II-1013256-2020 (#17432) (FINAL)

SUPPORTING INFORMATION	Incident Date		May 8, 2020	
	Location		Langley	
	Regulated industry sector		Electrical - Low voltage electrical system (30V to 750V)	
	Impact	Injury	Qty injuries	0
			Injury description	Not applicable
			Injury rating	None
	Damage	Damage	Damage description	The armoured cable protective sheathing was damaged as well as the insulation on the live conductors were damaged causing an electrical fault which resulted in the circuit breaker opening. The fire pump circuit was out of service for 48hrs
			Damage rating	Moderate
	Incident rating		Moderate	
Incident overview		<p>A construction worker was drilling holes into a concrete parkade of a residential multi family dwelling for replacement of expansion joints and drilled into an energized 600 volt fire pump cable beneath the concrete surface.</p> <p>An electrical fault between the energized conductors and the metal drill bit occurred and the fire pump circuit breaker opened causing a loss of power to a critical fire pump circuit.</p>

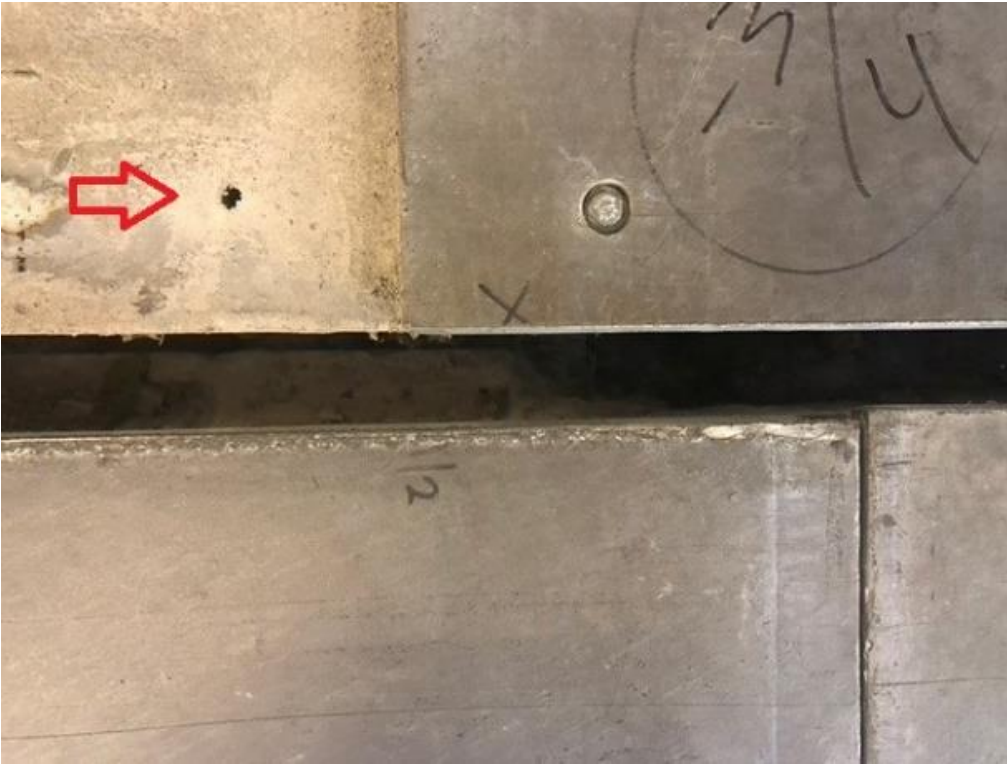
INVESTIGATION CONCLUSIONS	Site, system and components	<p>The fire pump maintains water pressure in a fire sprinkler suppression system throughout the building.</p> <p>The 600 volt fire pump is fed from an armoured cable encased in the parkade concrete slab and is protected by a circuit breaker. The armoured cable is a 3 conductor # 2/0 aluminum ACWU cable 1.5inches in outside diameter.</p> <p>The fire pump cable is considered fire and life safety equipment and is required by the BC electrical and the BC building code to be protected against fire to provide continued operation of not less than 1 hr. The fire pump cable is required to be embedded in not less than 2 inches of concrete or installed in a shaft enclosure of at least 1 hour fire resistance construction.</p> <p>There is no requirement for low voltage conductors (30-750 volts) to be identified in concrete slabs.</p> <p>Drilling or cutting into energized electrical cables or conductors presents a major electrical shock and fire hazard as well as the potential to damage important fire and life safety features within a building.</p> <p>Best practice for newly constructed or renovated buildings is to provide “as built” drawings to identify the routing of concealed electrical systems within the building that can be referenced to determine areas to avoid when cutting or drilling into the structure</p> <p>In the absence of, or in addition to as built drawings the best practice is X-raying concrete slabs to ensure electrical systems will not be damaged</p>

Causes and contributing factors	<p>It is highly likely that the construction worker not taking the appropriate steps to determine if the concrete slab was free of any electrical cables prior to drilling the hole was the cause of the incident.</p>

**Figure 1** 1/4inch hole drilled 6inches deep into the fire pump armoured cable in the concrete slab

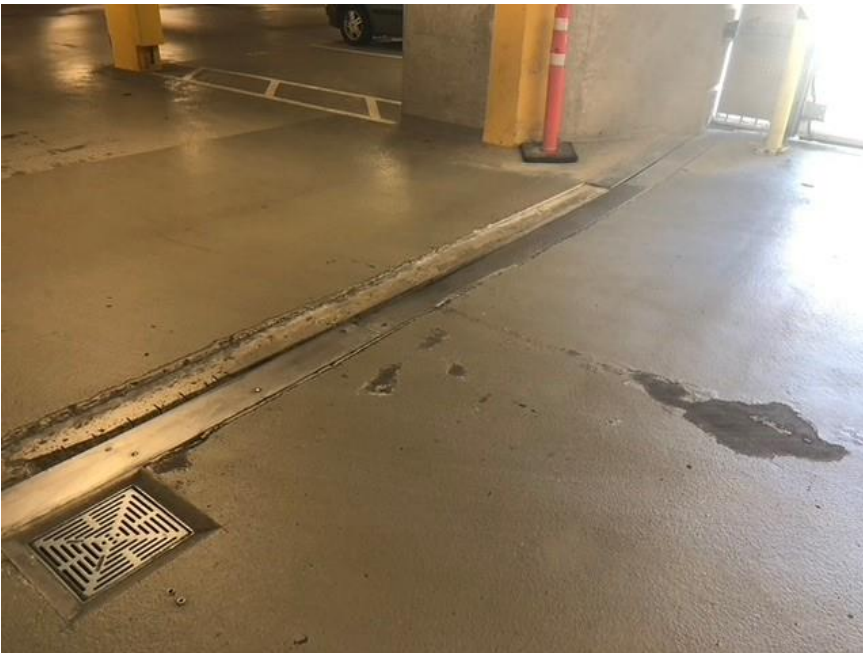
Failure scenario(s)	<ul style="list-style-type: none"> <li>- A construction worker was installing steel flanged expansion joints in a parkade as part of warranty work. See Figure 2</li> <li>- The construction worker did not confirm if there was any electrical cables in the slab prior to drilling.</li> <li>- The construction worker was drilling ¼ inch holes in the concrete slab with a 6 inch long drill bit in a 8 inch slab when they hit the energized armoured fire pump cable.</li> <li>- When the cable was hit while drilling the concrete slab an electrical fault occurred causing an arc and the circuit breaker to trip</li> </ul>
Facts and evidence	<p><b><u>Electrical Contractor Statement:</u></b></p> <ul style="list-style-type: none"> <li>- The construction worker was drilling 6 inches deep holes in the 8 inch thick concrete slab.</li> <li>- The concrete was not X-rayed to confirm any source of energy is present in the area prior to drilling.</li> <li>- The concrete drill bit was drilled into a live armoured cable in the concrete causing an arc and loss of power to the fire pump circuit.</li> <li>- The low voltage armoured cable was not marked in the concrete slab.</li> <li>- As built drawings were not available for the construction worker.</li> </ul>

**Figure 2 :** Rubber expansion joint with steel flanges installed
