Incident Summary II-1678433-2024 (#44647) (Final)

SUPPORTING INFORMATION	Incident Date	February 6, 2024
	Location	Rogers Pass
	Regulated industry sector	Electrical - High voltage electrical system (greater than 1000V)
	Impact	Qty injuries
		0
		Injury description
	Injury	N/A
		Injury rating
		None
SUPPORTING INFORMATION	Damage	Damage description
		A high voltage power supply and back up generator to a railway tunnel ventilation system was damaged at a fault in an underground junction.
		Damage rating
	Major	
	Incident rating	Major
	Incident overview	
		A fault in a 4160v 3-phase power cable providing power to a transformer tripped the private powerline protection providing power to the commercial railway tunnels. An emergency backup generator started and re-energized power to both tunnels following the loss of utility power, including the faulted cable.
		Power was then restored to all fans in the tunnel. A short time elapsed when a second fault occurred on backup power that caused damage to the generator electronic voltage regulator and de-energized the system. The resulting voltage spike damaged the separate cable feeding one (1) railway tunnel causing the fuses on phase B and C

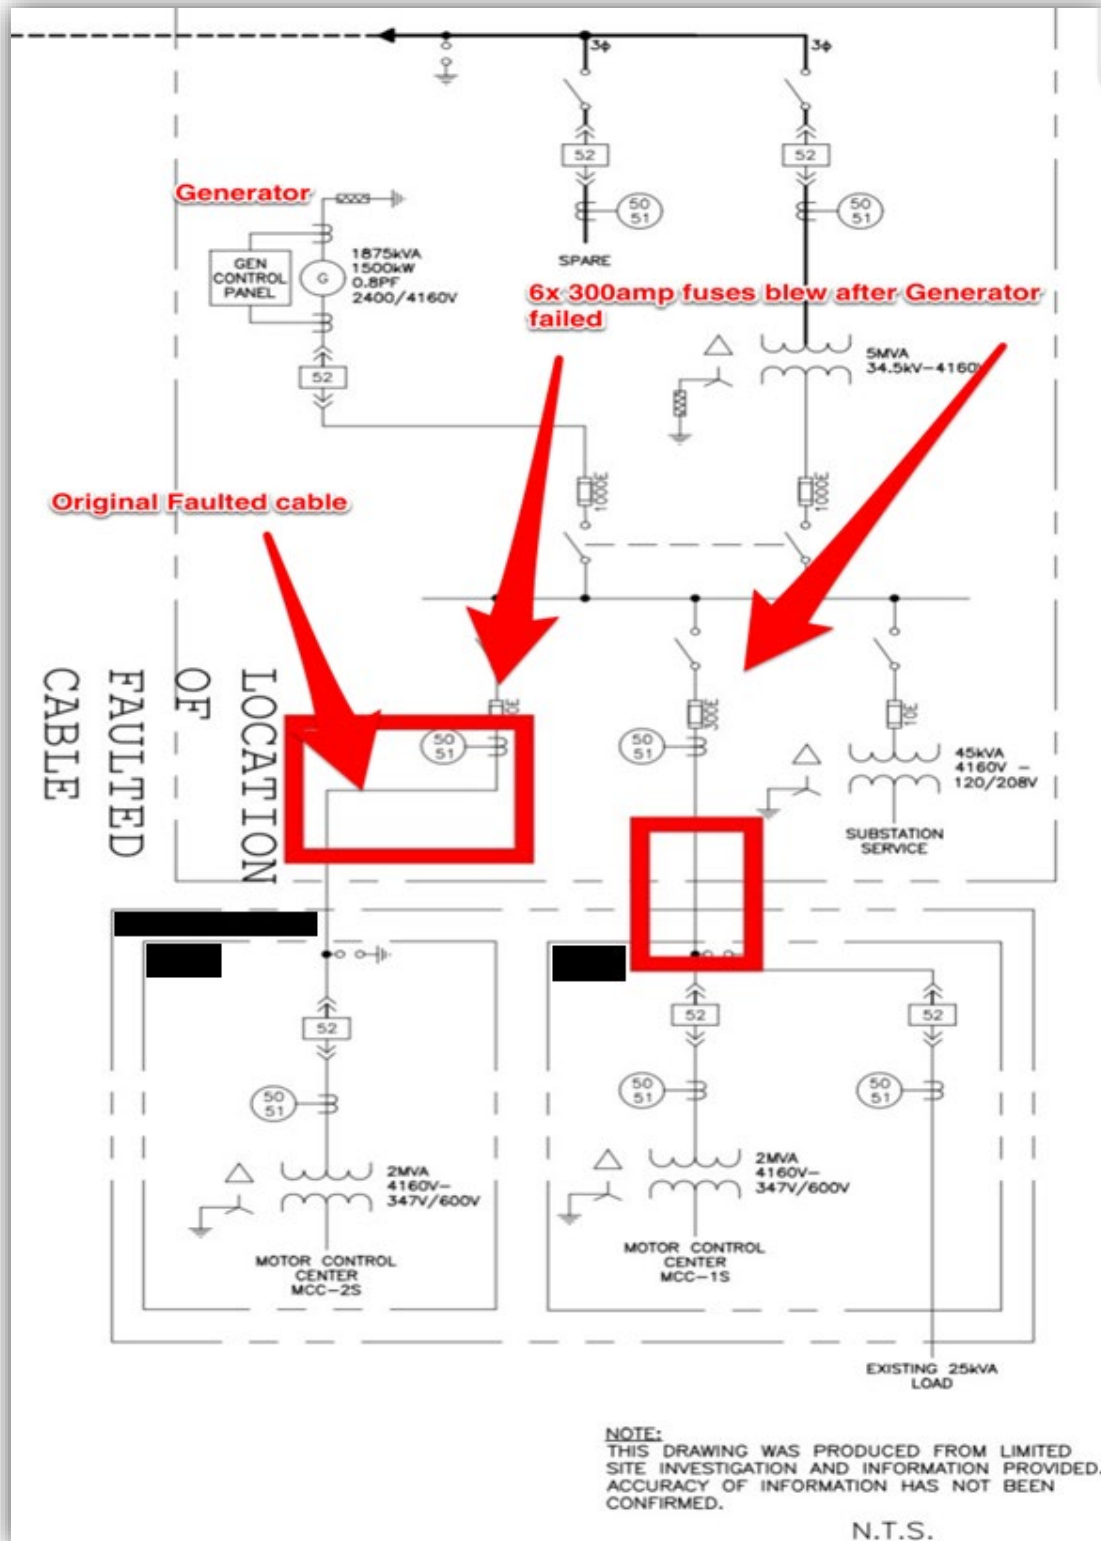
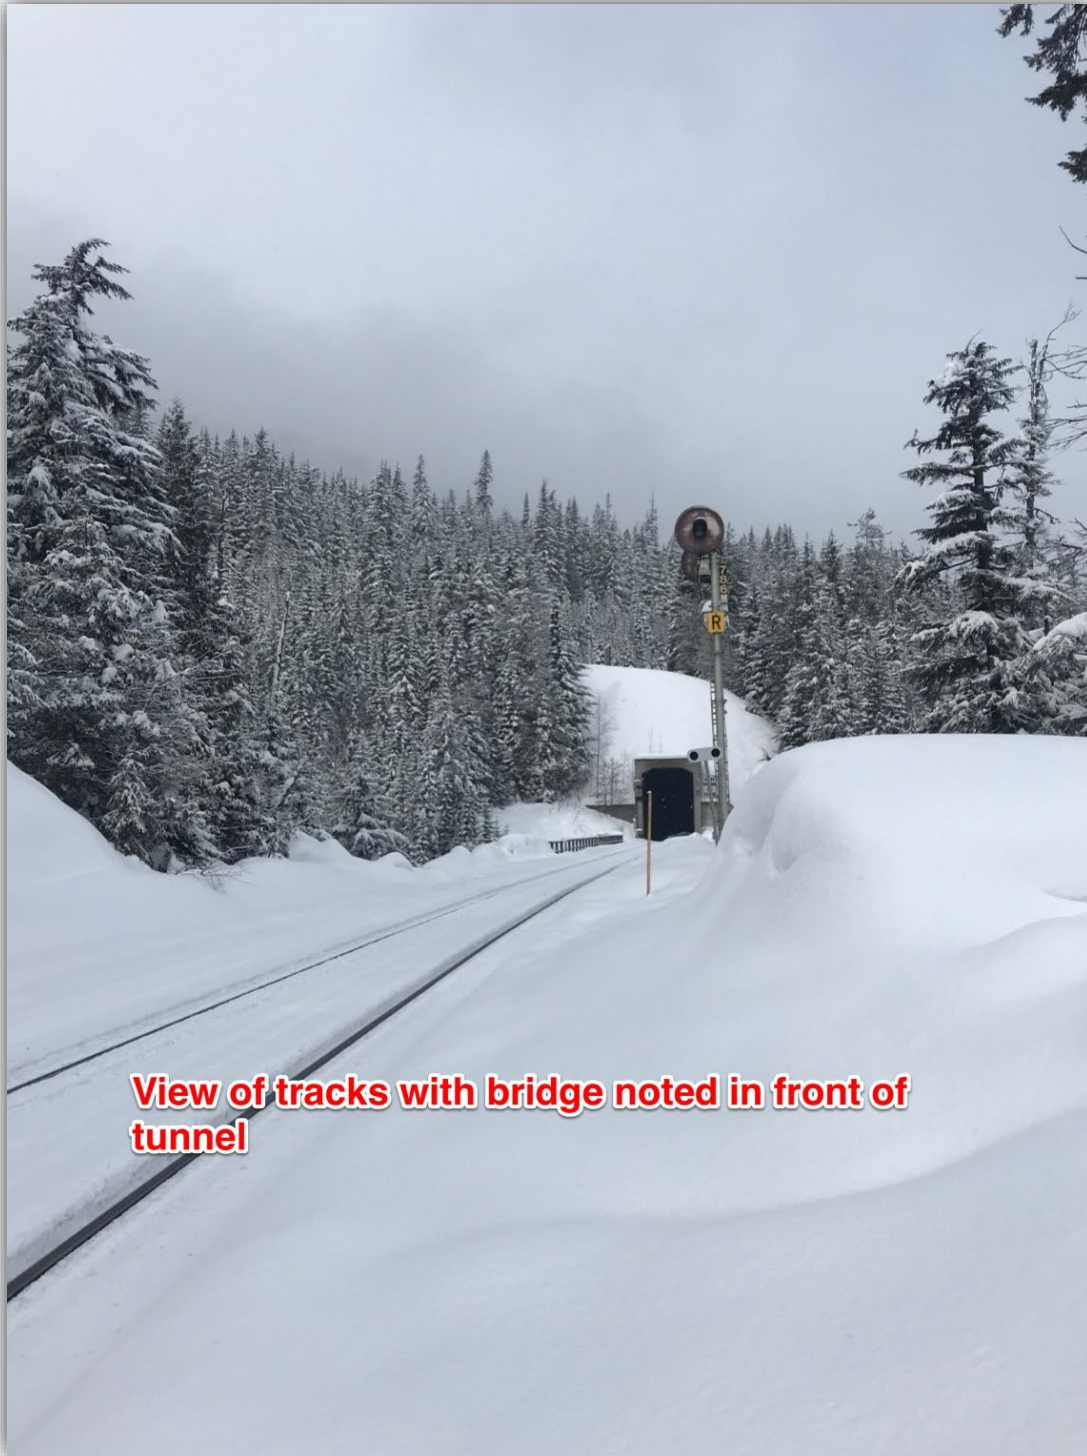
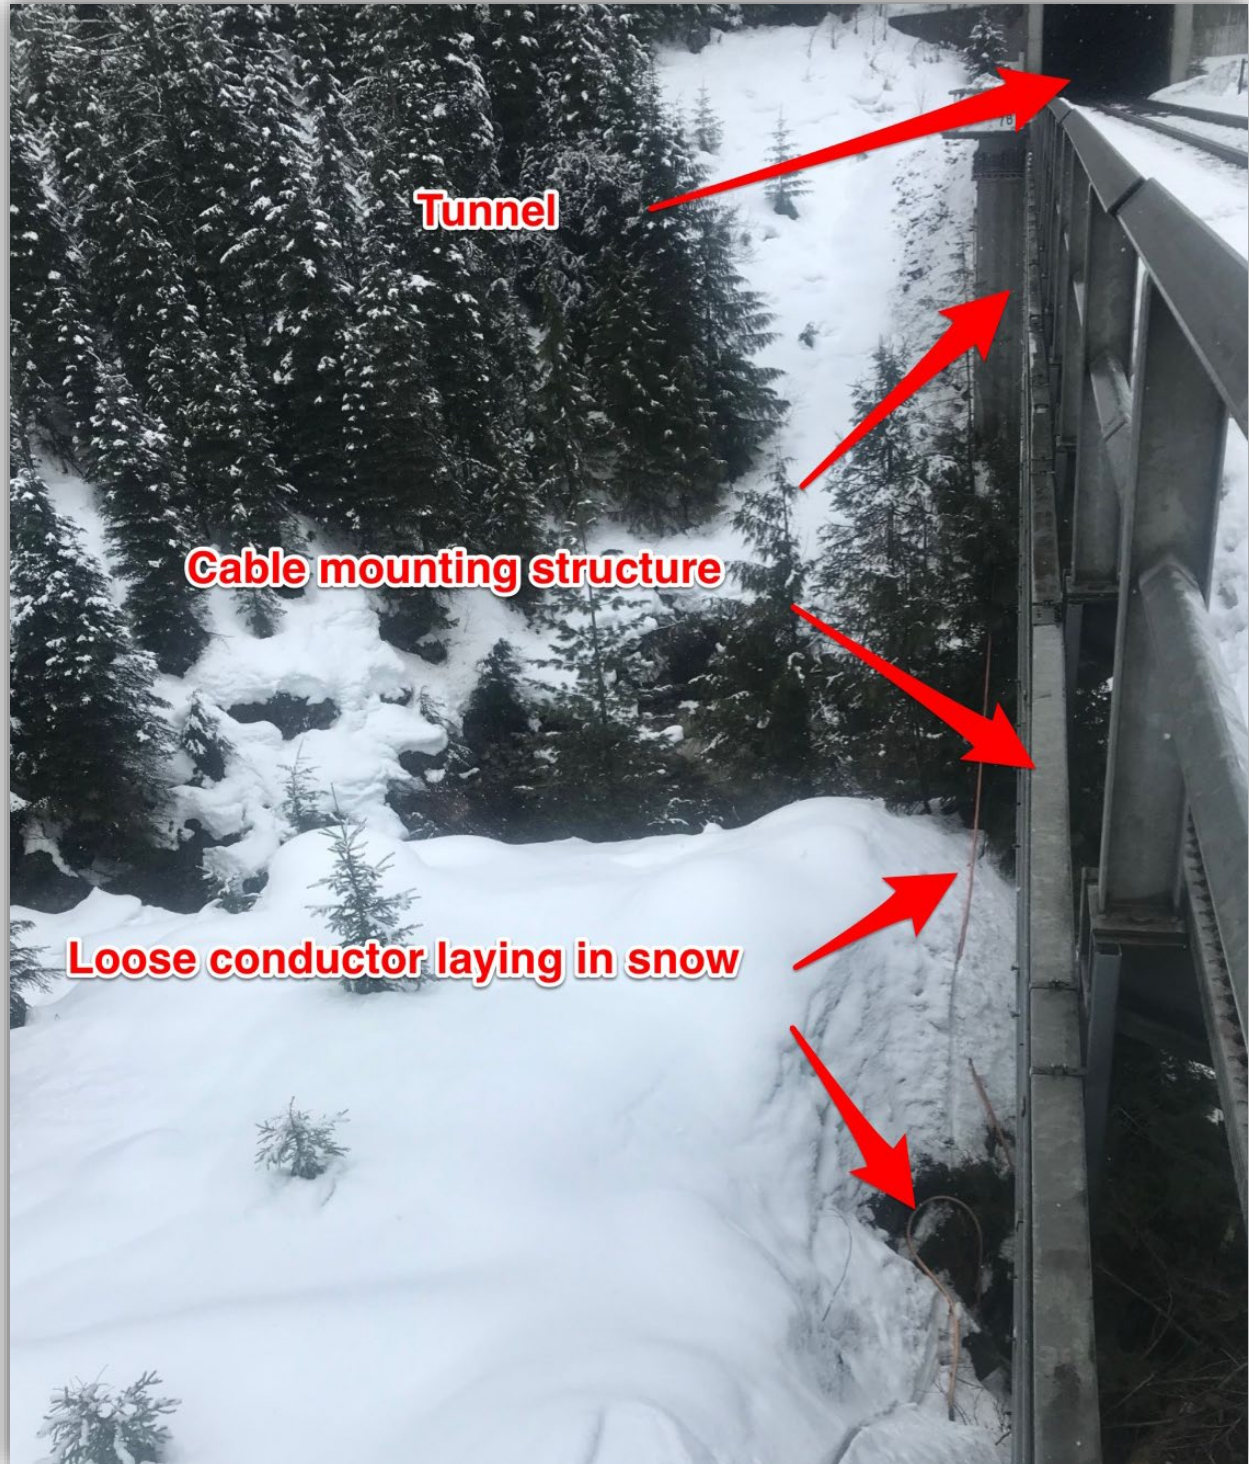
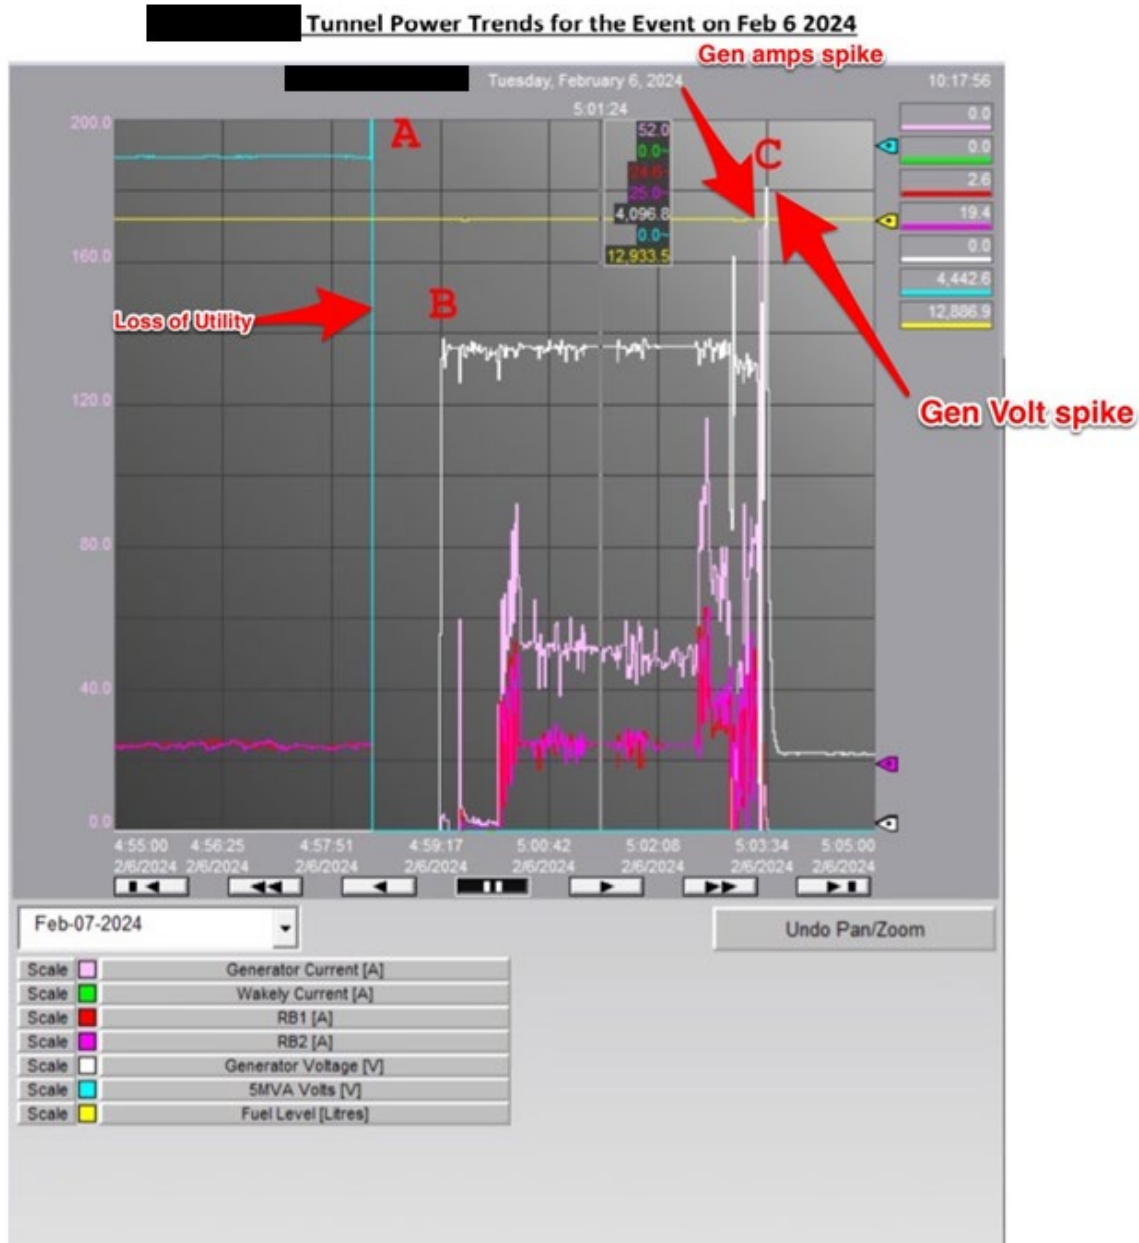
- A- This is where the first ground fault occurred, the feeder to RB2 faulted to the Junction box, the protection relay for our normal power feed opened up the tunnel feeder when the ground fault was detected.
- B- Generator started and brought the tunnel back online; inadequate protection allowed the generator to run with a ground fault present.
- C- RB2 feeder eventually fully faulted to ground and caused the generator current to quickly spike and then drop when motor protection shut down all fans simultaneously. This resulted in a spike in voltage from the Generator. The trends are not quick enough to capture the true magnitude of the current and Voltage spike. All 300A fuses protecting RB1 and RB2 blew.
