## Incident Summary #II-1817926-2025 (#55737) (FINAL)

| | Incident overview | A commercial oven in a grocery store, that had been altered approximately three weeks earlier, exploded on startup. | |

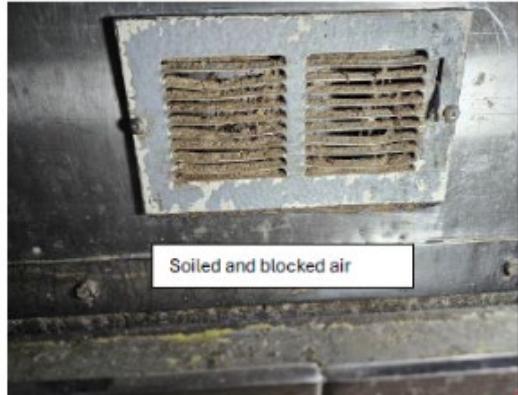
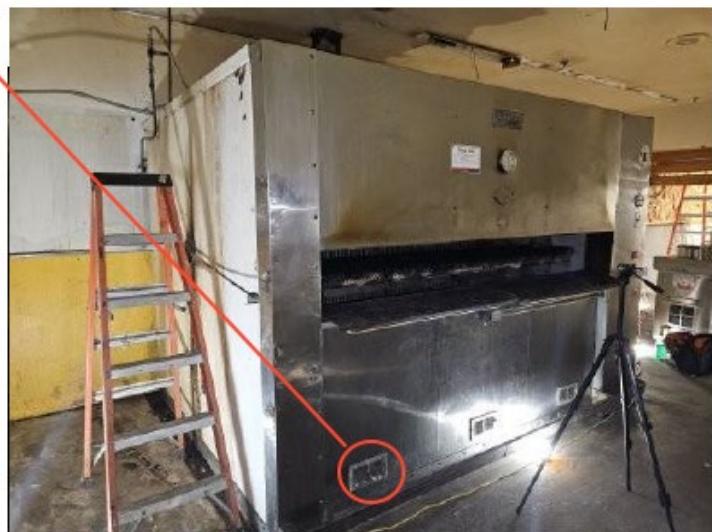
| | <ul style="list-style-type: none"> <li><b>Ventilation Concerns</b> - It was also noted that approximately 30% of the fresh air grills serving the commercial oven were obstructed, which may have contributed to poor combustion performance.</li> </ul> <p>The overall conclusion of the report was:</p> <p><i>"Based on observations of the burner lighting inconsistently, and the amount of gas coming from half of the burner while the other half is lit, we can determine that delayed ignition was the cause of the explosion. The amount of gas that would be required to reach a lower explosive limit of 4 percent gas in air [is] 23284.8 square inches (13.475 square feet) The burning rating is 240,000 Btu's at 3.5 inches water column manifold pressure. At these set points, with no airflow and only half the burner lit, the lower explosive limit causing an explosion would be met in 6 minutes and 44 seconds. Considering the timeline of events as described, this fits the length of time from startup of the oven to when the explosion occurred on site".</i></p> <ul style="list-style-type: none"> <li><b>Fire department</b> – Confirmed they had received a call on January 1, 2025, at the site address. They attended site whereupon they found the sprinkler system had activated in the bakery area, caused by an explosion from the oven. The fire department made the area safe.</li> </ul> |

Image 1 - Partially restricted combustion air inlets.

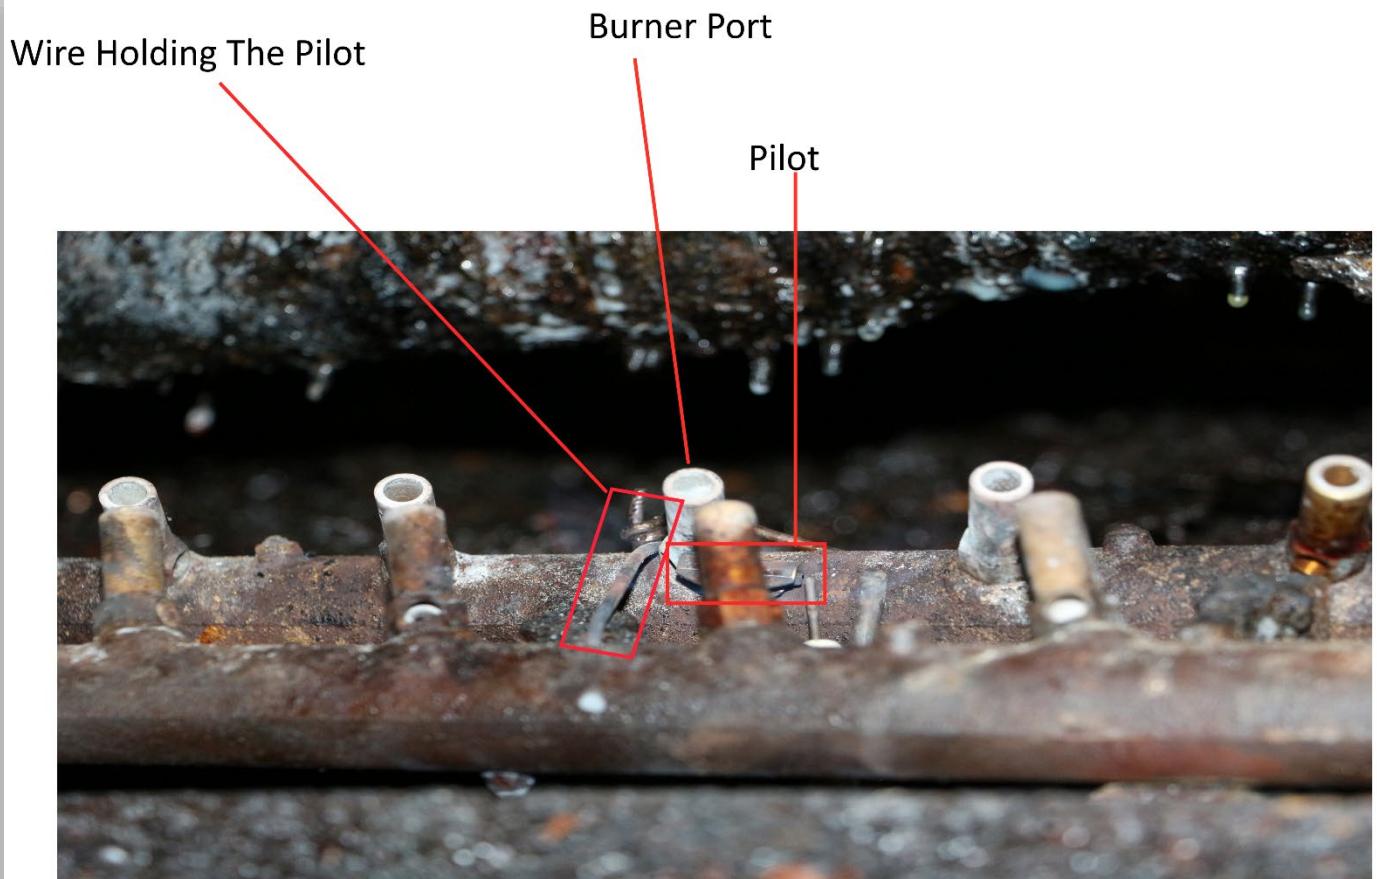
| <p>Facts and evidence</p> | <p><b>Site Observations</b><br/> The pilot was found 1-inch below the burner's jets as it was not secured as per current code. This possibly aided in the burner not igniting fully, as the position of the pilot relative to the burner jets is critical for proper ignition.<br/> The fresh air grills on the commercial oven were observed to be partially obstructed with dust and dirt which could reduce the amount of fresh air entering the combustion chamber. This could have several effects: <ul style="list-style-type: none"> <li>• Reducing the fresh air into the combustion chamber makes the natural draft effect to be reduced allowing more gas to accumulate in the combustion chamber and not be dissipated via the vent.</li> <li>• Reduces the gas air mixing effectiveness of the burner making the burner harder to ignite and maintain a constant flame throughout the burner.</li> </ul> While testing the low gas pressure on the low fire portion of the gas train, the gas pressure was so low that it showed zero gas pressure on the test gauge. This caused some of the burner jets to not stay ignited. This also allows unburnt gas to enter the combustion chamber due to the danger of causing another explosion. We could not determine the amount of unburnt gas that was released into the combustion chamber The gas safety officer observed that visually confirming full burner ignition at each initial startup could reduce, though not eliminate, the risk of explosion due to the low-fire condition. However, this procedure is not specified in the manufacturer's documented operating instructions. The influence of exhaust fans could not be confirmed or denied as at time of testing all exhaust fans had been removed due to asbestos contamination. The commercial oven is a natural draft type with no additional makeup air supplied so there is a remote possibility that the exhaust fans contributed to the explosion. It is important to note for testing purposes; the front doors of the commercial oven were left open so investigators could observe the burner to document the results and for safety. Having the oven open will improve air flow in the combustion chamber which improves the chances of the burners completely igniting. It was reported that the commercial oven is started with the doors closed. Combined with partially obstructed air grills, this condition may further inhibit full burner ignition. <b>Gas Contractor</b> – Supplied documents verifying the timeline of repairs, alterations and issues found with the commercial oven, including confirmation of the date the pilot was relocated. Confirmed the name and class of the gas fitter responsible for the work conducted on the commercial oven, and the date the gas fitter became certified with the authority having jurisdiction. <b>Gas Fitter</b> – During the interview conducted by the Gas Safety officer it was identified that some of the repairs were conducted without supervision and prior to the gas fitter receiving their gas fitter certification in October 2024. When asked how long the gas fitter had been working on the oven, it was determined work had been ongoing since 2022. The gas fitter explained the most recent issues started in June 2024 that and were related to the oven's burner and pilot system. To address the pilot issue the gas fitter explained that in July 2024, he replaced the thermocouple. However, the original thermocouple was 60 inches long and the gas fitter only had a 48-inch thermocouple available. To accommodate the shorter part, he relocated the entire pilot assembly 3 feet to the right of its original position and </p> |

| | <p>secured it using a piece of wire. The gas fitter stated that no consultation was made with the manufacturer regarding this modification. When questioned about the use of wire to secure the pilot, the gas fitter initially saw no issue, stating that the pilot had previously been held in place with wire.</p> <p>When the gas fitter saw the position of the pilot post-incident, he stated he had not placed it in the location observed, which was significantly lower than expected. He reiterated that when he tested the pilot, the burner ignited fully. However, he demonstrated limited understanding of how relocating the pilot and securing it improperly could have contributed to the explosion.</p> <p>The gas fitter expressed feeling pressured to restore the oven's functionality for the retail outlet and believed at the time that the work was safe, within his scope of practice, and compliant with code. This belief extended to all gas work he had performed. However, the Gas Safety Officer found that the actions and decisions taken did not reflect a clear understanding of safety standards or regulatory compliance.</p> |

Image 2 - The revised location of the pilot assembly.
