## Incident Summary #II-2038643-2026 (#61809) (FINAL)

| Incident overview | | In a mobile home park, a propane gas leak inside a fifth wheel RV caused an explosion and fire that destroyed the RV and injured the occupant and their pet dog. | | |

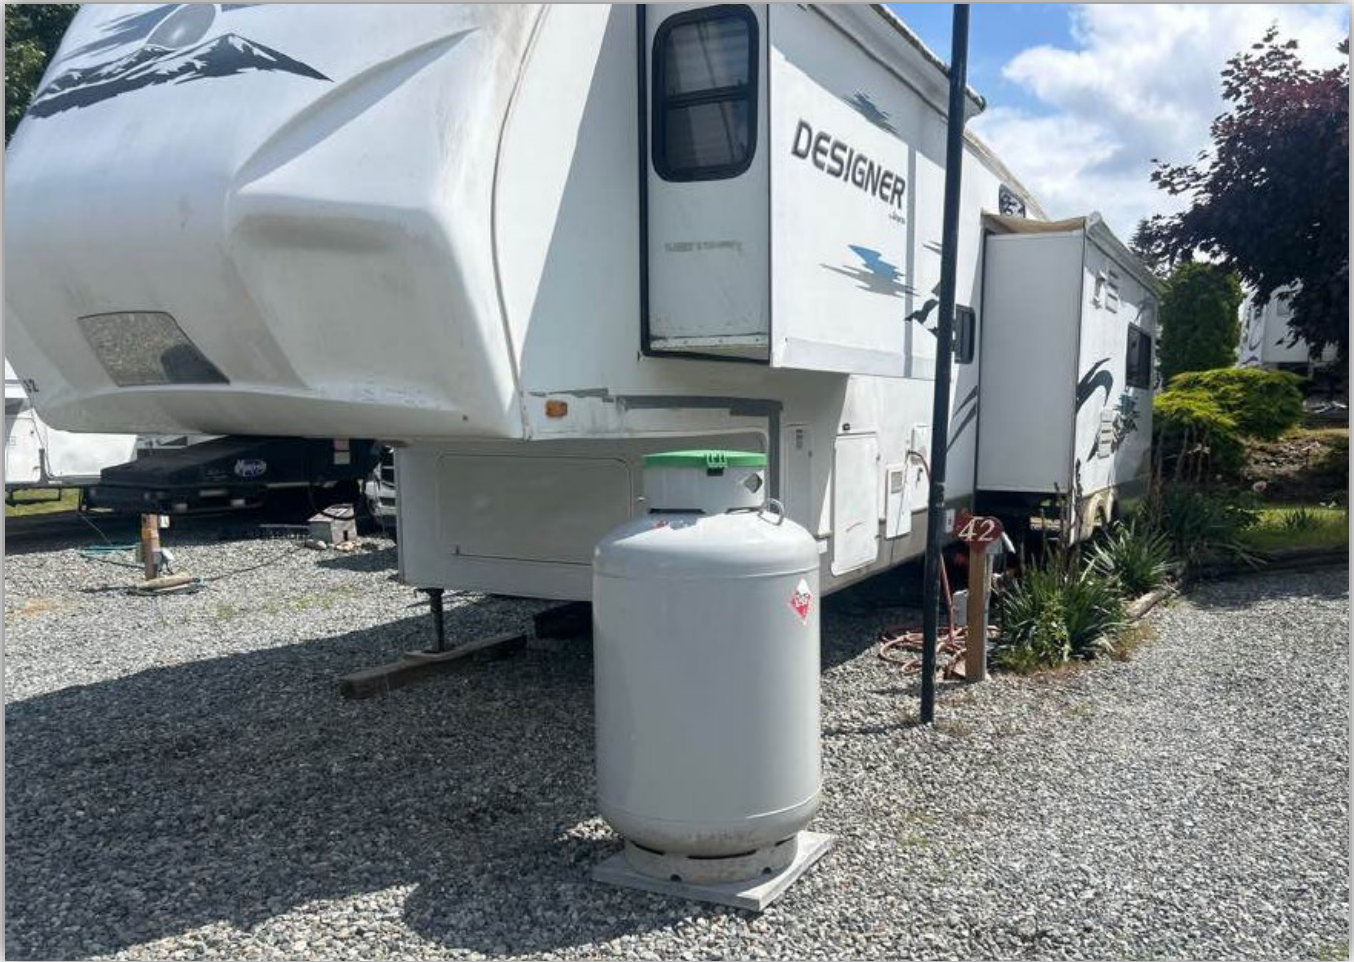
Image 1 – The propane cylinder at the time of installation (Image from the propane supplier's installation form).

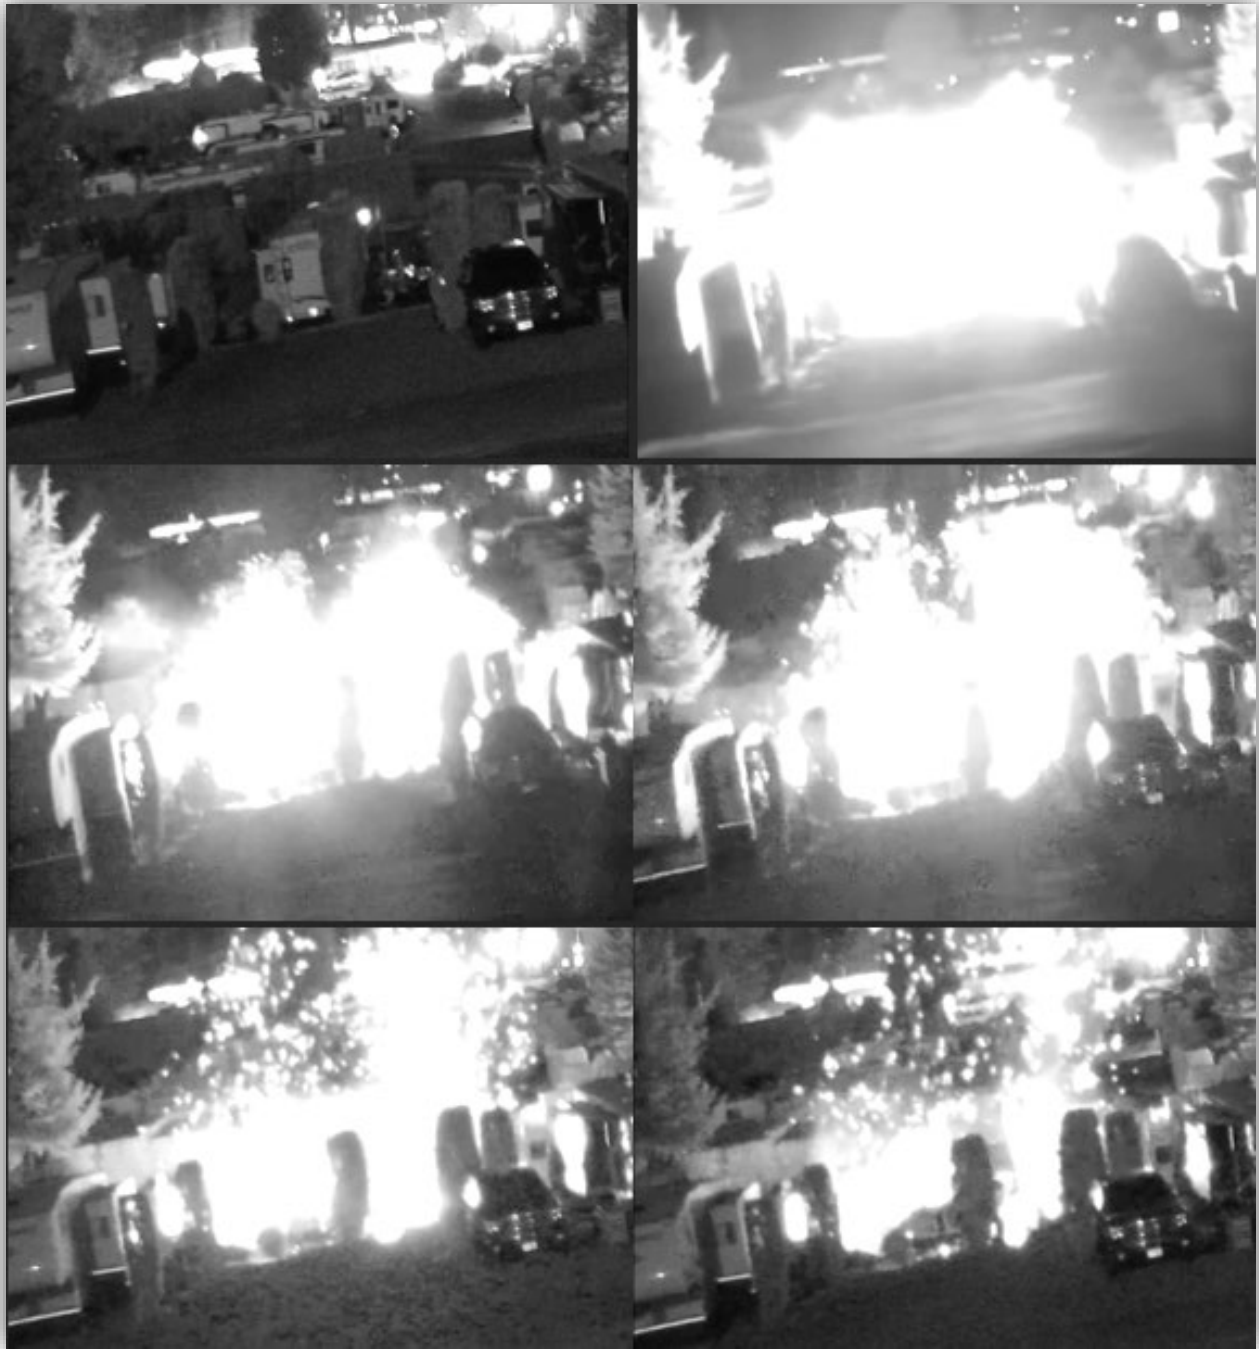
- The occupant can be seen arriving home at 18:20, and the explosion occurred 49 minutes later at 19:09.

Image 2 – Surveillance screenshots showing the explosion and fire.

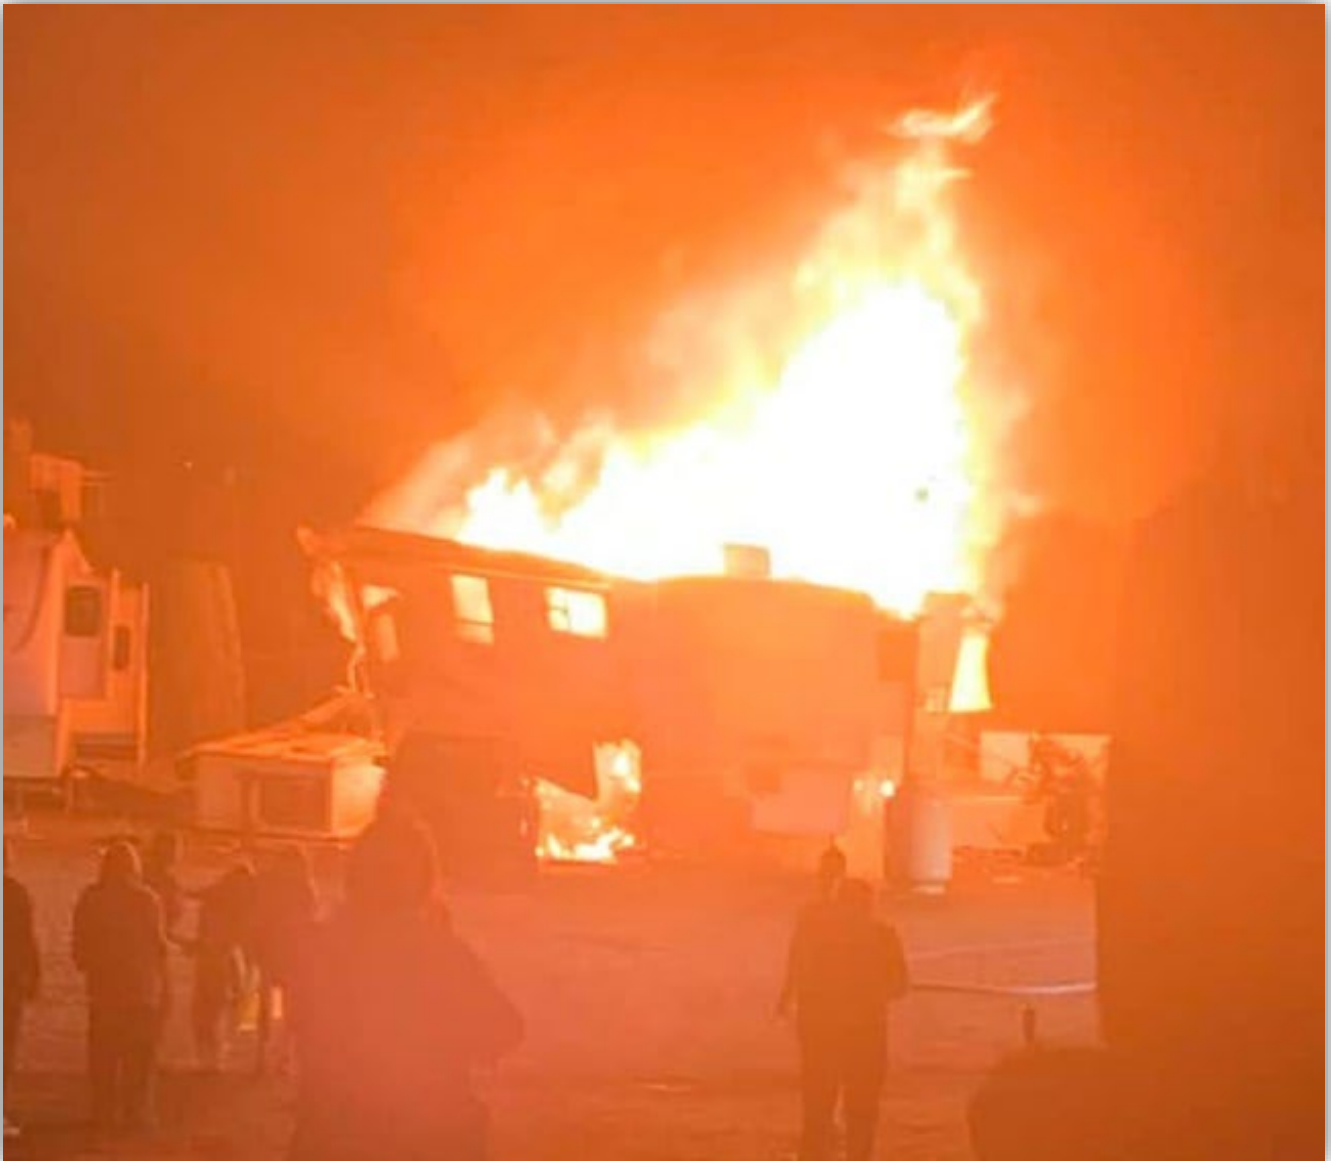
Image 3 – Bystander captured the scene shortly after the explosion.

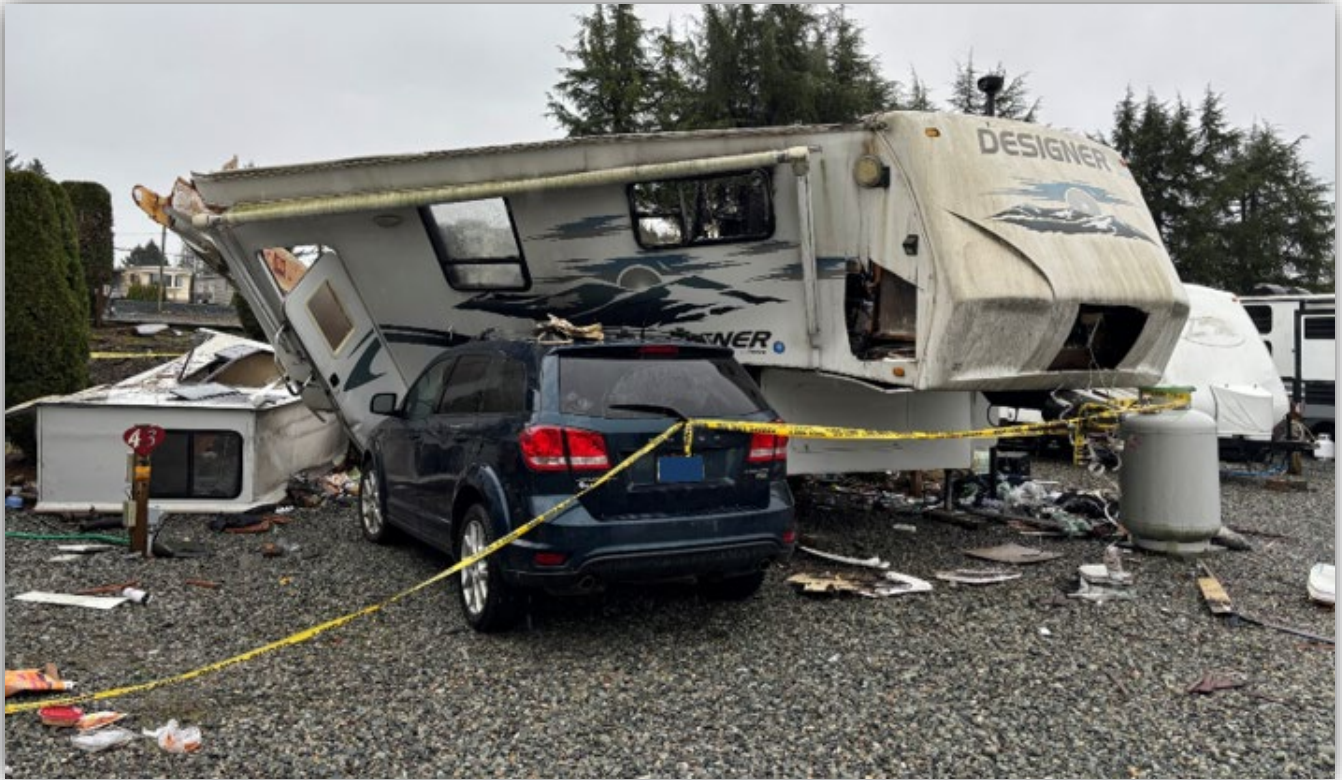
| | | Damage | Damage description | The subject recreational vehicle (RV) was destroyed, with the roof and walls pushed outward. The explosion also damaged the owner’s vehicle parked beside the RV. A resulting fire further damaged the RV’s internal structure and contents. |

Image 4 – Damage from the front (north side) of the RV.

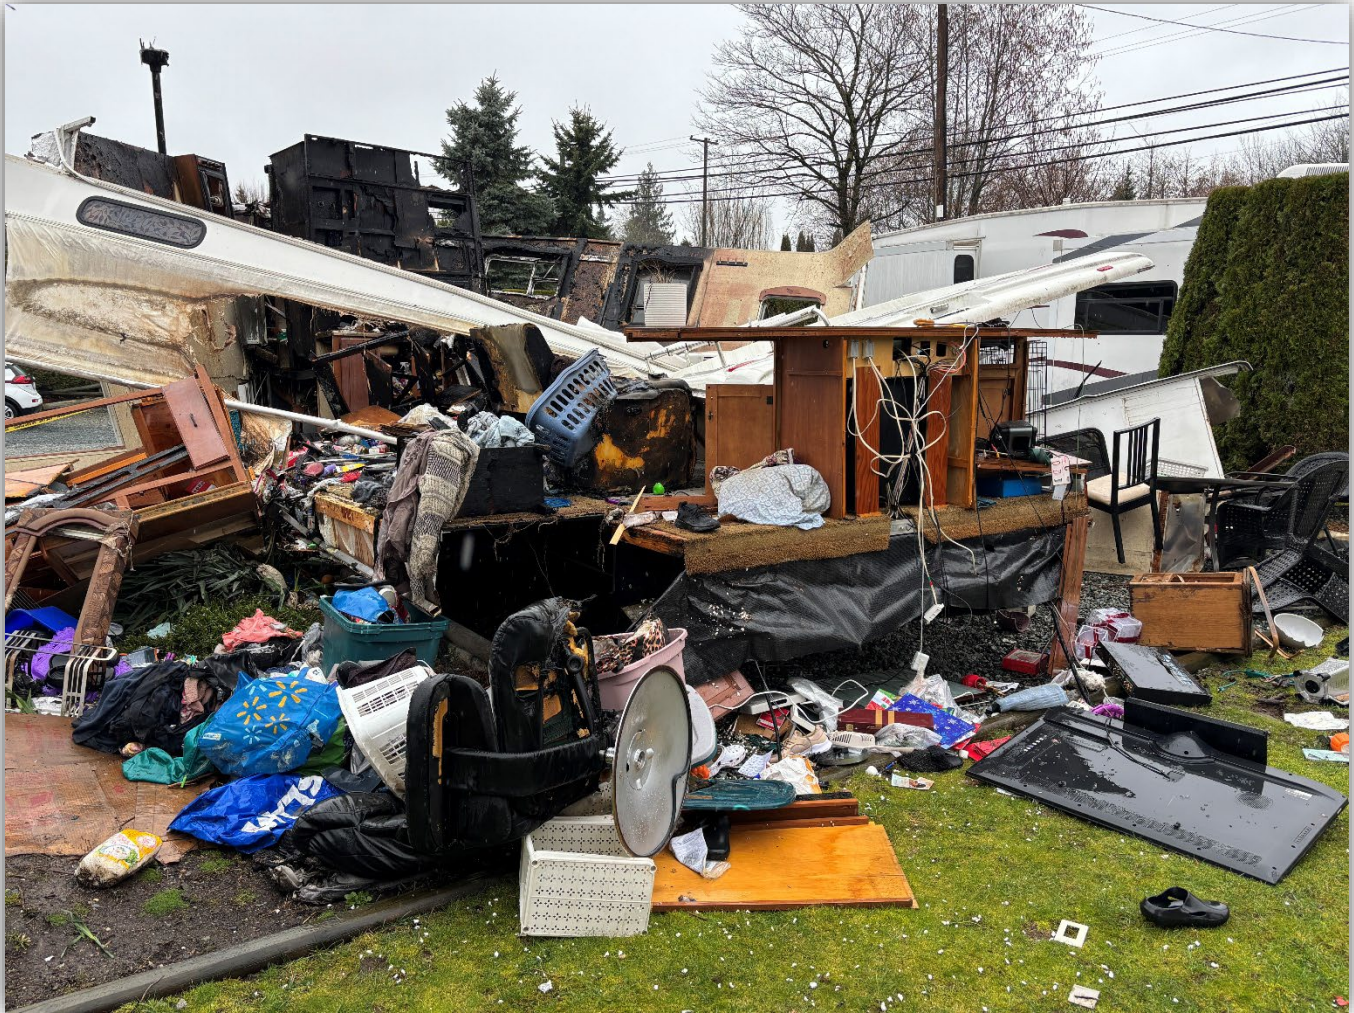
Image 5 – Damage from the rear (south side) of the RV.

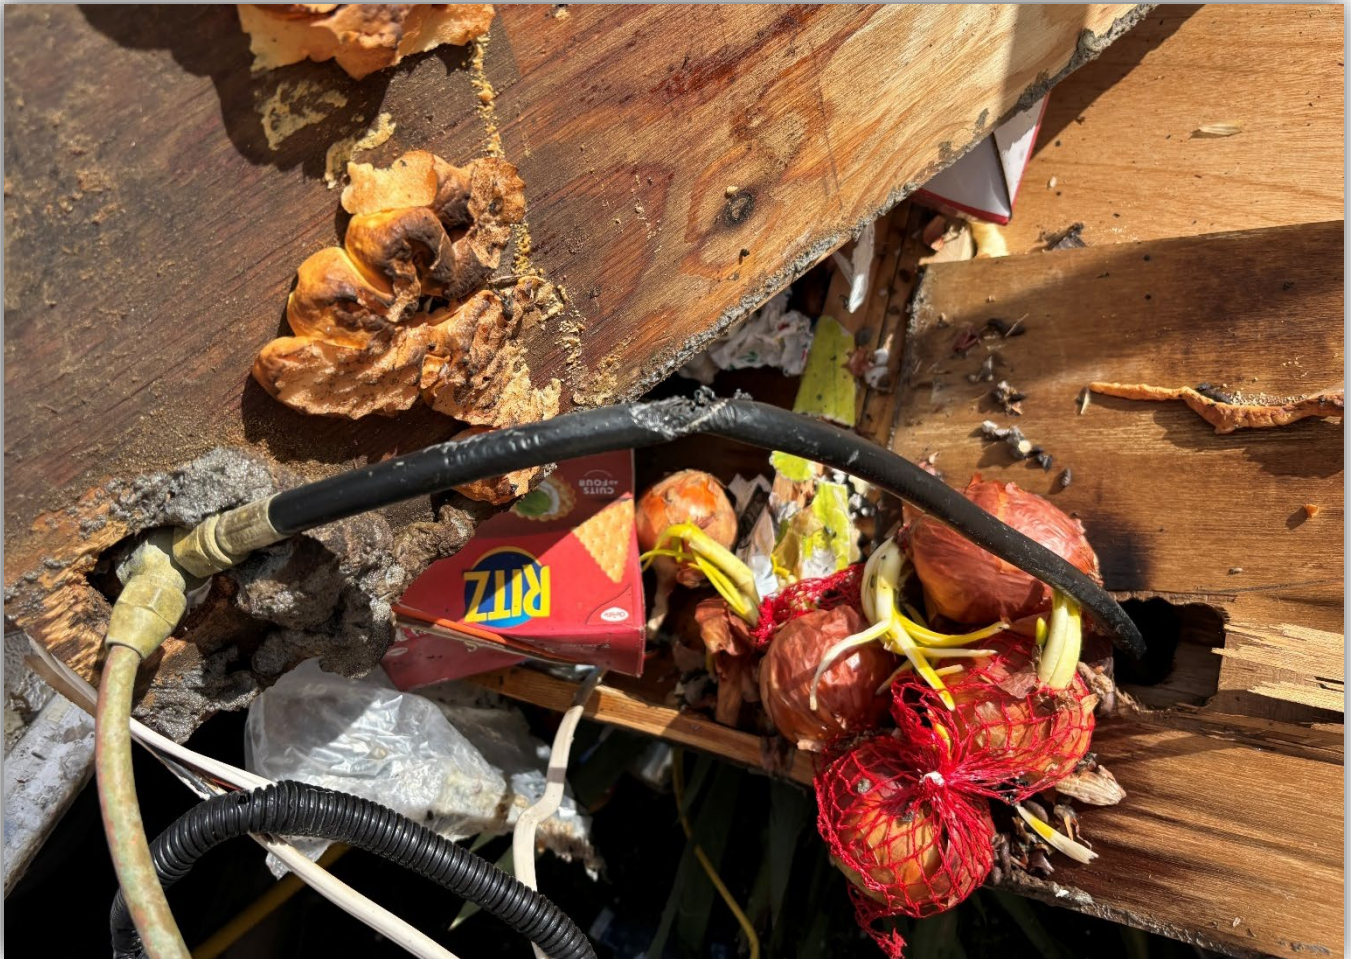
Image 6 – Copper (range) and rubber (fridge) propane gas line.

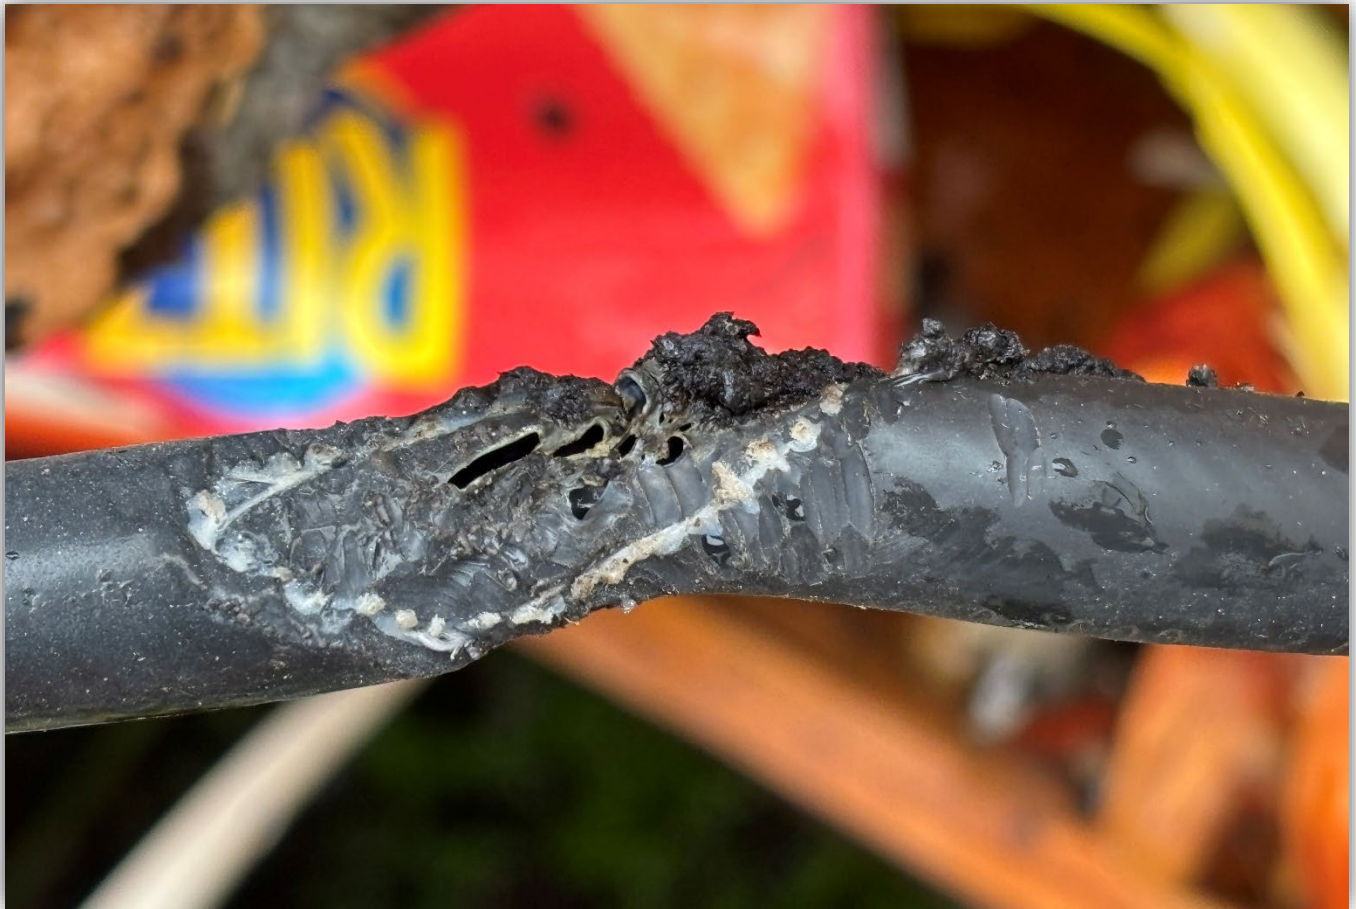
- The rubber gas hose was found to have irregular longitudinal cut marks consistent with rodent chewing at one location, with holes penetrating through to the inside of the hose.
- Electrical wires in the same area also had similar cut marks.
- The area of the RV in which the hose was located contained several food products and what appeared to be rodent droppings.
- The uncapped gas hose was found with a brass flare plug, observed in the same area on the floor of the RV.
- The shutoff valve upstream of the open gas line was observed in the partially open position after the explosion.
- An apartment-sized electric fridge was observed on the ground outside of the RV, opposite the original fridge location.
- The entire gas line from the propane cylinders was examined with no evidence of any other potential leak locations.

Although a partially open gas line was found inside the RV, evidence suggests the most likely cause was that rodents chewed through the flexible non-metallic gas hose that was routed inside the RV, resulting in a gas leak that caused an explosion and fire.

Image 7 – Close-up of rodent chew marks and holes on the rubber gas line.

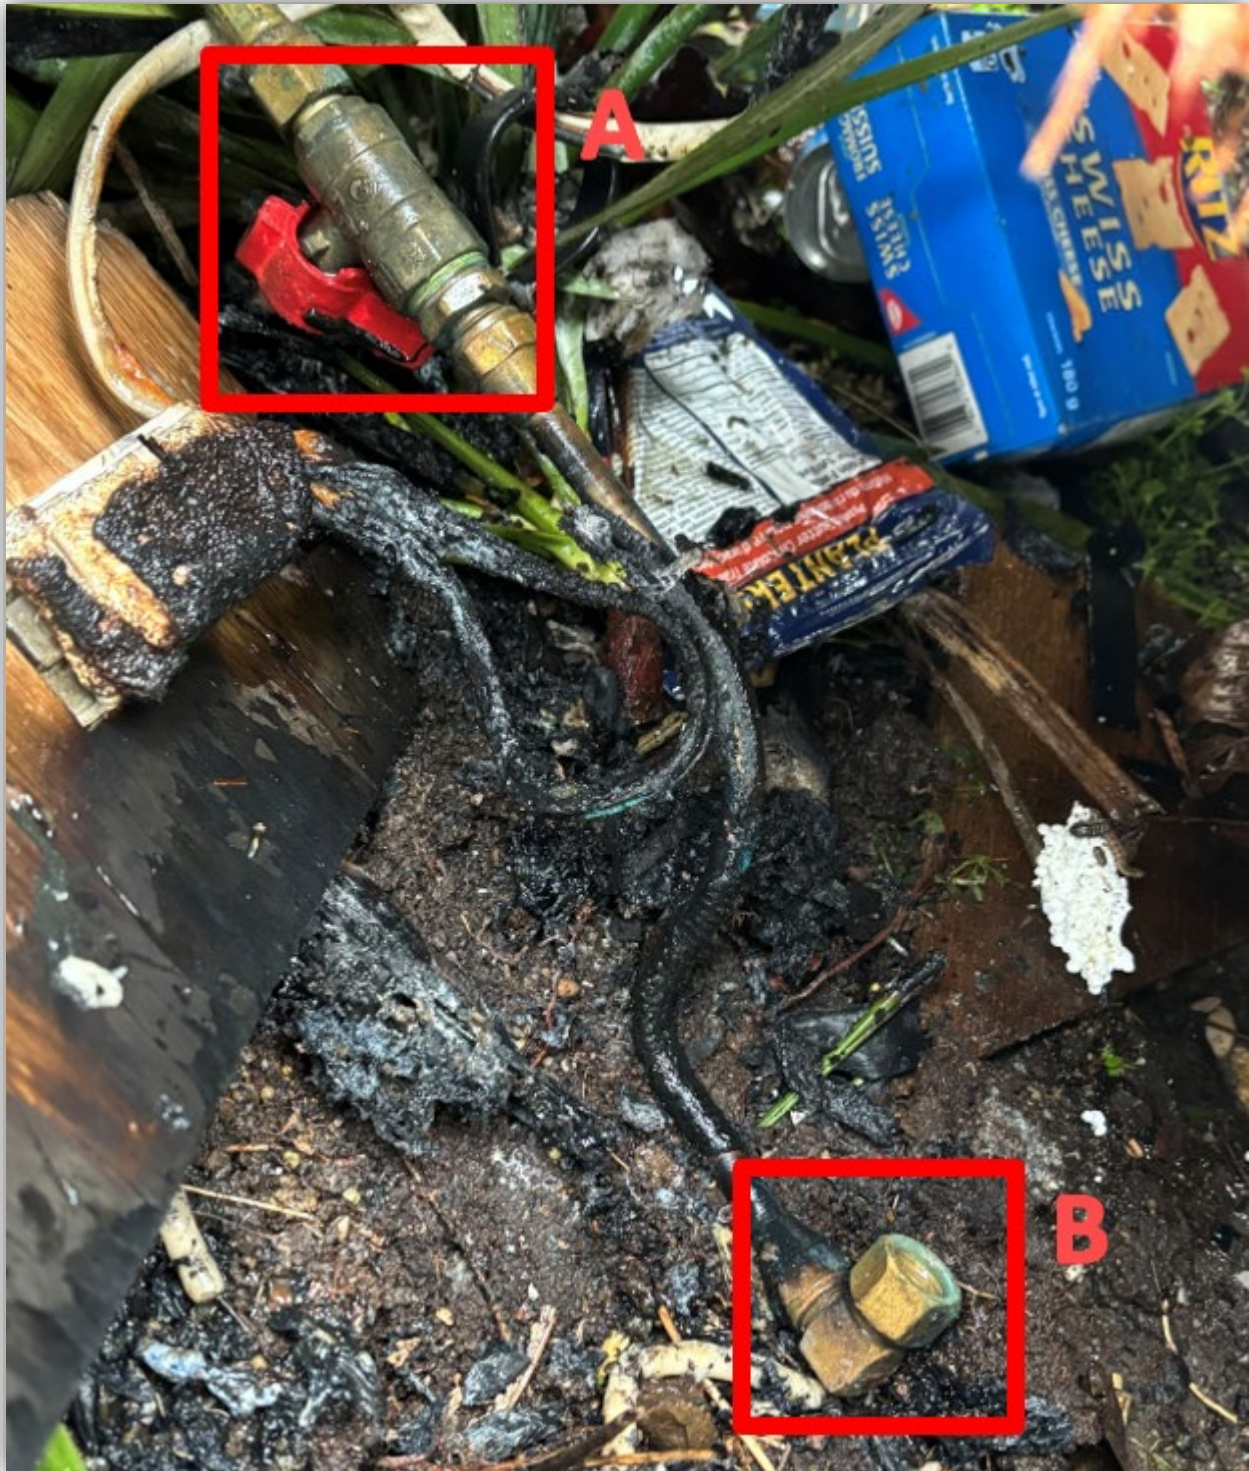
The RV's original refrigerator, which could be run on either electricity or propane, had stopped working and was removed. It was replaced with an electric-only, plug-in apartment-style refrigerator, installed in a different indoor location on the opposite side of the RV and plugged into a wall outlet. When the original refrigerator was removed, the gas supply line to it was disconnected, and a flexible rubber gas hose was left in the same space. The space previously occupied by the refrigerator was then used by the occupant for pantry storage (e.g., cookware and food items). At the end of the gas hose was a closed shut-off valve and a short section of copper tubing with a female flare fitting and nut. The corresponding male flare plug was nearby but had not been installed, leaving the end of the gas line open.

Image 8 – Original fridge gas line with partially open gas valve (A) and unplugged end (B).

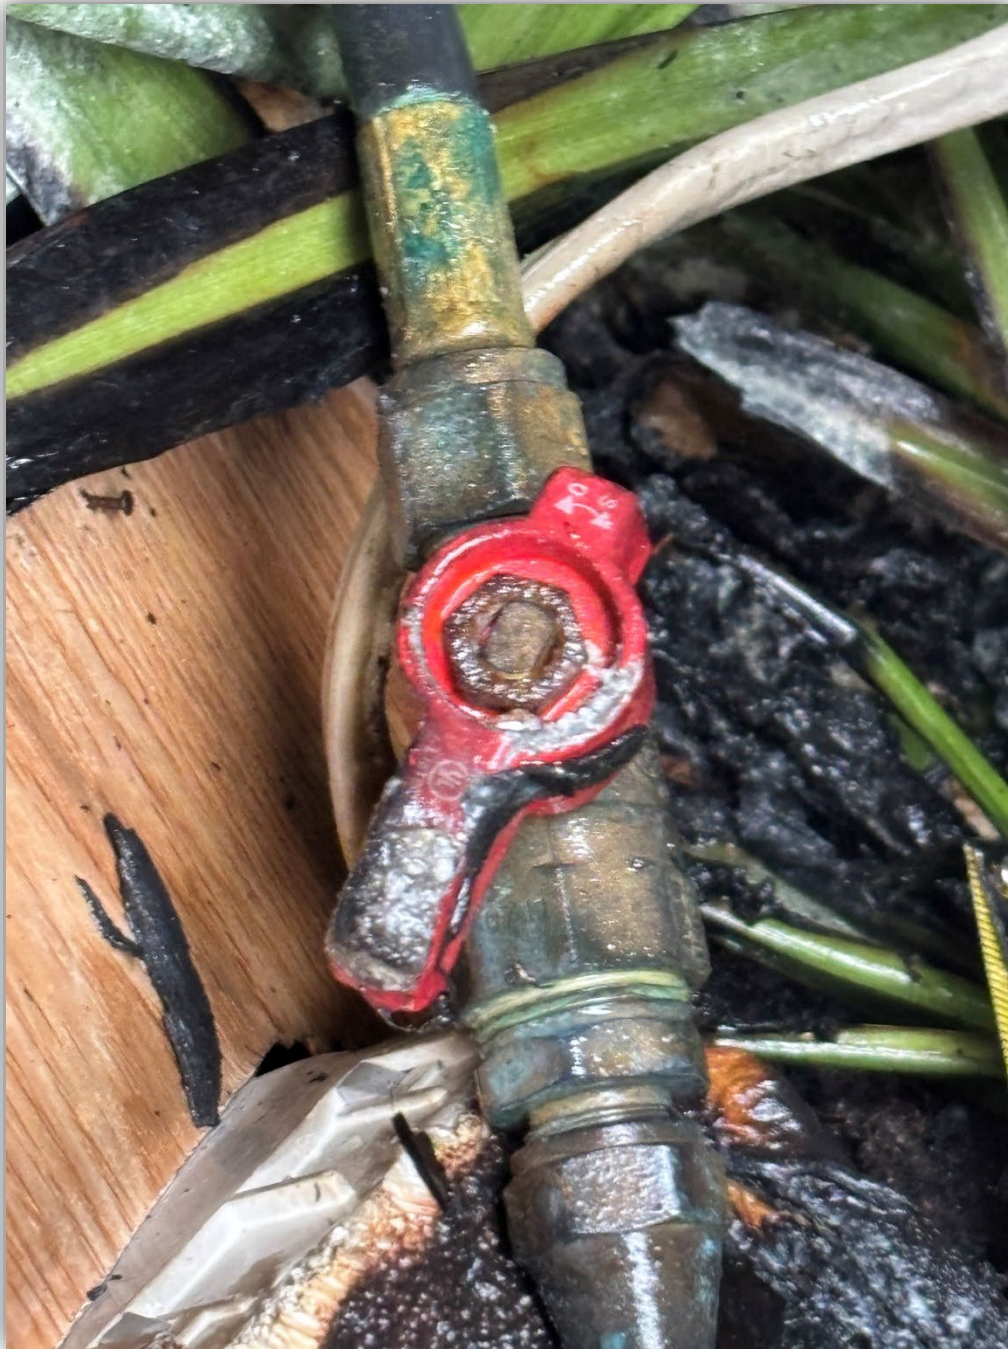
Image 9 – Close-up of the gas valve in the partially open position.

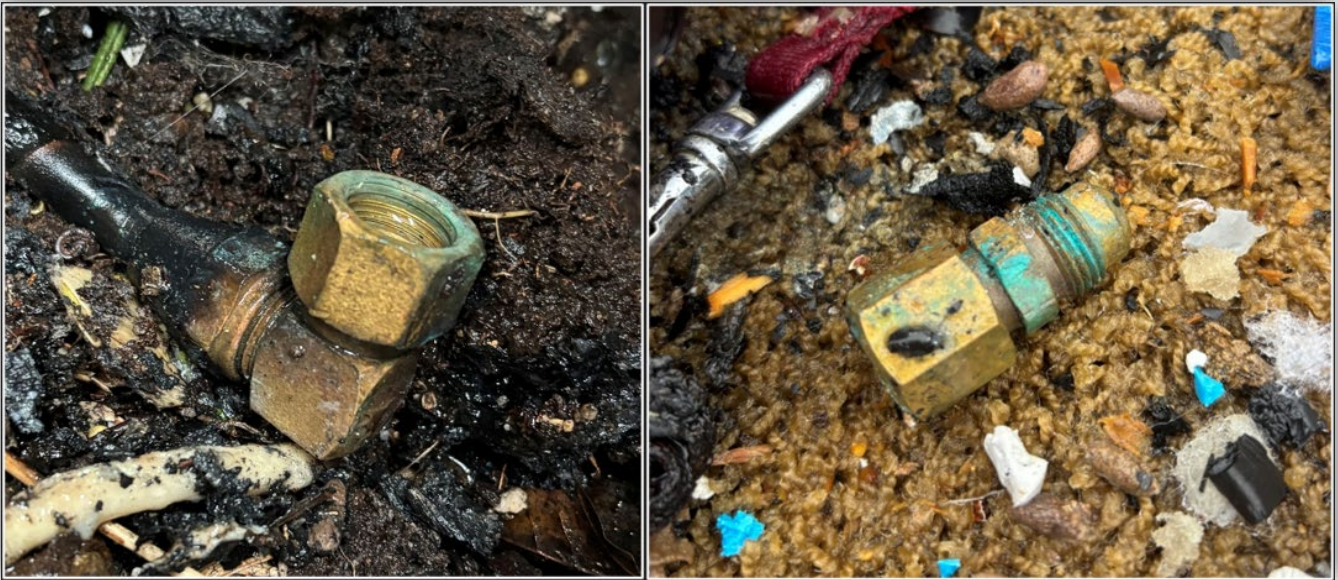
Image 10 – Closeup of unplugged gas line (Left) and gas line plug (Right) found in close proximity on the floor of the RV.

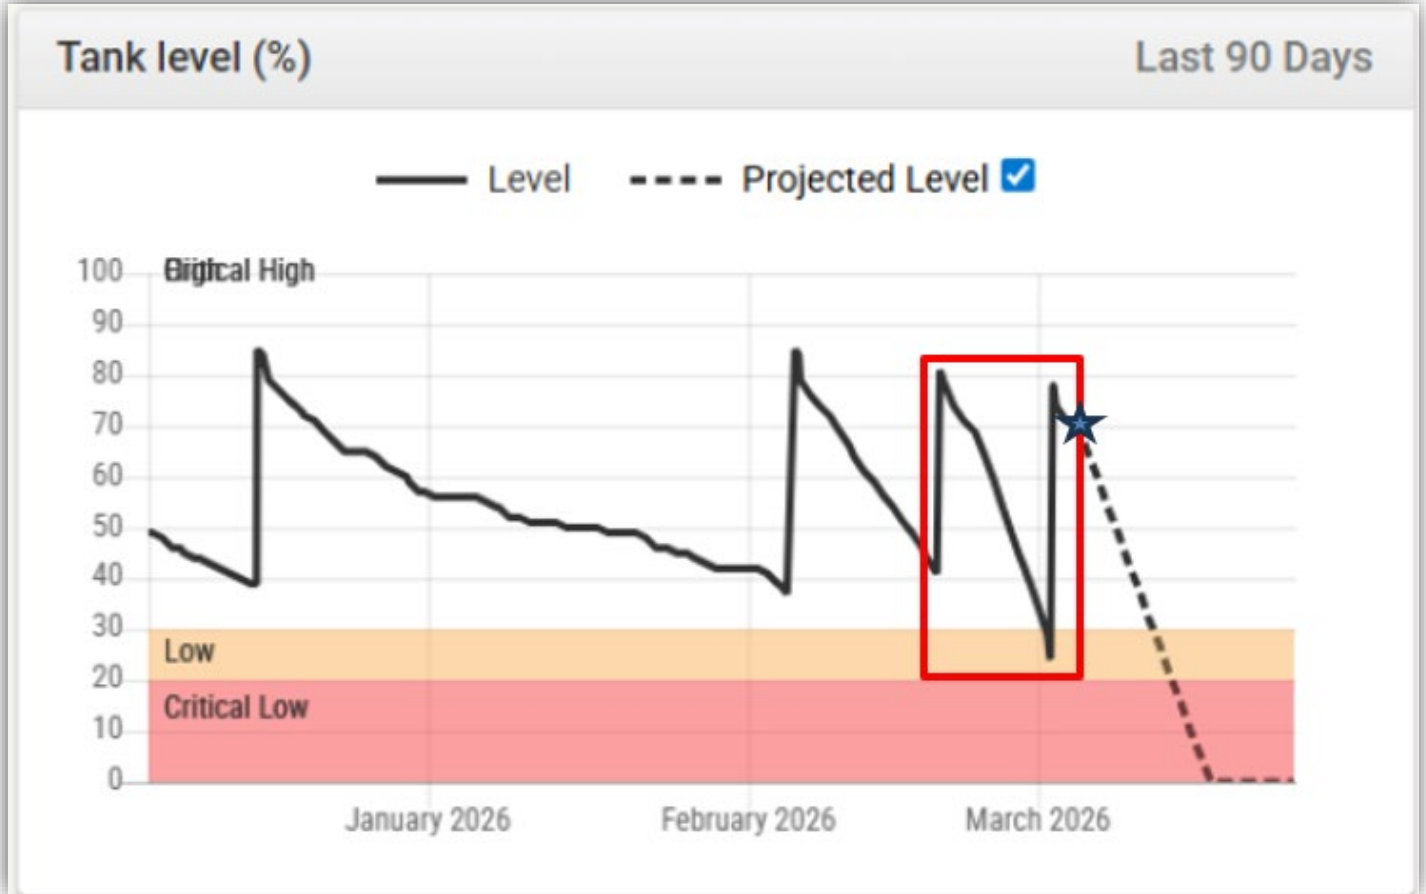
- The remote cylinder fuel level sensor identified the tank fuel level was at 24% at 4:30, the morning of the Incident and 78% at 10:47, following the fuel delivery.
- The propane delivery driver arrived at the site approximately 10:30, performed a visual inspection of the cylinder, and filled the tank from 24% to approximately 80% using the fixed liquid level gauge.
- During the entire delivery the driver did not notice anything abnormal or out of place that was a cause of concern.
- At no time did the delivery driver open or close the fuel supply service valve to the RV gas system during the delivery.
- The owner was not home at the time of the delivery, and the fuel delivery slip was left in the door of the RV.

Chart 1 – Tank remote fuel level sensor readings, highlighting the higher-than-average fuel consumption rate prior to the final fuel delivery on the day of the Incident. Star showing time of Incident (Dashed line is only a projection).

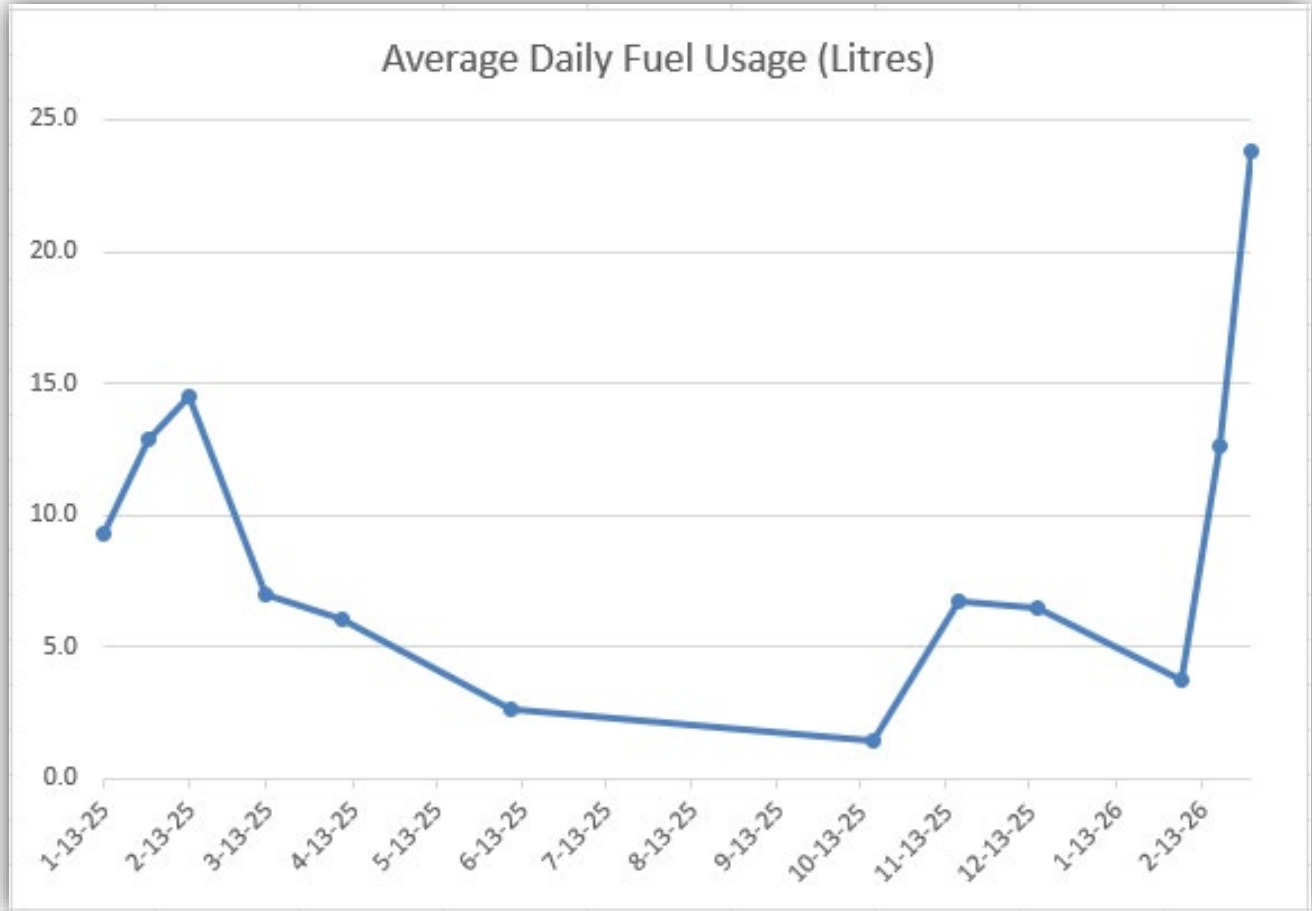
- Remote cylinder monitoring and fuel delivery documentation for the site reveals an overall average of 41.5 days between deliveries.
- For the same time period during the previous two years, the cylinder averaged 21.5 days between fuel deliveries, and fuel consumption averaged 10.27 litres per day.
- The last fuel delivery was on the morning of the Incident, 11 days after the previous fill. Gas consumption during that time averaged 23.8 litres per day, indicating an abnormal increase in fuel consumption in the days prior to the Incident.

Chart 2 – Average daily fuel usage in litres based on fuel delivery times and volumes.
