## Appendix B

# Delayed Ignition Testing

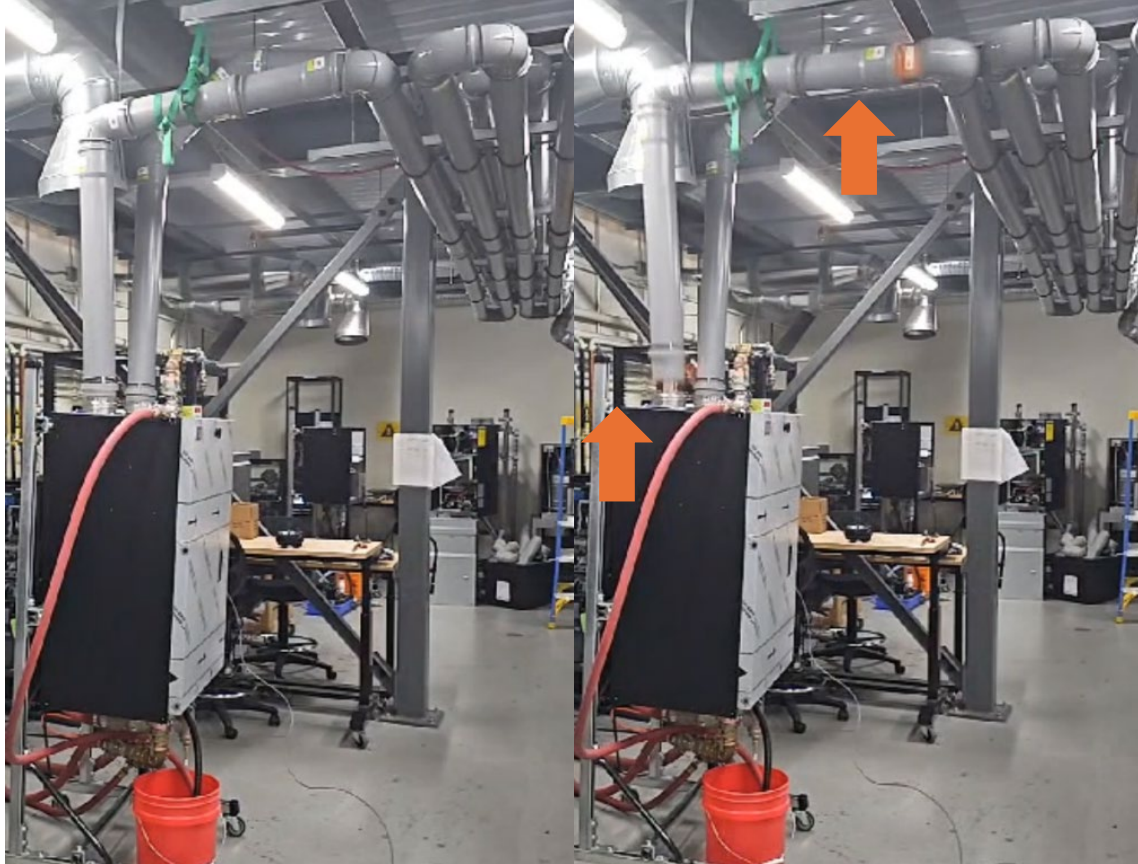
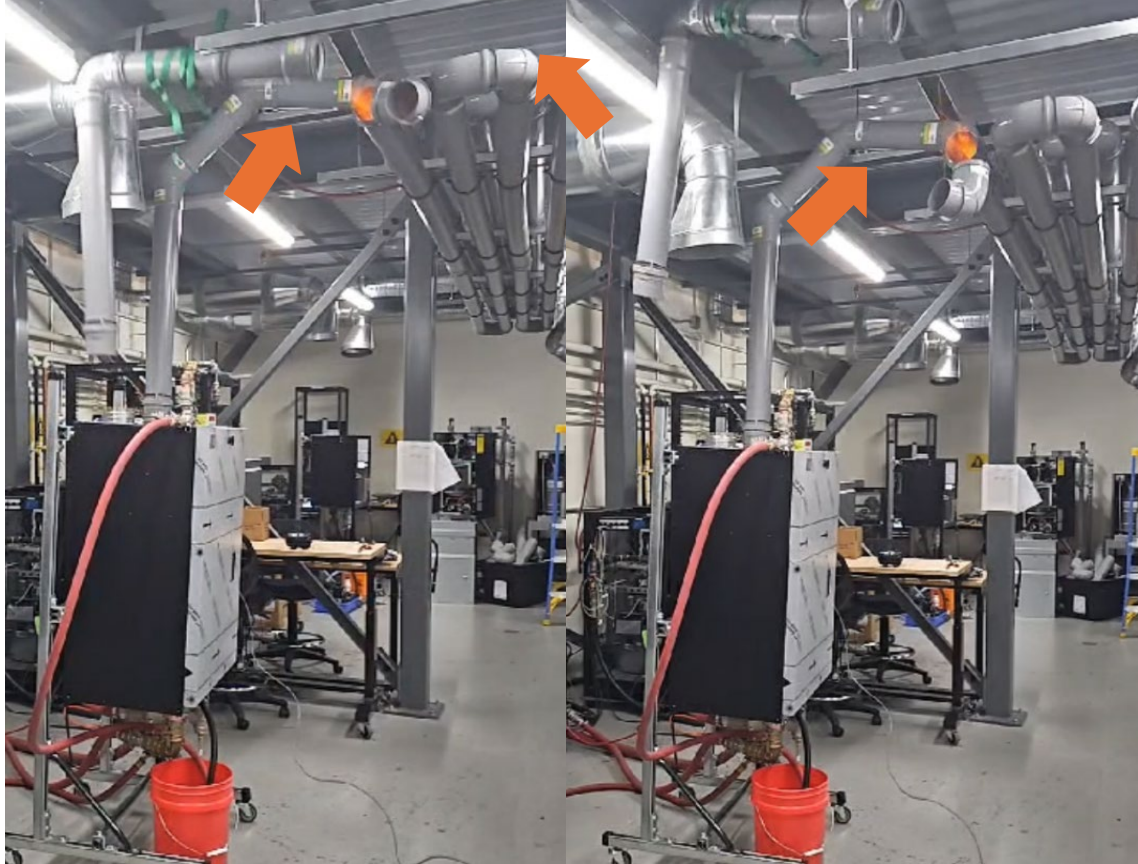
Image 5 – Test 2, showing the vent blown out of the boiler vent connector with 10 in-lb. of torque on the vent connector clamp and a 1.5-second arc-ignition delay.

Image 6 – Test 2, showing the vent blown out of the boiler vent connector with 10 in-lb. of torque on the vent connector clamp and a 1.5-second arc-ignition delay.

| Test number | Boiler vent connect or clamp torque (in-lb) | Delayed-ignition time (seconds) | Results |
|---|---|---|---|
| 2 | 10 | 1.5 | Vent blown off at connector; vent joints moved approximately 1/8 to 1/4 inch; second 90-degree elbow blown off. |

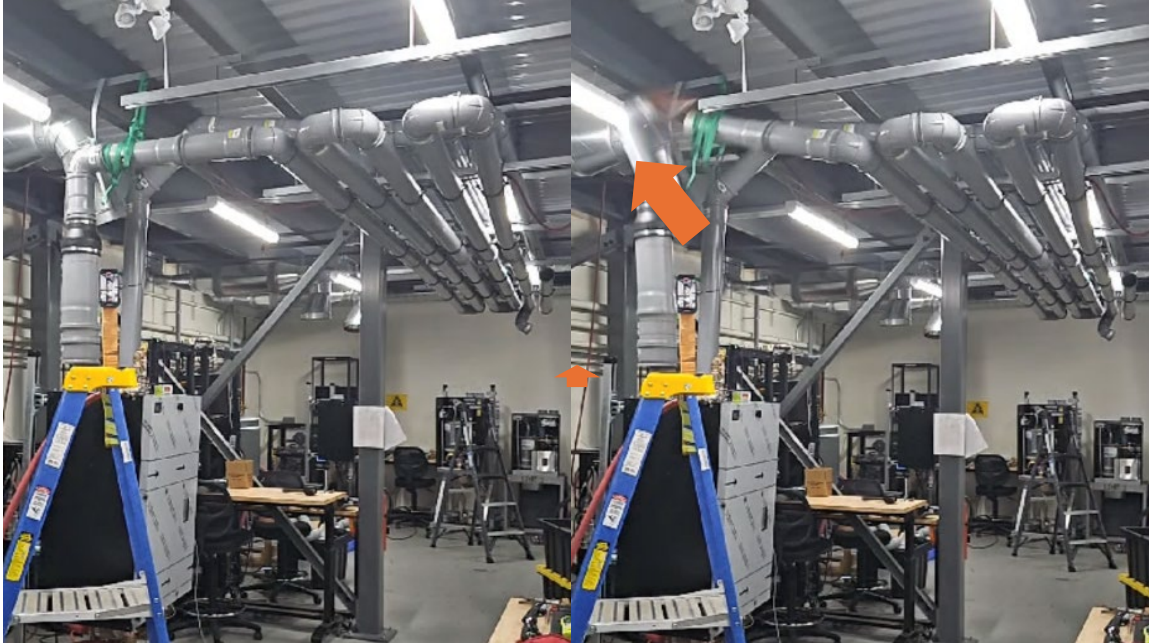
Image 7 – Test 10, showing the first 90-degree vent fitting blown off. The vent moved upward approximately  $\frac{3}{8}$  inch with 50 in-lb. of torque on the boiler vent connector clamp and a 2.5-second arc-ignition delay.

| Test number | Boiler vent connect or clamp torque (in-lb) | Delayed-ignition time (seconds) | Results |
|---|---|---|---|
| 10 | 50 | 2.5 | Vent connector moved approximately 3/8 inch; first, third, fourth, fifth, and sixth 90-degree elbows blown off. |

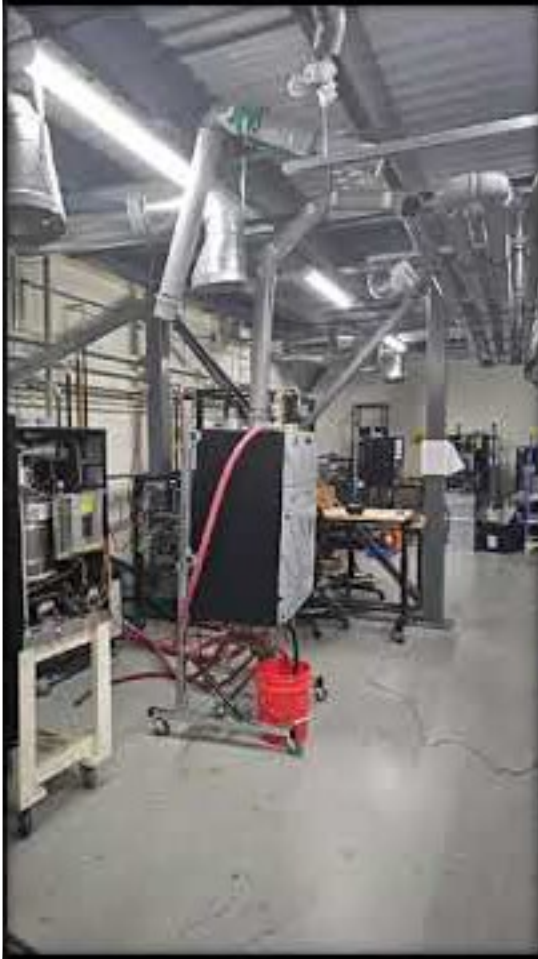
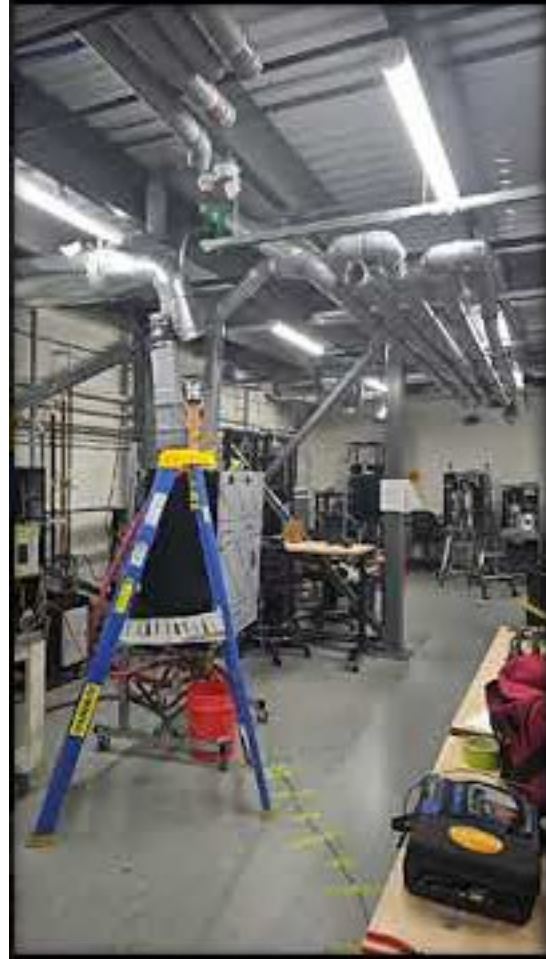
Video 1 – Catastrophic venting failure with a 1.0-second ignition delay. Video 2 – Catastrophic venting failure with a 2.5-second ignition delay.

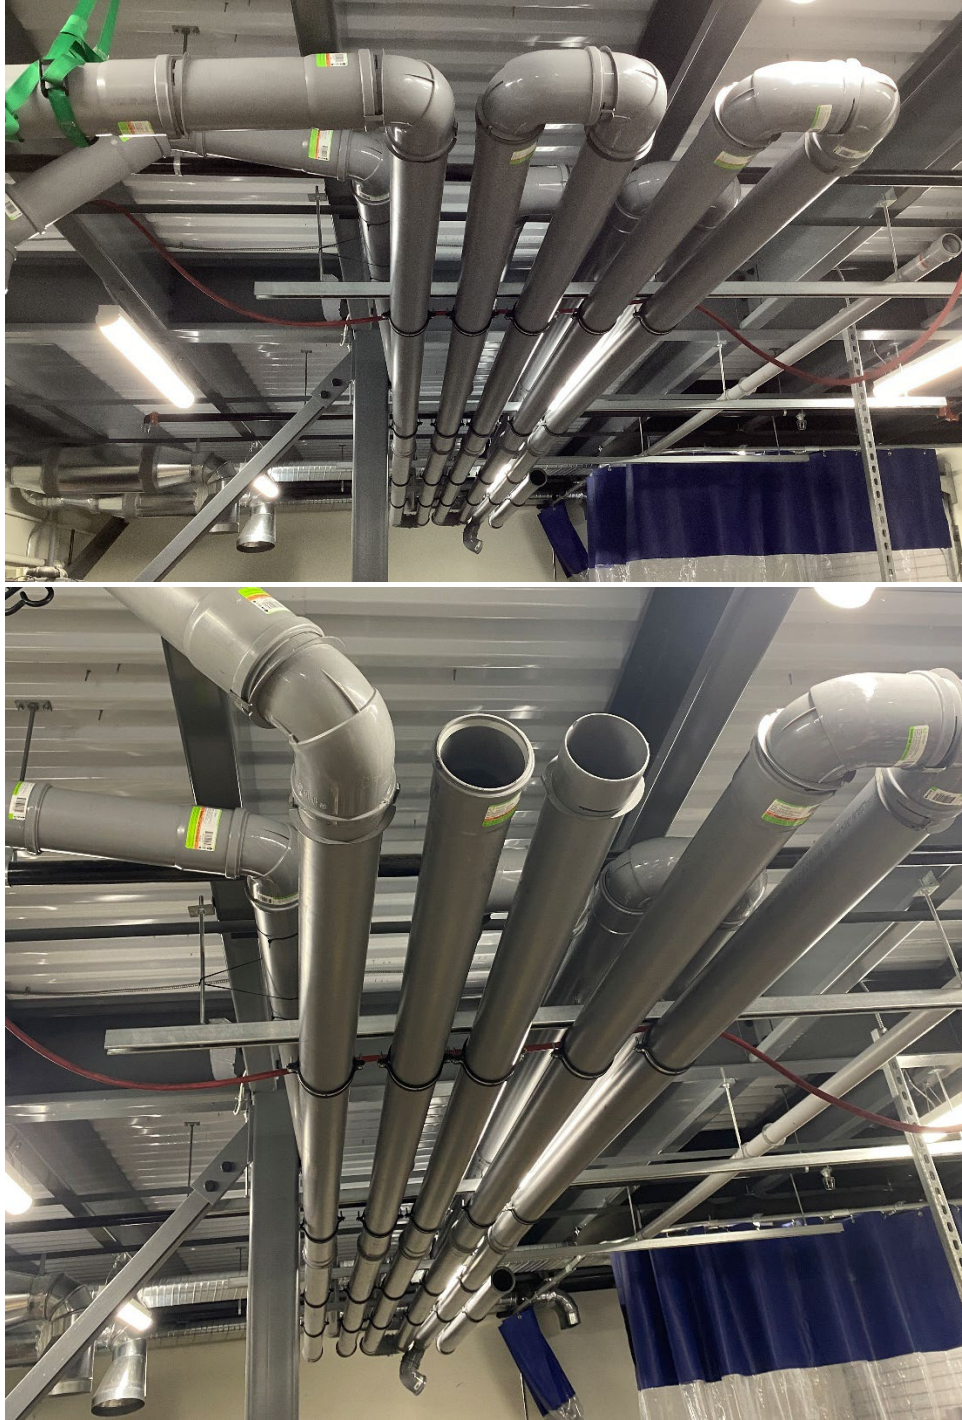
Image 8 – Boiler vent system before (top) and after (below) the 2.5-second delayed-ignition test.

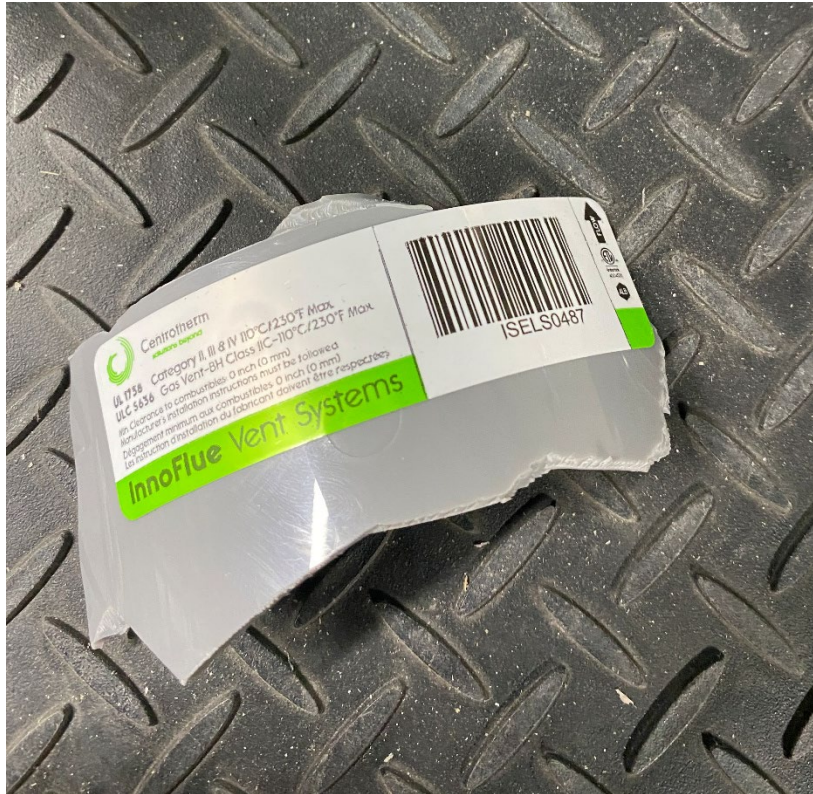
Image 9 – Broken piece of a vent elbow after it was propelled against the laboratory wall during a 2.5-second delayed ignition.
