Incident Summary (Reference #5605195)

SUPPORTING INFORMATION	Incident Date		September 13, 2016	
	Location		White Rock	
	Regulated industry sector		Natural gas system and low voltage electrical system (30V to 750V)	
	Impact	Injury	Qty injuries	1
			Injury description	A furnace installer received first and second degree burns to the left side of his face and his left arm.
			Injury rating	Moderate
	Damage		Damage description	Fire damage to the gas piping system, new furnace, and fire and arcing damage to a receptacle and cover plate. Extensive fire and smoke damage to the basement of a house.
			Damage rating	Major
	Incident rating		Major	
Incident overview		A fire occurred during a furnace replacement installation for a house. A heating contractor’s installer was performing gas and electrical work at the time of the incident. Natural gas entered the basement area and was ignited by an electrical arc causing the fire and resulting injuries to the installer.

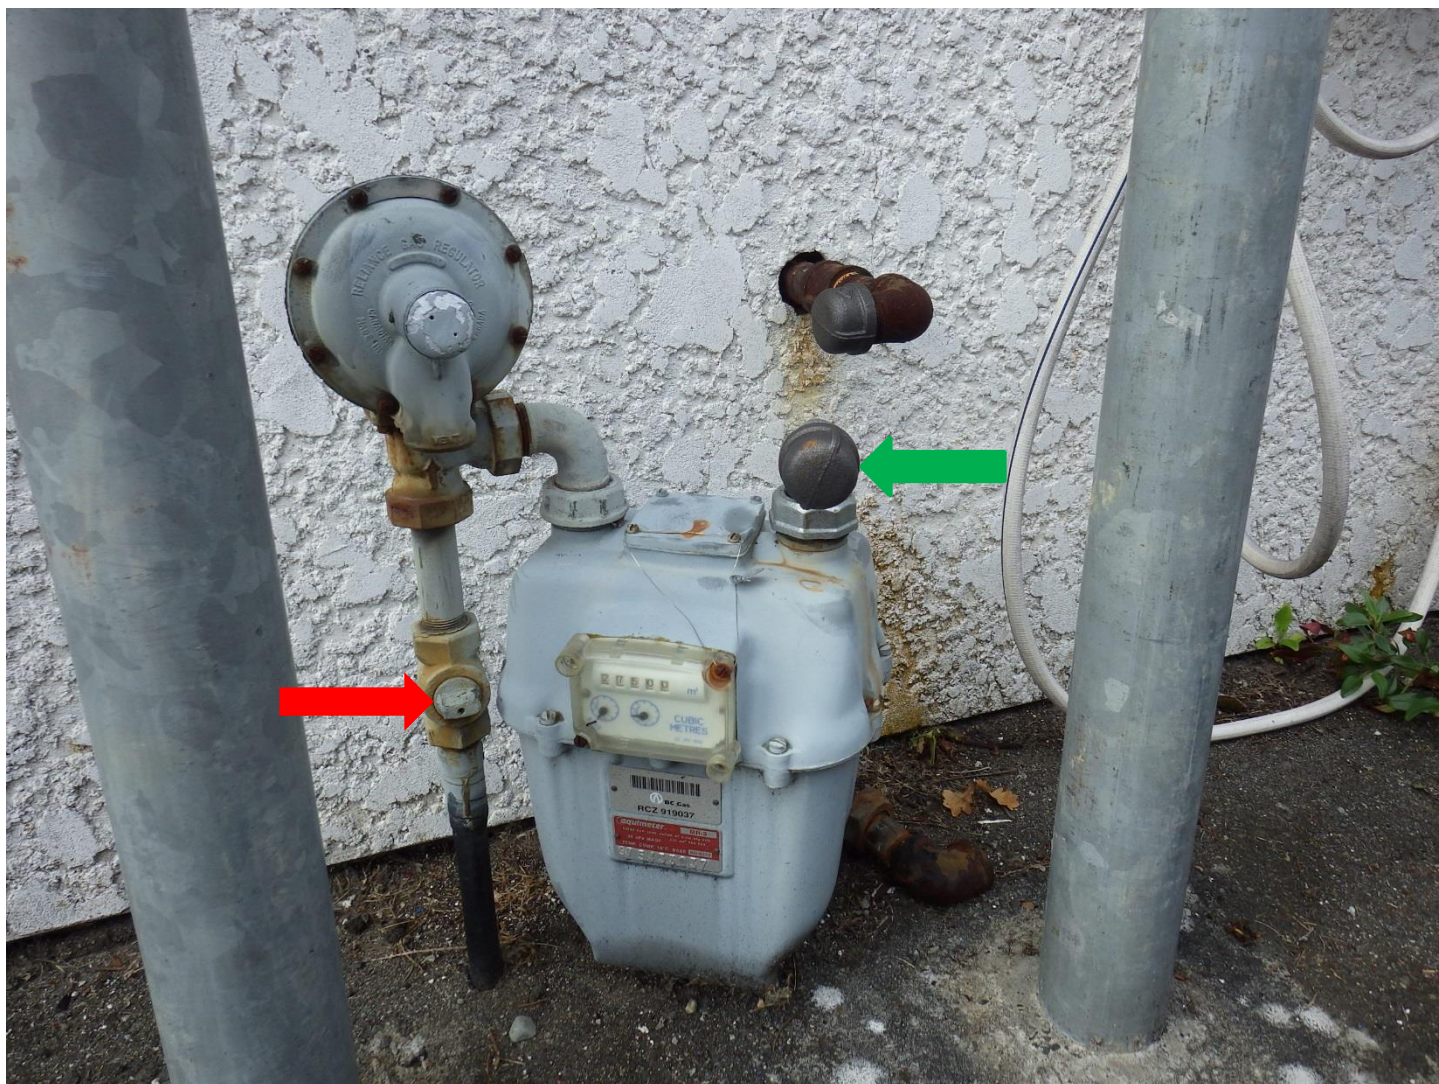
Figure 2

This photo shows the main gas valve at the meter that was turned off by the fire department at the time they attended the fire scene (see red arrow). The natural gas meter was disconnected from the house and capped off by the gas utility approximately a week after the incident occurred (see green arrow).

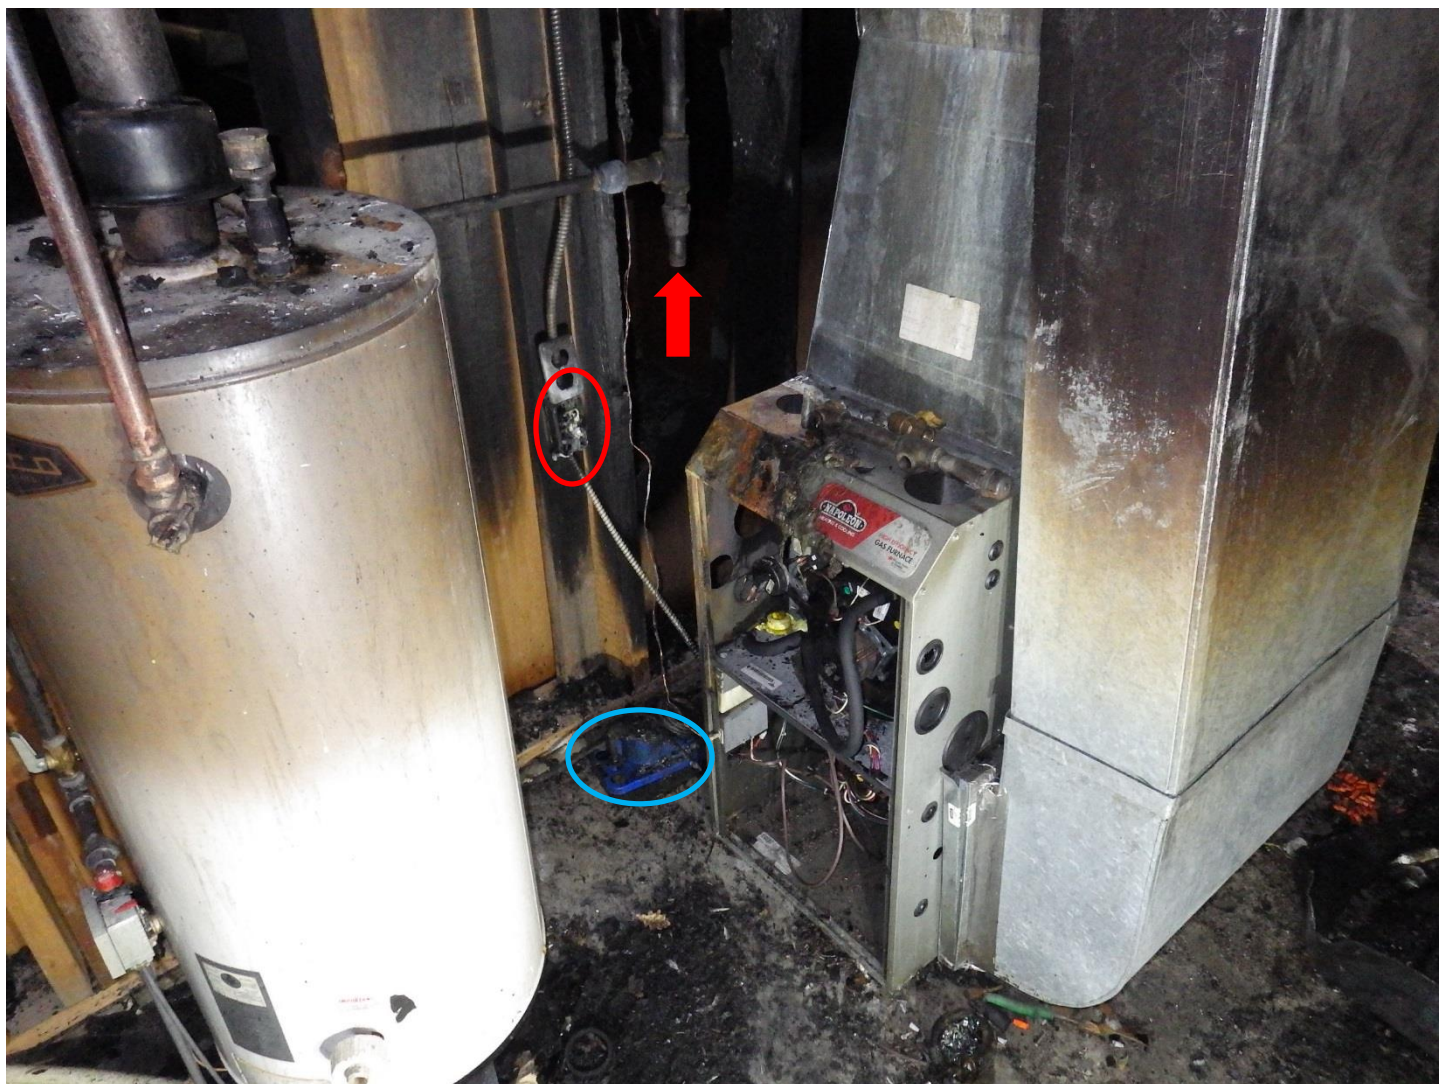
Figure 4

This photo shows the new furnace in place and connected to the newly installed receptacle (see red oval). The gas pipe connection to the furnace was incomplete with the gas pipe open when the incident occurred (see red arrow). The condensate pump that was plugged into the receptacle at the time of the incident was sitting on the floor (see blue oval). The photo also shows the fire damaged wall adjacent to the furnace.

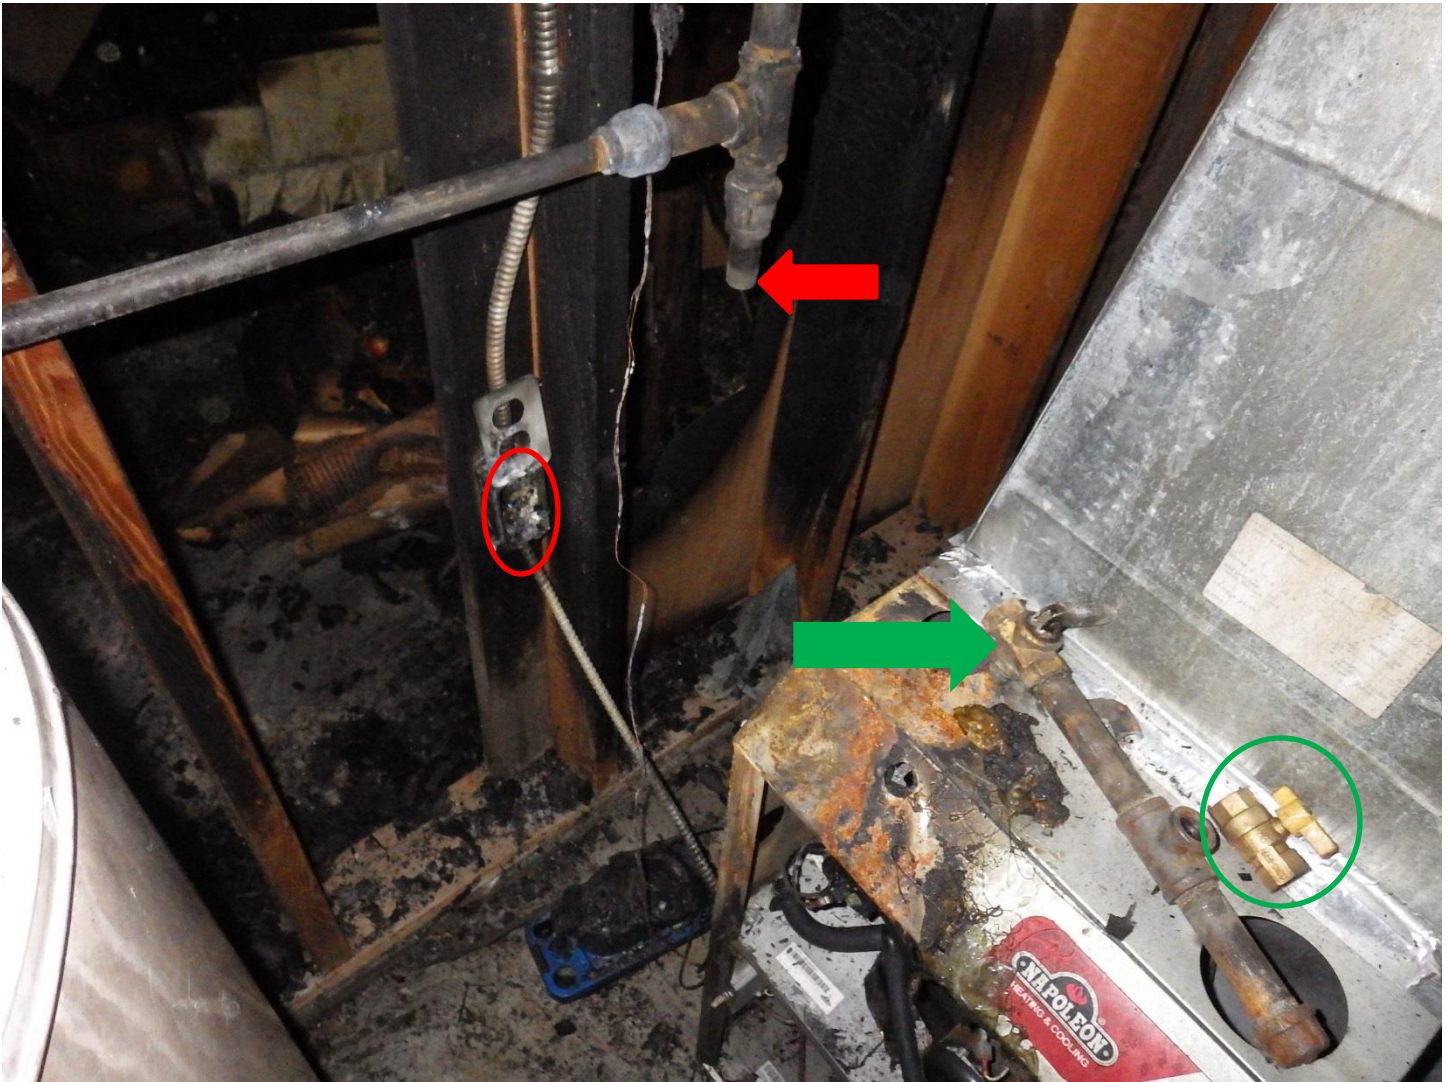
Figure 5

This photo shows the new furnace connected to the newly installed receptacle (see red oval). The gas pipe connection to the furnace was incomplete with the gas pipe open when the incident occurred (see red arrow). The green arrow shows the old furnace shut off valve and section of pipe that the installer removed which left the pipe open allowing gas to enter the basement. There was a new valve sitting on the new furnace (see green oval). The photo also shows the fire pattern on the studs and wood panelling adjacent to the furnace.

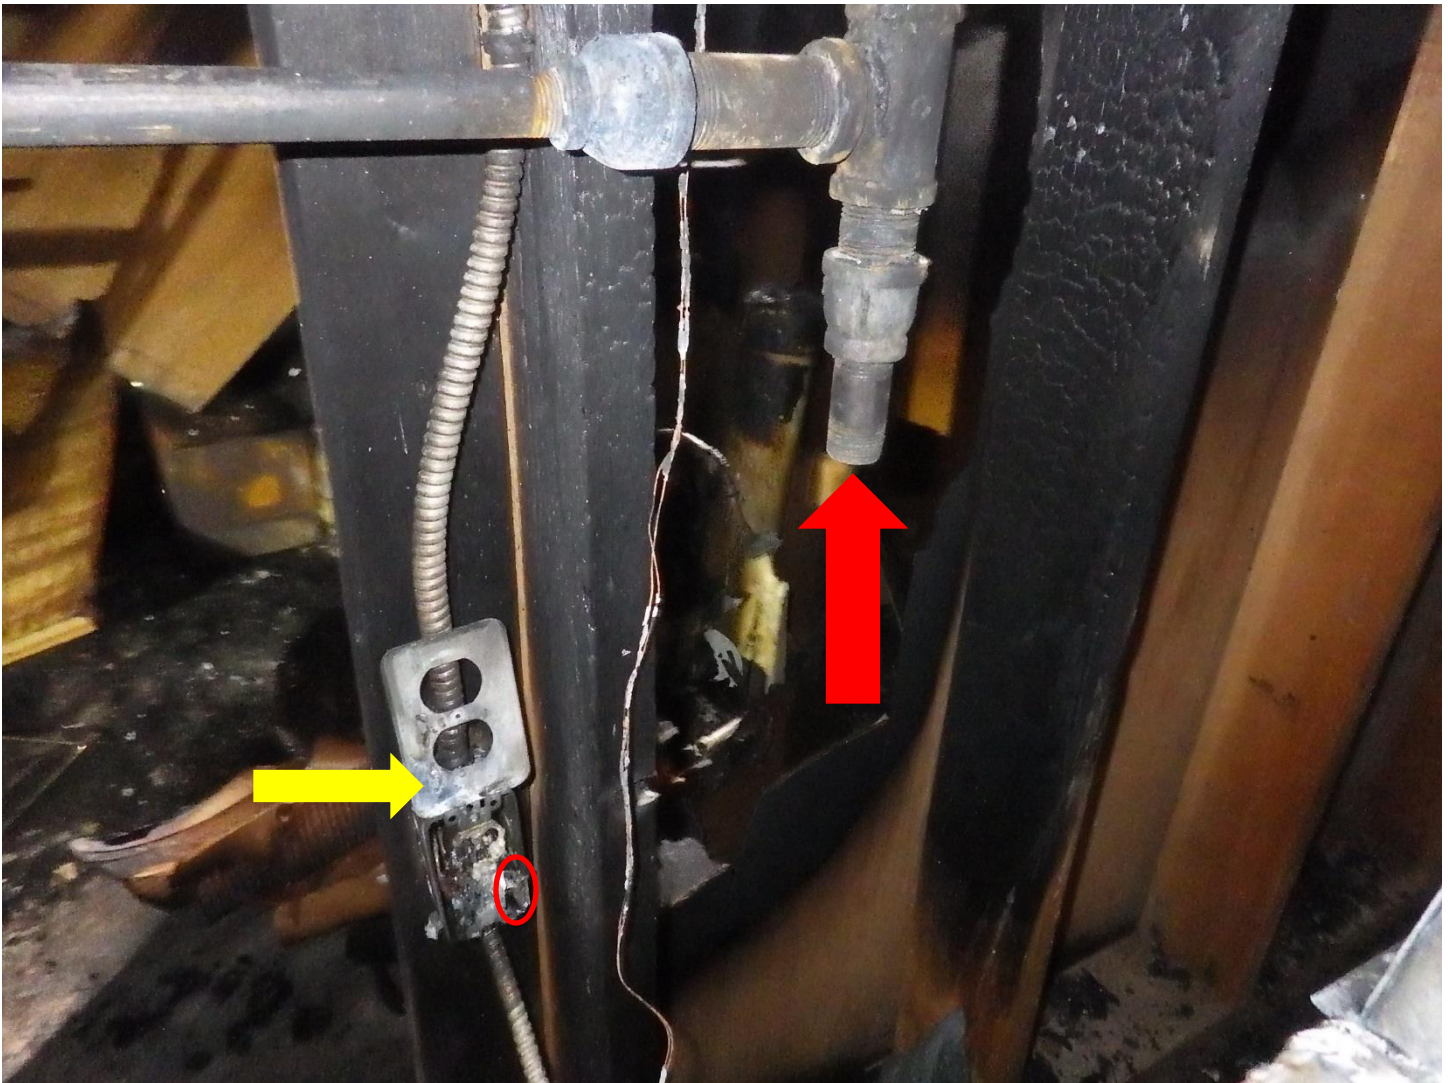
Figure 6

This photo shows the open gas pipe that allowed gas to enter the basement area prior to the incident (red arrow). It also shows the area on the receptacle where the electrical arc occurred (red oval) - this is the point of origin of the explosion/fire. The yellow arrow shows the arc damage on the back of the receptacle cover. The cover was removed from the receptacle and placed on top of the outlet box for the photo.

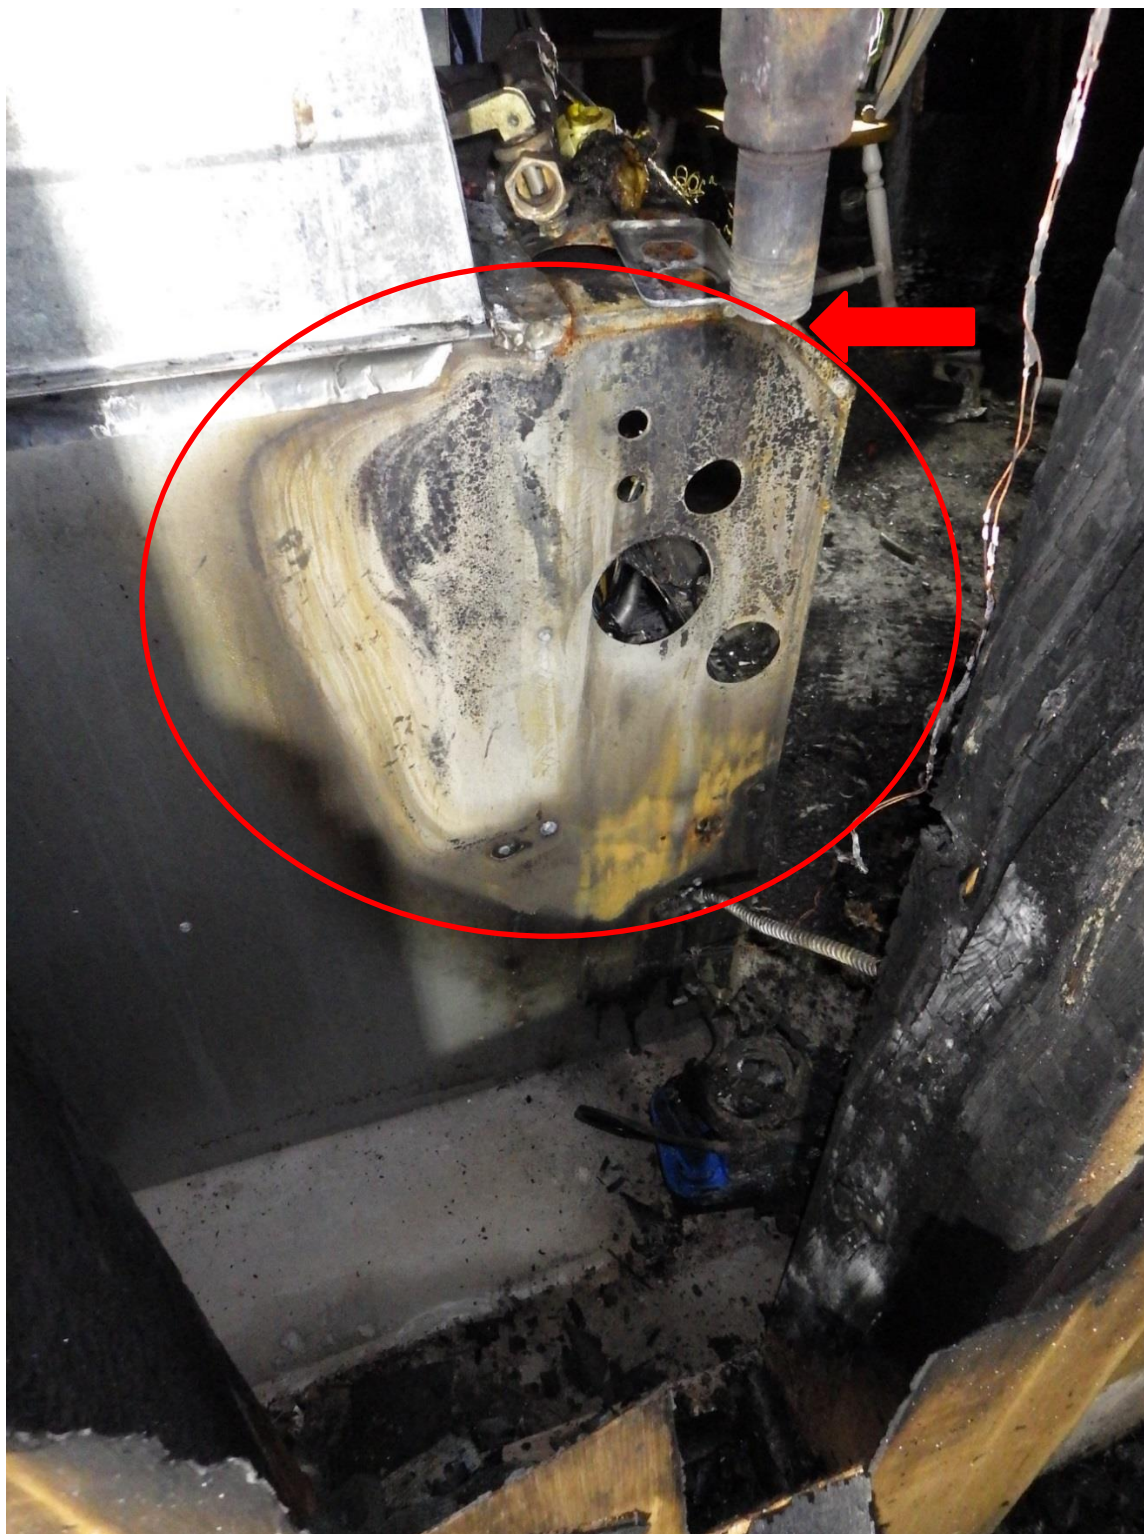
Figure 7

This photo shows the open gas pipe (red arrow) and the side of the furnace that was located adjacent to the wall. The fire pattern on the side of the furnace (red oval) is from the flame that was coming from the open gas pipe.

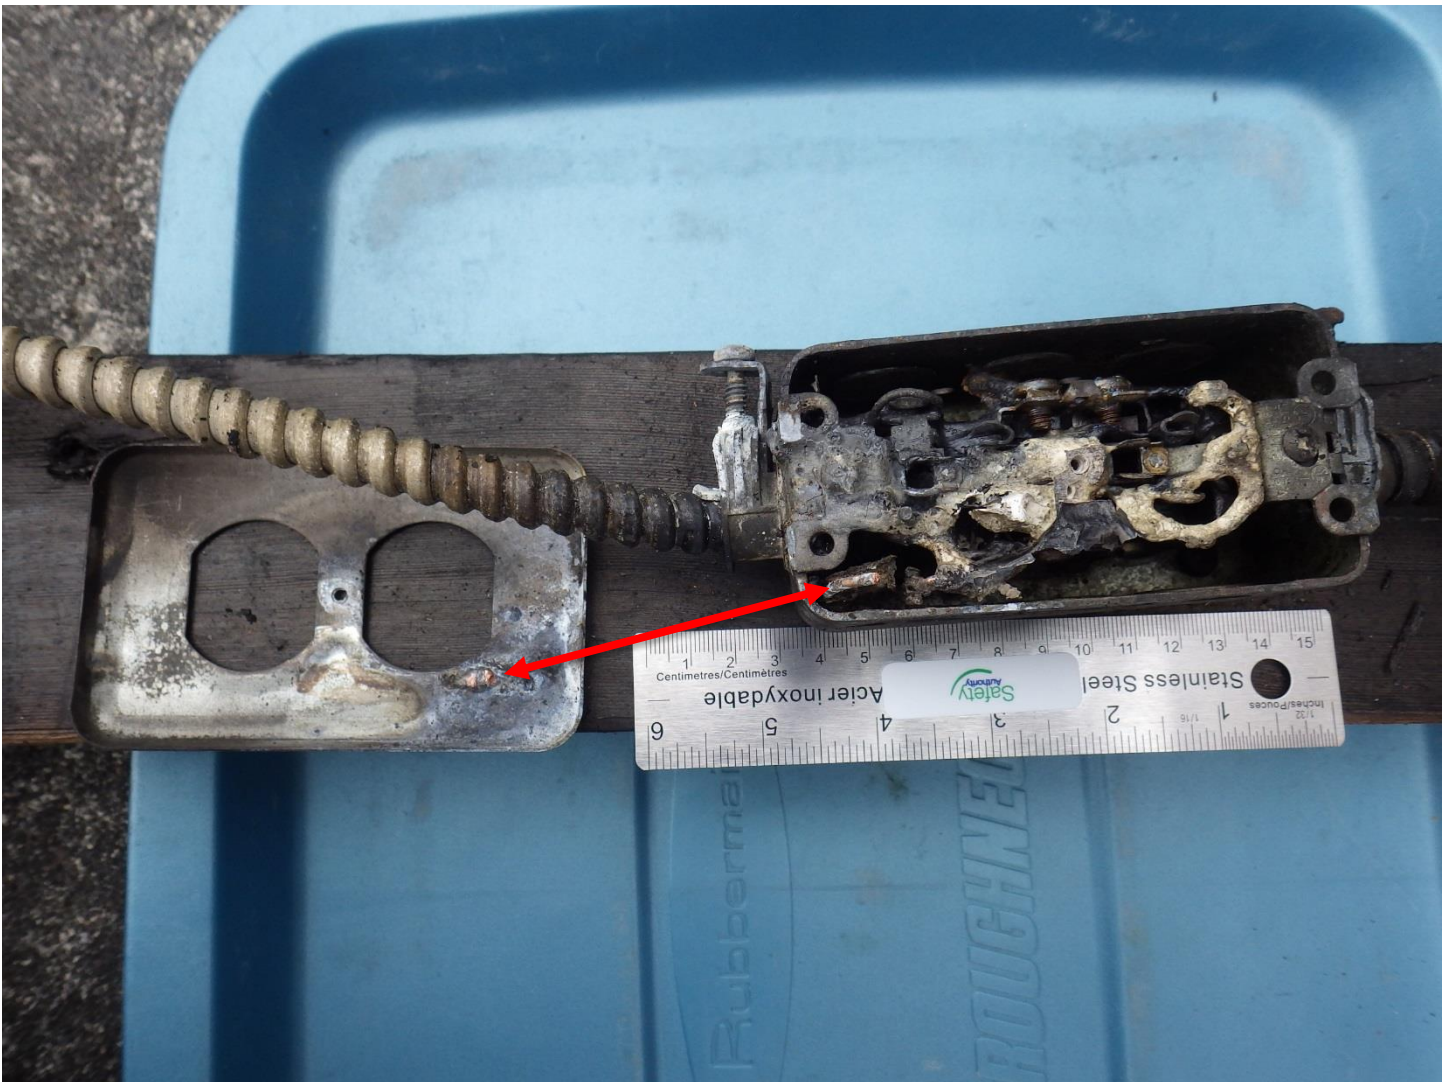
Figure 8

<p>with the cover plate and the uninsulated part of the conductor in close proximity to the metal cover plate. See figures 8, 10, 12 and 13.</p> <ul style="list-style-type: none"> - The damaged #12 gauge copper conductor was terminated on the screw terminals on the receptacle. The conductor was from the armoured cable that ran from the bottom of the outlet box to the connection at the furnace. See figures 5, 8, 10, 12 and 13. - The conductor had arced to the extent that it burned apart and was detached from the receptacle about 1-1/4 inches from the receptacle termination point. See figures 8, 10, 12 and 13. - The metal cover plate had arcing on it that was extensive enough to show through the metal cover plate to the front of the cover. This was a large sustained electrical arc that would have produce a significant amount of heat and a significant visible flash. It is unknown why the circuit breaker did not trip to prevent this type of arcing. See figure 11. - The existing branch circuit from the panel to the furnace was a 2 conductor #14 gauge copper non-metallic sheathed cable (15A, 120V branch circuit). Due to the fire damage the circuit could not be traced back to the breaker. Some breakers in the panel appeared to be in the tripped position and some were in the off position. All 15A, 120V branch circuits in the panel appeared to be terminated onto 15A rated circuit breakers. See figure 17. - There were no Arc Fault Circuit Interrupter (AFCI) breakers in the panel. The furnace installer installed a new receptacle on an existing branch circuit for the condensate pump. The current electrical code required AFCI protection for the installation of a new receptacle on the existing circuit. See figure 17. <p>Other sources of ignition ruled out:</p> <ul style="list-style-type: none"> - The hot water tank adjacent to the furnace was in operation at the time of the incident. However the pilot light and burner were ruled out as the ignition source. In order for the hot water tank to be the ignition source the gas in the basement would have had to accumulate from the ceiling down filling the house which when ignited would have likely caused a very large deflagration and damage to the entire structure which was not the case. - The furnace pilot light was considered as an ignition source because the electrical wiring to the furnace was connected and energized at the time of the incident. This was ruled out because the front access panel of the furnace was removed which activated the safety switch to disconnect the power to the furnace. <p>No other competent ignition sources appeared to be present in the vicinity of the open gas pipe at the time of the incident.</p>

The conductor connected to the receptacle was in contact with the receptacle's metal cover plate indicating it was not properly installed onto the receptacle and not properly tucked into the outlet box to prevent damage to the conductor's insulation. The energized conductor contacted the bonded metal cover plate causing an electrical fault and the resulting electrical arc.

This photo shows the electrical outlet box, receptacle, and cover plate removed from the house for closer observation. The red arrows show the points between the conductor and the cover plate that contacted creating an electrical fault and the resulting electrical arc.

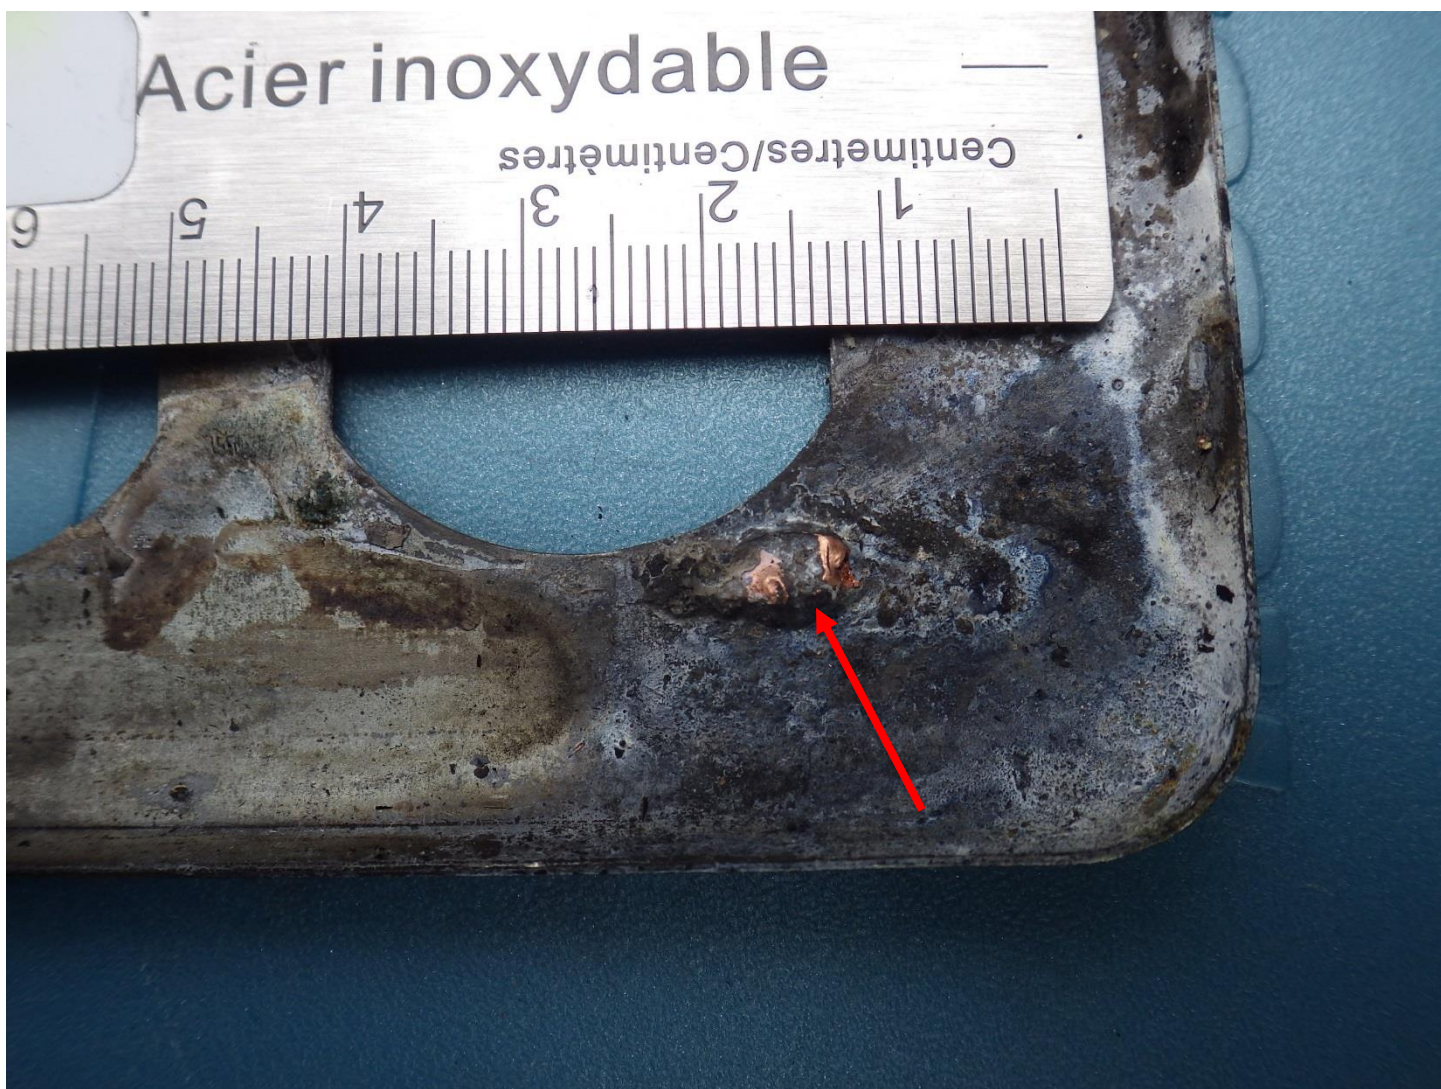
Figure 9

This photo shows a close up of the arc damage to the back of the cover plate. A piece of the copper conductor is melted to the cover plate.

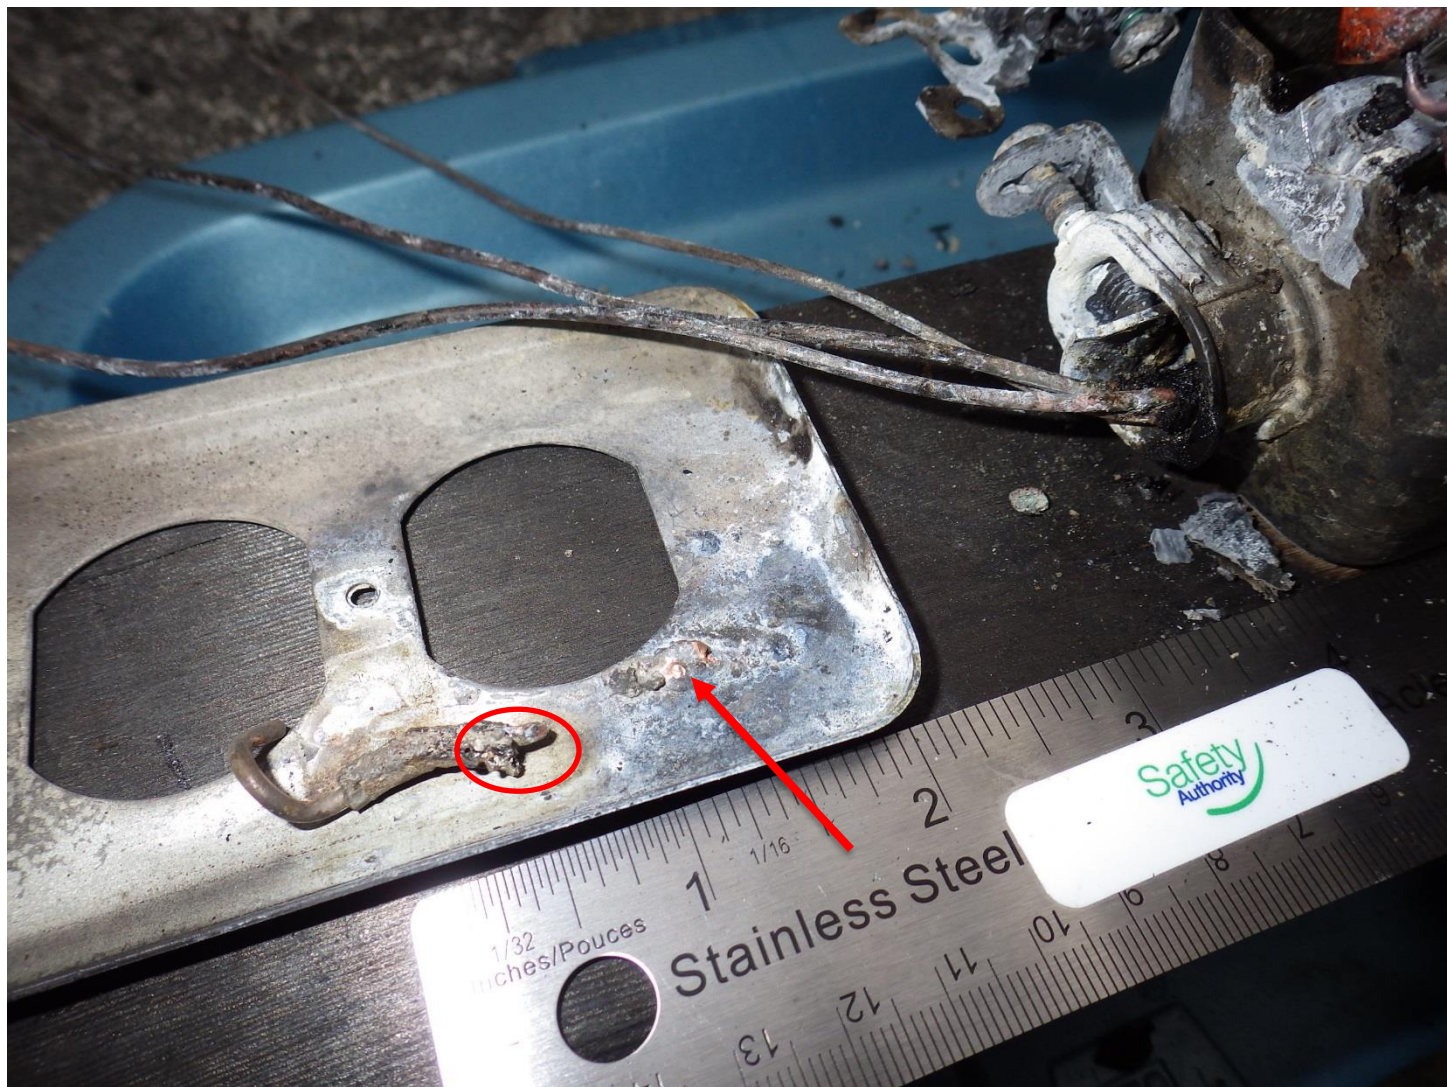
Figure 10

This photo shows the piece of conductor that was removed from the receptacle. The conductor arced to the point that it melted the copper conductor apart (see red oval). The copper material melted to the cover plate is part of what used to be the conductor (see red arrow).

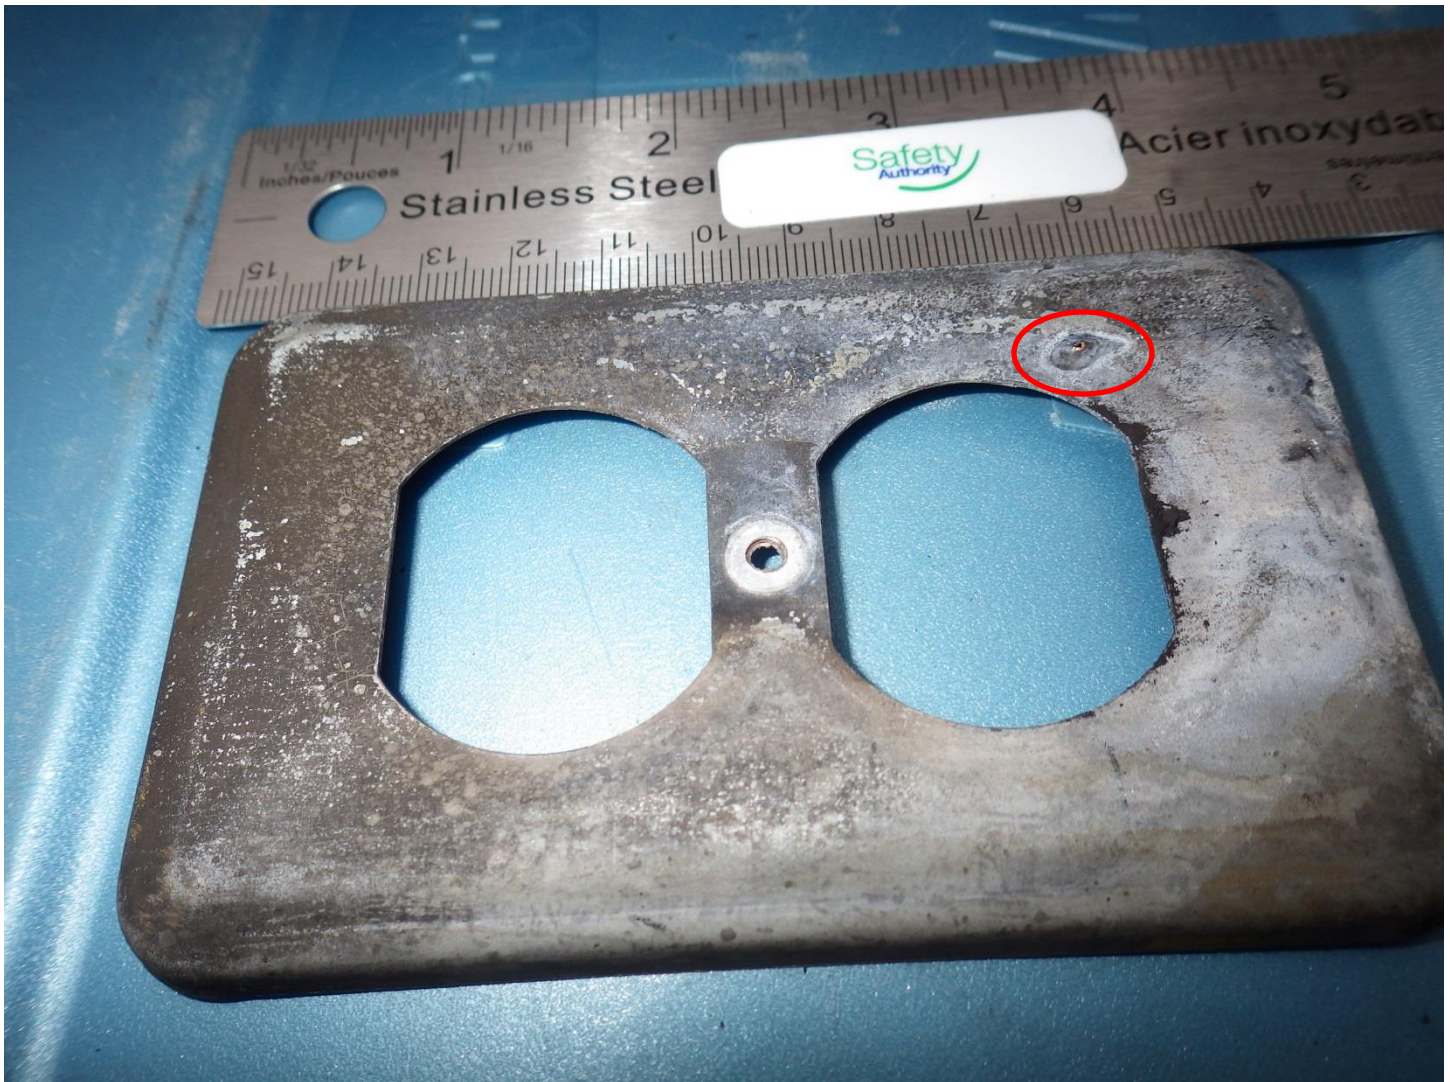
Figure 11

This photo shows the front of the cover plate in the location where the copper conductor contacted the back of the cover plate creating an electrical fault to ground and the resulting electrical arc that ignited the natural gas (see red oval).

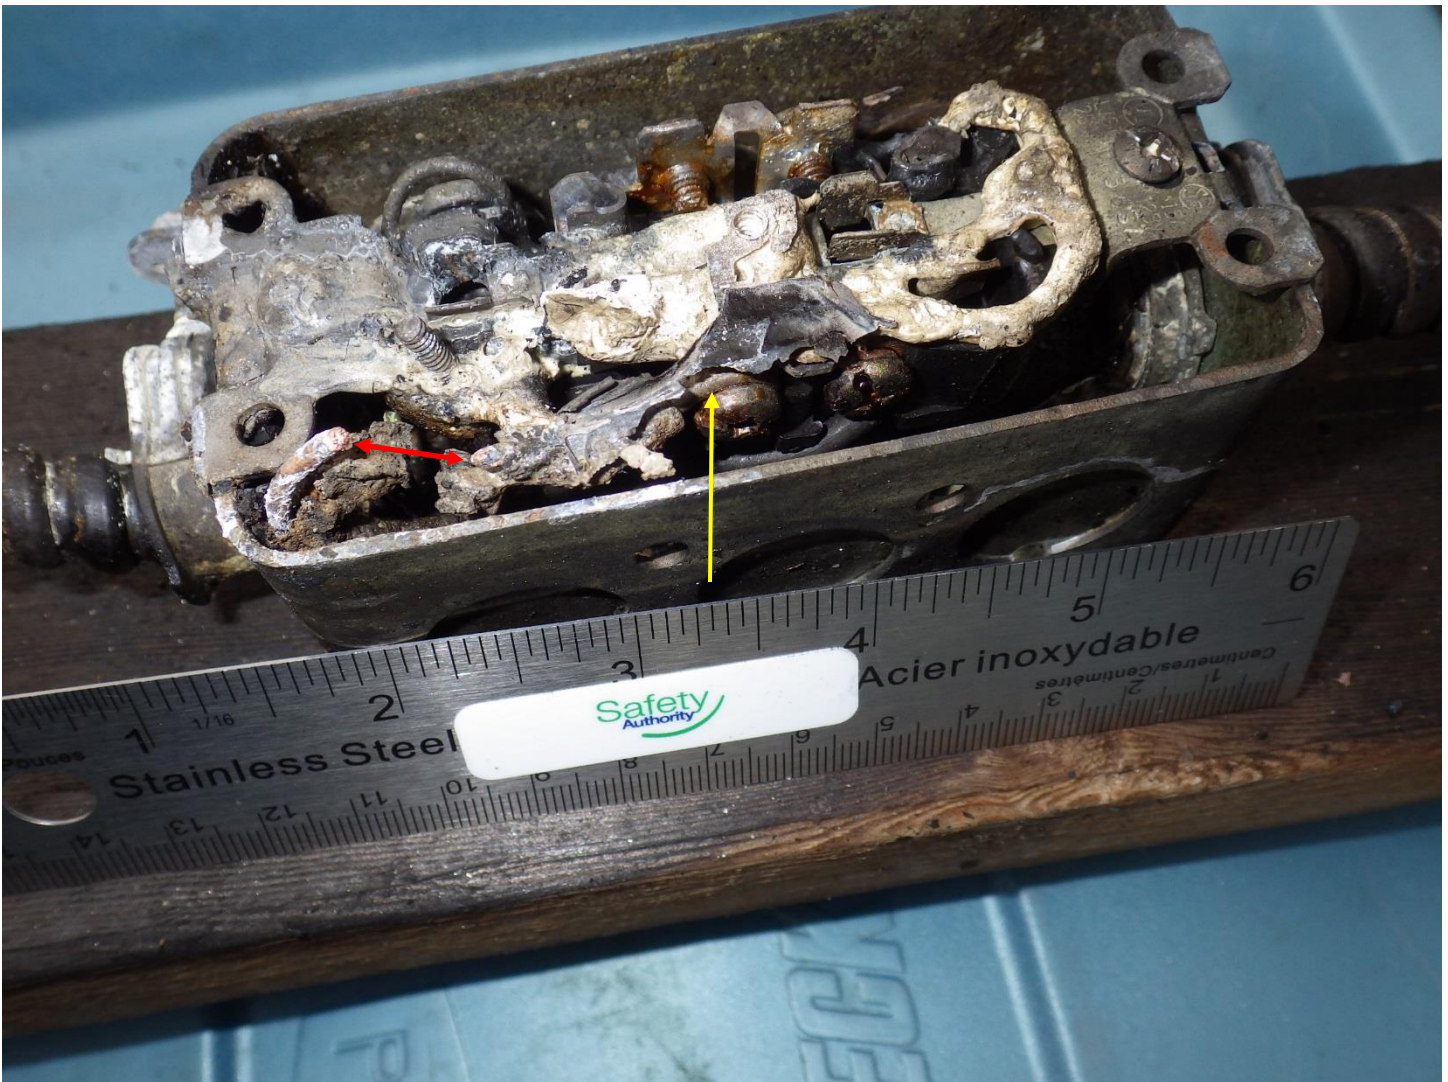
Figure 12

This photo shows the conductor for the receptacle melted apart (red arrows). The location of the conductor at the front of the receptacle indicates that it was not properly installed onto the receptacle or properly positioned in the outlet box prior to the cover being installed (see yellow arrow). The result was the energized conductor contacted the metal cover plate causing an electrical fault and the resulting electrical arc that ignited the gas. This is the point of origin of the fire.

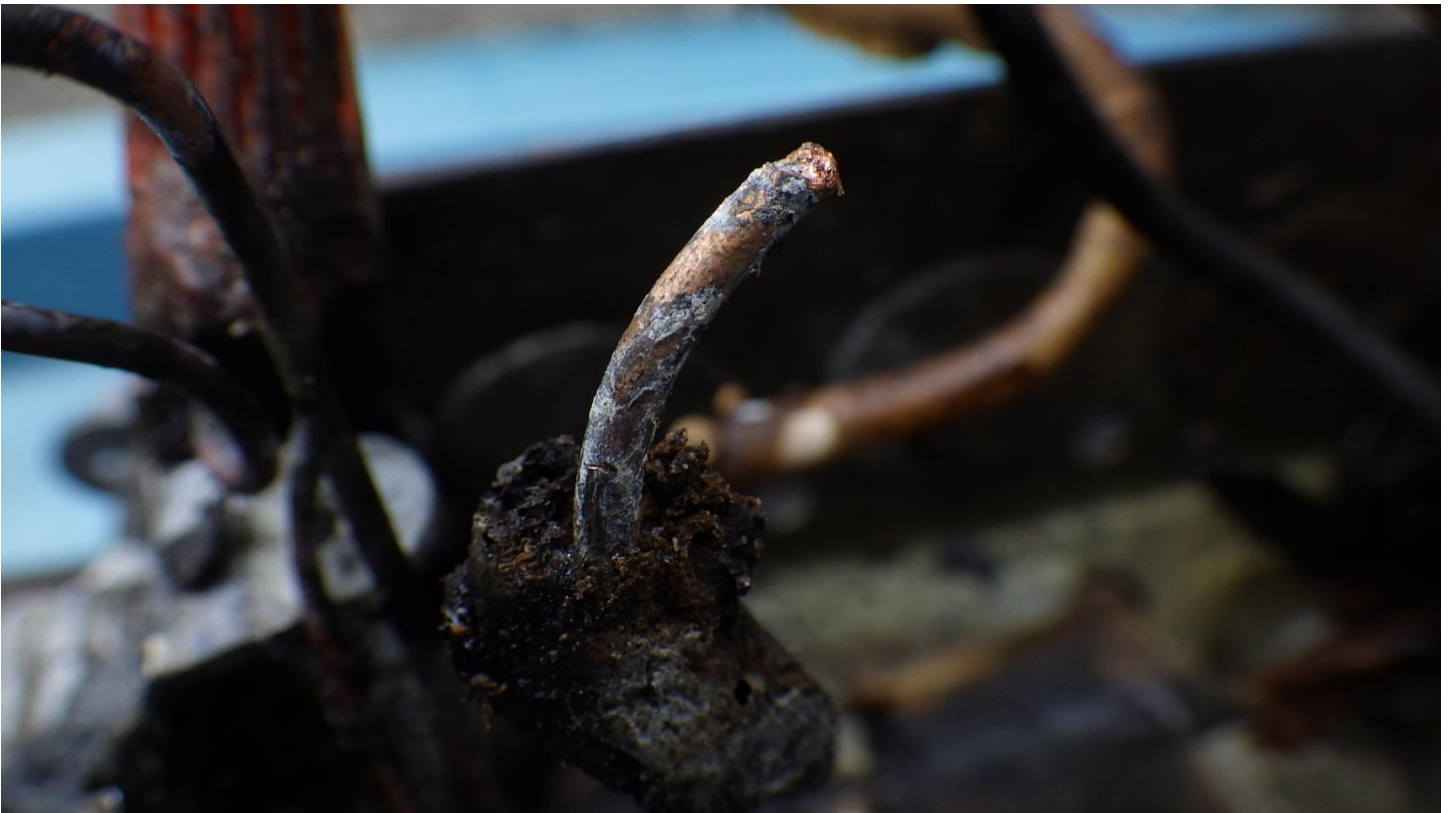
Figure 13

This photo shows one end of the energized conductor that contacted the metal cover plate and caused an electrical fault melting the conductor apart and causing the electrical arc that ignited the gas.

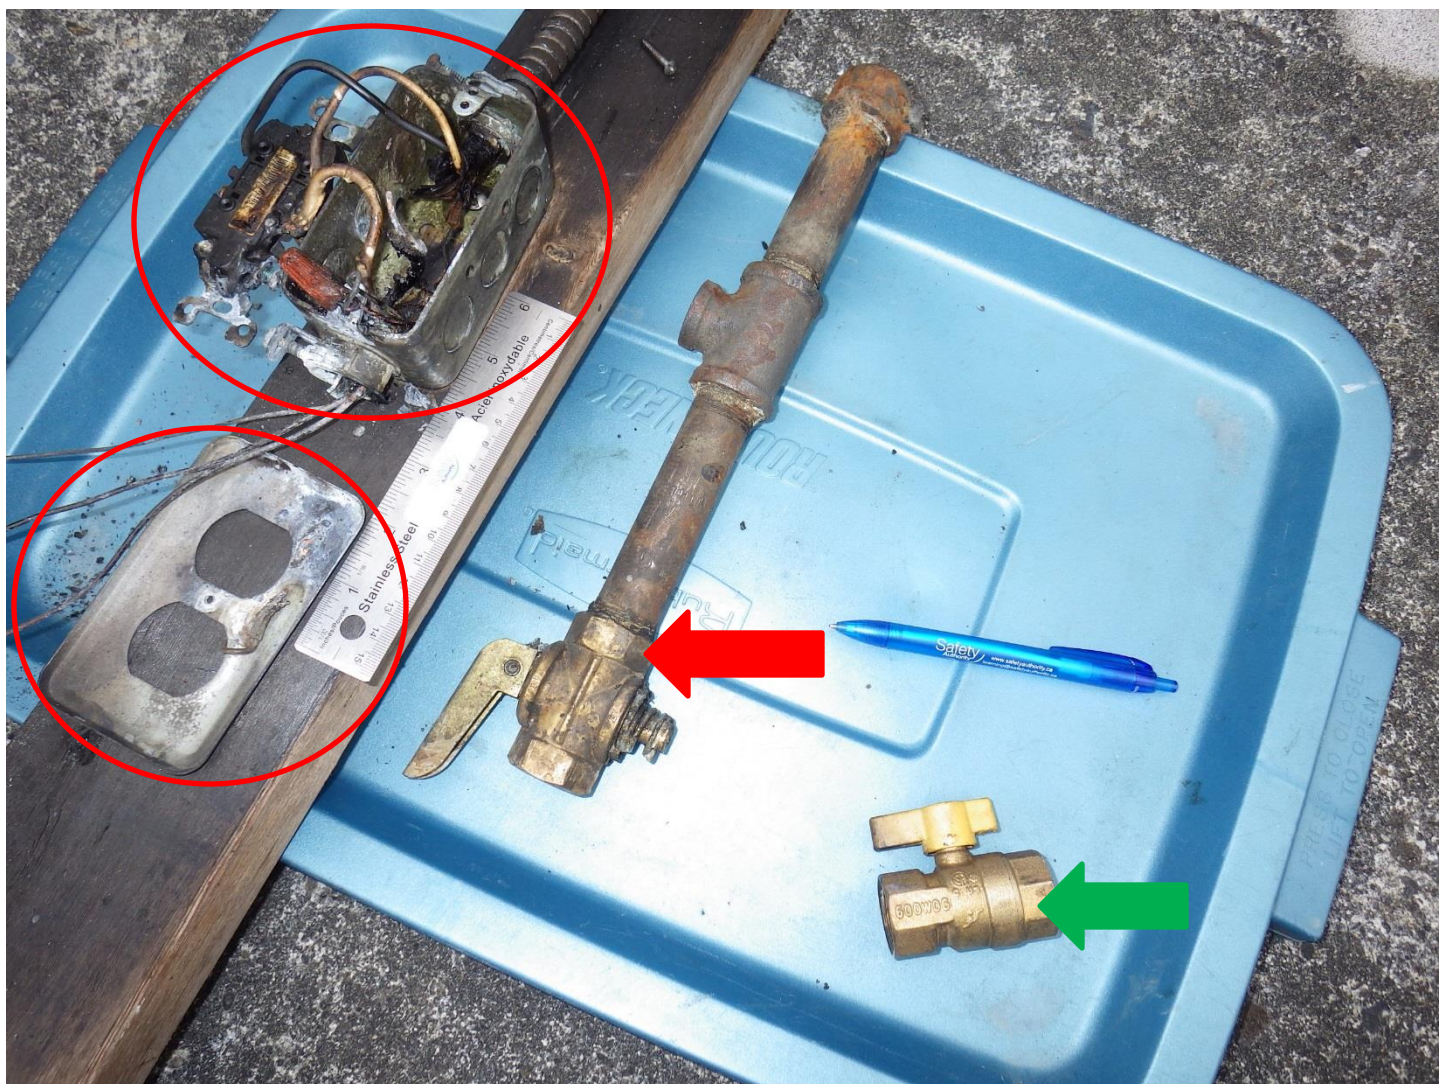
Figure 14

This photo shows the components involved in the incident. The gas valve and section of pipe that was removed (red arrow), the new valve that was sitting on the new furnace (green arrow), the outlet box/receptacle and the cover plate (red ovals).

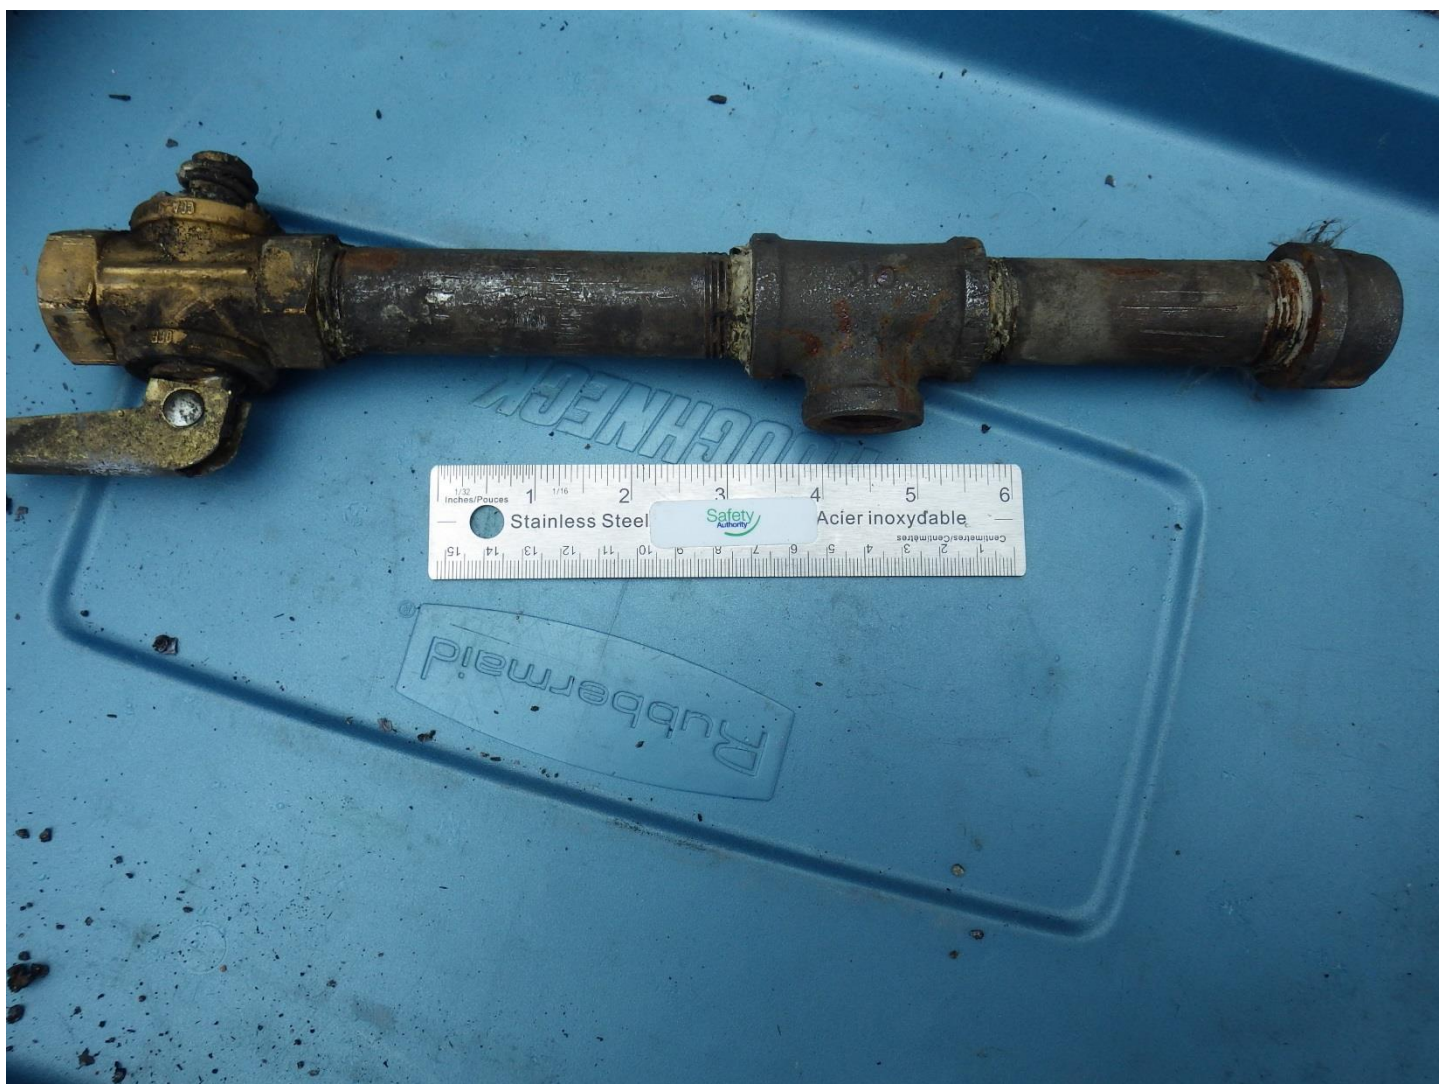
Figure 16

This photo shows the section of pipe that was accidentally removed by the installer which allowed gas to enter the house prior to the incident (gas valve, nipples, and fittings).
