Incident Summary (Reference #5605195)

SUPPORTING INFORMATION	Incident Date		September 13, 2016	
	Location		White Rock	
	Regulated industry sector		Natural gas system and low voltage electrical system (30V to 750V)	
	Impact	Injury	Qty injuries	1
			Injury description	A furnace installer received first and second degree burns to the left side of his face and his left arm.
			Injury rating	Moderate
	Damage		Damage description	Fire damage to the gas piping system, new furnace, and fire and arcing damage to a receptacle and cover plate. Extensive fire and smoke damage to the basement of a house.
			Damage rating	Major
	Incident rating		Major	
Incident overview		A fire occurred during a furnace replacement installation for a house. A heating contractor’s installer was performing gas and electrical work at the time of the incident. Natural gas entered the basement area and was ignited by an electrical arc causing the fire and resulting injuries to the installer.

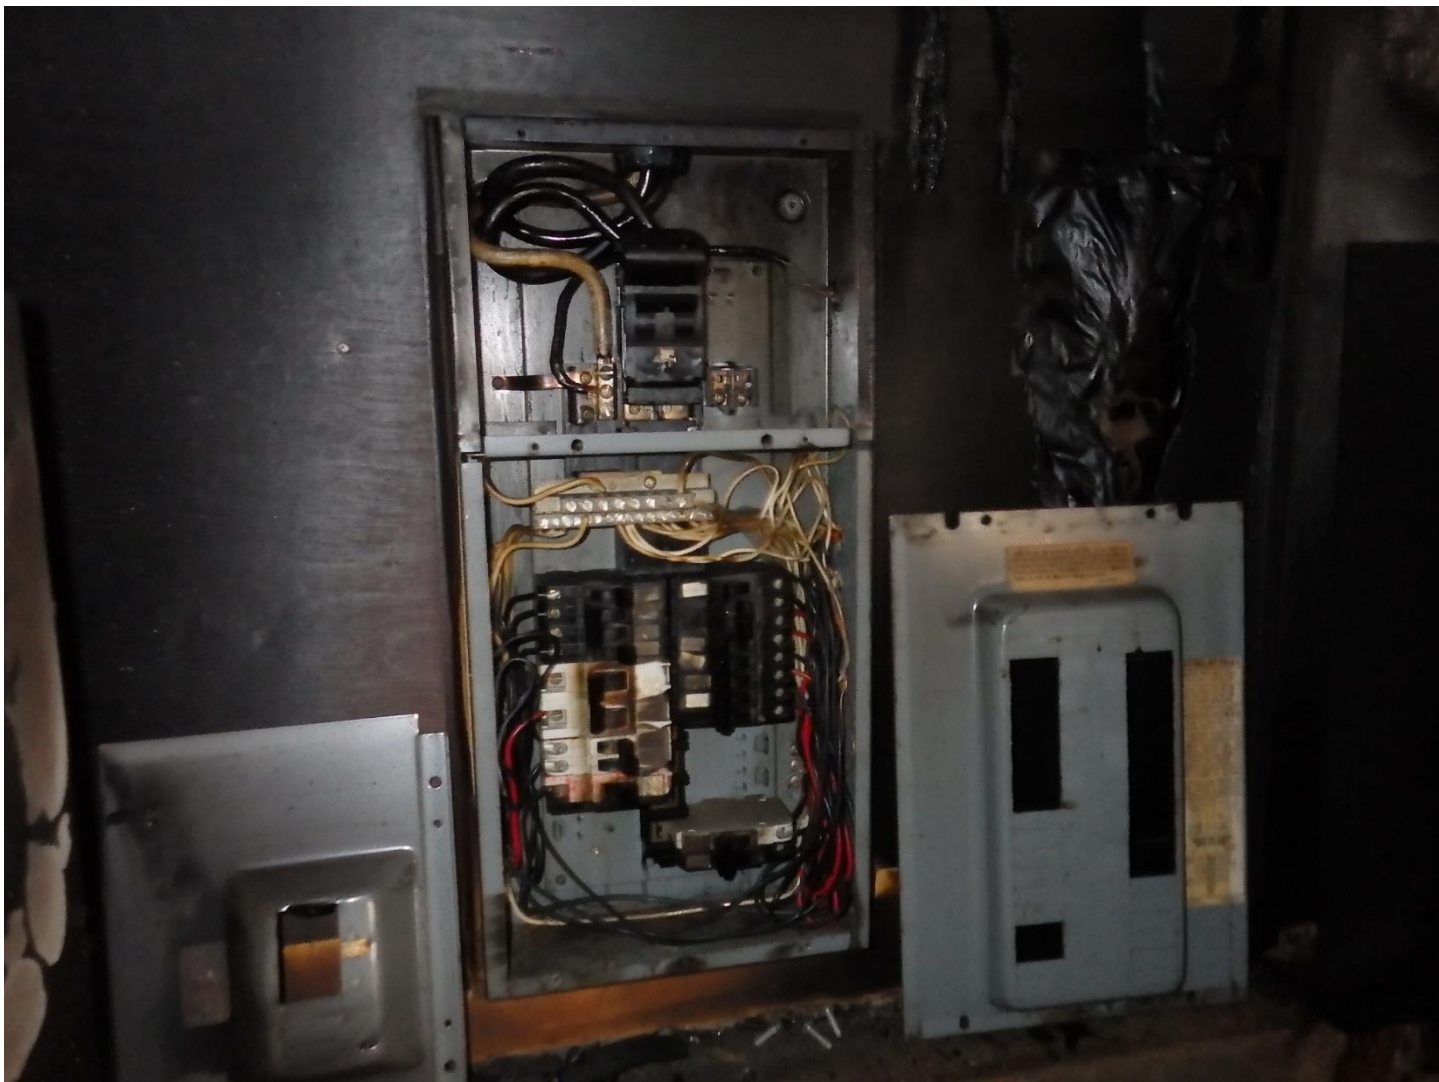
Figure 17

This photo shows the electrical panel with the cover removed. Due to damage to the branch circuit wiring the circuit breaker for the furnace could not be identified. All #14 awg branch circuit conductors were terminated to 15 Amp rated circuit breakers which appeared correct. Some breakers were tripped and some were in the off position.
