## Incident Summary (5615627) (Final)

Incident Date			April 28, 2017
INVESTIGATION CONCLUSIONS Cul	Location			Cultus Lake
	Regulated industry sector			Gas – Propane System
	Impact	Injury	Qty injuries	0
			Injury description	None
			Injury rating	None
		Damage	Damage description	A brass fitting in the service valve was strained and broke in half. The damage released a substantial amount of propane in an unplanned, uncontrolled manner but was contained at the site of the equipment.
			Damage rating	Major
	Incident rating		rating	Major
	Incident overview			A 500 USWG propane storage tank installed at a residential home, rolled off of its blocks and snapped a brass fitting installed in the tanks service valve. A substantial amount of propane was released into the atmosphere before the flow of fuel could be stopped.
				A propane storage tank is a steel container designed to contain Liquefied Petroleum Gas (LPG) in both liquid and vapour states. Propane is stored as a liquid and expands in volume 270 times to be used a combustible vapour fuel. Propane is kept in the liquid form by pressure. When the pressure inside of the container drops the liquid propane will boil off and change stat

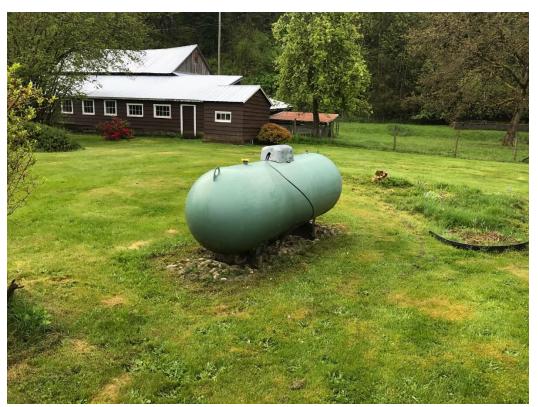
Propane tank after repair

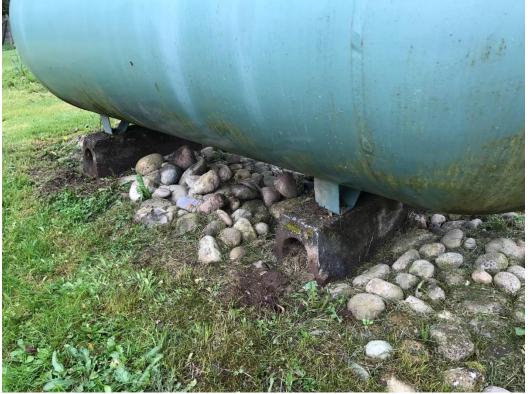
Causes and contributing factors	It is highly likely that soft unstable ground under one side of the blocks allowed the weight of the tank and fuel to push one side of the blocks into the ground causing the tank to roll off of the blocks snapping the brass fitting in the service valve causing the fuel leak.

Concrete blocks after repair. Top of this side of the blocks were flush with ground when the tank rolled.

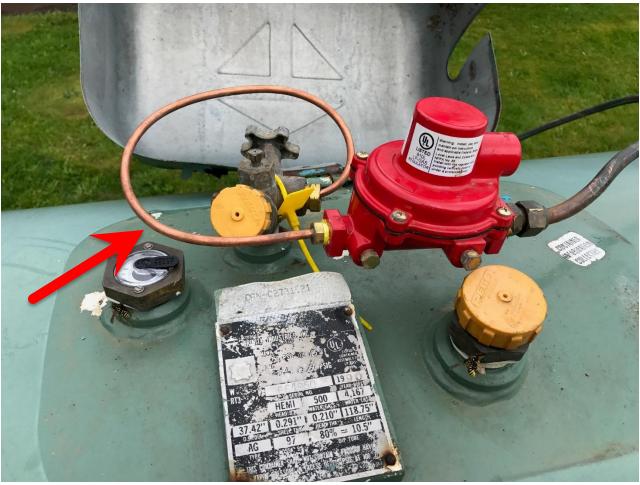
New flexible copper connector which replaced solid brass connector.
