## Incident Summary (5594218) Final

SUPPORTING INFORMATION	Incident Date		May 26, 2016		
	Location		Abbotsford		
	Regulated industry sector		Electrical – low voltage		
	Impact	Injury	Qty injuries	0	
			Injury description	N/A	
			Injury rating	N/A	
		Damage	Damage description	A receptacle and power bar were destroyed in a fire located in the bedroom of a residential townhouse unit. Fire and smoke damage to the bedroom and the basement.	
			Damage rating	Moderate	
	Incident rating		Moderate		
Incident overview		A fire occurred where a power bar was plugged in to a receptacle. The power bar was used to provide power to a portable heater and other portable electrical equipment located in a bedroom.			
INVESTIGATION CONCLUSIONS	Site, system and components		<p>The incident occurred in the basement of one unit of a five unit townhouse building. The basement was unfinished and part of it was being used as a bedroom.</p> <p>The south wall in the bedroom had one 15A, 120V duplex receptacle, and the east wall of the basement had one 15A, 120V duplex receptacle installed for the washer. These were the only two receptacles observed in the basement.</p> <p>Several power bars and extension cords

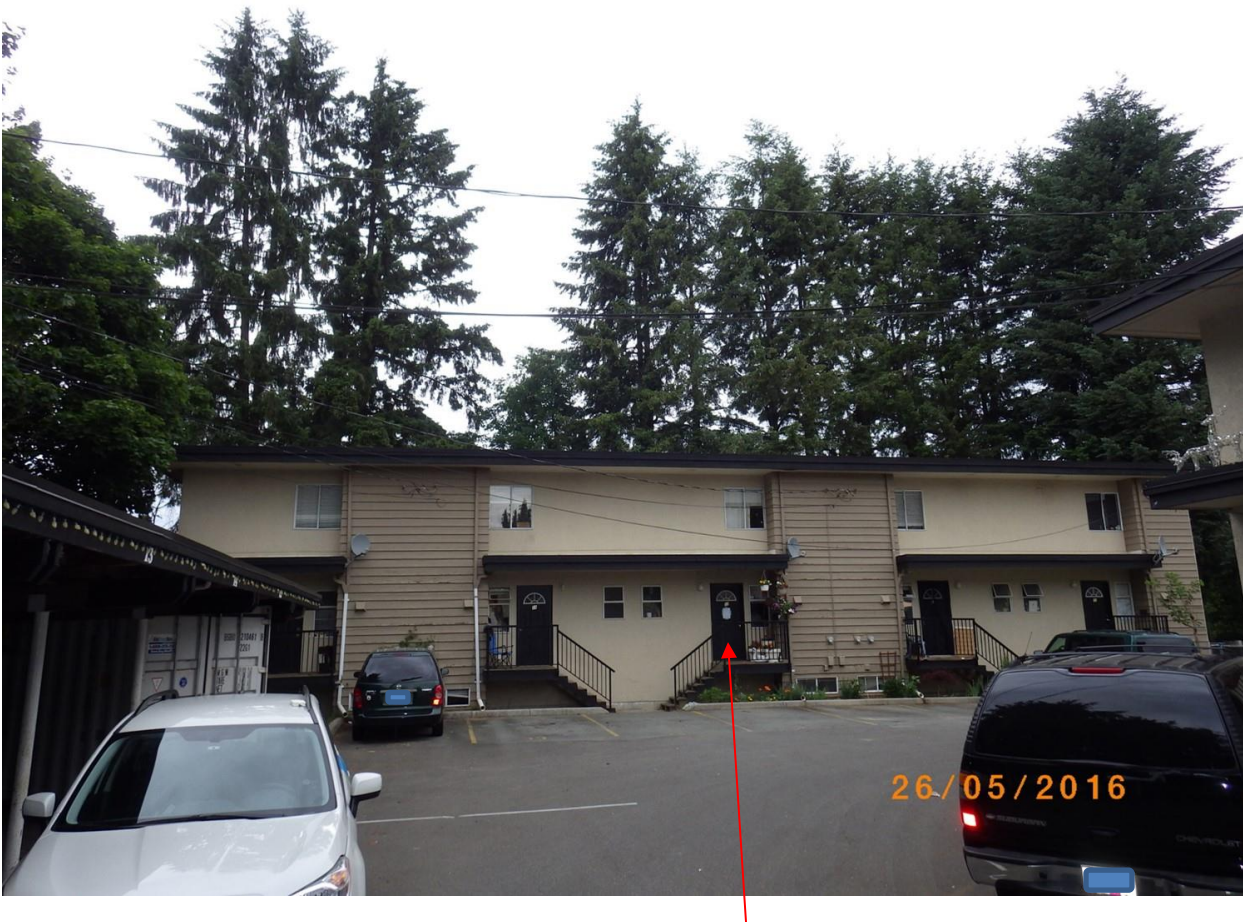
*Figure 1 - Unit where the fire occurred (red arrow).*

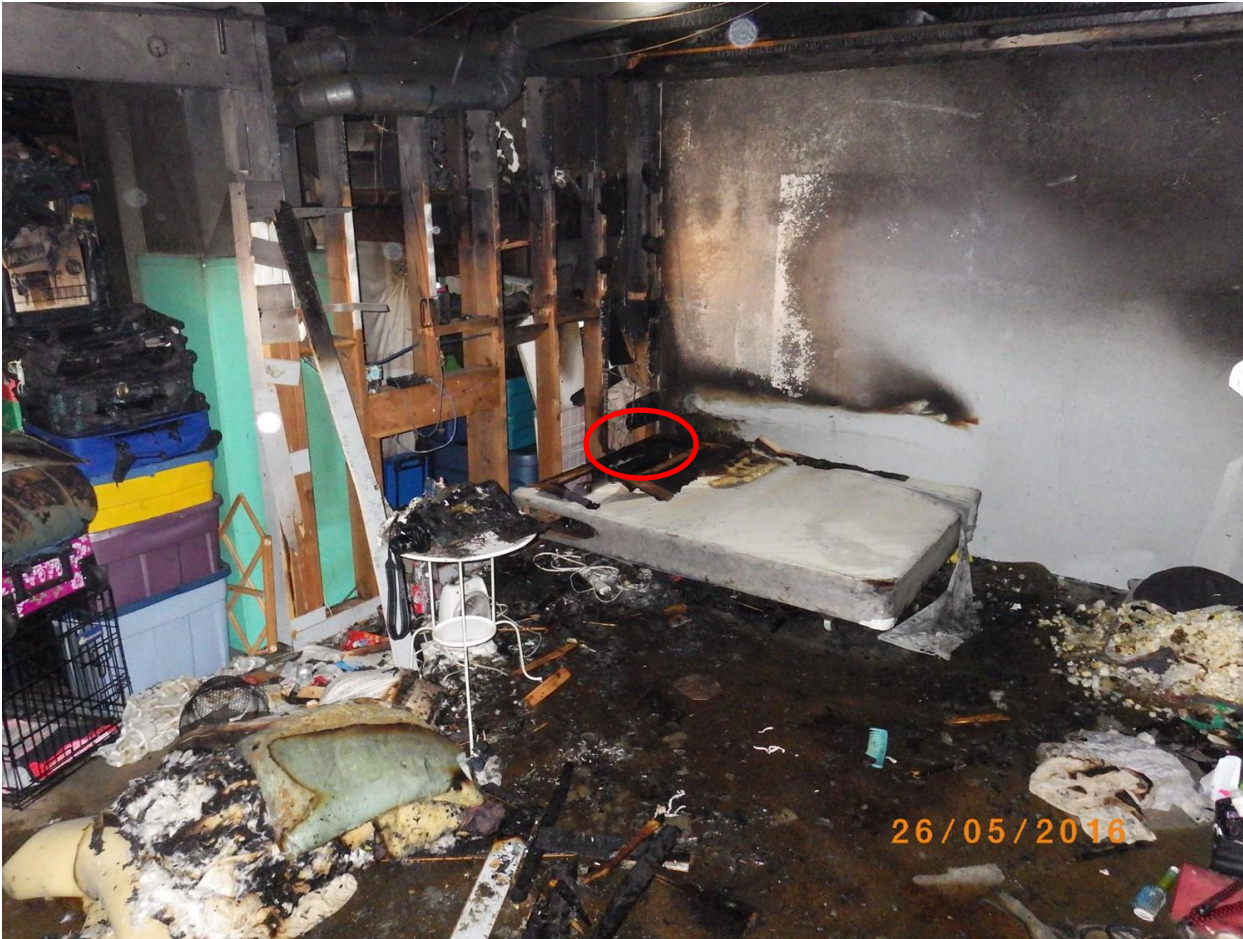
*Figure 2 – Basement bedroom and area of origin determined by fire department investigators (red outline). Box spring only - the mattress was removed by fire fighters at the time of the fire.*

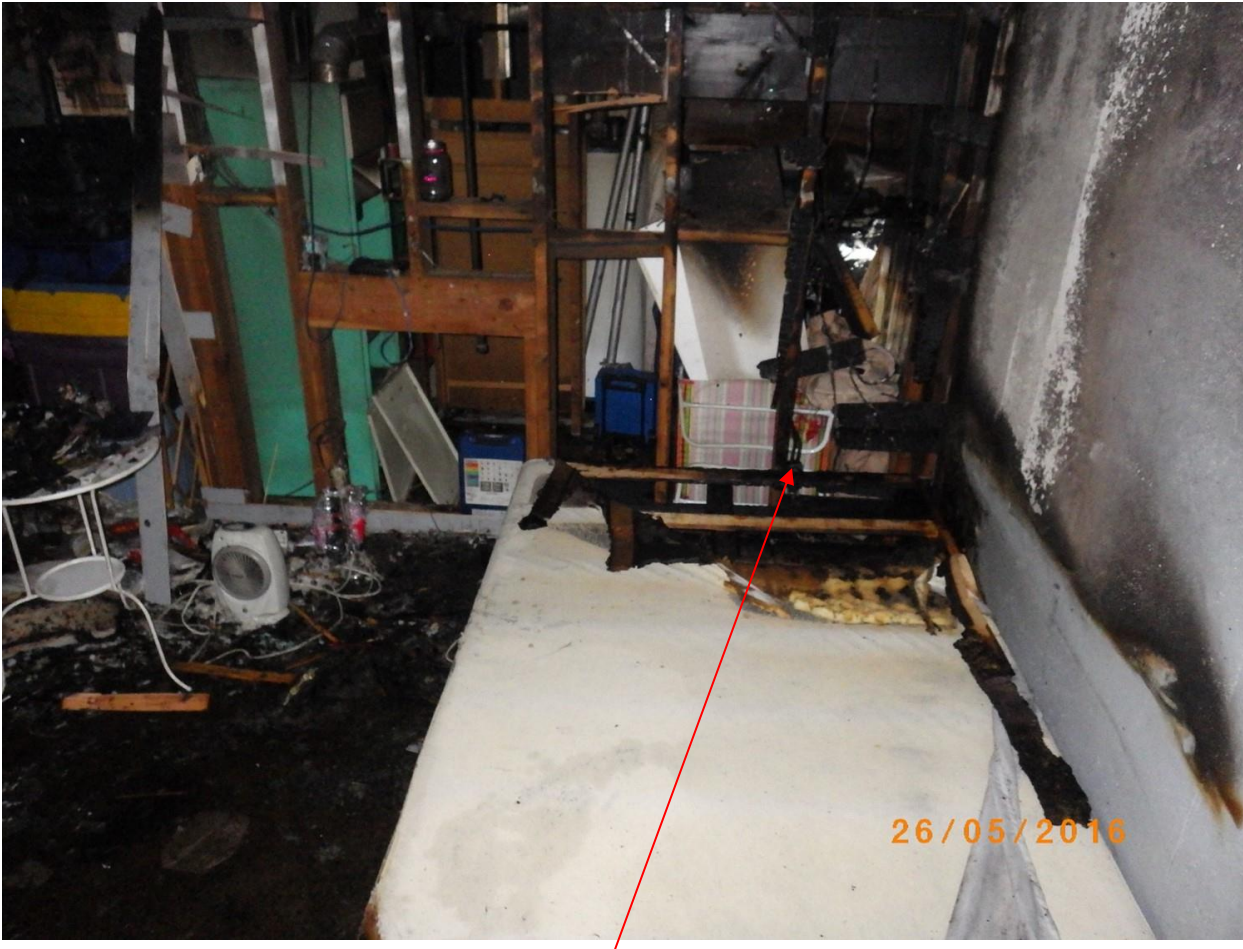
*Figure 3 - Receptacle on the wall at the head of the bed where the fire originated (red arrow).*

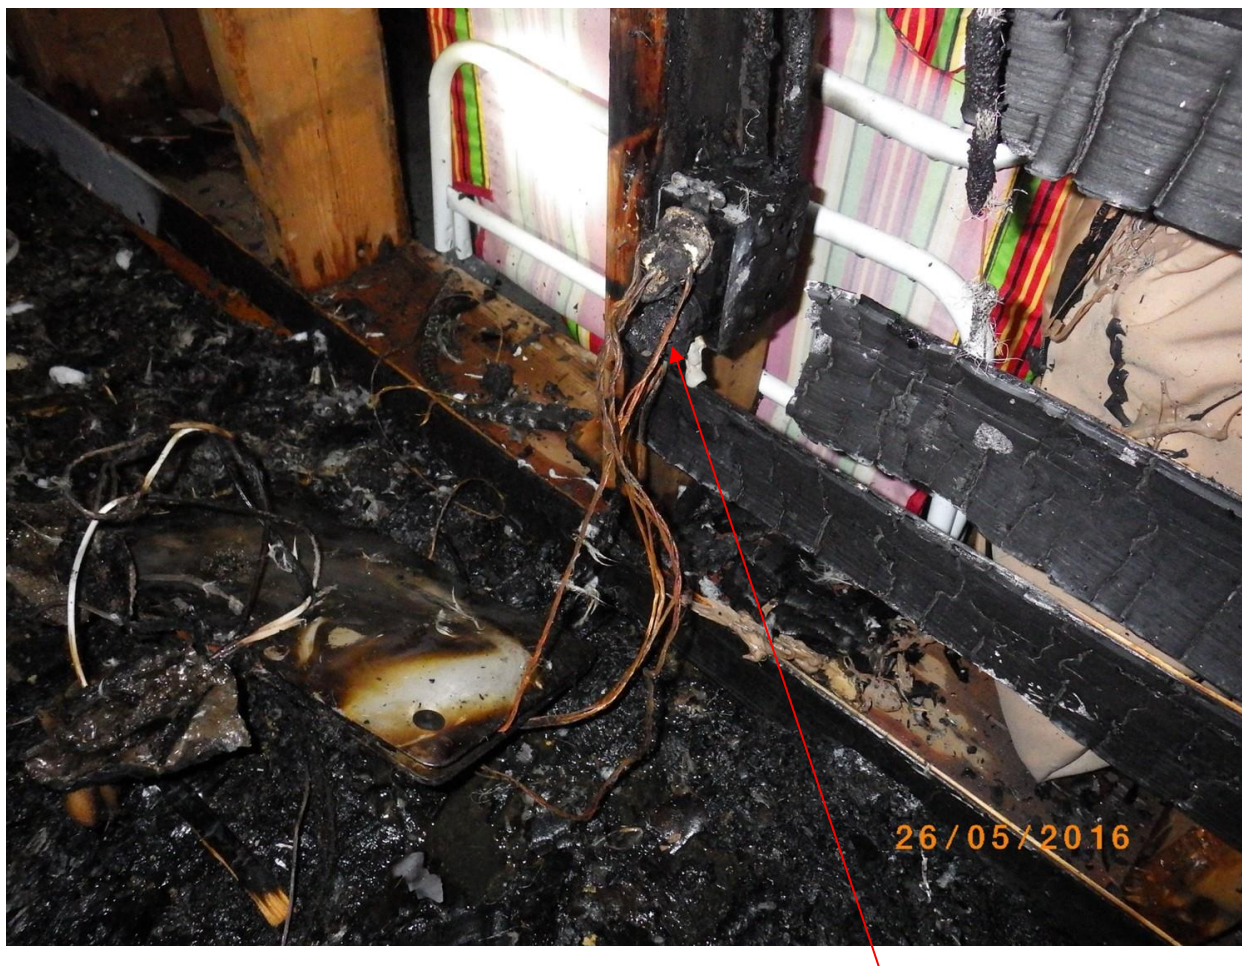
<p>the power bar was plugged into is connected to a 20A circuit breaker in the panel (see figure 13).</p> <ul style="list-style-type: none"> <li>- The connection point between the receptacle and power bar on the bedroom wall at the head of the bed was extensively fire and heat damaged (see figure 4 and 5).</li> <li>- When separated from the receptacle one of the cord end attachment blades remained inside the receptacle (see figure 6 and 7).</li> <li>- The separated attachment blade is missing approximately 5mm of length (see figure 8).</li> <li>- The separated blade has a bulb formed on the exposed end indicating a high heat condition occurred at this point (see figure 7).</li> <li>- The plastic attachment cord end where the blade detached also has a bulb formed indicating a high heat condition occurred at this point as well (see figure 9 and 10).</li> </ul>
	<p>Causes and contributing factors</p>	<p>The cause of this incident is very likely an overheated connection between a receptacle and a power bar that was being used as a substitute for permanent wiring and was being overloaded over an extended period of time.</p> <p>The oversized 20A circuit breaker contributed by not providing the proper protection for the 15A circuit, receptacle, and portable equipment plugged into it. The breaker may have been installed by an unqualified person in an effort to solve a perceived nuisance breaker tripping problem.</p> <p>Failure of the occupants to recognize the warning signs related to tripping breakers and a burning plastic smell were also contributing factors.</p>

*Figure 4 - Power bar cord end plugged into the wall receptacle at the head of the bed (red arrow).*

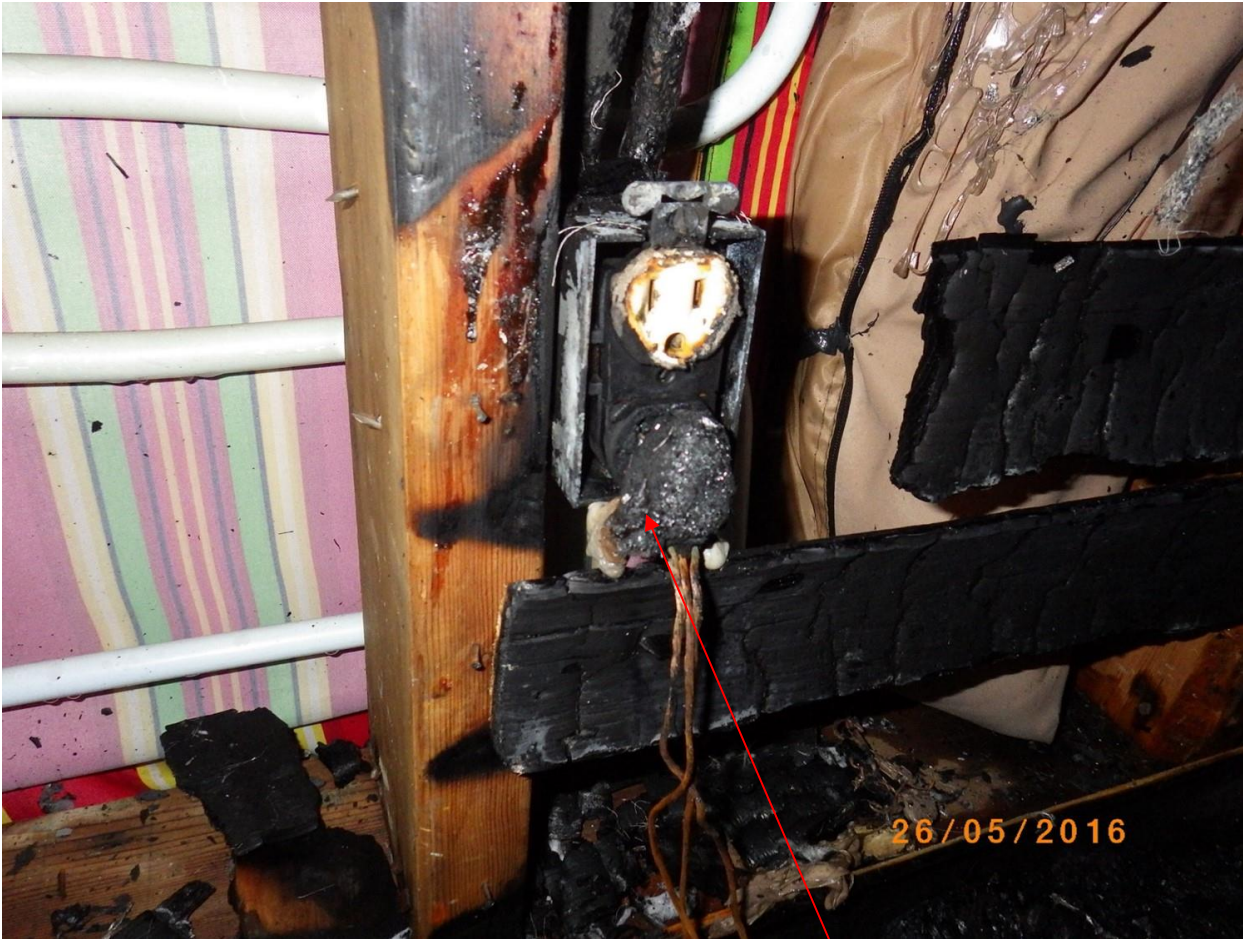
*Figure 5 - bedroom receptacle with power bar cord plugged into the bottom outlet (red arrow). This is the point of origin.*

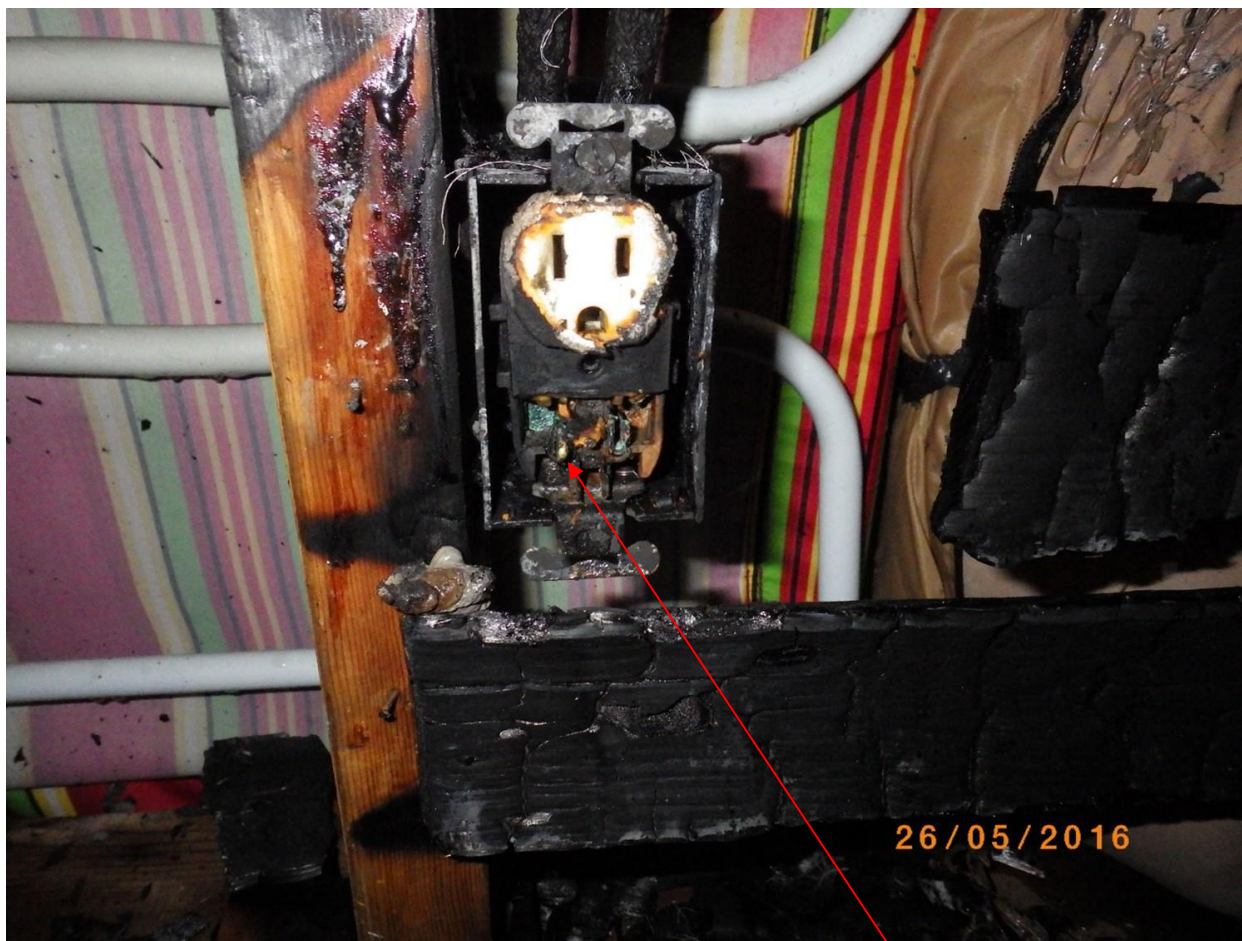
*Figure 6 - receptacle with cord end removed. Cord end blade remained in the receptacle (red arrow).*

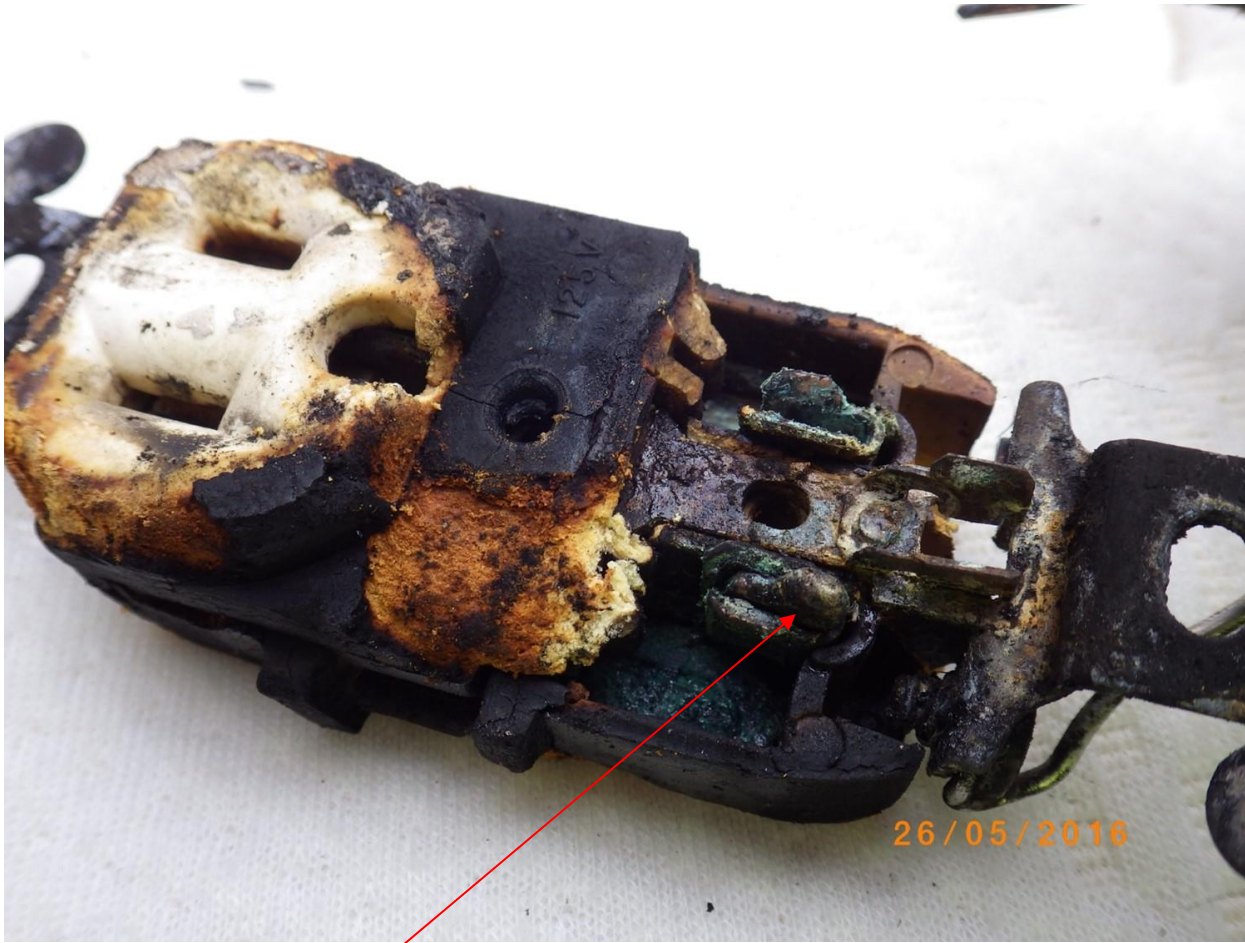
*Figure 7 - Receptacle removed from the outlet box. One of the cord end blades remains in the receptacle. A bulb is formed on the end of the receptacle blade (red arrow) indicating a high heat condition.*

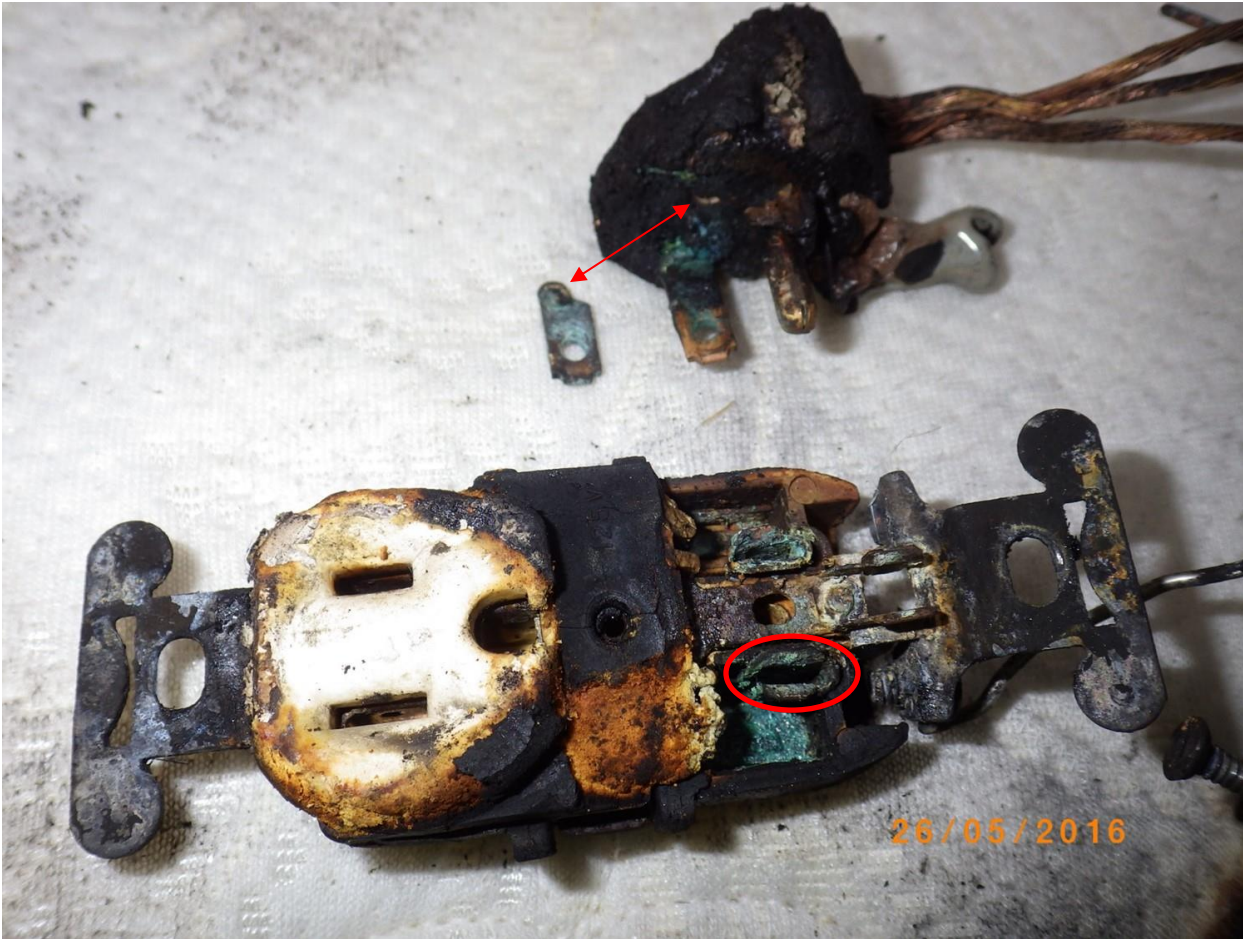
Figure 8 - Receptacle, cord end, and cord blade removed from the receptacle. Red arrow shows where the cord end blade was detached from the cord end. Red oval shows the receptacle opening where the blade was removed from.

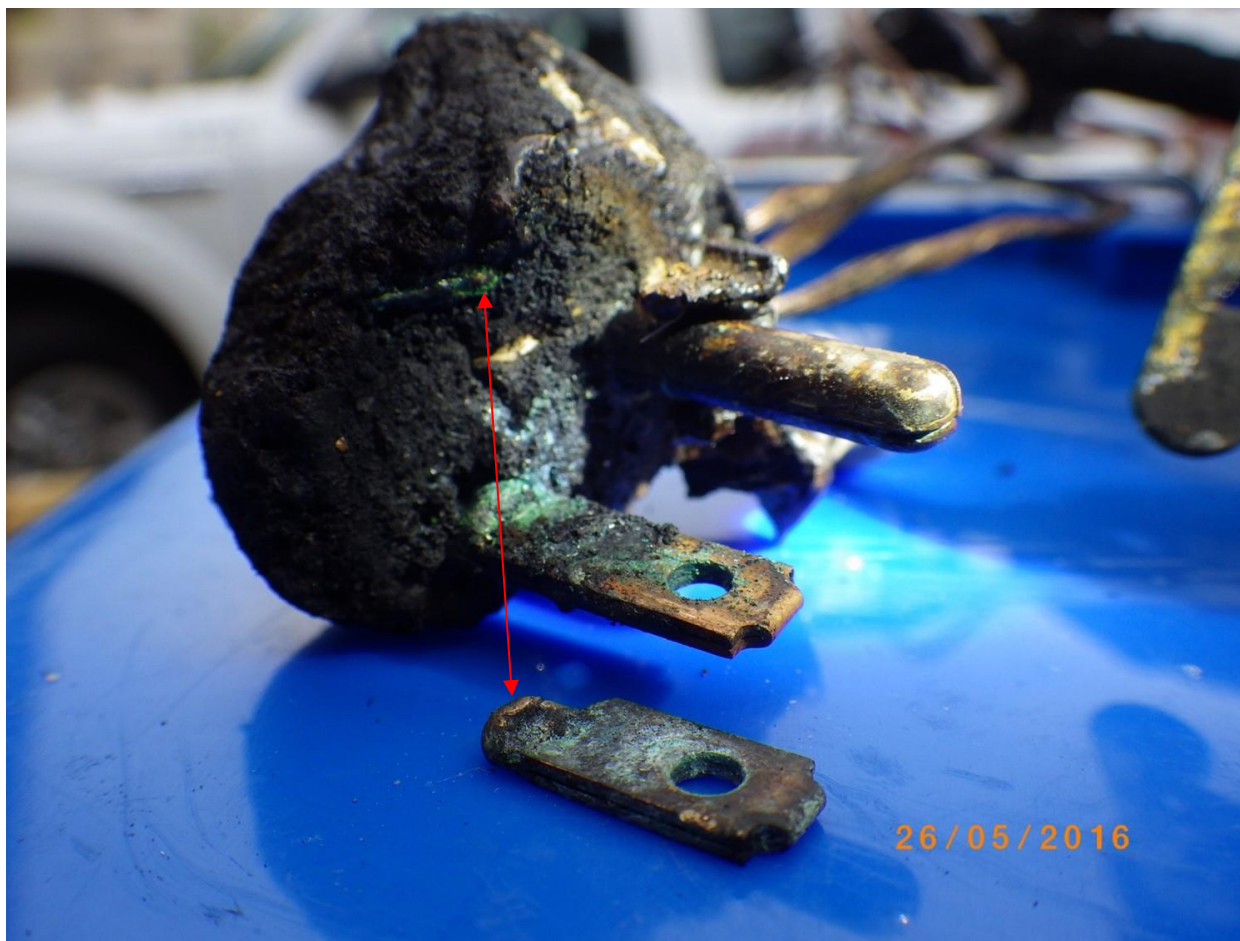
*Figure 9 - cord end with the detached blade. The red arrow shows where the blade was connected and the bulb on each end of the blade and attachment cord indicating a high heat condition occurred.*

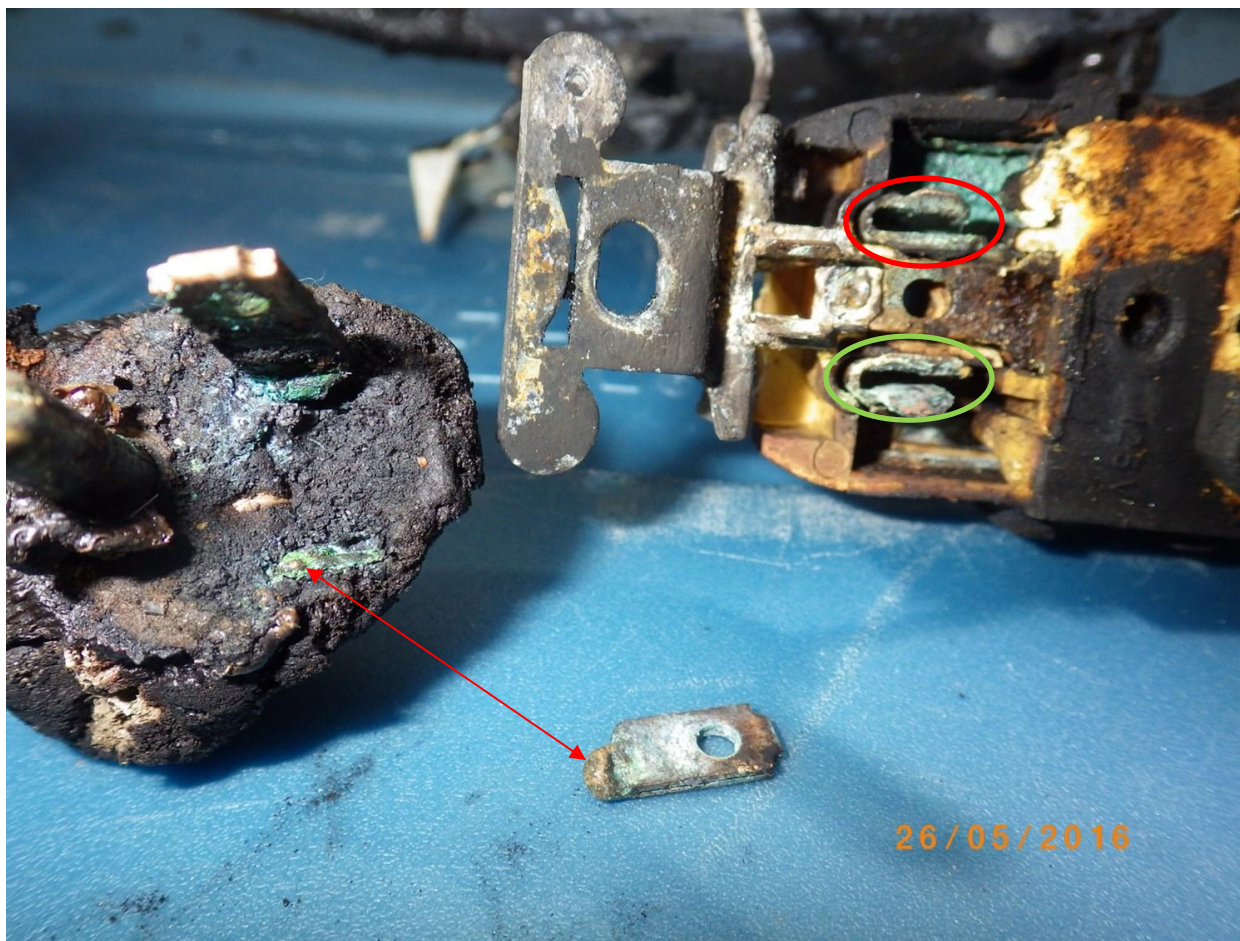
Figure 10 – The cord end, detached blade, and receptacle. The red arrow shows where the blade was attached to the cord end. The blade and the cord end have bulbs where the blade detached (red arrow) indicating a high heat condition occurred. This is the point of origin.

The receptacle opening where the blade was inserted (red oval) appears to be more open than the lower receptacle opening (green oval) indicating possibly a loose connection between the cord end blade and the receptacle creating a high resistance condition.

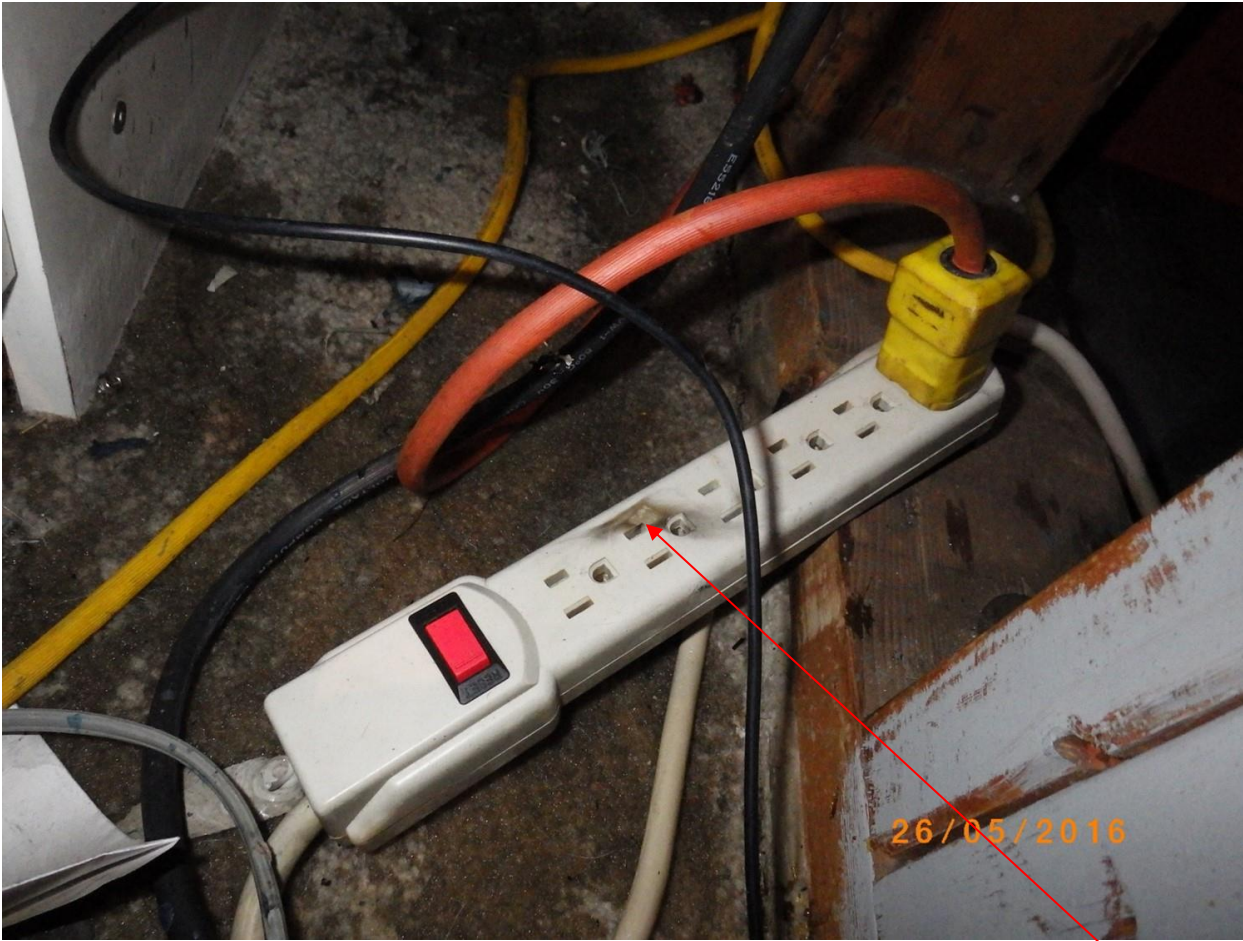
*Figure 11 - One of the other power bars used in the bedroom shows signs of heat damage at one of the outlets (red arrow). This was likely caused by over loading of the power bar in the bedroom area. This example shows the improper use of power bars in the bedroom area.*

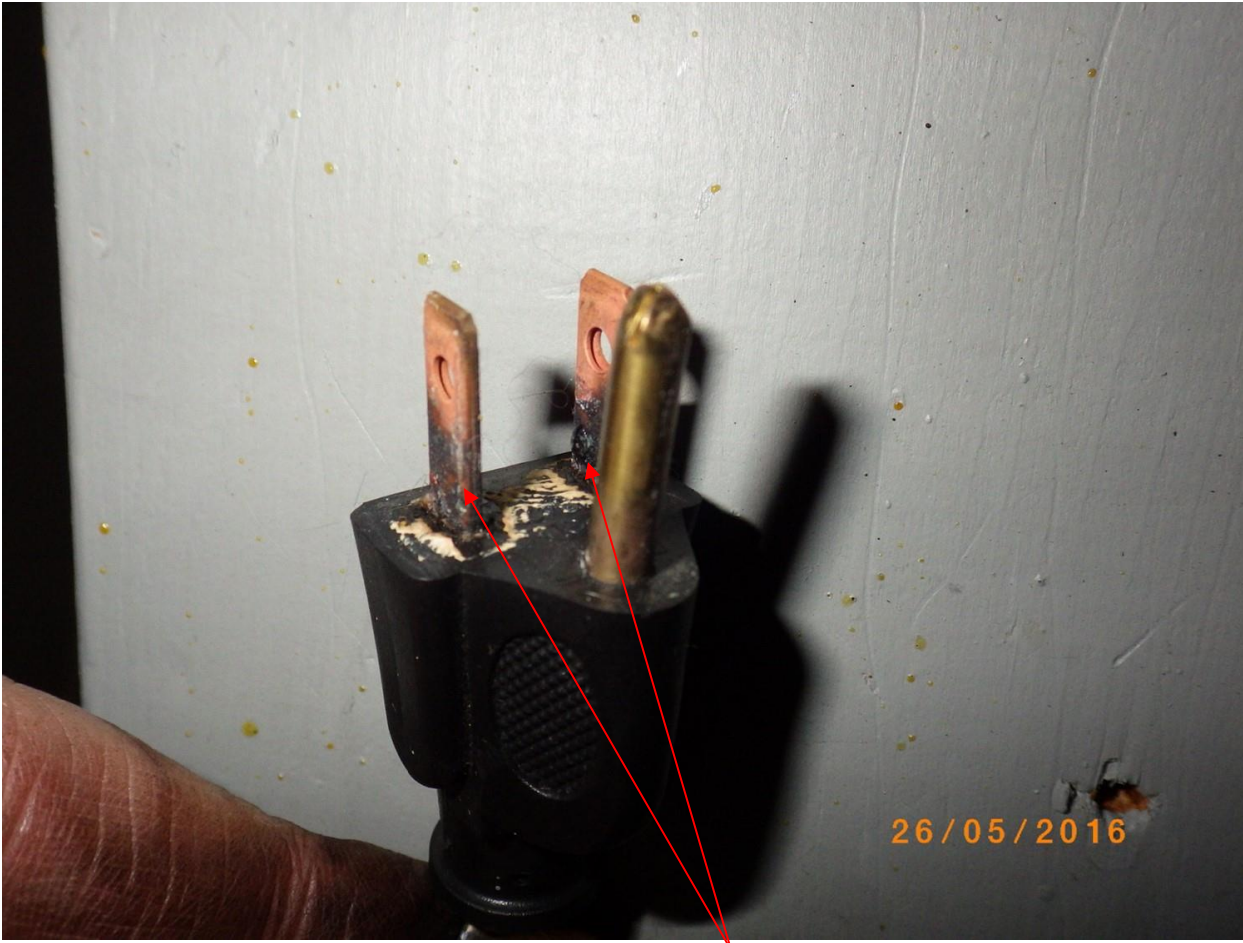
*Figure 12 - One of the extension cords used in the bedroom shows signs of heat and discoloration on the cord end (red arrows). This was likely caused by over loading of the extension cord in the bedroom area. This example shows the improper use of extension cords in the bedroom area.*

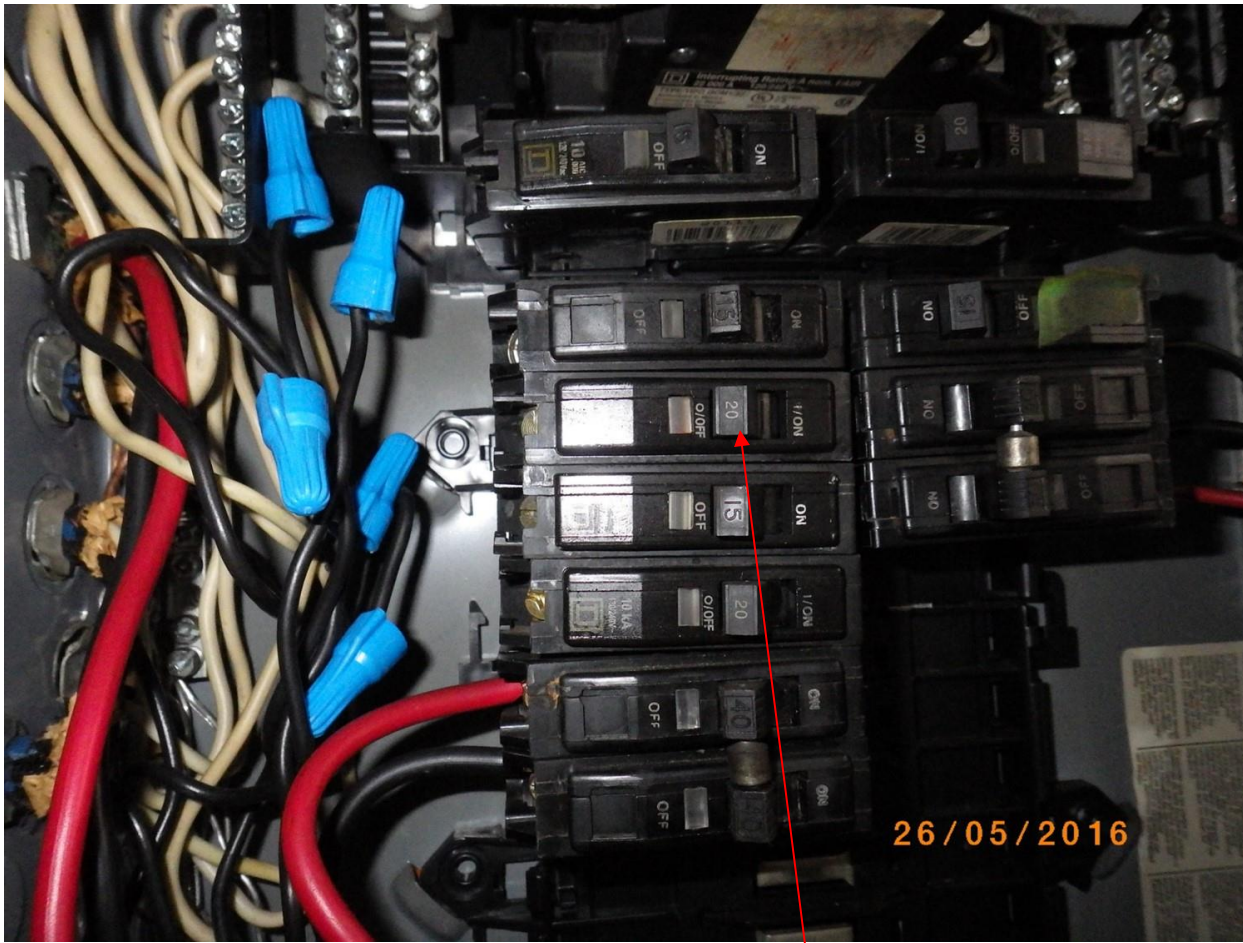
Figure 13 – This photo shows the circuit breakers in the electrical panel located in the basement of this unit. The circuits were previously disconnected from breakers by the restoration company's electrician to make the site safe. Circuit #7 (20A rated circuit breaker) was the circuit connected to the basement receptacle circuit (red arrow). This circuit breaker was over sized for the 15A rated branch circuit wiring and receptacle.
