Incident Summary #II-1945527-2025 (#58254) (FINAL)

SUPPORTING INFORMATION	Incident Date	July 27, 2025	
	Location	Osoyoos, BC	
	Regulated industry sector	Gas - Natural gas system	
	Impact	Qty injuries	0
		Injury description	N/A
		Injury rating	None
	Damage	Damage description	Gas BBQ is a complete loss. There are broken windows and fire damage to the deck and framing.
		Damage rating	Major
Incident rating	Major		
Incident overview	Several hours after using a built-in natural gas BBQ, framed in combustible construction, the combustible construction around the BBQ caught fire. This fire burnt through the deck and damaged the framing of the deck.		
INVESTIGATION CONCLUSIONS	Site, system and components	Manufacturer's installation instructions state that built-in BBQs must be framed in non-combustible construction. Failure to frame the BBQ in non-combustible construction will expose the framing to high temperatures, pyrolyzing the combustible framing, which can lead to a fire.

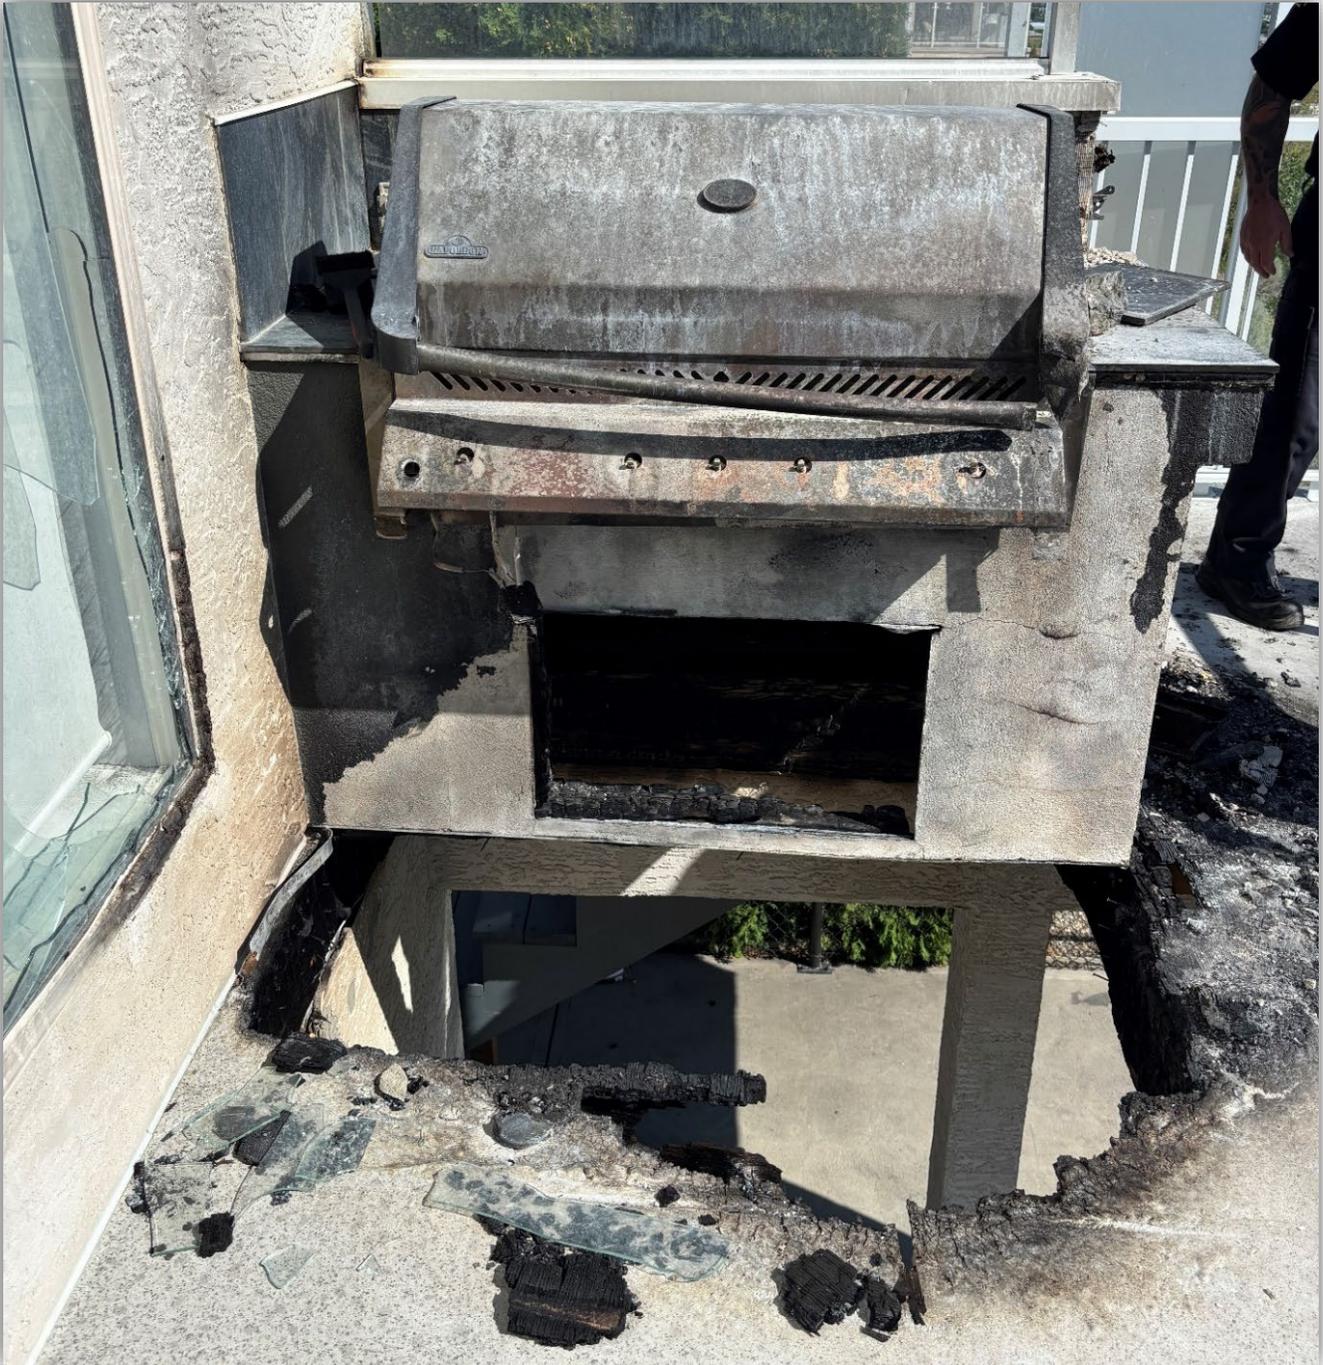
Image 1 - BBQ as found at time of investigation.

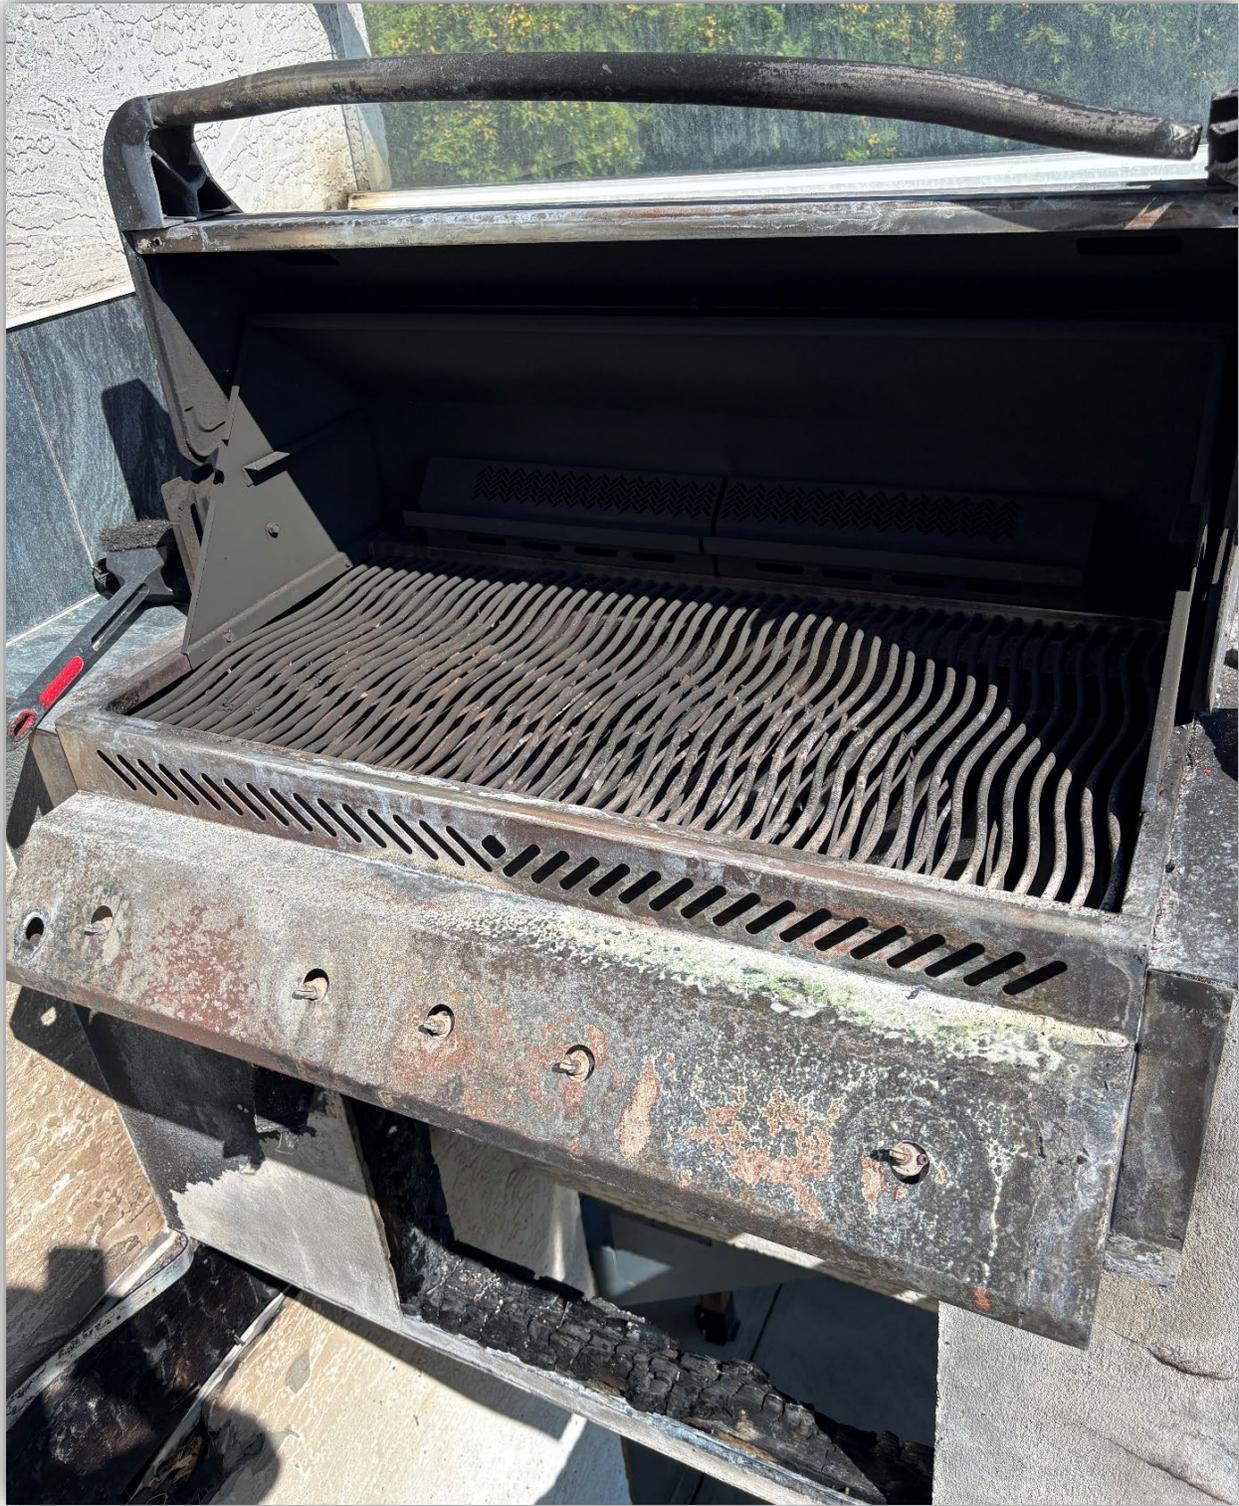
Image 2 - Interior of BBQ. Note: all handles appear to be in the OFF position.

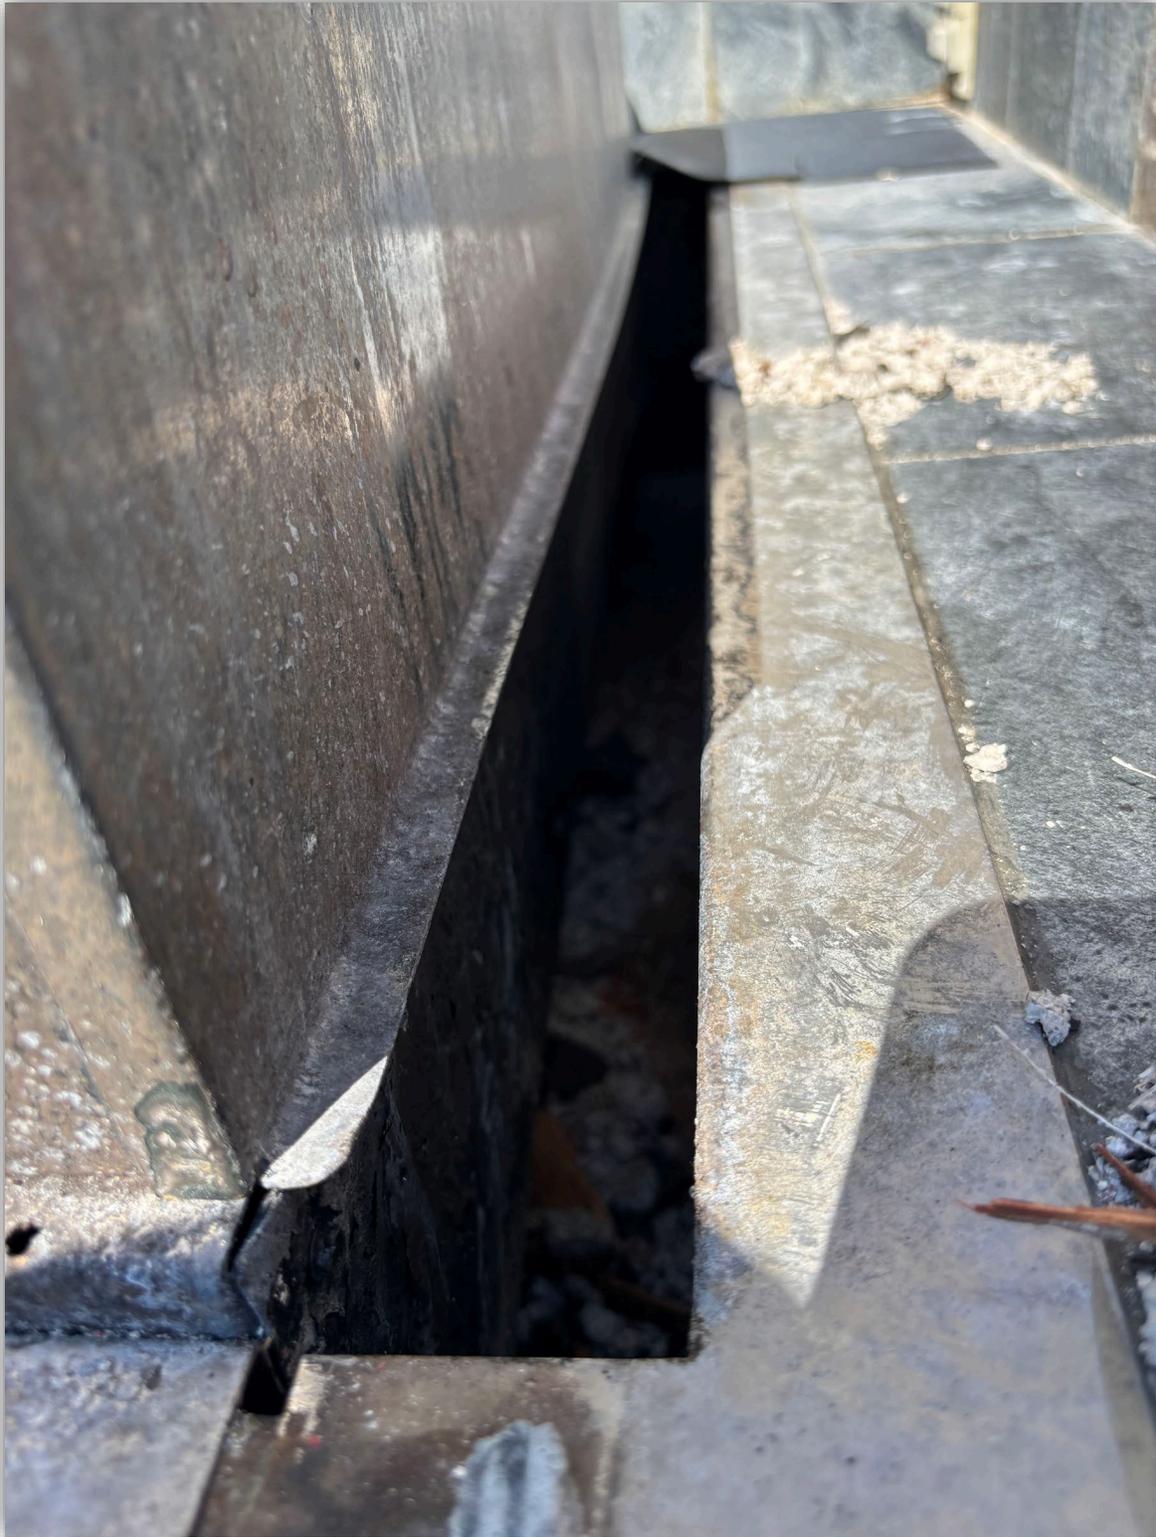
Image 3 - Stainless tray that the BBQ was installed in.

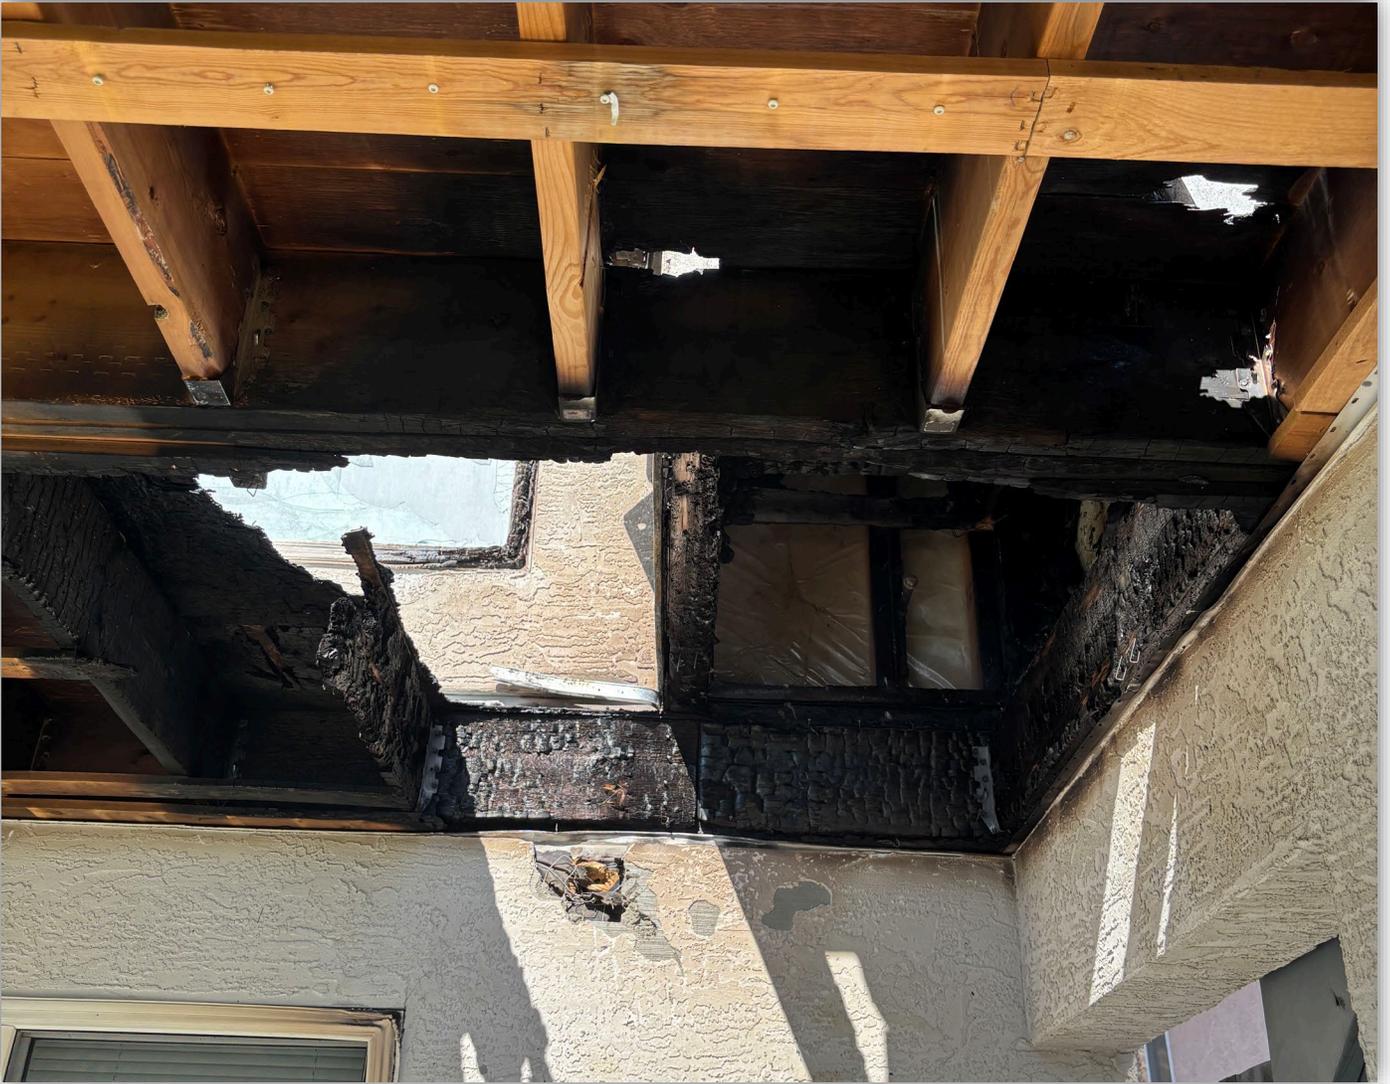
Image 4 - The damage to the deck below the BBQ.

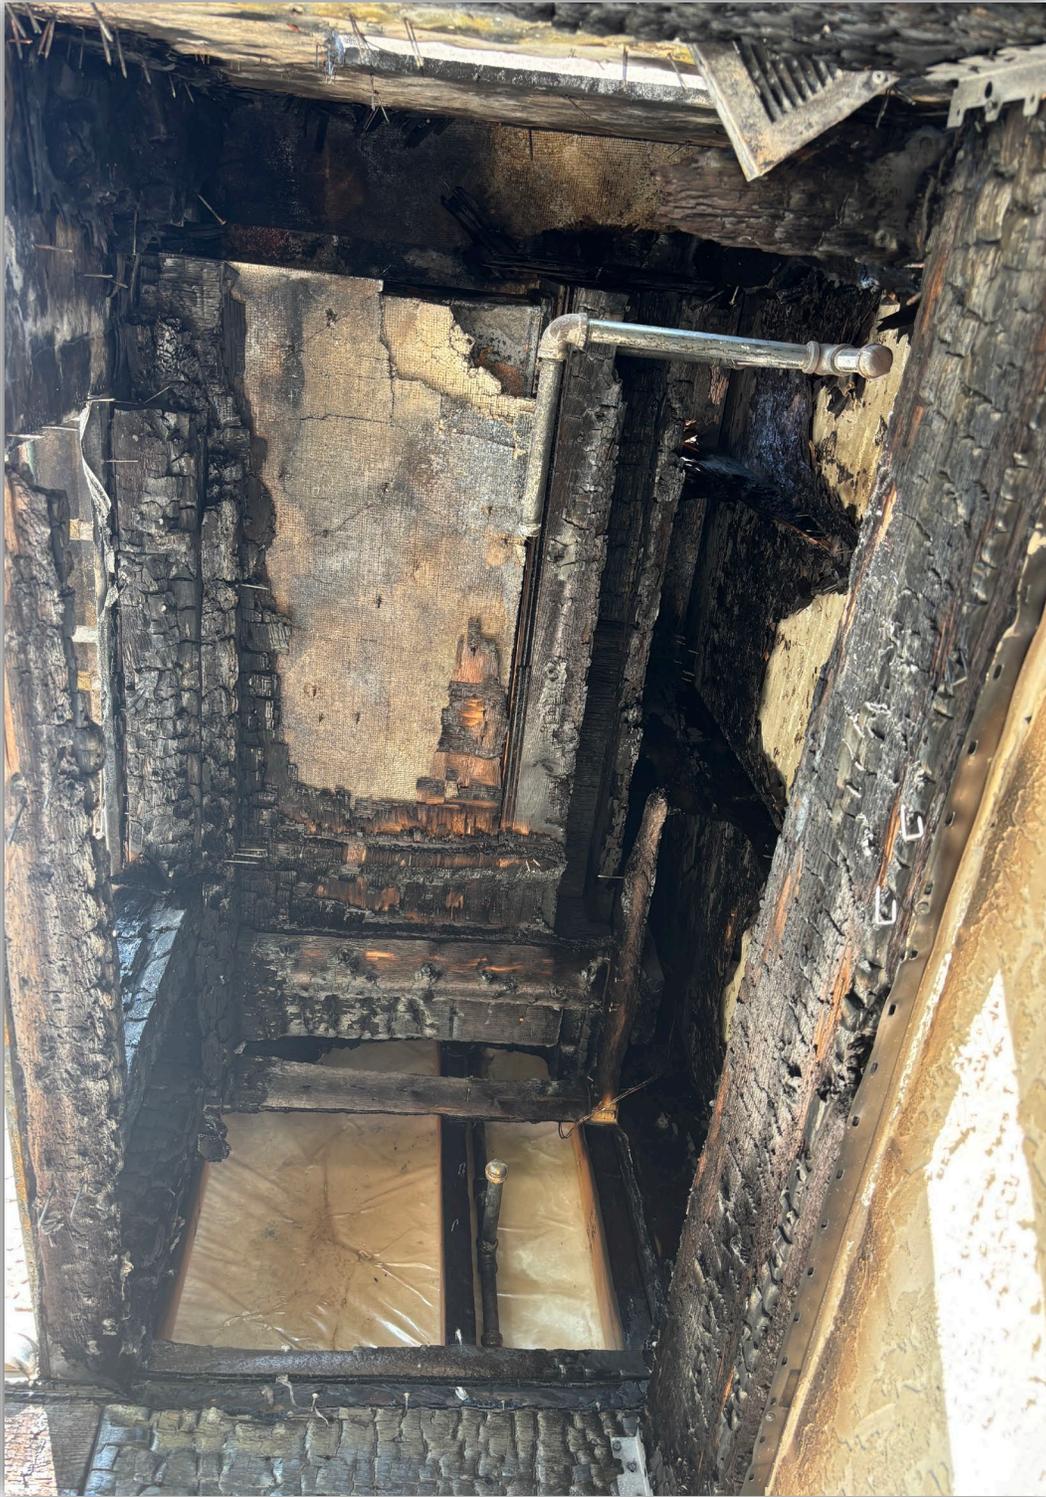
Image 5 - The damage to the BBQ from below.

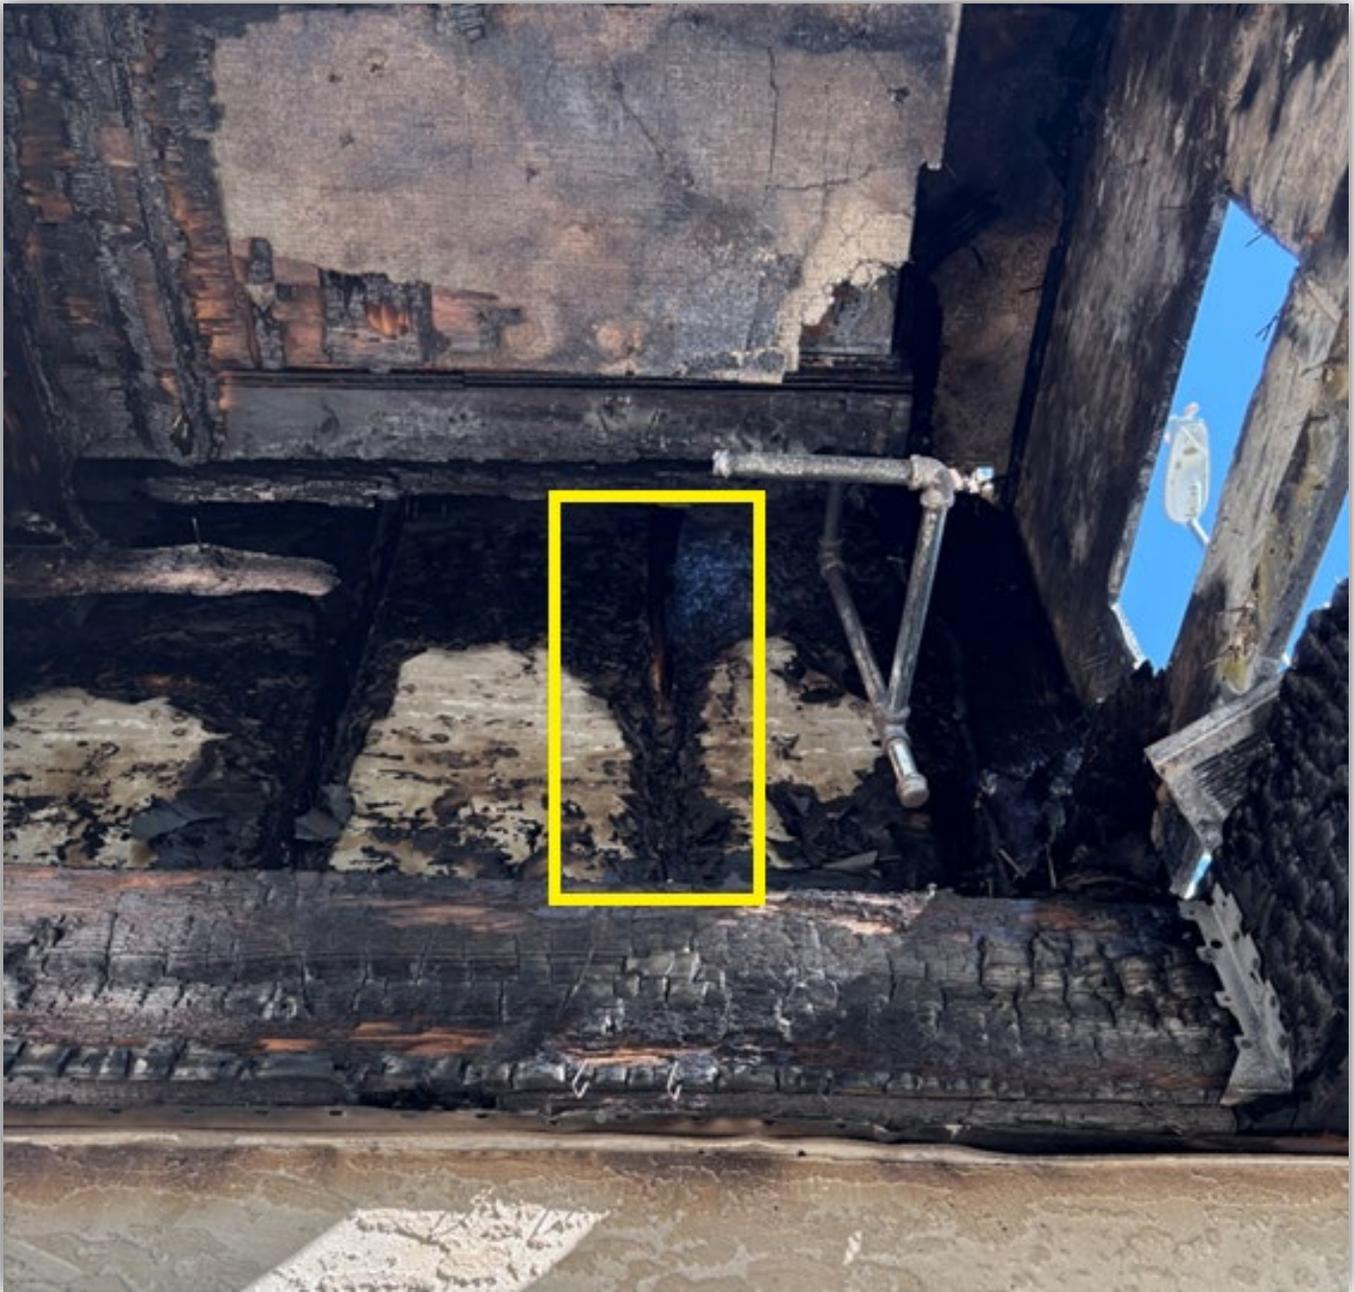
It is highly probable that the BBQ's installation in combustible framing contributed to the fire at this property.

Image 6 - The damage to the cabinet in which the BBQ was installed. Highlighted area contained the worst of the fire damage indicating the most likely point of origin of the fire.
