Incident Summary #II-1169032-2021 (#21353) (FINAL)

| | Regulated industry sector | | Passenger ropeways - Above surface ropeway | |
| Incident overview | | Maintenance staff determined that the top return station bull wheel axle had migrated up and out of its normal working position by approximately 4”. | | |

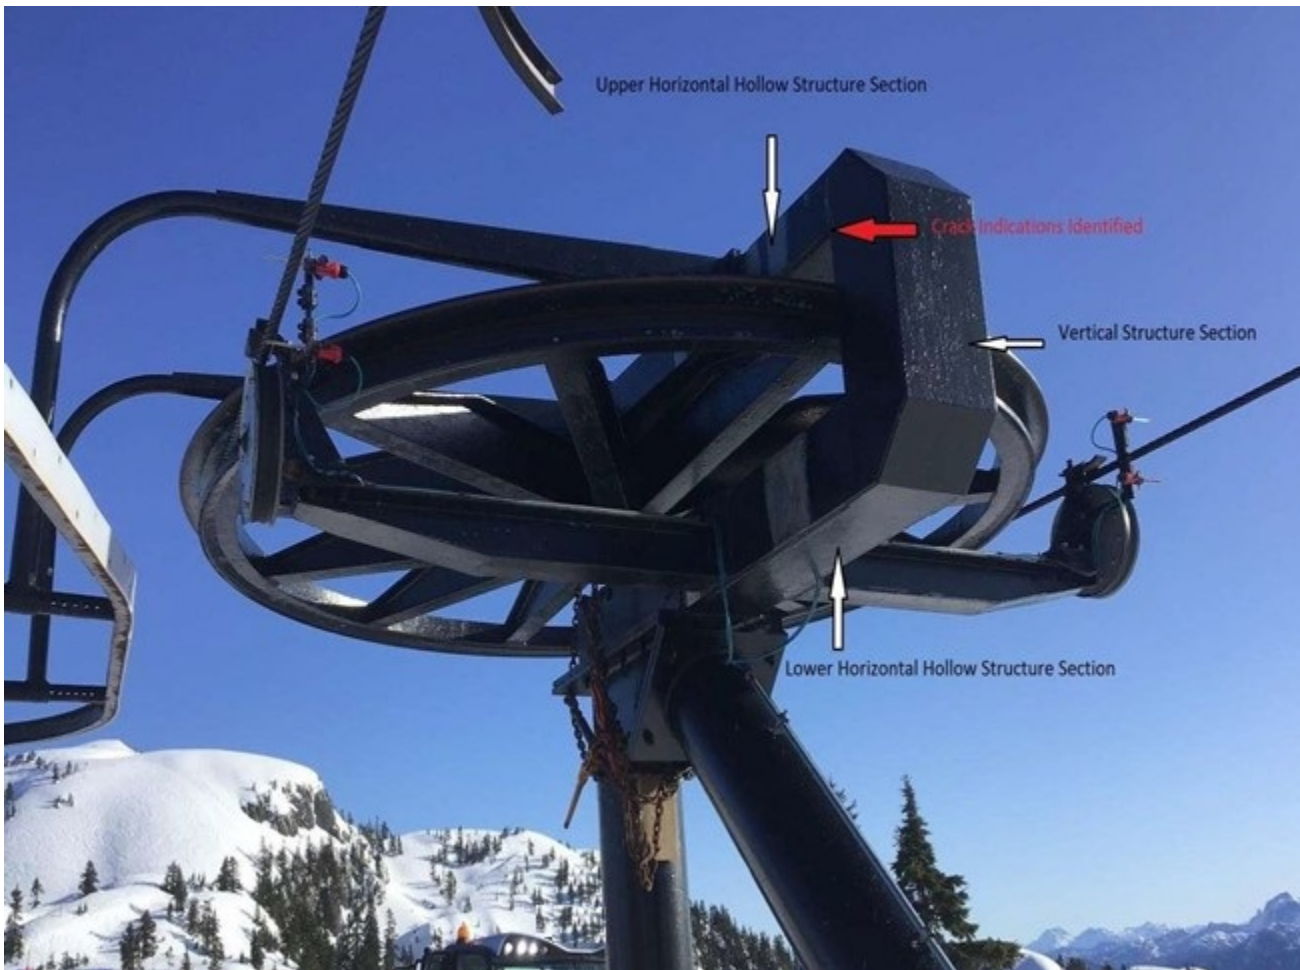
Photo 2, Bull Wheel F Frame Labeled, Guide Sheaves Shown in Photo

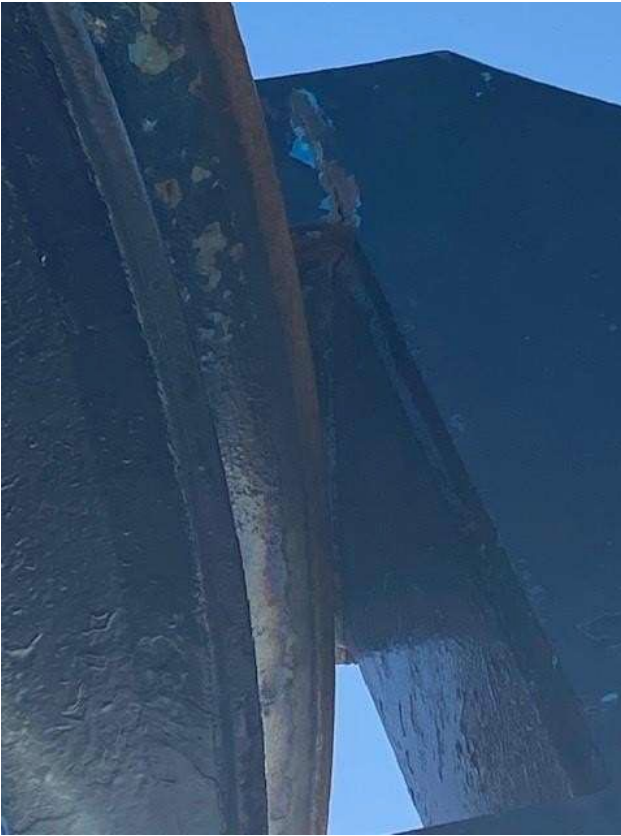
| | | Damage | Damage description | <ul style="list-style-type: none">The bull wheel axle was observed to have migrated 4” up from its normal working position.Cracking indications identified in the bull wheel support structure (F Frame). |

Photo 3, Crack Indication in F Frame. See Photo 2.

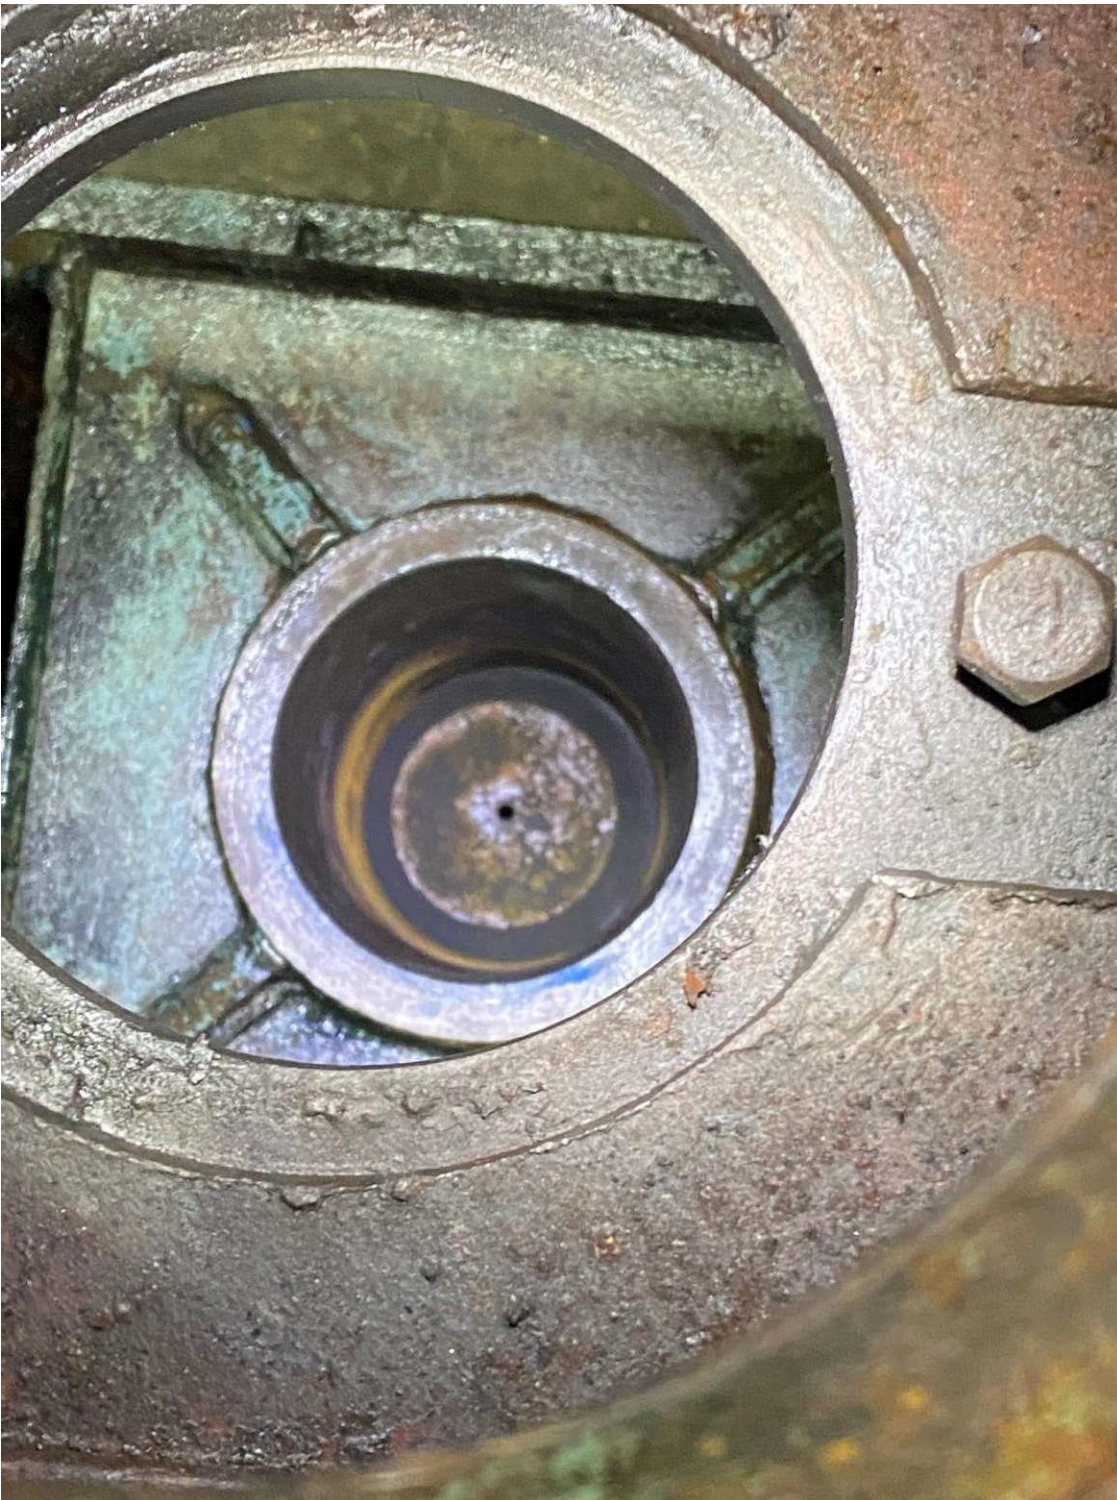
| <p>Causes and contributing factors</p> | <p>Rust observed in the lower horizontal hollow structure section bull wheel axle bore provides evidence that it is very likely that water had collected at the bottom of the axle bore (between bottom of the axle bore and the bottom free-floating end of the bull wheel axle). The absence of drain hole(s) would have certainly prevented the egress of accumulated water. The accumulation of water at the bottom floating end of the bull wheel axel would very likely be subject to freezing resulting in a likely ice jacking condition.</p> <p>Porosity observed in the original welding of the lower axle bore may have provided an ingress point for moisture to enter the lower bore.</p> <p>With the bull wheel axle and bull wheel having migrated upward into the upper fixed end in the axle bore (bore situated in the upper horizontal hollow structure of the F frame) the upper horizontal hollow structure of the F frame is not only subjected to the intended horizontal loading but also an upward vertical force. This factor was the very likely cause of the cracking indication identified in the upper horizontal hollow structure of the F frame.</p> |

Photo 4, Photo of upper and lower bull wheel axle bore (axle and sleeve removed). Looking through both the upper and lower horizontal hollow structure sections (*note, rust in lower bore) (**note, the small hole in the lower bore did not provide a drainage feature).

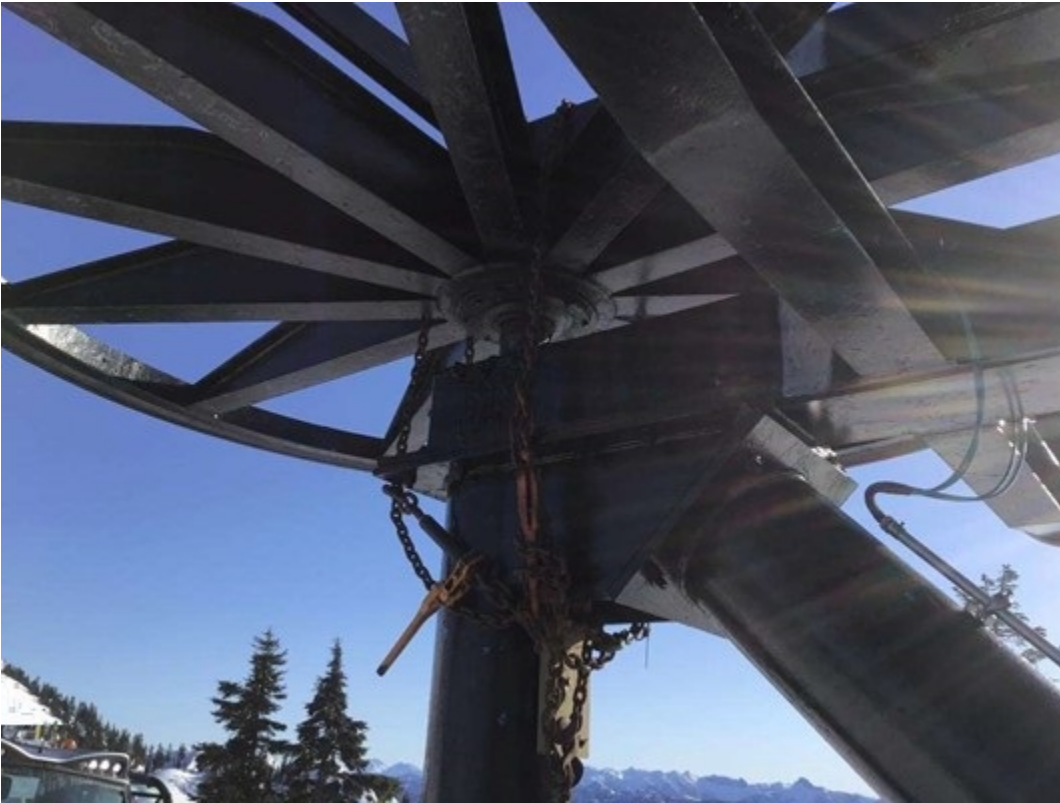
| | Return station bull wheel axel and bull wheel assembly had migrated upward (approximately 4" from its original working position). |

Photo 5, Bull wheel (chains and load binders installed to prevent further lifting of the bull wheel assembly).
