Incident Summary #II-1526459-2023 (#33813) (FINAL)

SUPPORTING INFORMATION	Incident Date	March 22, 2023	
	Location	Lower Mainland	
	Regulated industry sector	Passenger ropeways - Above surface ropeway	
	Impact	Qty injuries	0
		Injury description	N/A
		Injury rating	None
	Damage	Damage description	A bolt used to align a sheave assembly was found to be broken during a periodic inspection.
		Damage rating	Moderate
	Incident rating	Moderate	
Incident overview	While maintenance staff were performing a routine periodic inspection, a tower alignment bolt was found to be broken. The bolt was replaced as per manufacturers specifications and procedures, and after testing, the ropeway was returned to normal operations.		
INVESTIGATION CONCLUSIONS	Site, system and components	<p>In this ropeway configuration, tower sheave assemblies are aligned using two bolts. These bolts are used to align sheave assemblies on the vertical and horizontal plane to ensure the haul rope runs in the centre of the assembly sheaves and position the ropeway cable so it can be monitored by the ropeway's safety circuit tower mounted switches.</p> <p>Specifications and procedures for the use and setting of the alignment

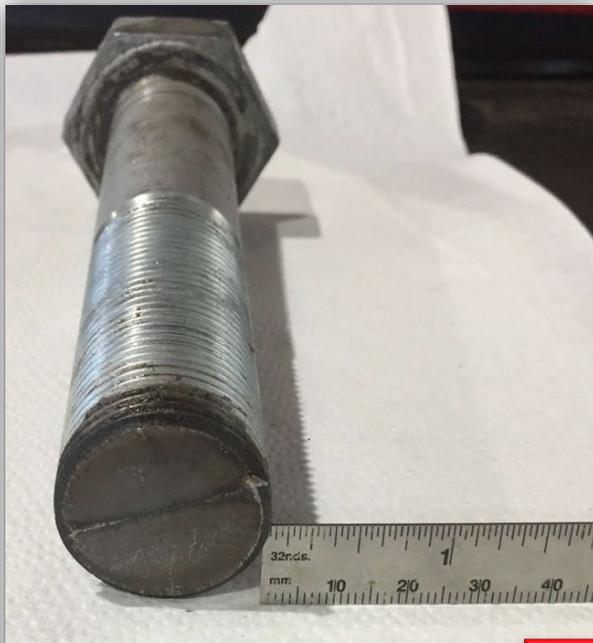
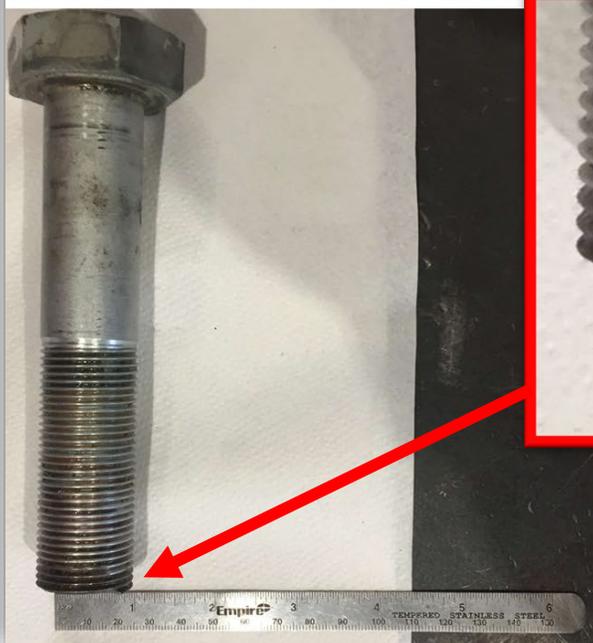
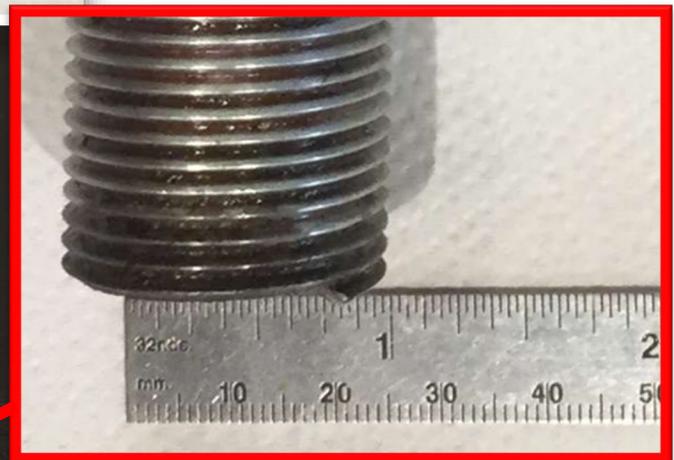
- Manufacturer provided specifications and procedures for installation and alignment of tower assemblies using the X/Y bolts.
- Independent laboratory report produced from analysis of the broken bolt attributes the broken bolt to a resonant vibration condition.

The failure of the X/Y bolt was likely caused by sustained vibrations caused by normal operating conditions of the ropeway.

X/Y bolt - The bolt broke off at the root of the threaded section of the bolt, the other section of the broken bolt was destroyed during extraction.

Failure scenario(s)	<ul style="list-style-type: none"> March 22, 2023, while performing monthly periodic tower inspection, maintenance staff found the broken bolt Tower 32 downhill side. Bolt was replaced as per manufacturers specifications and procedures and the ropeway was put back in normal operation. 	
	Facts and evidence	<ul style="list-style-type: none"> 2012 Safety Order SO-PR-2012-2 was issued to all duty holders with this configuration of ropeway. May 16, 2013, Safety Order Response Form received from the duty holder verifying that all X/Y bolts had been changed to rolled thread. 2015 Tower 32 downhill side assembly was rebuilt, and X/Y bolts were replaced again at this time. Safety order response form was received as per the requirements of the Safety Order for this ropeway. Work order was produced by the duty holder from the rebuild of Tower 32 downhill side in 2015. Tower 32 is a compression tower, where the haul rope is held down by the sheave assemblies. As the raised profile of the carrier grip passes through the sheave assembly, vibration is created. This vibration is accounted for in the design.
