## Incident Summary Reference #5616081 - Final

SUPPORTING INFORMATION	Incident Date			May 17, 2017
	Location			Peace River Region
	Regulated industry sector			Boiler and Pressure Vessel
	Impact	Injury	Qty injuries	None
			Injury description	None
			Injury rating	None
		Damage	Damage description	Loss of equipment
			Damage rating	Major
		Incident rating		
	Incident overview			May 18, 2017 initial notification received indicated that: The plant facility received an alarm from its fire detection system; and a loss of containment of process involving a fire occurred.
INVESTIGATION CONCLUSIONS	Site, system and components		<p>A pressure vessel separator was involved in this event. The vessel separates gas from liquids during processing. A safety relief valve protects the vessel from an overpressure event.</p> <p>This separator has an 18 inch manway door for access to the units inside compartment. A gasket is used to seal the 18 inch door. During the analysis of the event it was revealed that the wrong size of gasket may have been used.</p>

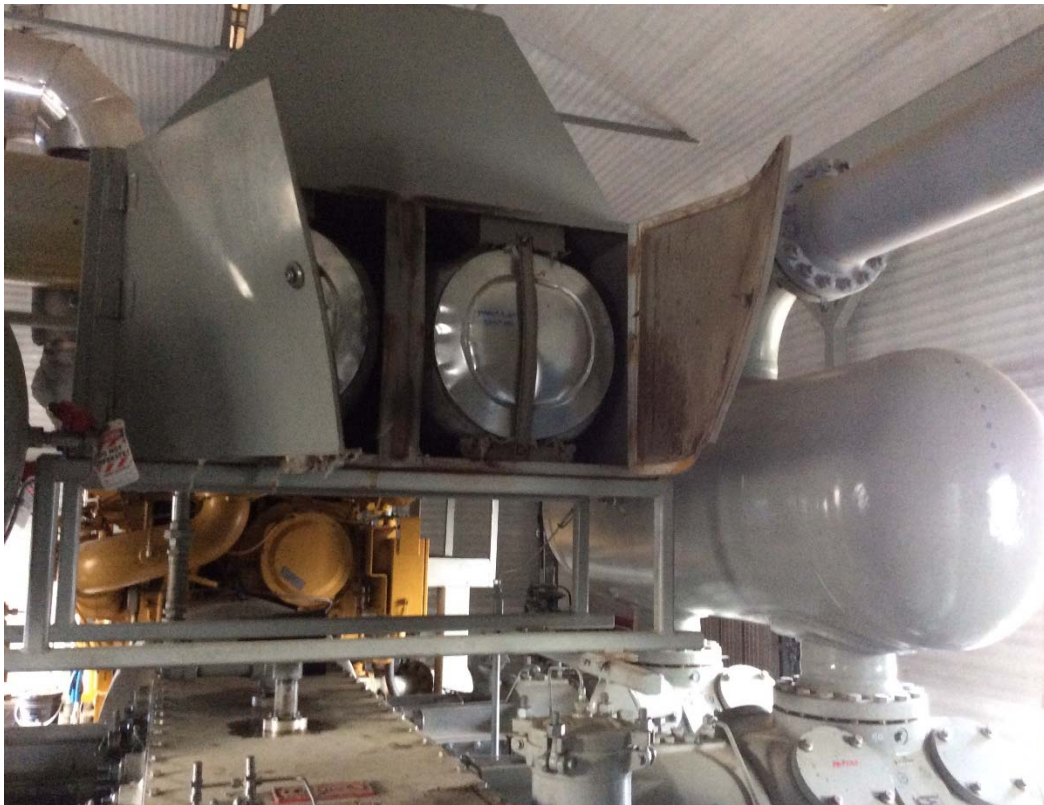
**K-440 Compressor intake – may have contributed to ignition of vapour cloud - notice damaged doors**

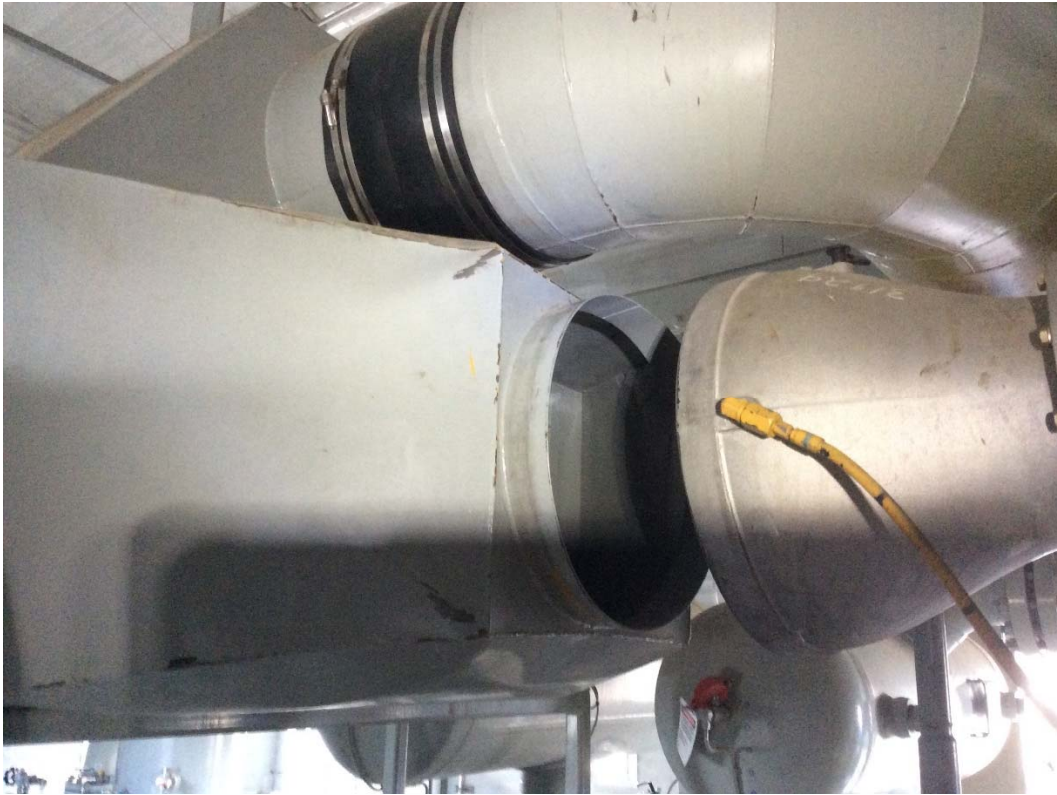
**K-440 Compressor damage on rear side of air intake assembly**

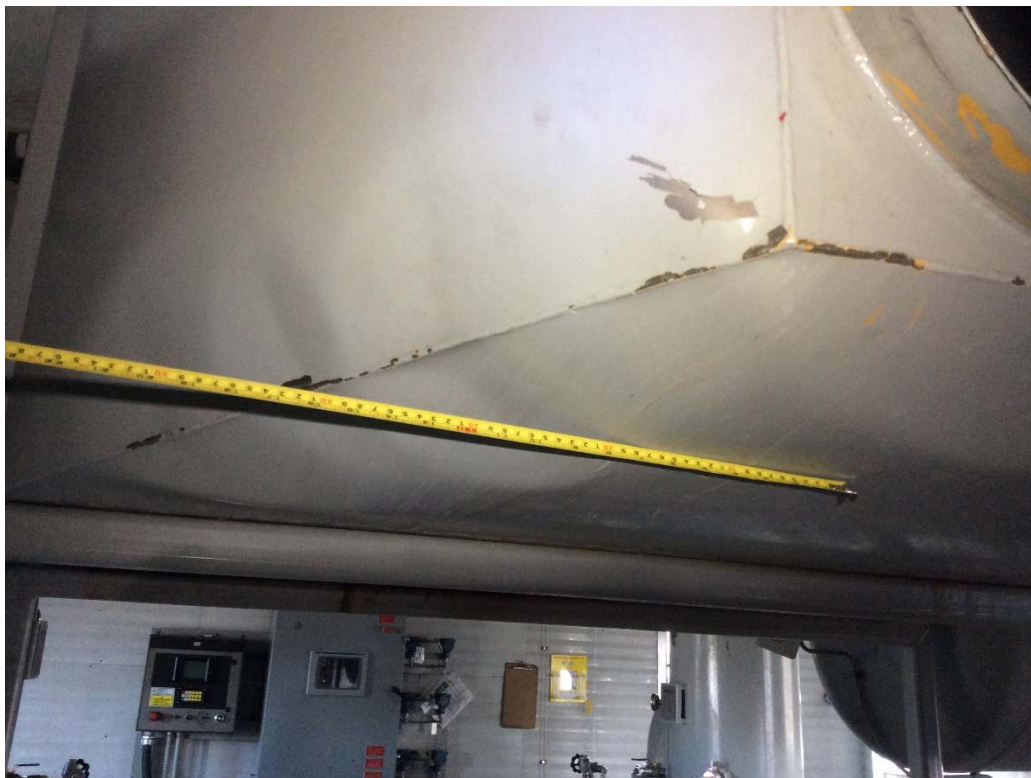
**K-440 rear damaged intake as observed – note intake bulged**

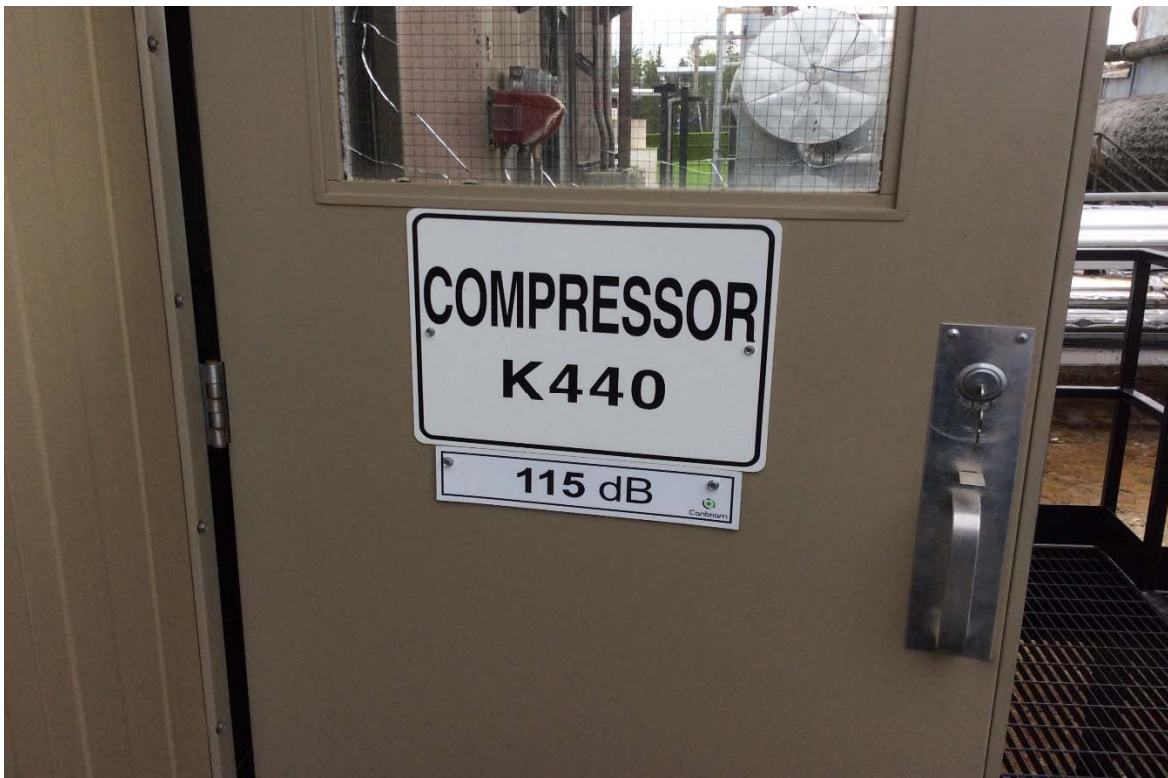
**K-440 Compressor doorway – Note broken safety glass**

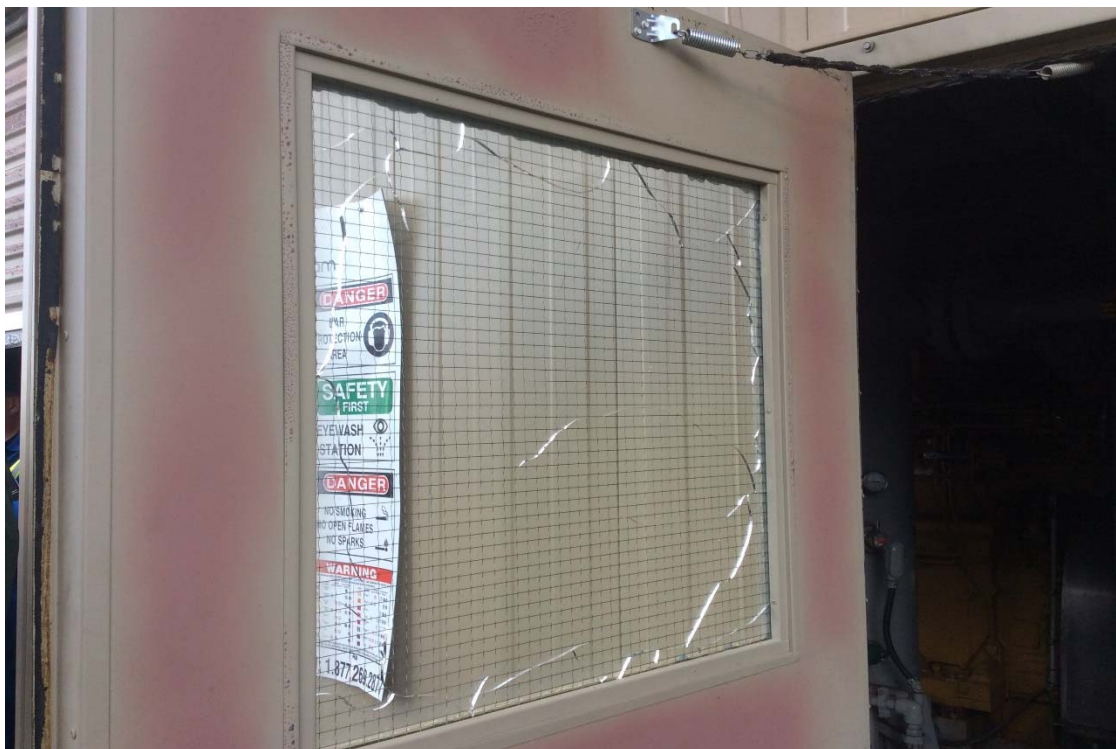
**K-440 building door- note heat pattern around broken window**

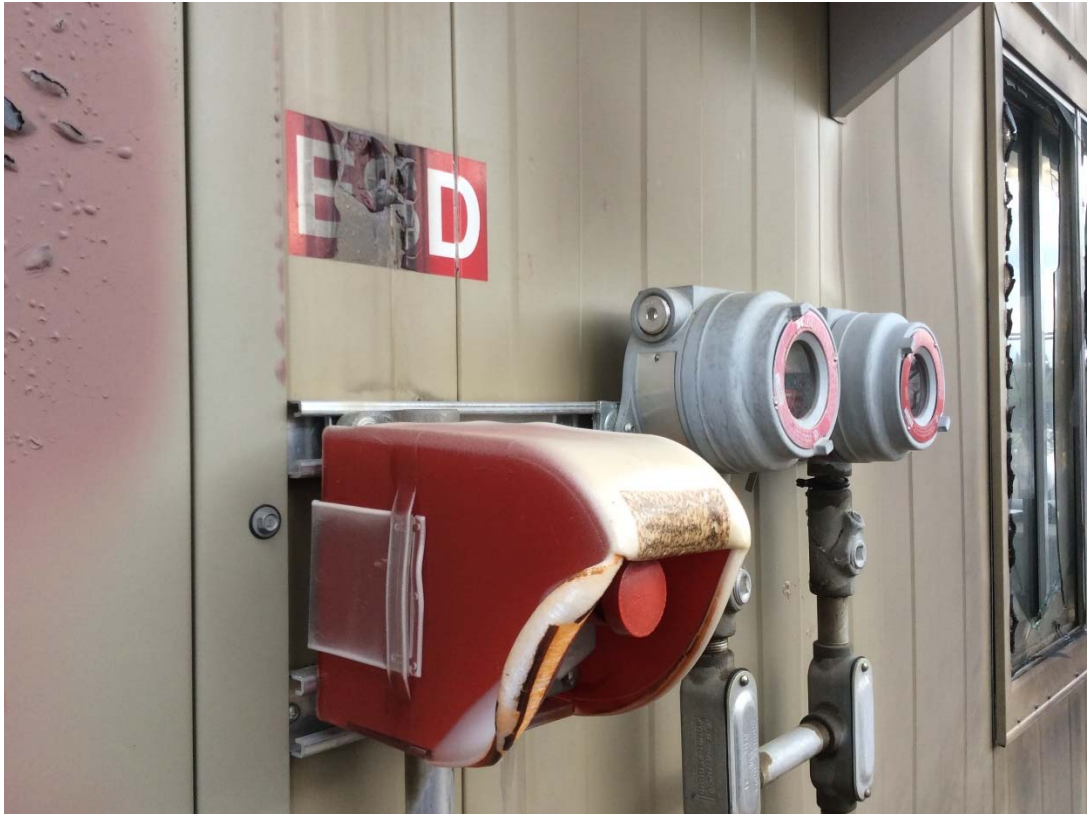
**K-440 Compressor building melted ESD button**

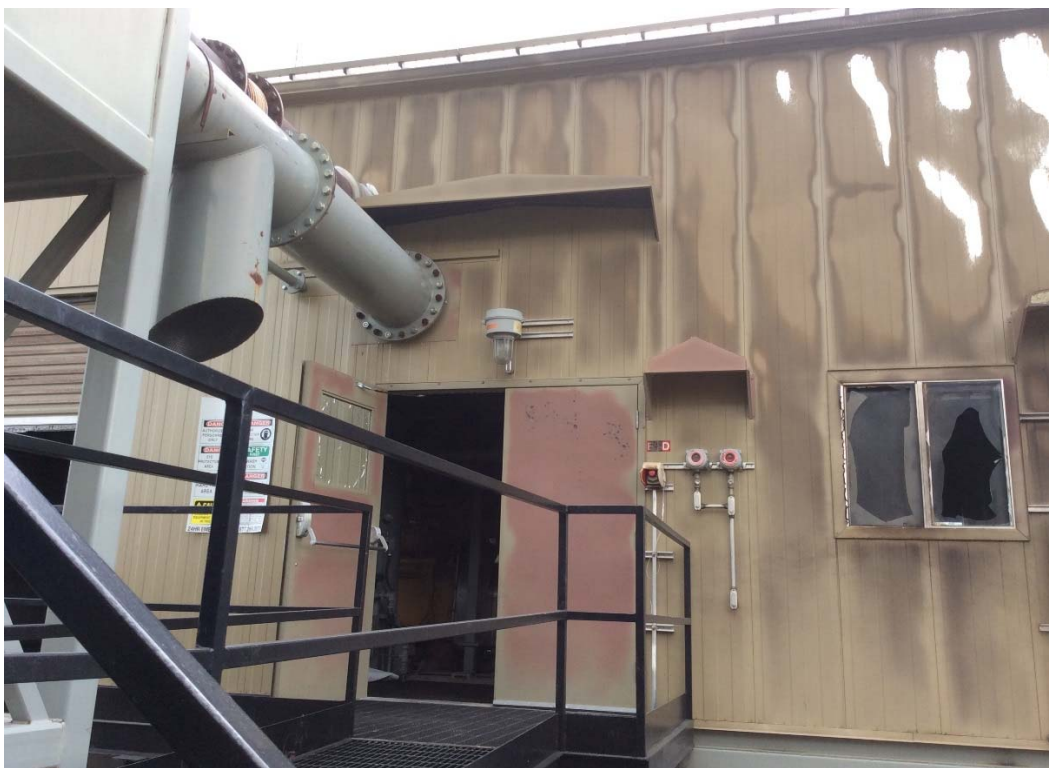
**K-440 Compressor building melted paint, windows and exterior steel wall**

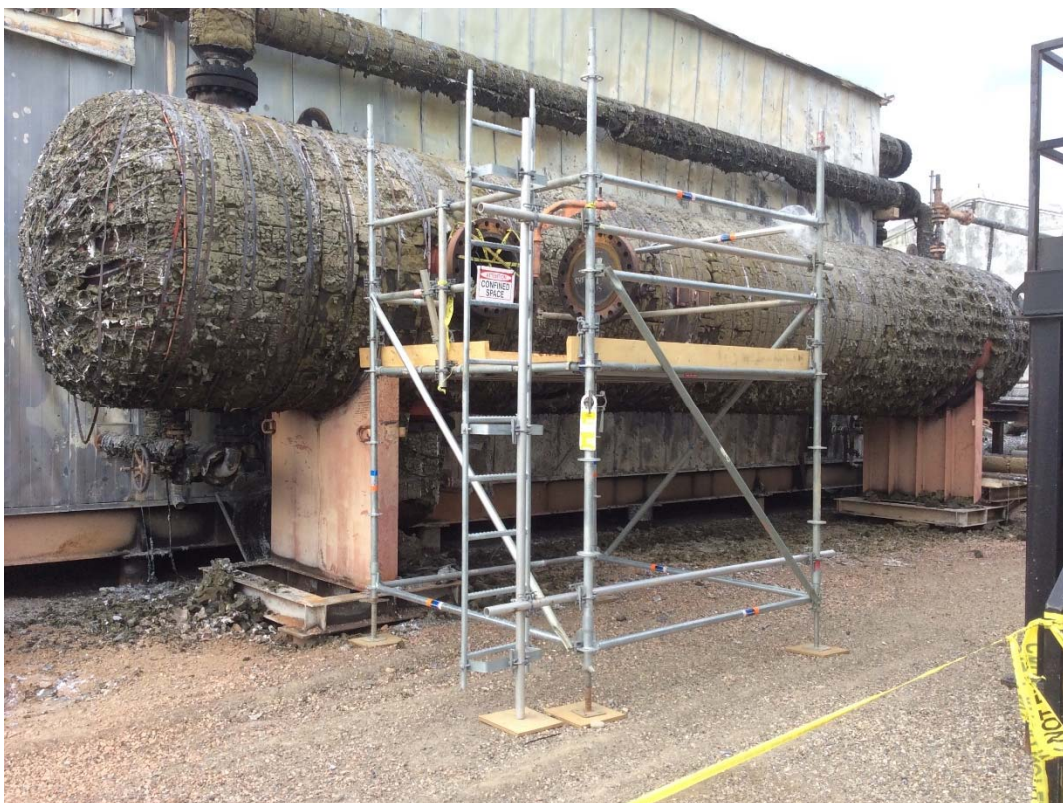
**V-665 Low Temperature Separator – exterior fire damaged.**

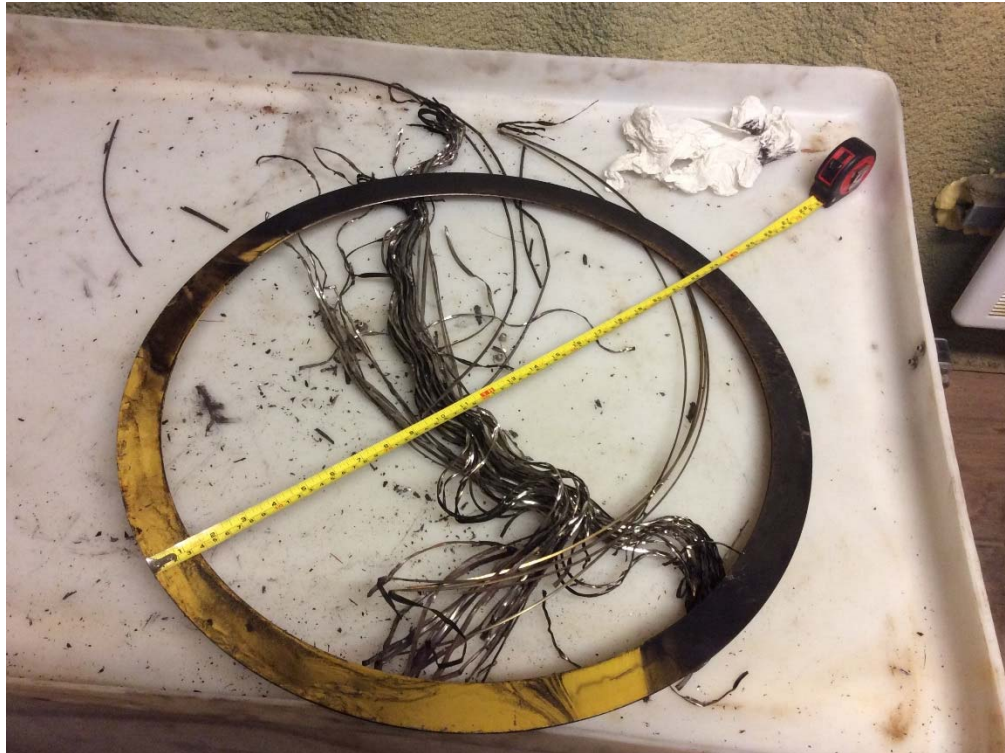
Failure scenario(s)		<ol style="list-style-type: none"><li>1. A Contributing factor may have been the wrong class series of gasket used – a class 300 was used instead of a class 600. Each gasket class has different dimensional sizes which if the correct size is not used, may contribute to failure of the gasket.</li><li>2. Safety relief valve may not have functioned as intended,</li><li>3. A vapour cloud may have leaked out of the 18 inch inspection nozzle (manway) and may have been ignited by compressor</li></ol>	
	Facts and evidence		<ol style="list-style-type: none"><li>1. The 18 inch door gasket indicates class 300 series,</li><li>2. The safety relieve valve examined by valve service shop indicated that the valve set pressure could not be determined,</li><li>3. Security footage shows ignition of a possible vapour cloud just after operator entered the control room</li></ol>	
	Causes and contributing factors		<ol style="list-style-type: none"><li>1. A contributing factor may have been that the wrong gasket class (size) was used</li><li>2. The safety relief valve may have failed to operate as designed.</li></ol>

**V-665 Low Temperature 18 Inch Inspection Nozzle gasket – removed by Owner representative**

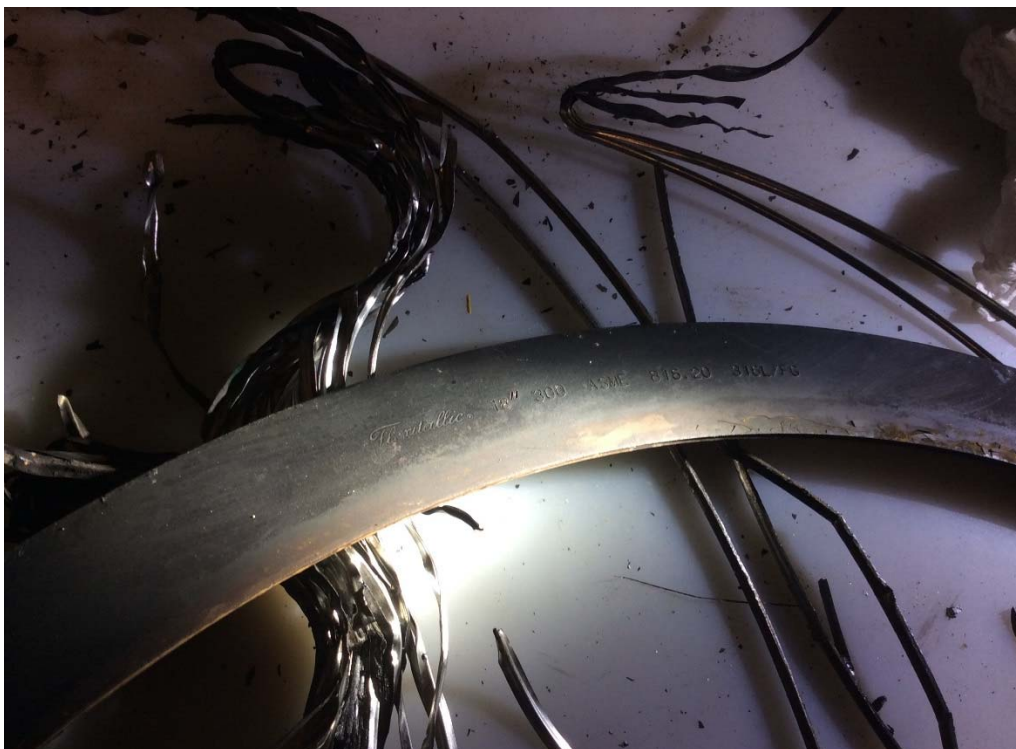
**V-665 Low Temperature 18 inch Inspection Nozzle gasket – Note: rated only for 300 lbs class**

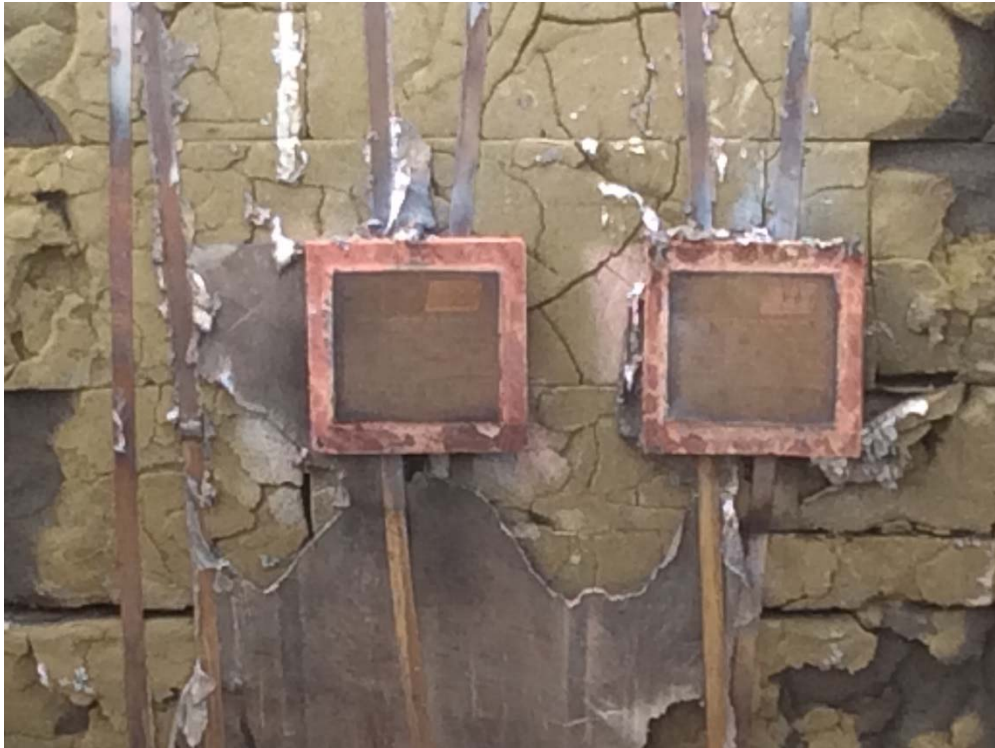
**V-665 Low Temperature Separator – Nameplates damaged by fire.**
