Incident Summary #II-1265213-2021 (#24329) (FINAL)

SUPPORTING INFORMATION	Incident Date		October 5, 2021
	Location		Burnaby
	Regulated industry sector		Gas - Natural gas system
	Impact	Qty injuries	0
		Injury description	NA
		Injury rating	None
	Damage	Damage description	Holes in a gas line and an uncontrolled natural gas release into an occupied space.
		Damage rating	Moderate
Incident rating		Moderate	
Incident overview		A natural gas line had holes drilled into it by fastening screws during installation of the microwave's supporting bracket. Natural gas was released from the holes and by way of wall openings into the apartment.	
F INVESTIGATION CONCLUSIONS	Site, system and components	<ul style="list-style-type: none">- The building is a 26 story high rise building of concrete construction. The interior walls of this 17th floor apartment are steel framed with gypsum wall board covering.- The gas riser line feeds multiple floors and is a 1.25 inch black iron schedule 40 pipe with a 0.14 inch (3.556mm) wall thickness. It is run within the steel framed kitchen wall in the apartment space. A gas stove cooking appliance is connected to the gas riser line below the microwave installat

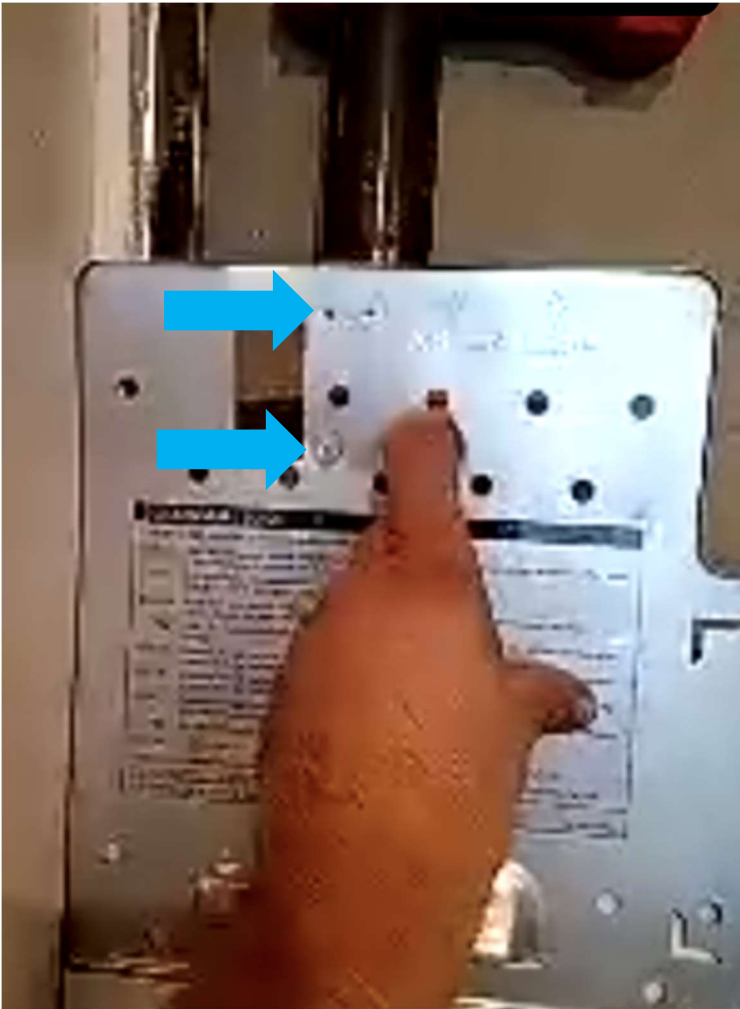
Figure 1 - Mounting bracket, with holes directly in front of gas line

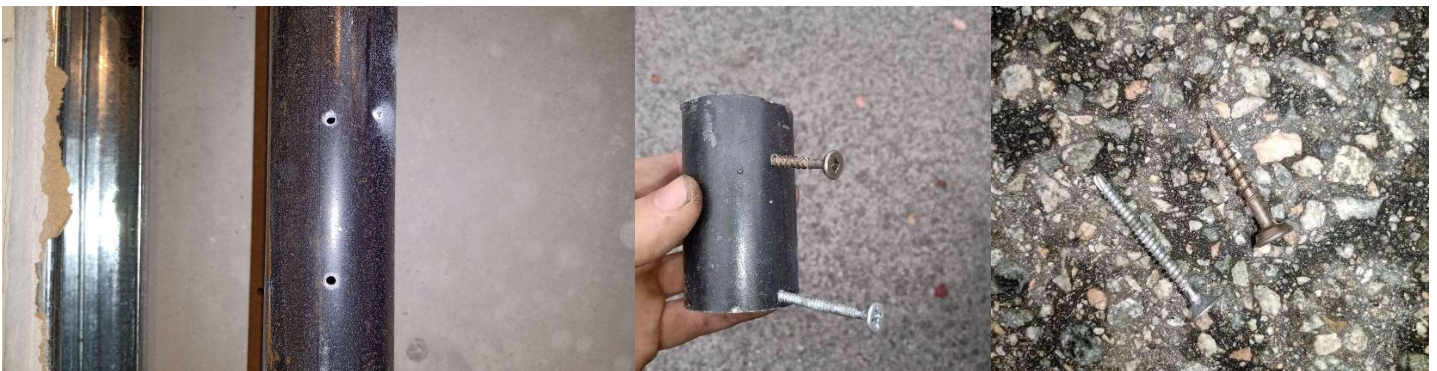
Causes and contributing factors	<p>The incident was caused by the drilling of holes in the gas pipe which was mistaken by the installer of the microwave bracket as a steel stud behind the drywall.</p>

Figure 2 - Gas pipe with holes (left), screws in the pipe (center) and after removal (right)
One of the self tapping screws was likely replaced with a wood screw during install.

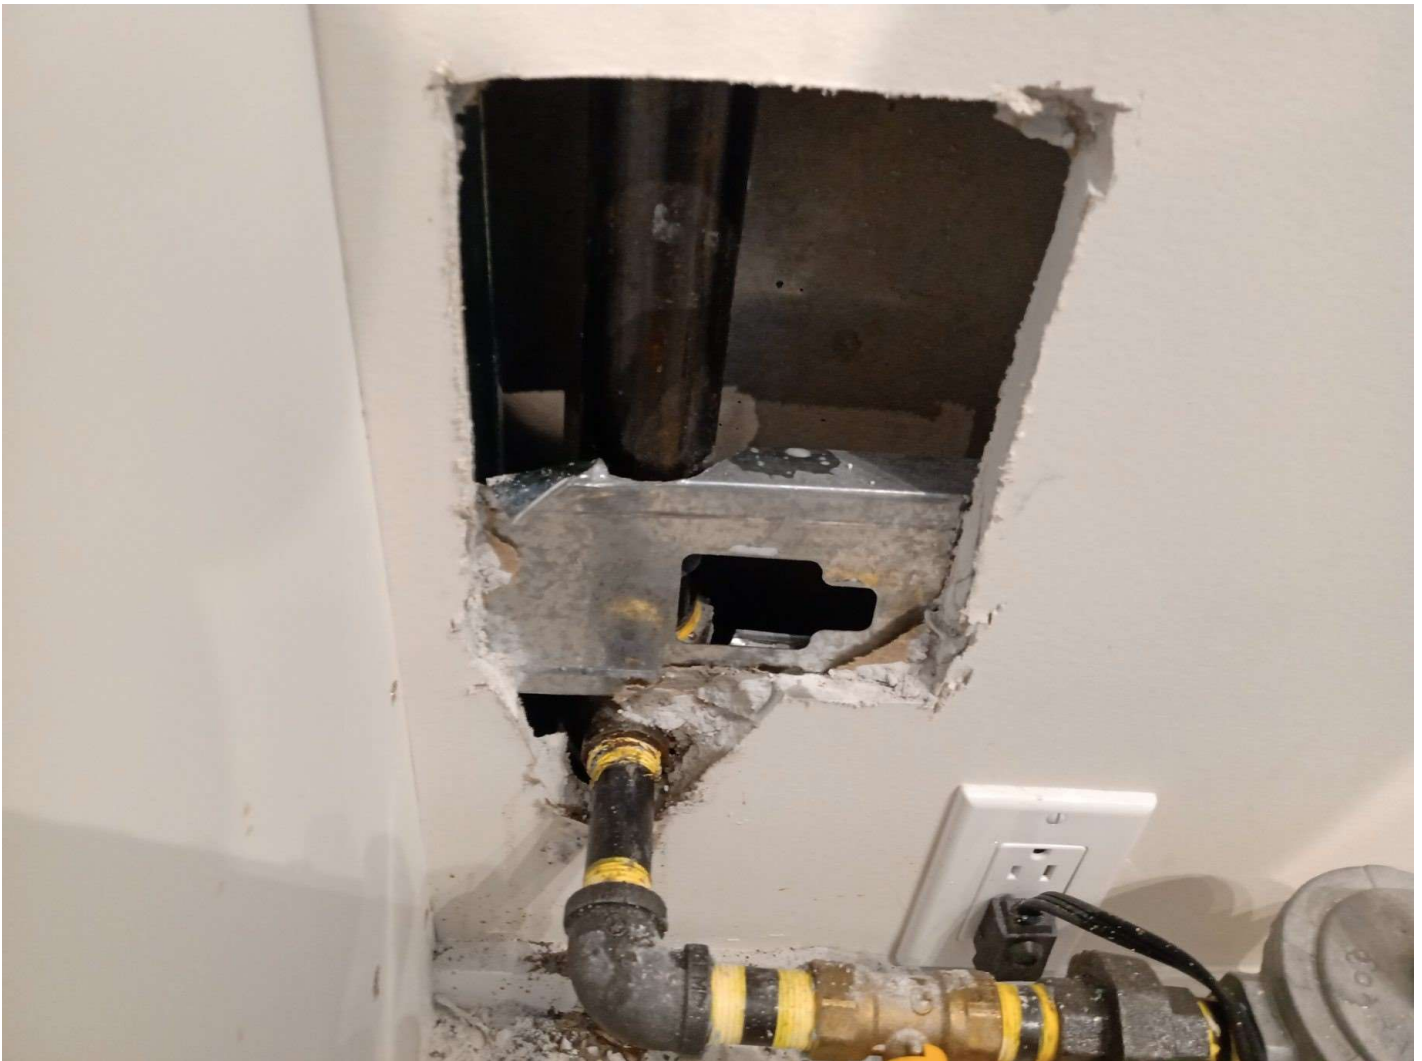
Figure 3 - Gas pipe in the wall

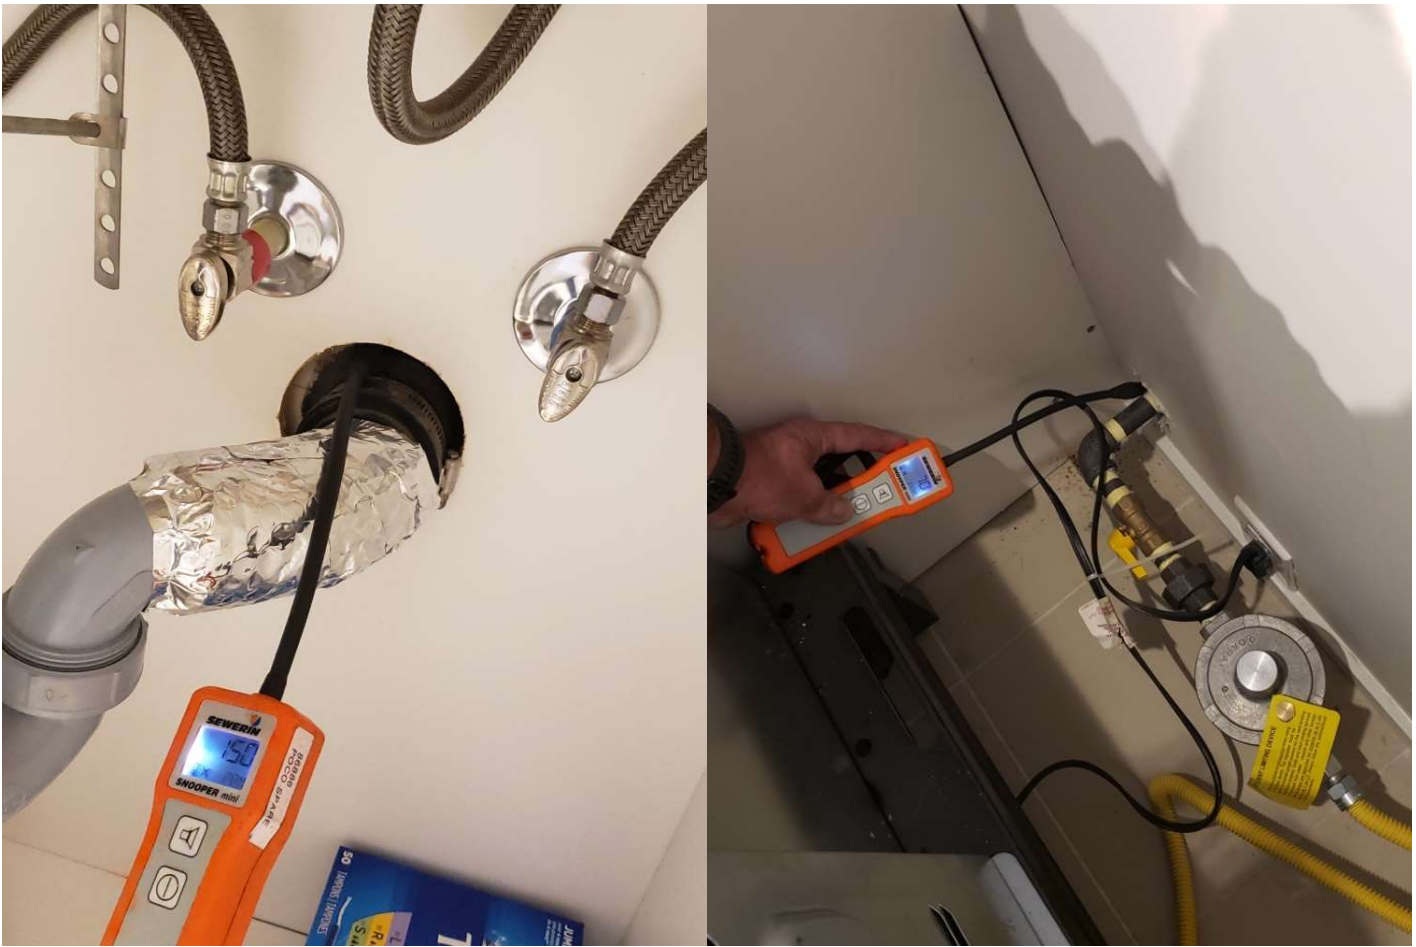
Figure 4 - Utility gas technician test results 150 parts per million (ppm) under bathroom sink (left) and 70 ppm behind kitchen stove (right)
