Incident Summary #II-1424820-2022 (#29512) (FINAL)

| | Incident Date | | August 22, 2022 |
|---|---|---|---|
| SUPPORTING INFORMATION | Location | | Quesnel BC |
| | Regulated industry sector | | Electrical - Low voltage electrical system (30V to 750V) |

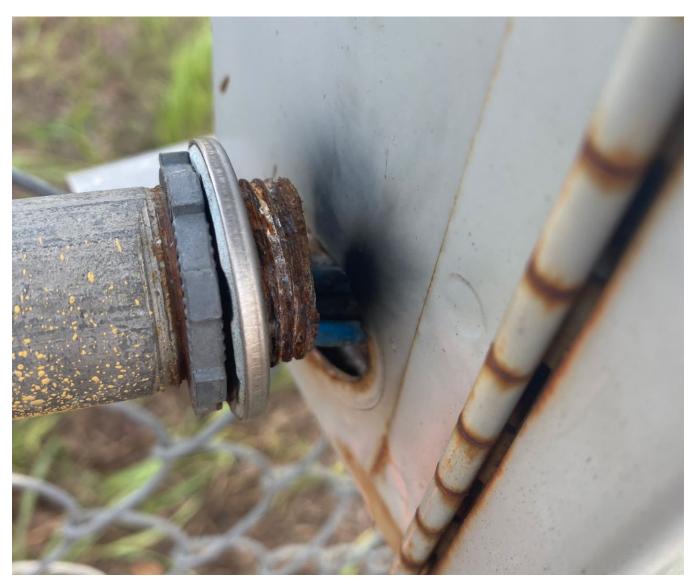
| | Incident Date | | August 22, 2022 |
|---|---|---|---|
| | Failure scenario(s) | | The wiring in the conduit was pinched against the metal enclosure and the insulation was damaged. The energized conductor contacted the enclosure and energized it. Normally, there is a good connection to ground through the bonding system, and a fault is cleared by the breaker tripping. In this case the bond path was lost, so the metal just became energized. |
| | Facts and evidence | | Photos provided show no bond wiring installed through the conduit. The installation was relying on the conduit itself for bond path. This bond path was lost when the locknut became loose. The Photo also shows the conductors in contact with the enclosure. |

Photo 1 - Conductors in contact with enclosure

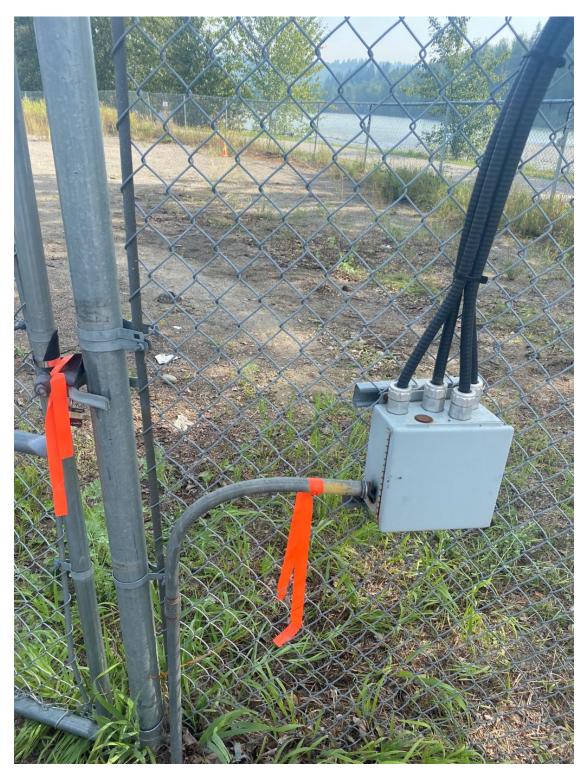
Photo 2 - Overall site view

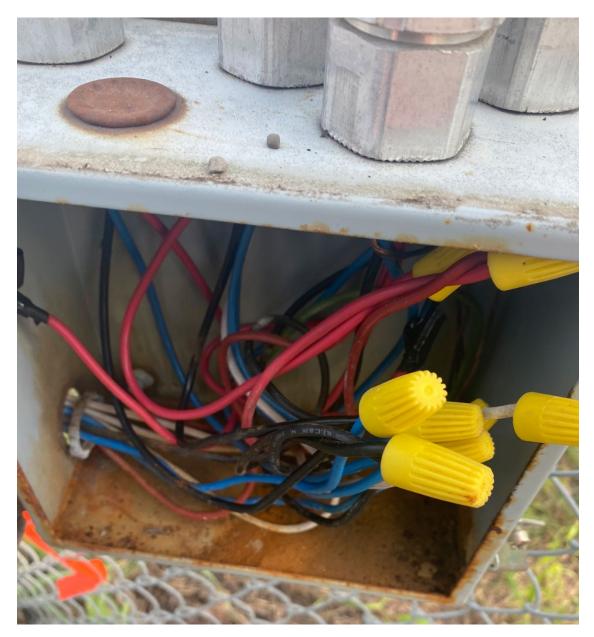
Photo 3 - Conductors in splice box
