## Incident Summary Reference for II-757706-2018 (9168)

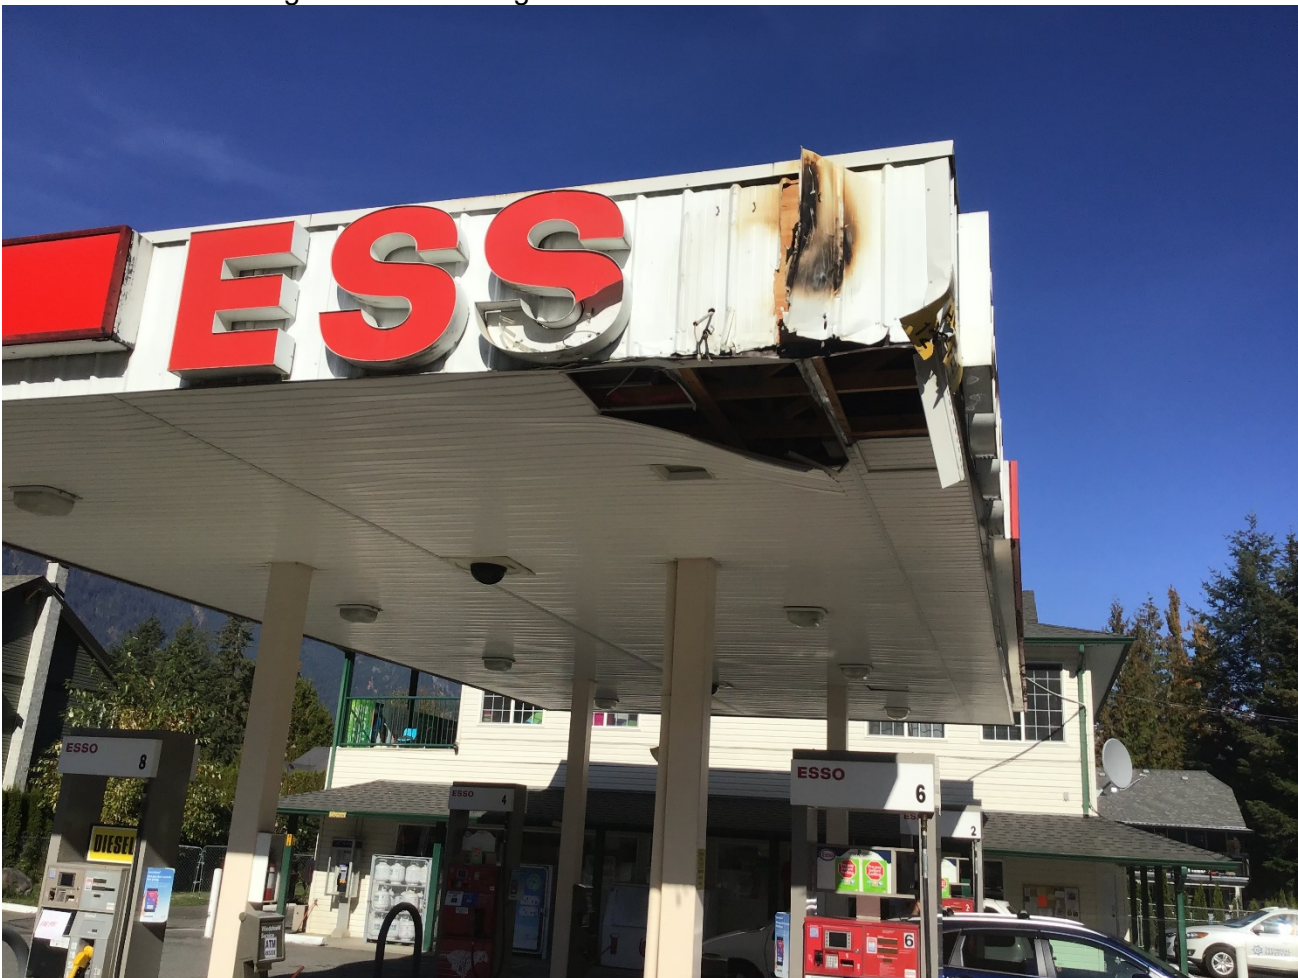
Statements from Dickson Signs -The operation and the wiring connection used on these signs and the damage to the canopy
Causes and contributing factors	It is possible that this fire was caused by the high voltage wiring coming in contact with the plywood backing of the sign from previous damage to the canopy.

Photo of the ESSO Sign and the missing "O"

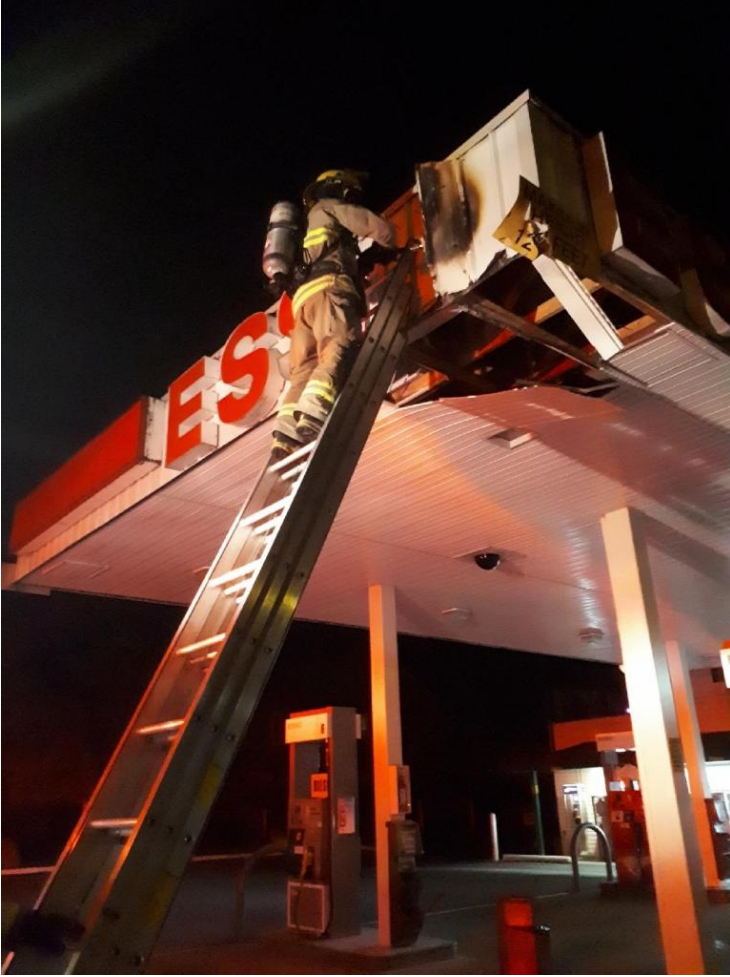
A Photo provided by to Hope Fire Department taken the night of the fire

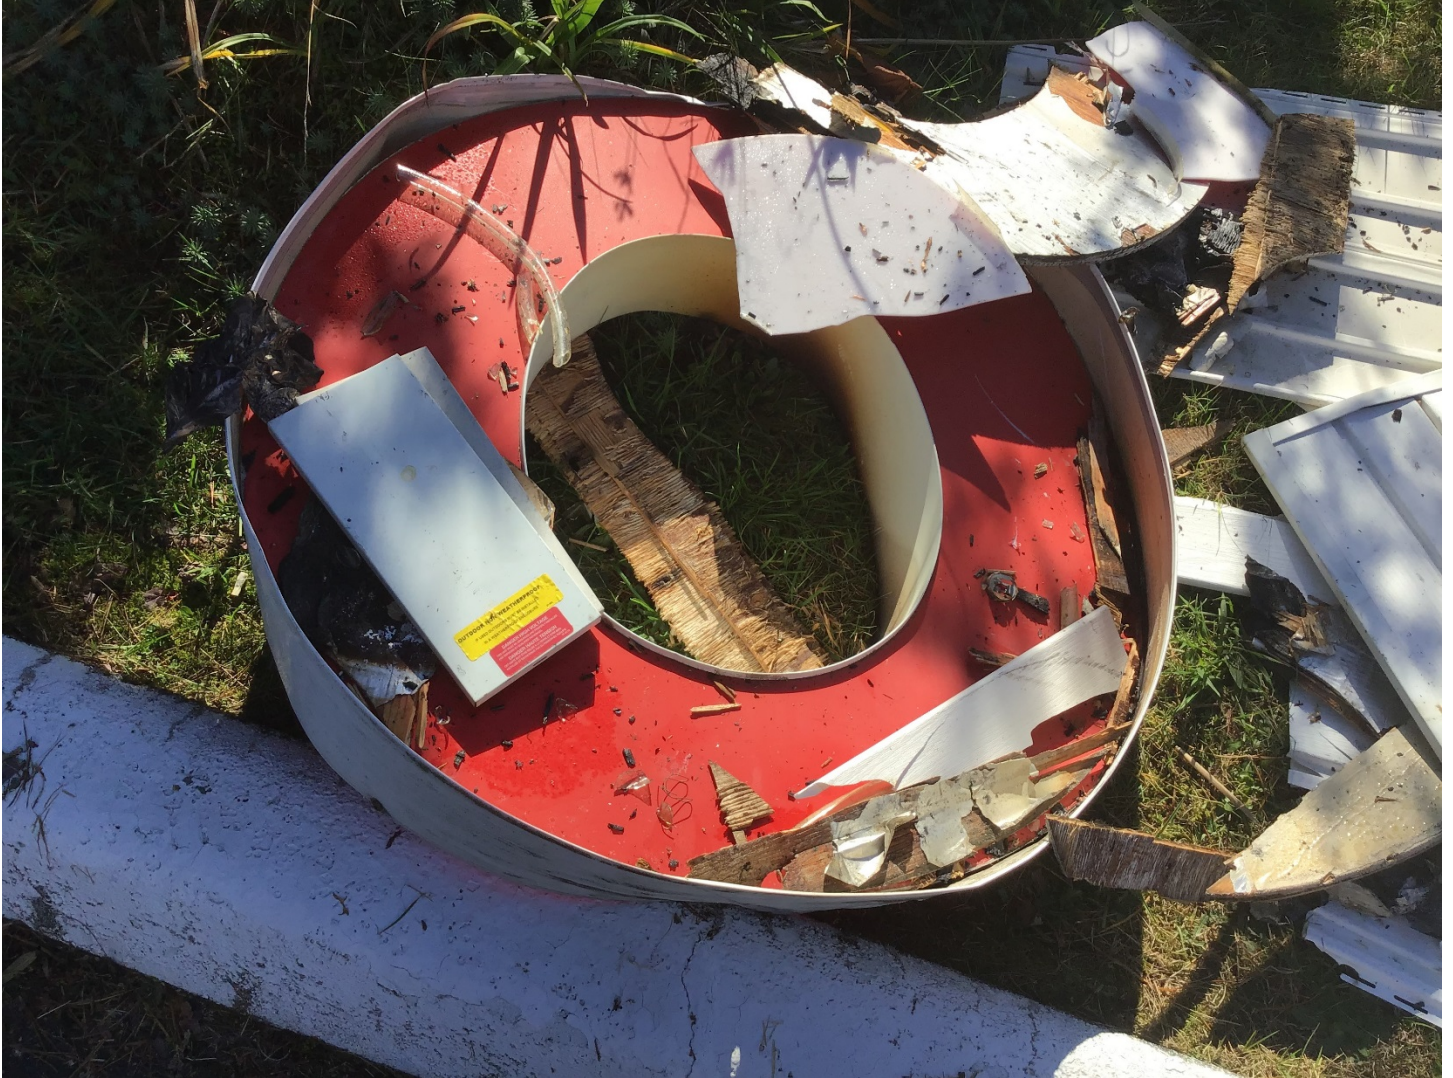
Failure scenario(s)	<p>Before the fire it is thought that a large vehicle had stuck the canopy. The striking of the canopy caused the glass tube with the high voltage neon wiring light connection to break, allowing the high voltage connection to touch the plywood backing of the sign.</p> <p>Over time with the high voltage neon sign wiring in contact with the plywood backing, and with the signs being turned on and off, this would cause a slow burn of the plywood.</p> <p>On the night of October 14 2018 there was a fire at the letter "O" of one of the 3 signs.</p>	
	Facts and evidence	<p>Facts and Evidence are based on the following</p> <p>Observations made at the site -Charring of the plywood backing</p> <p>Statements from the Hope Fire Department -They observed the damage to the canopy near the sign</p>

A photo of the letter "O" after the fire
