Incident Summary #II-882604-2019 (#14507) (FINAL)

SUPPORTING INFORMATION	Incident Date		June 30, 2019	
	Location		Nanaimo	
	Regulated industry sector		Electrical - High voltage electrical system (greater than 750V)	
	Impact	Injury	Qty injuries	0
			Injury description	None
			Injury rating	None
		Damage	Damage description	Main high voltage interrupting switch for a transformer failed when opening. Two of the phase interrupters failed catastrophically erupting the outer porcelain housings.
			Damage rating	Major
		Incident rating		Major
	Incident overview		<p><i>*The following fields of information are taken from an independent engineering report. The report is attached to the incident file listed above and referenced here within.</i></p> <p>During a routine isolation process to install equipment and record measurements to facilitate future retrofit installations of breakers, A main high voltage interrupting switch for a transformer failed when opening resulting in an arc flash and damage to the equipment.</p>

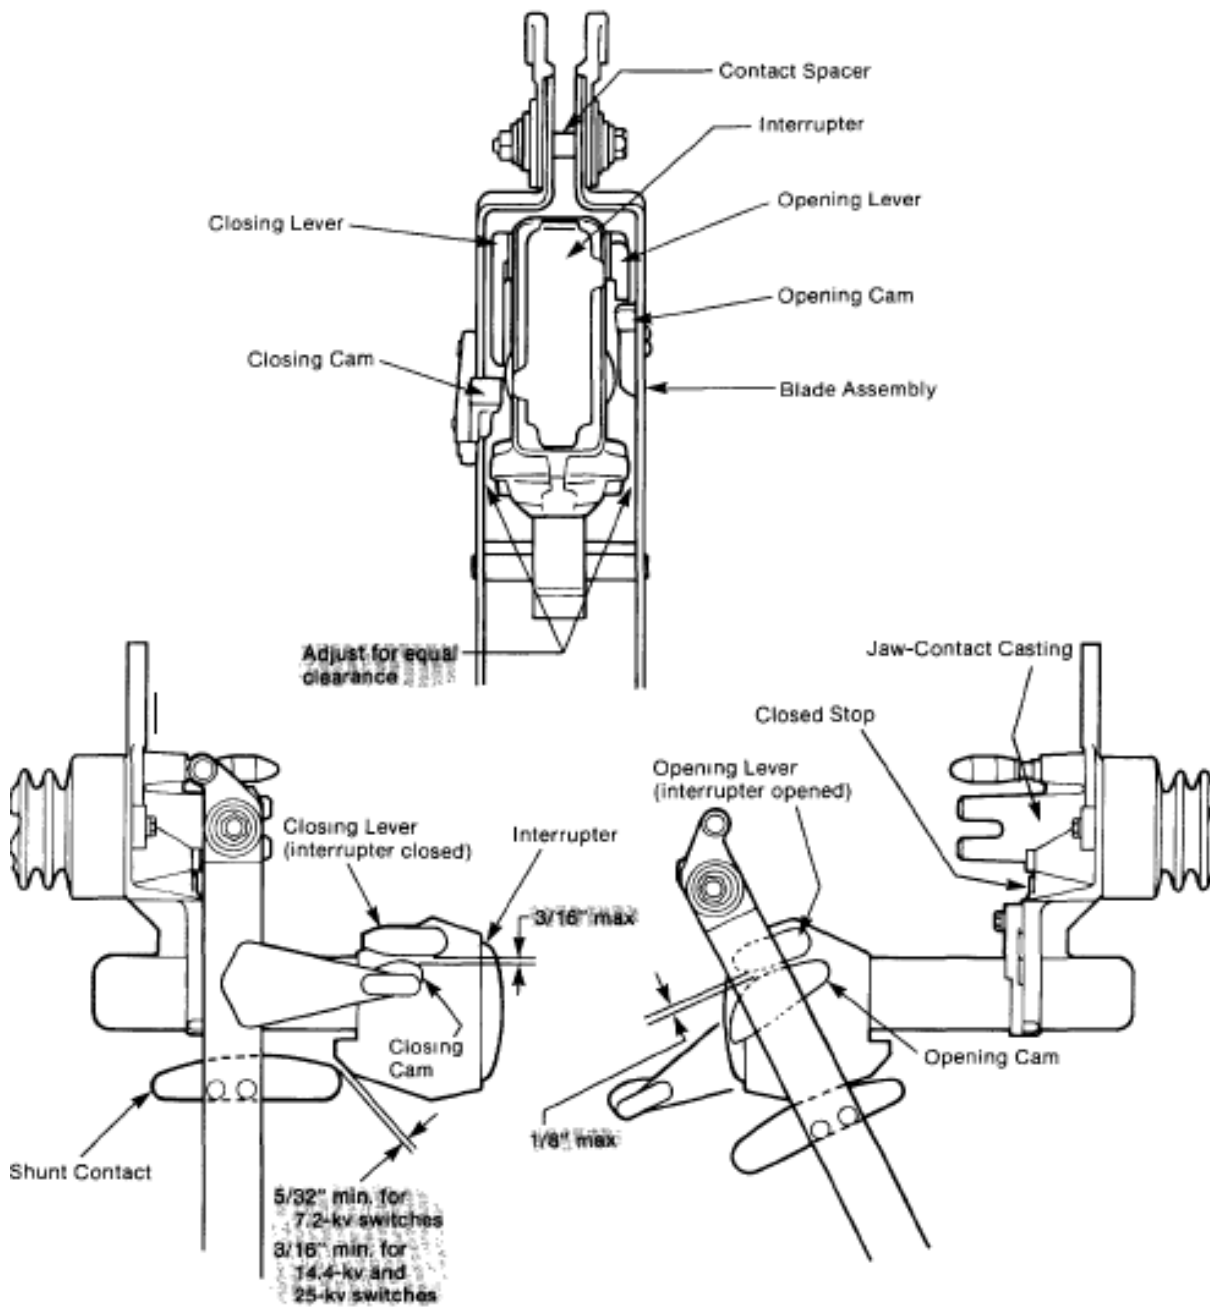
Detail of switch components

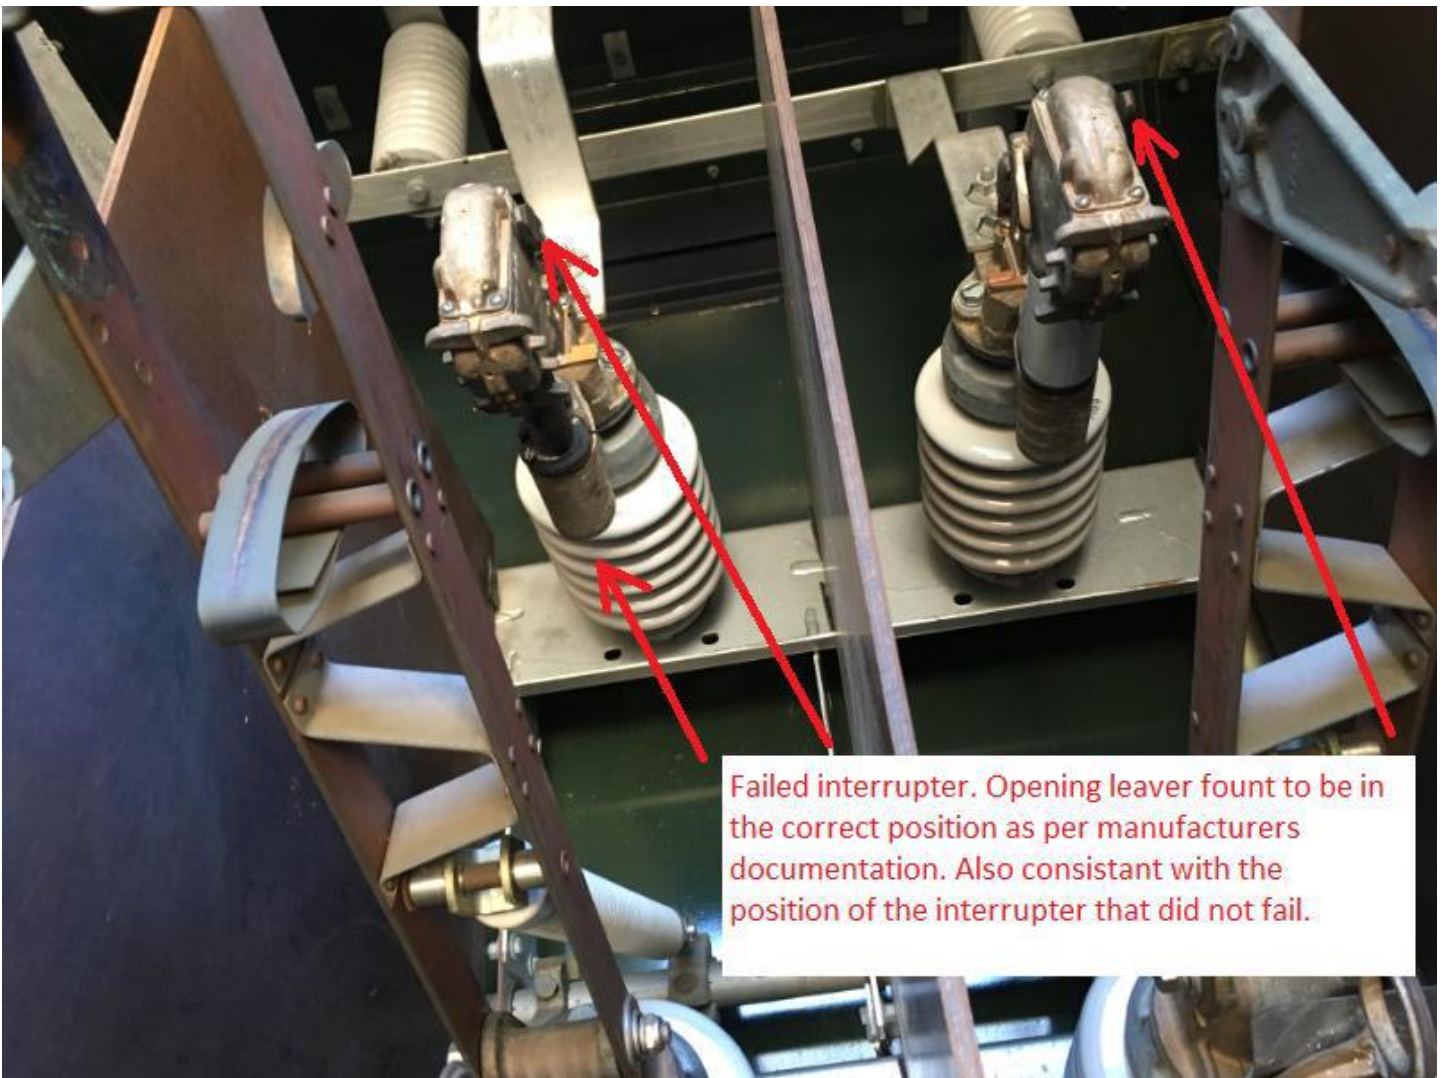
<p>4. The interrupter mechanism simply failed on two of the three phases. The pull in plunger may have moved away from the stationary contact, however the trailer mechanism did not engage properly, and the deionizing gas did not blow out the arc.</p>
Facts and evidence	<p>Upon inspection immediately following the incident, the opening and closing levers on all three interrupter chambers did appear to be in the correct positions.</p> <p>When personnel operated the switch there was a noticeable lag between the sound of the switch mechanism completing its travel and the fault that occurred soon thereafter. The flash over marks indicate that for one of the reasons noted above the interrupter did not sufficiently extinguish the arc within the interrupter as designed.</p> <p>As the switch travelled to the open position the arc was maintained creating a phase to phase fault which was cleared by the upstream pole mounted recloser.</p> <p>From discussions with the manufacturer, these interrupters have a 20-25-year life span before correct operation of the interrupter could become unreliable. The majority of the major electrical distribution system is approximately 40 years in age.</p>

Causes and contributing factors	<p>It is likely that the switch and internal components exceeding the manufactures recommended life span caused the failure of the switch to interrupt the electrical circuit without an arc and caused the interrupter to fail to extinguish the arc as designed.</p>

Failed Interrupter

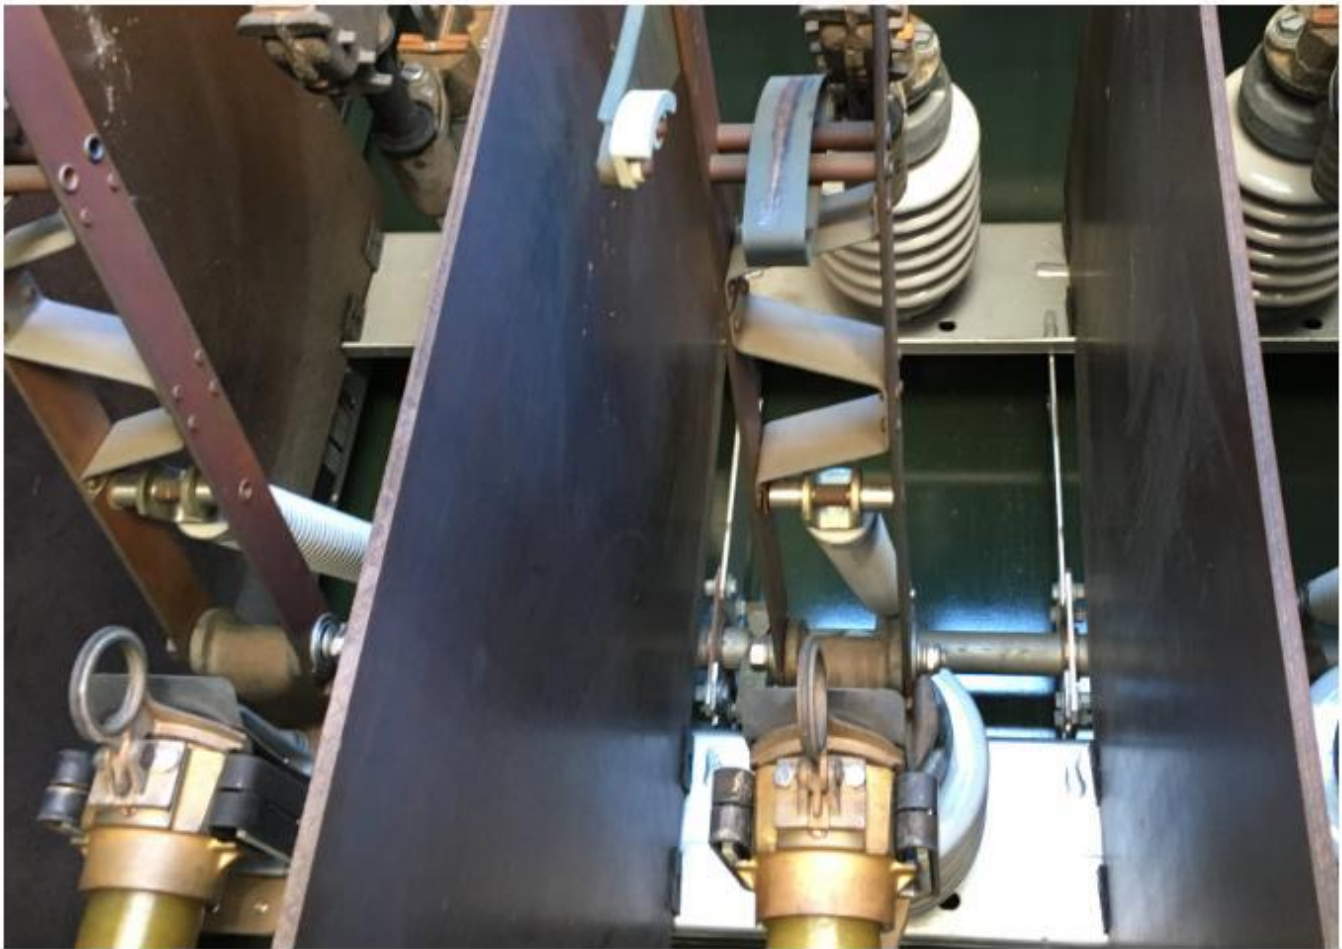
Burning on insulating material suggests that eventually the arc drawn resulted in a phase to phase fault. No tracking across this barrier to any grounded metal was evident. Would also explain the complete destruction of two interrupter mechanisms.
