## Incident Summary #II-1708402-2024 (#46057) (FINAL)

SUPPORTING INFORMATION	Incident Date		May 8, 2024
	Location		Burnaby BC
	Regulated industry sector		Boilers, PV & refrigeration - Boiler and pressure vessel system
	Impact	Qty injuries	0
		Injury description	N/A
		Injury rating	None
		Damage description	Explosion damage in a mechanical room including pushed out walls, broken drywall, minor fire damage at the ceiling level and disengagement of the vent piping at multiple locations for boiler #1.
		Damage rating	Moderate
Incident rating		Moderate	
Incident overview		A commercial water heating boiler in a retail shopping mall had operational issues that allowed natural gas to accumulate in the mechanical room leading to an explosion.	
INVESTIGATION CONCLUSIONS	Site, system and components		<p>The facility is a large retail shopping mall that uses hot water boilers to heat common indoor spaces. There are two natural gas fired 2,500,000 btu boilers used for the heating. One boiler is typically set as the primary boiler and the second acts as a standby and both are controlled by a remote direct digital control (DDC) system. The boilers are Category IV forced draft boilers that use a f

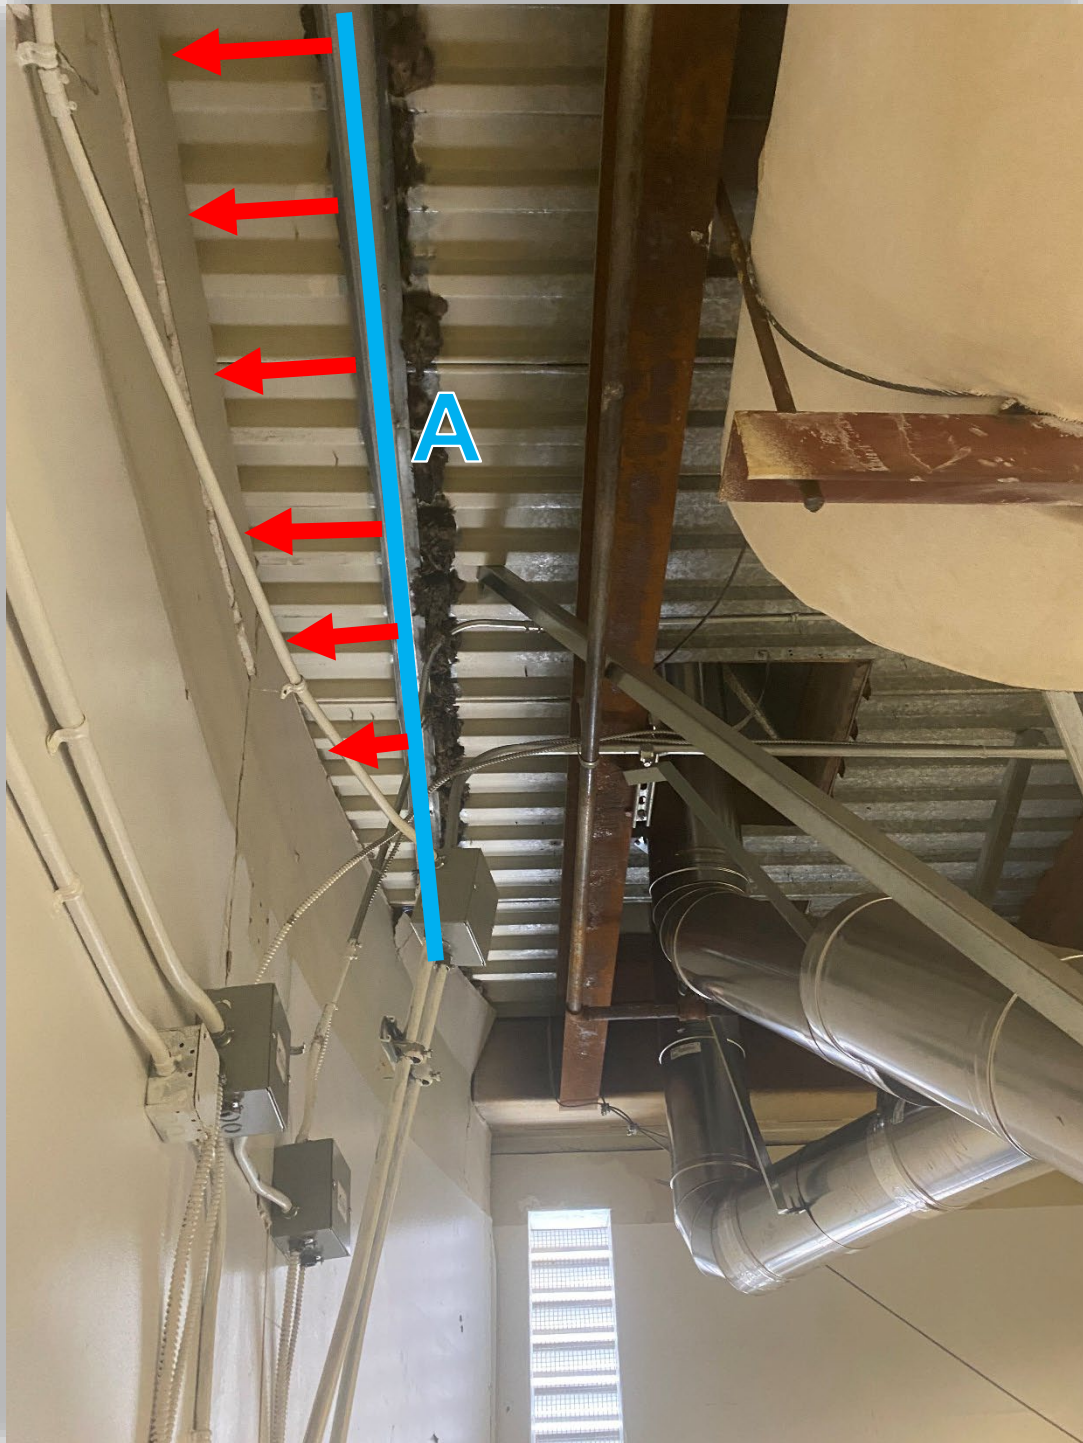
- The explosion damaged the interior and exterior walls of the mechanical room. The force pushed the walls outward and damaged the drywall and exterior stucco.
- The venting for boiler 1 was found disconnected in multiple locations and a pipe plug for a testing port on the vent adapter was found blown out and laying on the floor.

Image 2 – Damaged wall of mechanical room. [A] line indicated original location of the wall and the arrows show the amount the wall was pushed in by the explosion.

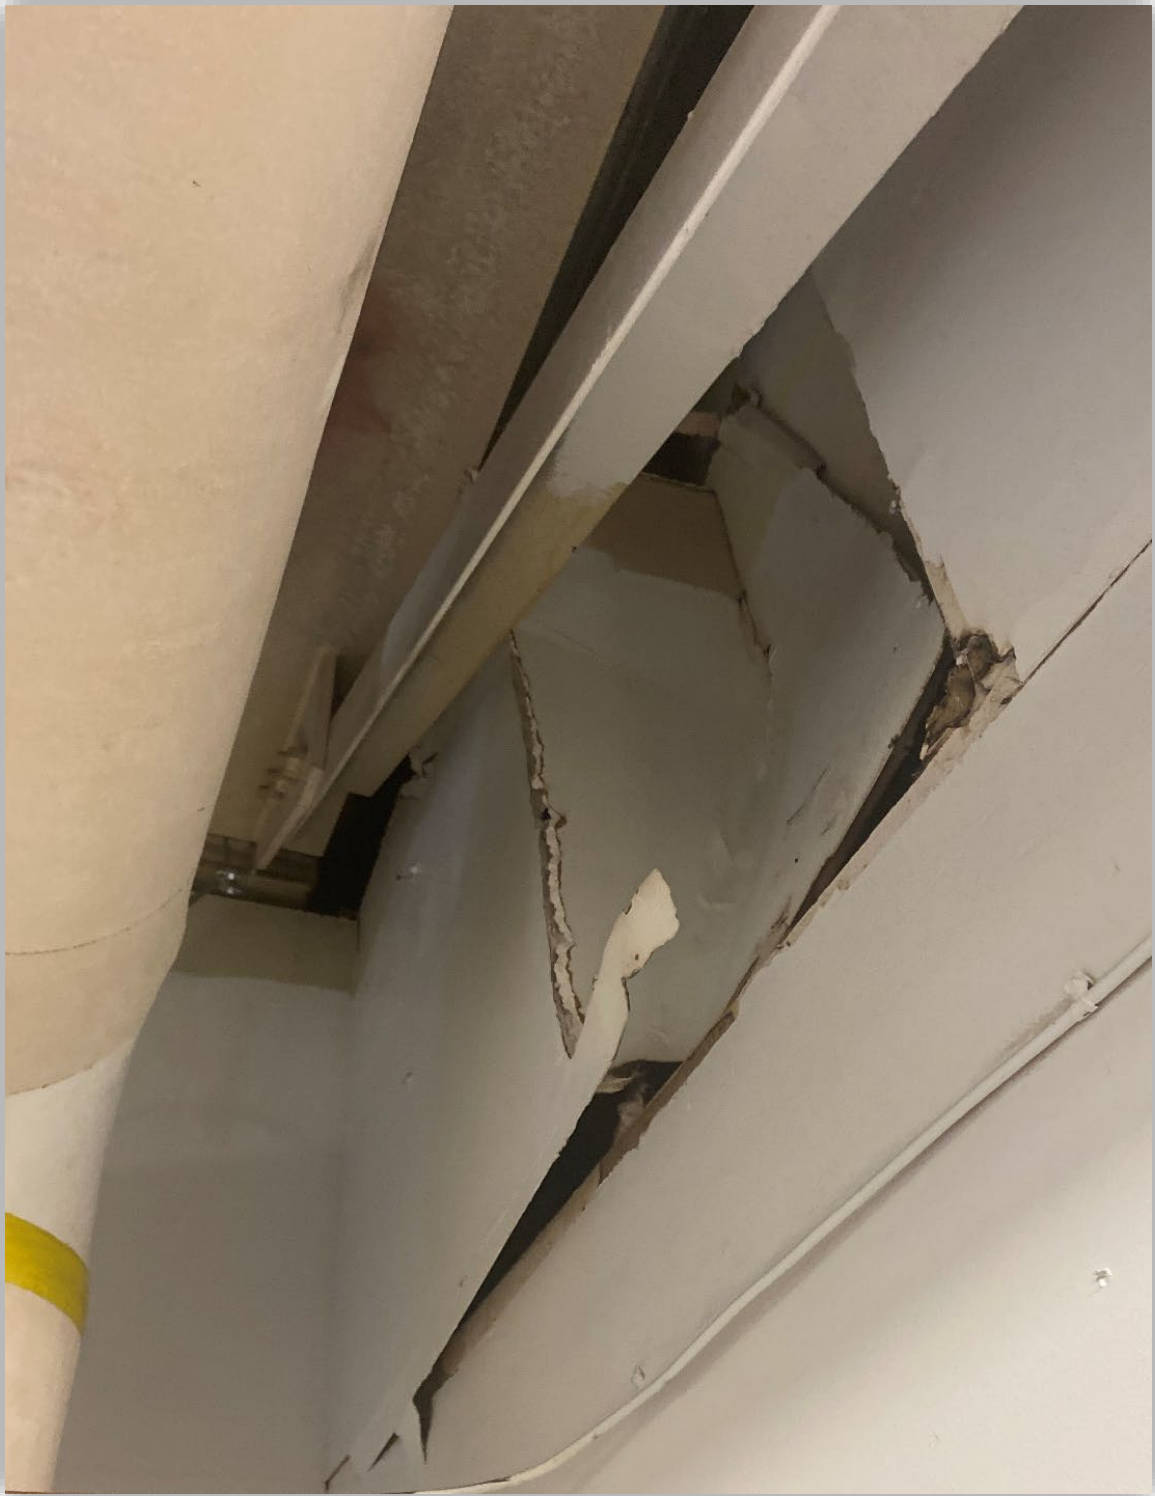
Image 3 – Damaged drywall at ceiling of mechanical room.

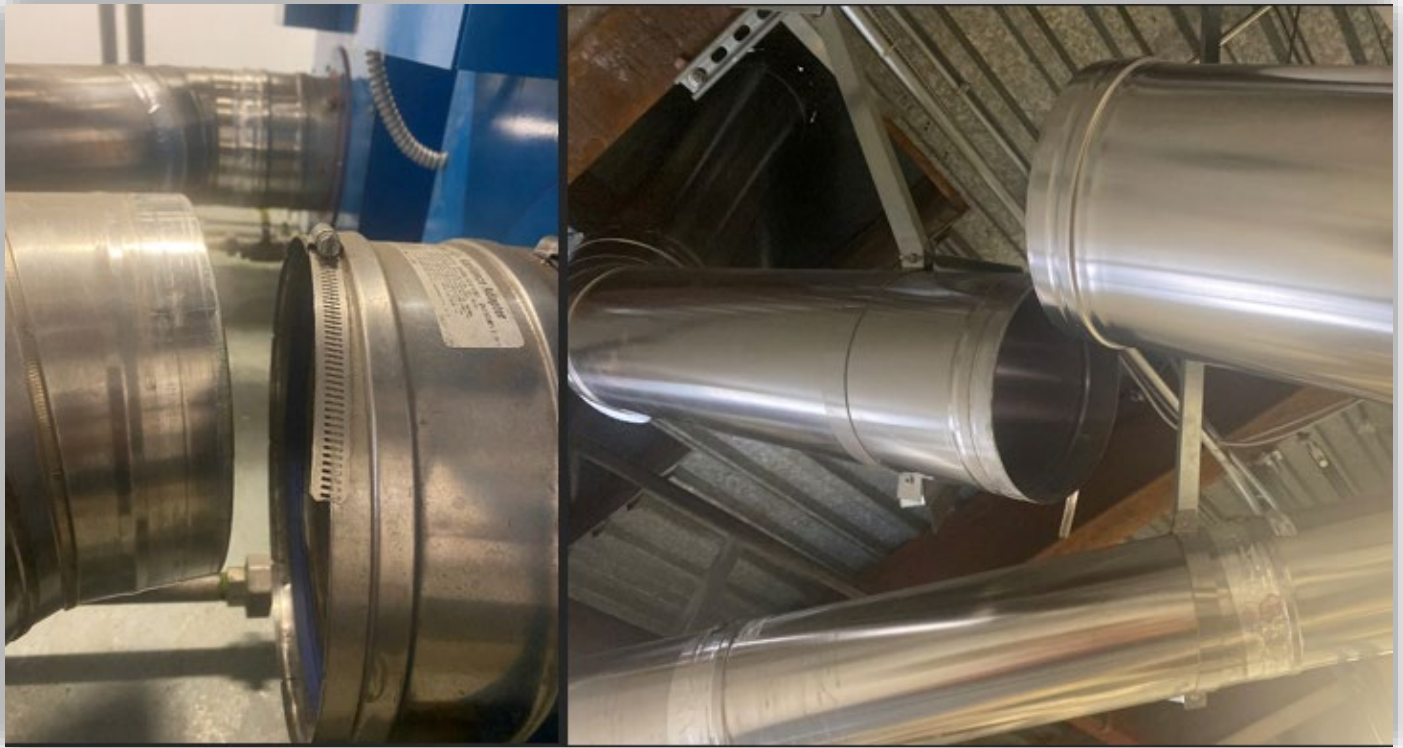
Image 4 – Dislodged venting components from Boiler #1 after explosion.

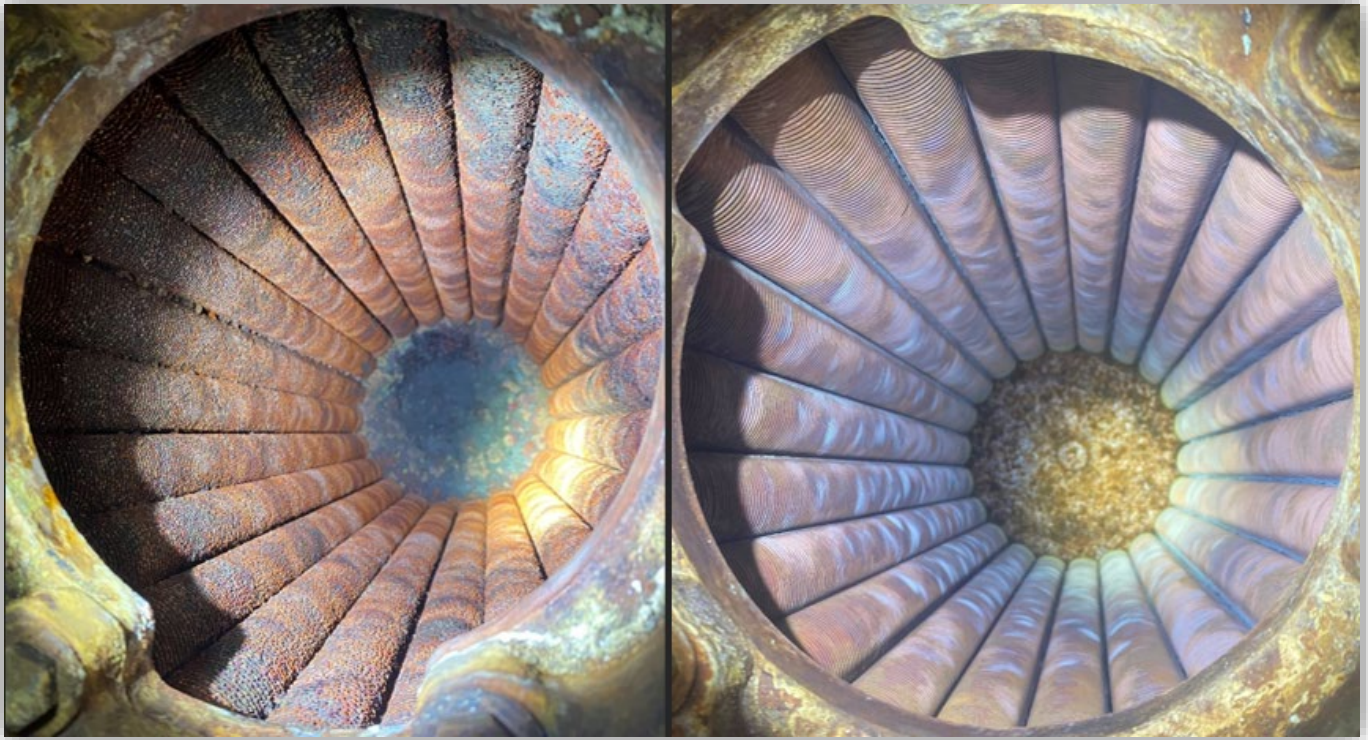
The restricted heat exchanger allowed unburnt gas to backdraft into the mechanical room space, accumulate and contact a source of ignition causing an explosion.

Image 5 – Comparison of the dirty and plugged heat exchanger of Boiler #1 (Left) to relatively clean heat exchanger of Boiler #2 (Right).

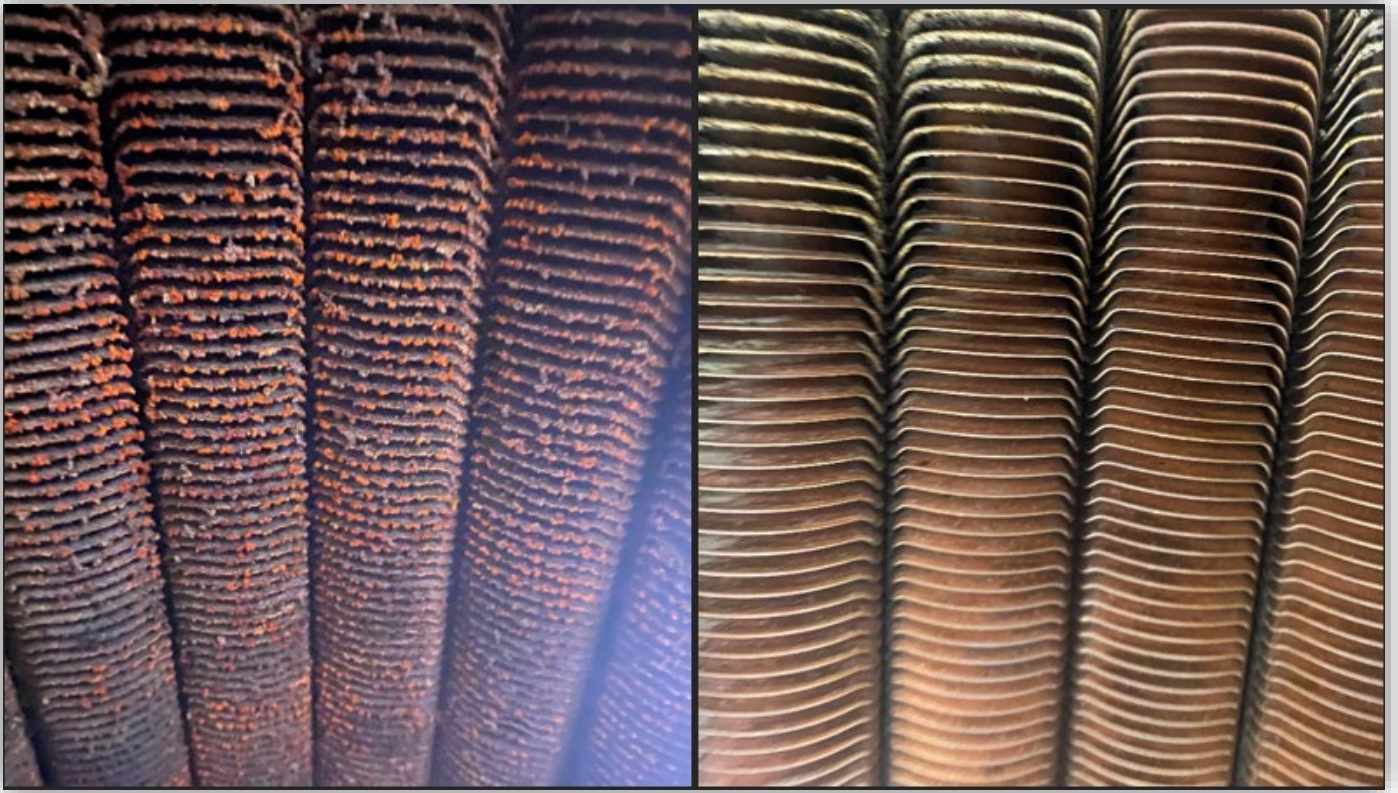
Image 6 – A second comparison of the dirty and plugged heat exchanger of Boiler #1 (Left) to relatively clean heat exchanger of Boiler #2 (Right).

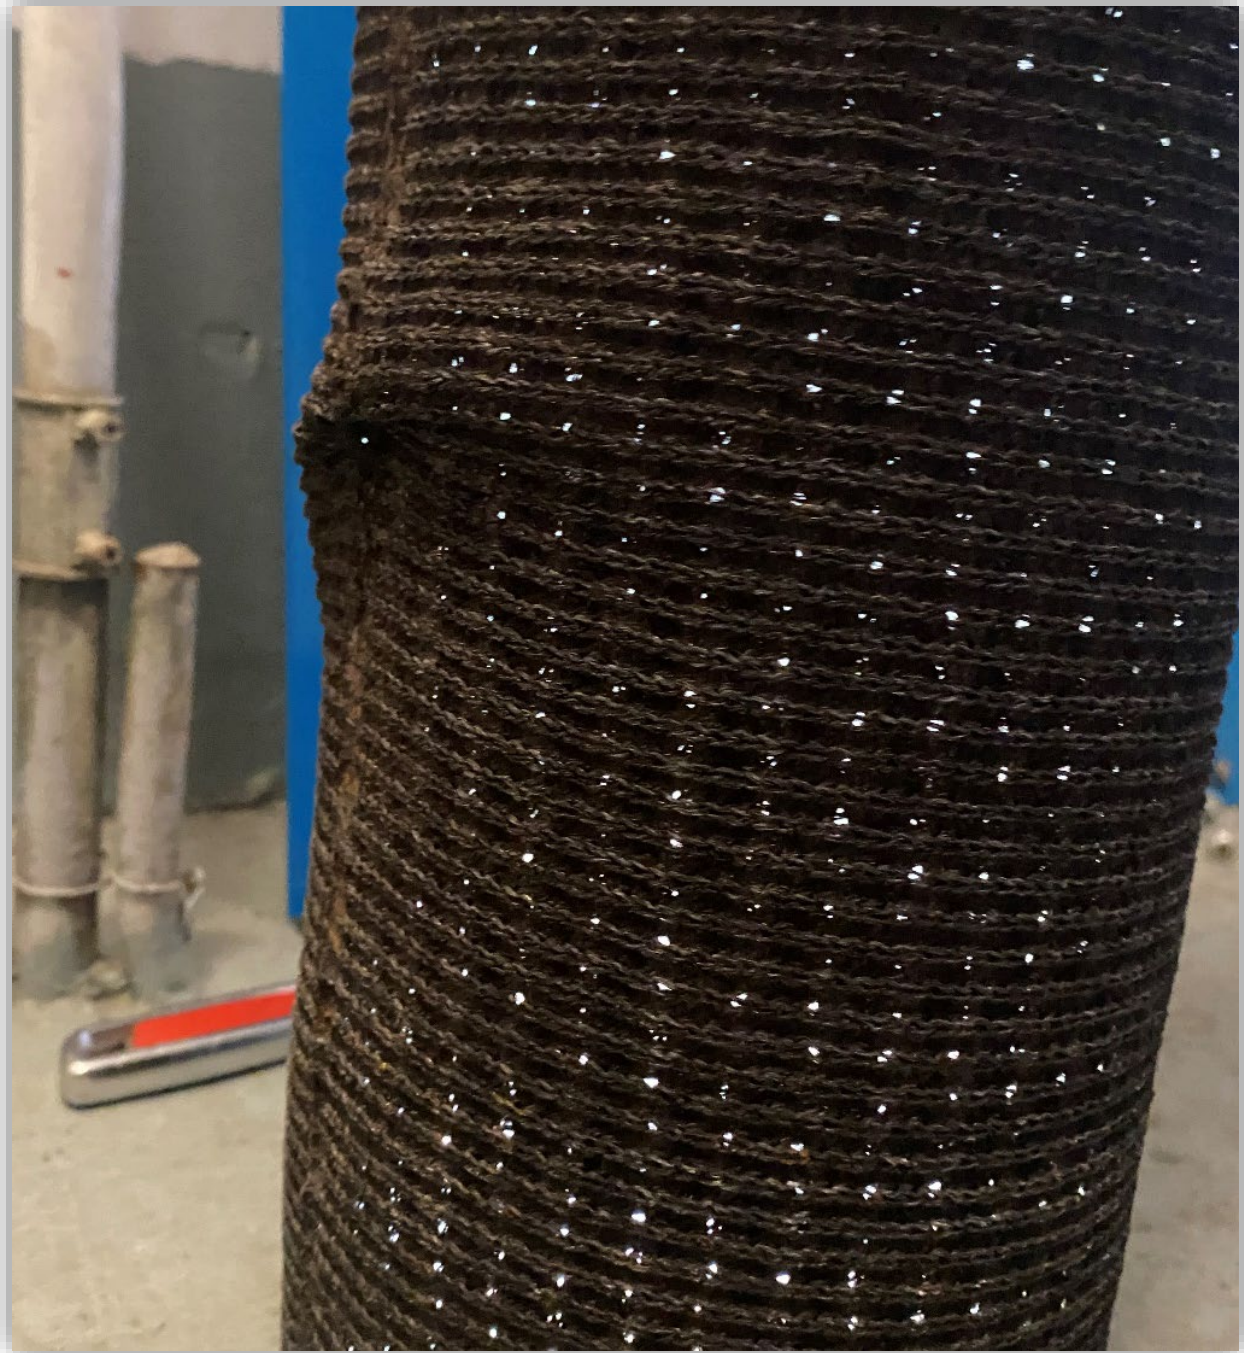
Image 7 – Deformed burner mesh from Boiler #1.

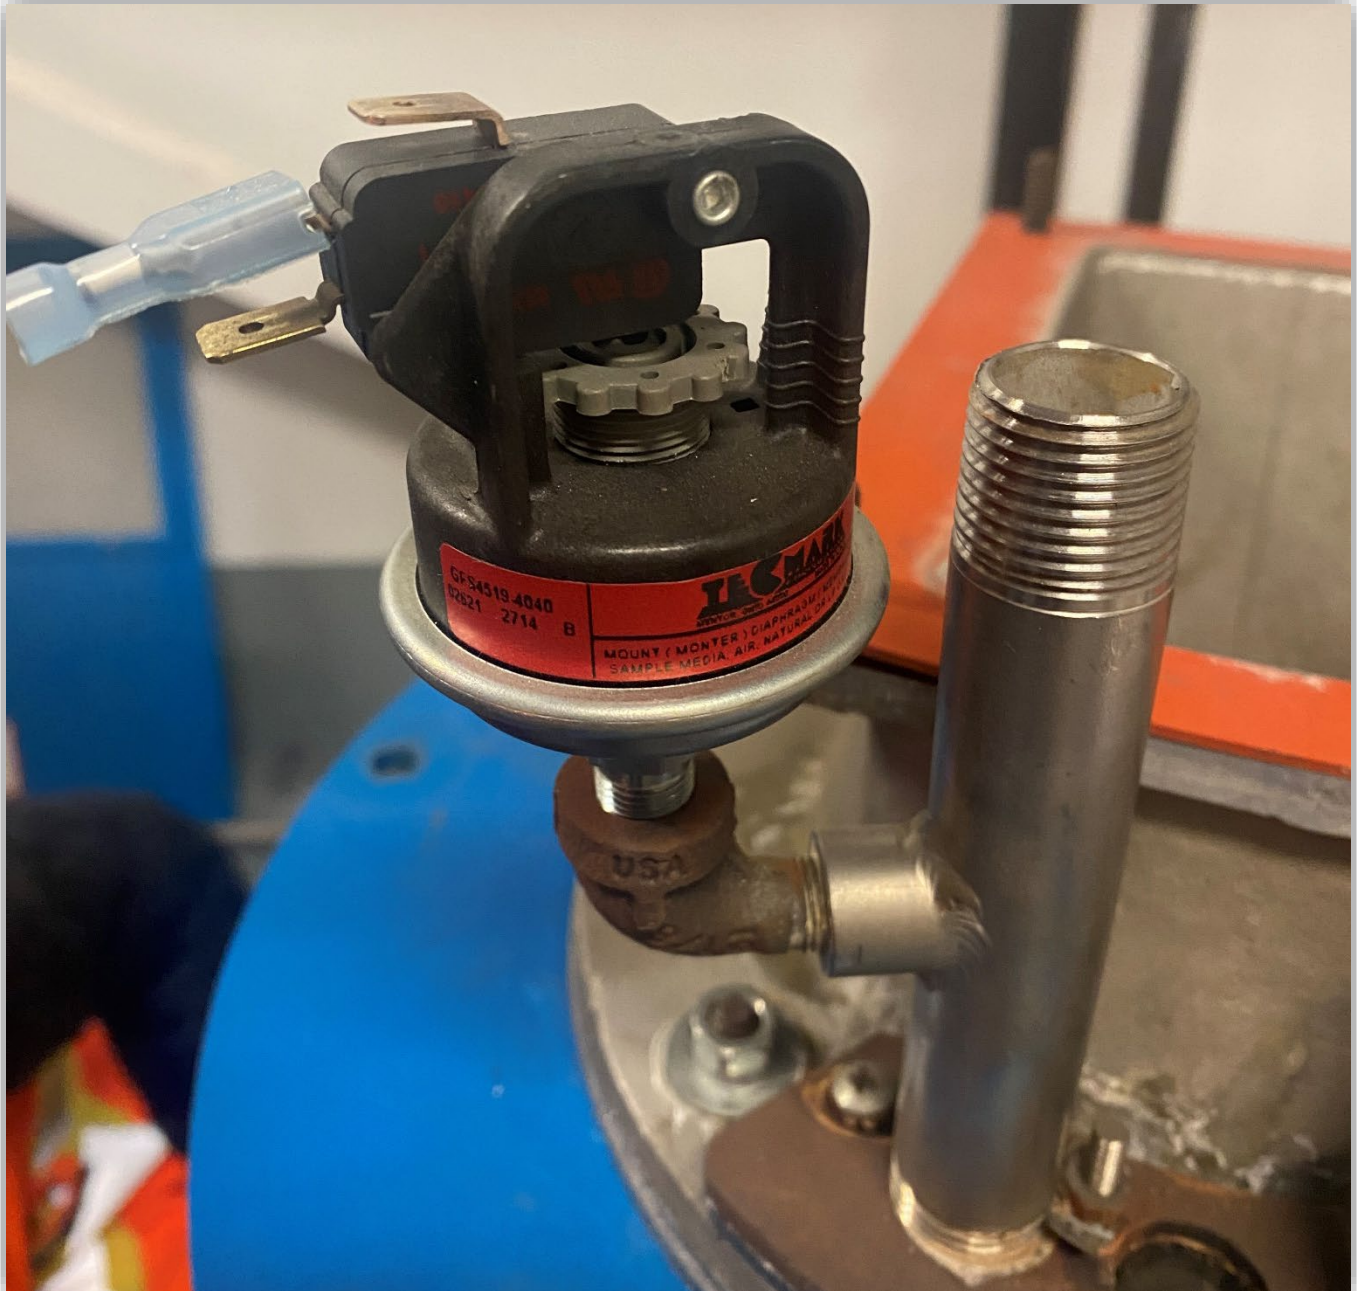
Image 8 – High exhaust backpressure switch installed on boiler with a black iron street elbow. *(Image taken during disassembly with other components and wiring removed).*

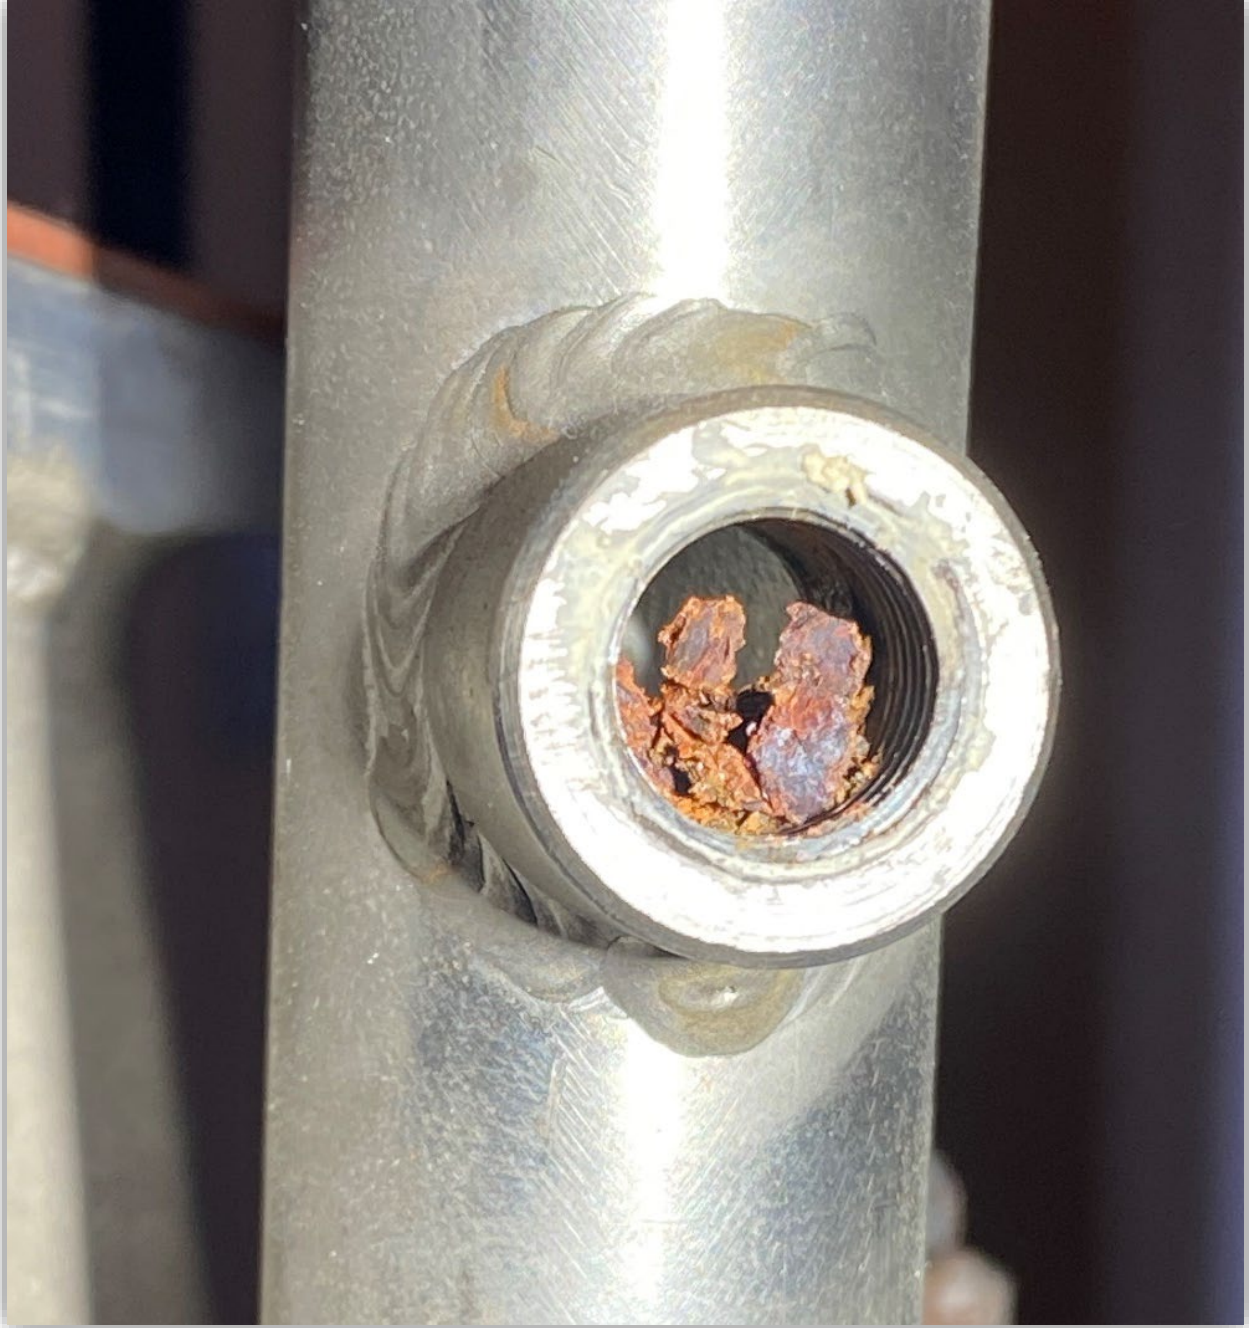
Image 9 – Corrosion debris inside 1/4" outlet housing the black iron street elbow for the high exhaust backpressure switch.

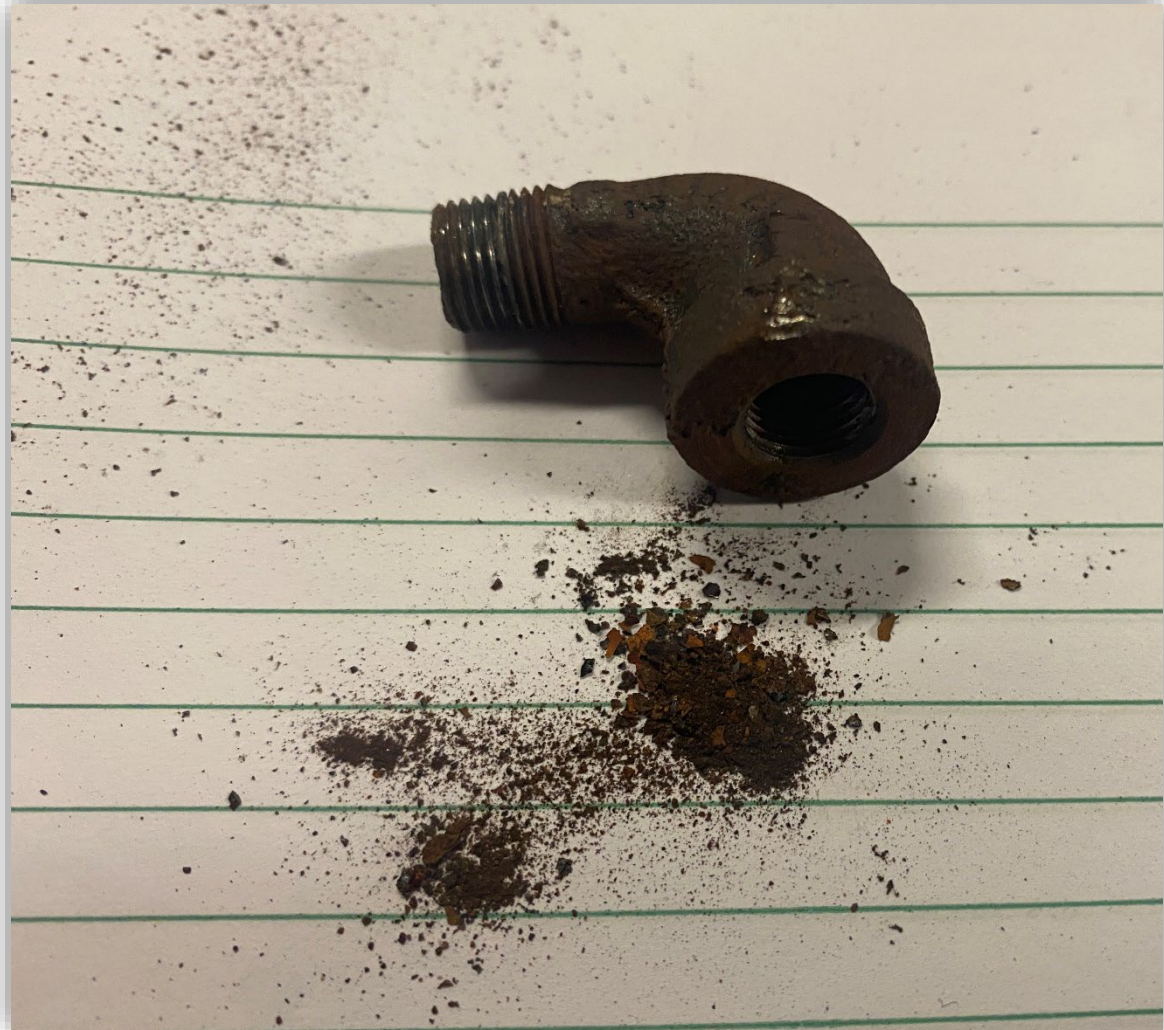
Image 10 – Corrosion debris from inside black iron street elbow housing the high exhaust backpressure switch.

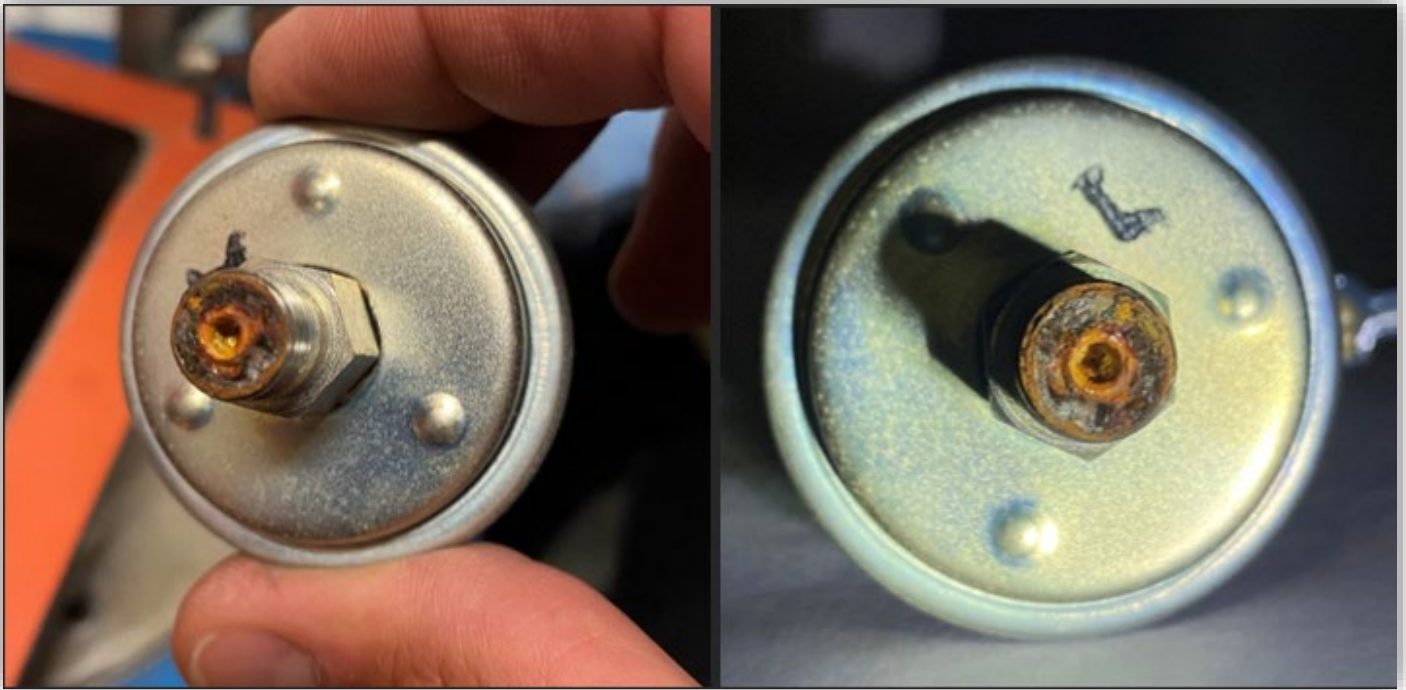
- The high exhaust back pressure switch becoming ineffective at safely stopping the operation of the boiler due to corrosion and debris plugging the sensor inlet.
- The high exhaust back pressure switch not being part of manufactures recommended routine maintenance, inspection or testing failed to identify it's ineffectiveness prior to the incident occurring.
- The continued operation of the boiler after high levels of CO were measured in the flue gas provided more opportunities for an incident to occur.
- Ineffective communication and understanding of the hazards associated with the continued operation of the boiler failed to inform decisions to halt the operation of the boiler.

Image 11 – Corrosion plugged inlet to the high exhaust backpressure switch for Boiler #1.
