## Incident Summary #II-1546083-2023 (#35112) (FINAL)

SUPPORTING INFORMATION	Incident Date		May 6, 2023
	Location		Nanaimo
	Regulated industry sector		Amusement Rides and Devices - Amusement ride
	Impact Injury	Qty injuries	1
		Injury description	Rider experienced a seizure minutes after exiting the ride.
		Injury rating	Moderate
	Damage	Damage description	A primary safety restraining device failed on an amusement ride gondola relying on the redundant secondary safety device to secure the rider.
		Damage rating	Moderate
Incident rating		Moderate	
Incident overview		While riding on an amusement ride, a passenger’s restraint system loosened, frightening the rider. Shortly after the ride ended, the rider experienced a seizure and received medical attention.	
INVESTIGATION CONCLUSIONS	Site, system and components	<p>The amusement ride was manufactured in the Netherlands, is named “SPEED” and is a “Booster” design. The ride consists of a vertical arm attached at its pivot point to the base of the ride. Gondolas are attached at either end consisting of four riders each, two facing forwards and two facing backwards (<a href="#">Photo 1</a>). Rider’s load and unload at the bottom of the ri

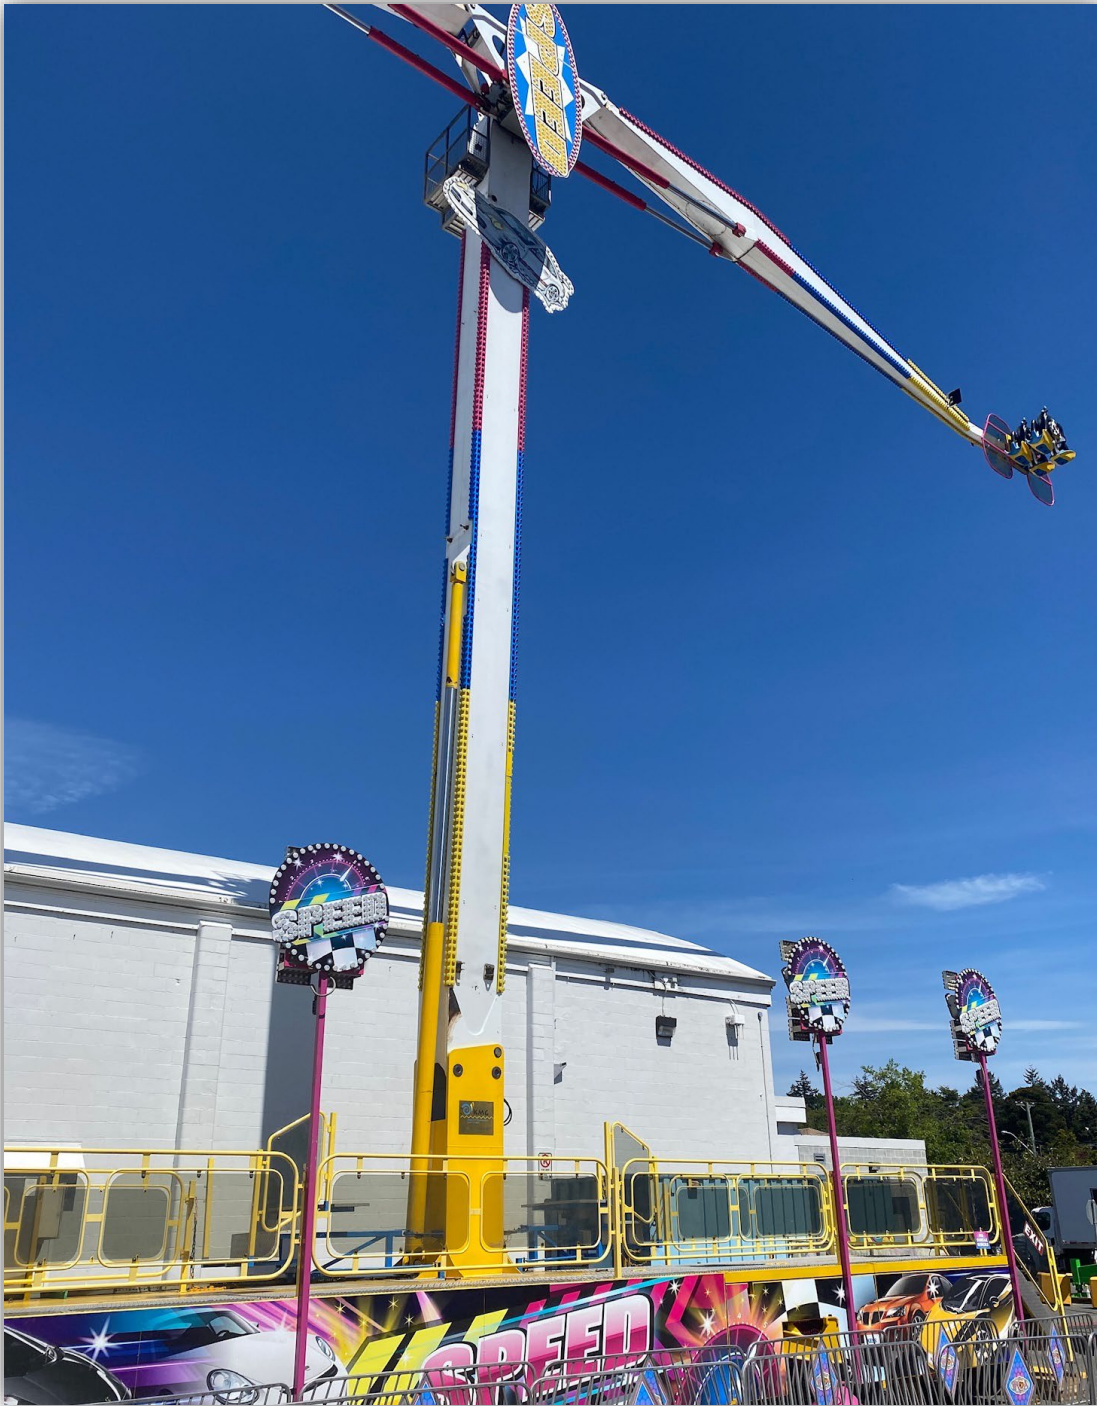
Photo 1 – Amusement ride set up - one side of the rotating arm with a 4-person rider gondola at the end.

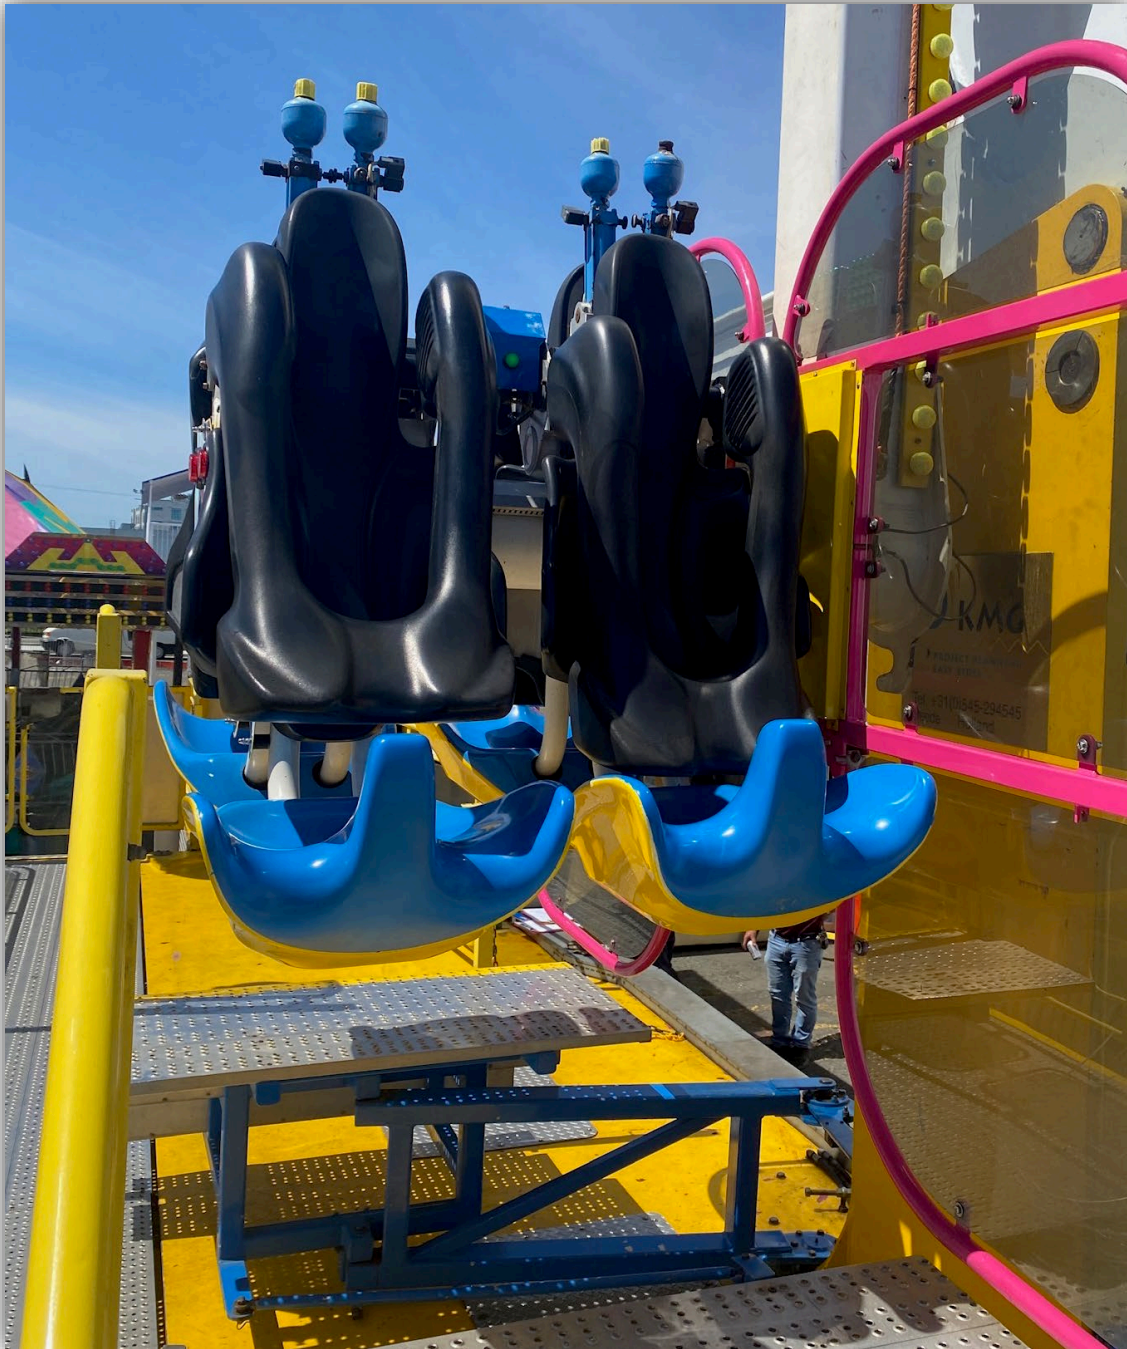
Photo 2 – Rider gondola at the lower base loading location.

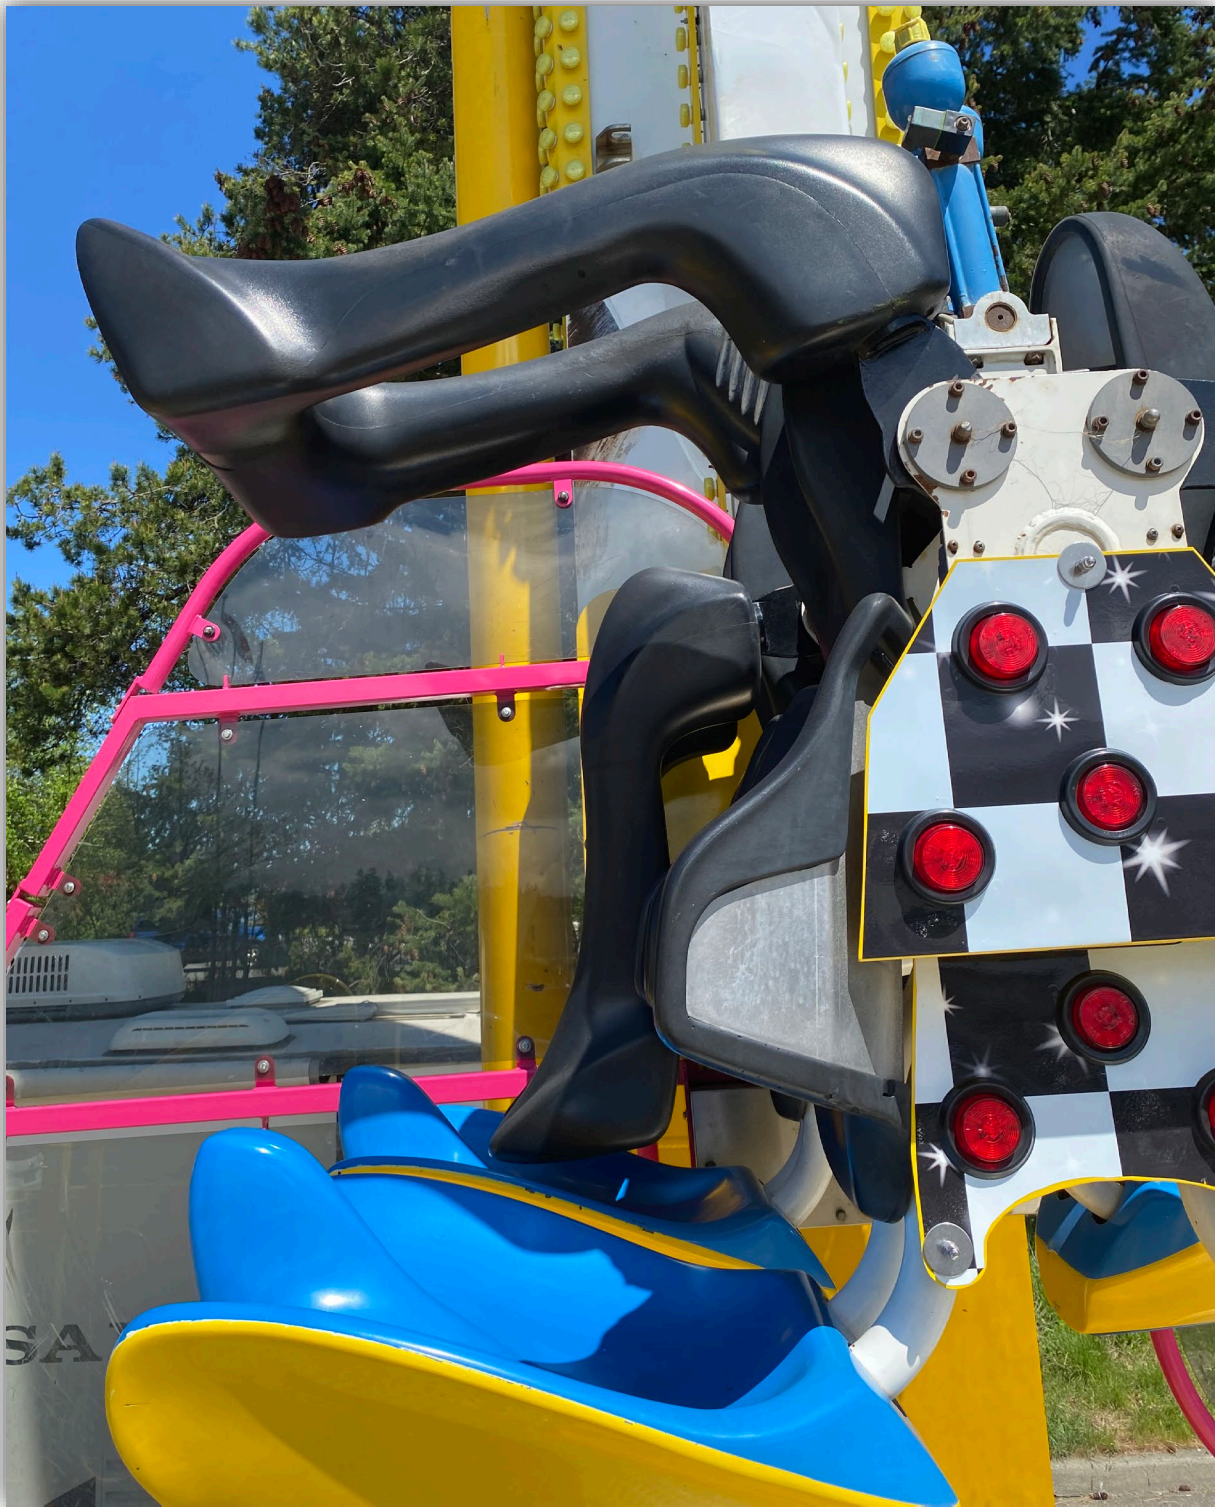
Photo 3 – Rider gondola - Restraint bars in the fully open (front) and fully closed (rear) positions.

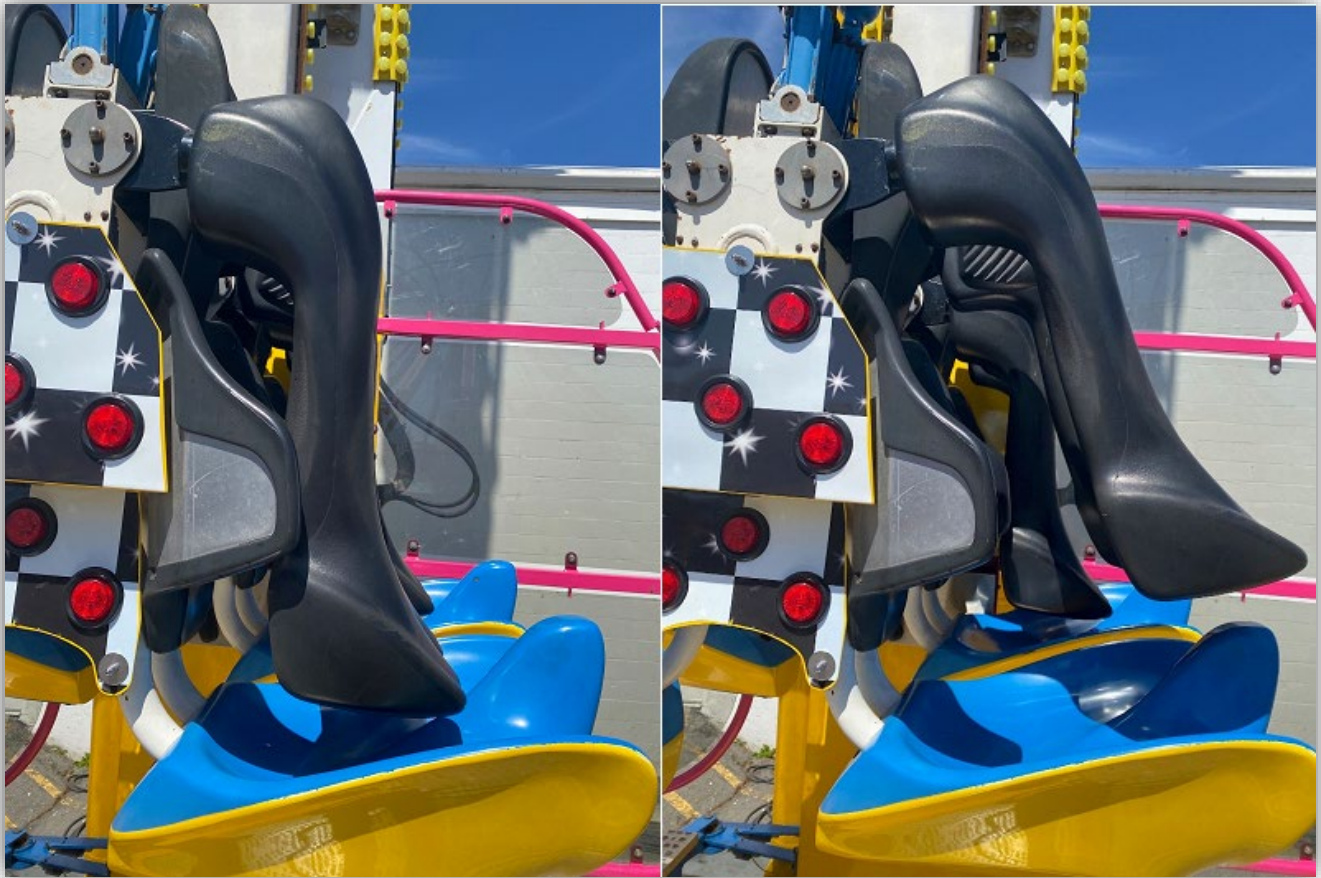
Photo 4 – Front rider seat, the restraint bar in the fully closed position (left) and the position locked by the secondary restraint mechanism (right).

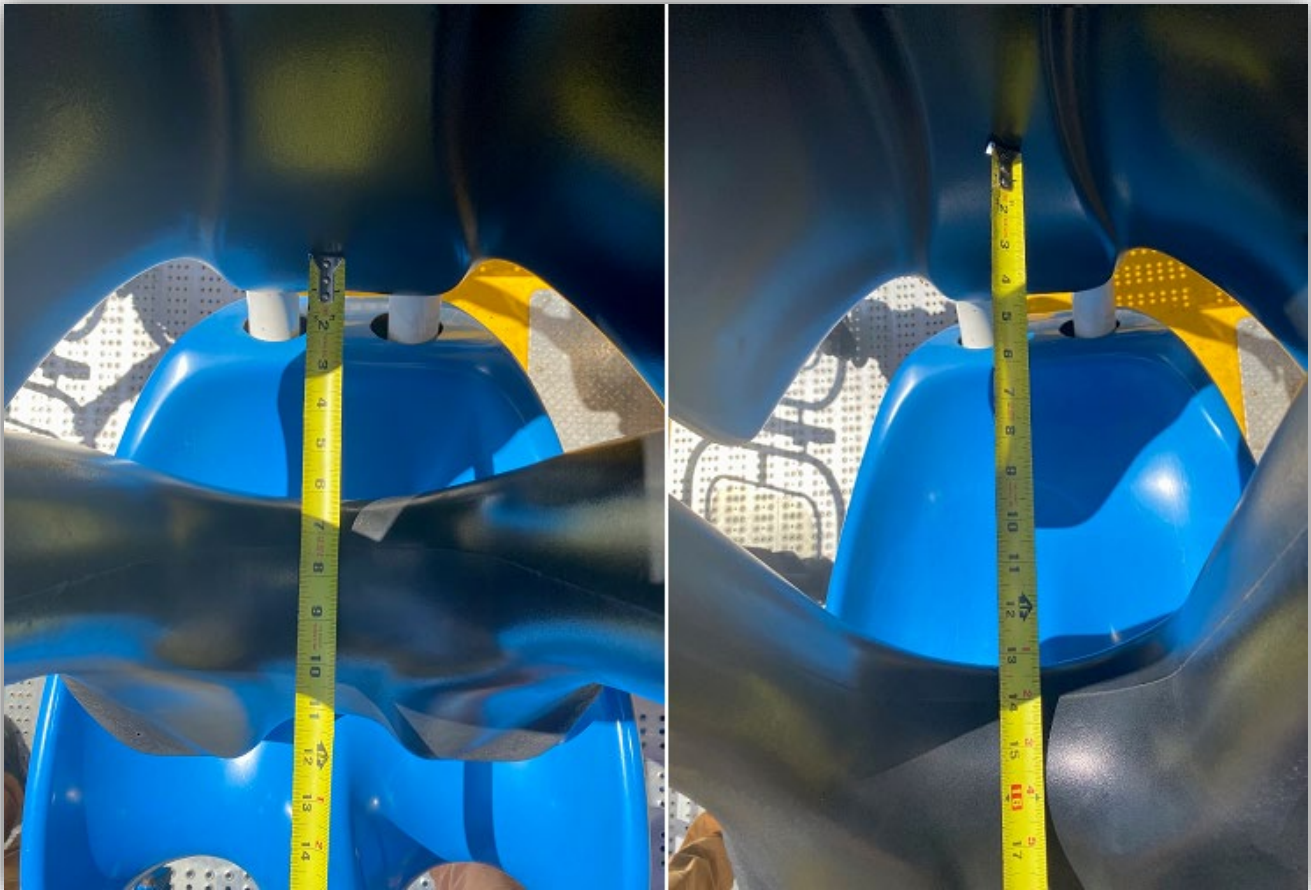
<p>hydraulics failed to hold pressure and the restraint bar raised up to a maximum of 7" (<a href="#">Photo 5</a>) before the cam contacted the secondary restraint system which would not allow it to raise any further. The rider became frightened and called out to the ride operator to stop the ride.</p> <p>The ride operator did not hear the calls from the rider and allowed the ride to finish after its regular timed interval. Shortly after exiting the ride, the rider experienced a seizure, were attended to on site by a first aid attendant before emergency medical responders arrived and they were transported to a hospital for further medical attention.</p>
Facts and evidence	<p><u>Interview Statements</u></p> <p><b>Owner &amp; manager</b></p> <ul style="list-style-type: none"> <li>• Around 8pm on the day of the incident, they were informed of a person complaining that a lap bar came up on the Speed ride and there was a first aid call of for person having a seizure.</li> <li>• They were not initially aware the two incidents were connected.</li> <li>• The first aid attendant attended to the individual until an ambulance arrived to take the person to the hospital.</li> <li>• The ride was closed for approximately 20 minutes, and they tested the functionality of the restraint systems. They did not find any evidence of failures and put the ride back into operation for the remainder of the evening until they closed at 10pm.</li> <li>• The ride remained closed the next day while a more thorough inspection and testing took place, again with no evidence of failures found.</li> <li>• The ride was reopened two days after the incident.</li> <li>• They had not been aware of or had not received any direct communication from the ride operators of any issues with the ride restraints during setup or operation of the ride at that ride location.</li> <li>• They were not aware of the unsatisfactory designation given to the ride restraints on the set-up inspection checklist or the daily inspection and maintenance form.</li> </ul> <p><b>Ride operator</b></p> <ul style="list-style-type: none"> <li>• They had filled out the "Setup inspection checklist" and "Daily inspection and maintenance" forms documenting "unsatisfactory" for the ride restraints but did not otherwise directly inform the management or owner of the situation.</li> <li>• The primary solenoid valve would, at times, fail to open requiring manual operation of the bypass valve to open the restraints to release the riders on the one seat.</li> <li>• To try to fix the problem, they had removed the solenoid valve, cleaned it, and reassembled it which improved the functionality, but it still continued to have intermittent issues.</li> <li>• During operation of the ride, after setup and leading up to the incident, the valve had failed multiple times requiring opening of the bypass valve knob to release the riders from the one seat.</li> <li>• The seat with the intermittent restraint valve operation was the same seat the rider rode in that experienced the medical issue.</li> </ul> <p><u>Documents</u></p> <p><b>Inspection forms</b></p> <ul style="list-style-type: none"> <li>• <b>Annual inspection service report (June 1-2, 2022)</b> – Passed tests for restraints on all gondolas but it identified a gondola restraint solenoid as "weak" and informed to consider replacement.</li> <li>• <b>Set up inspection checklist (May 2, 2023)</b> – Checklist item for "Check restraints for proper operation and condition" documented as <u>unsatisfactory</u></li> </ul>

Photo 5 – Top view of the restraint bar in the fully closed position (left) and with the restraint bar cam against the secondary safety lock bar (right) showing a difference of approximately 7”.

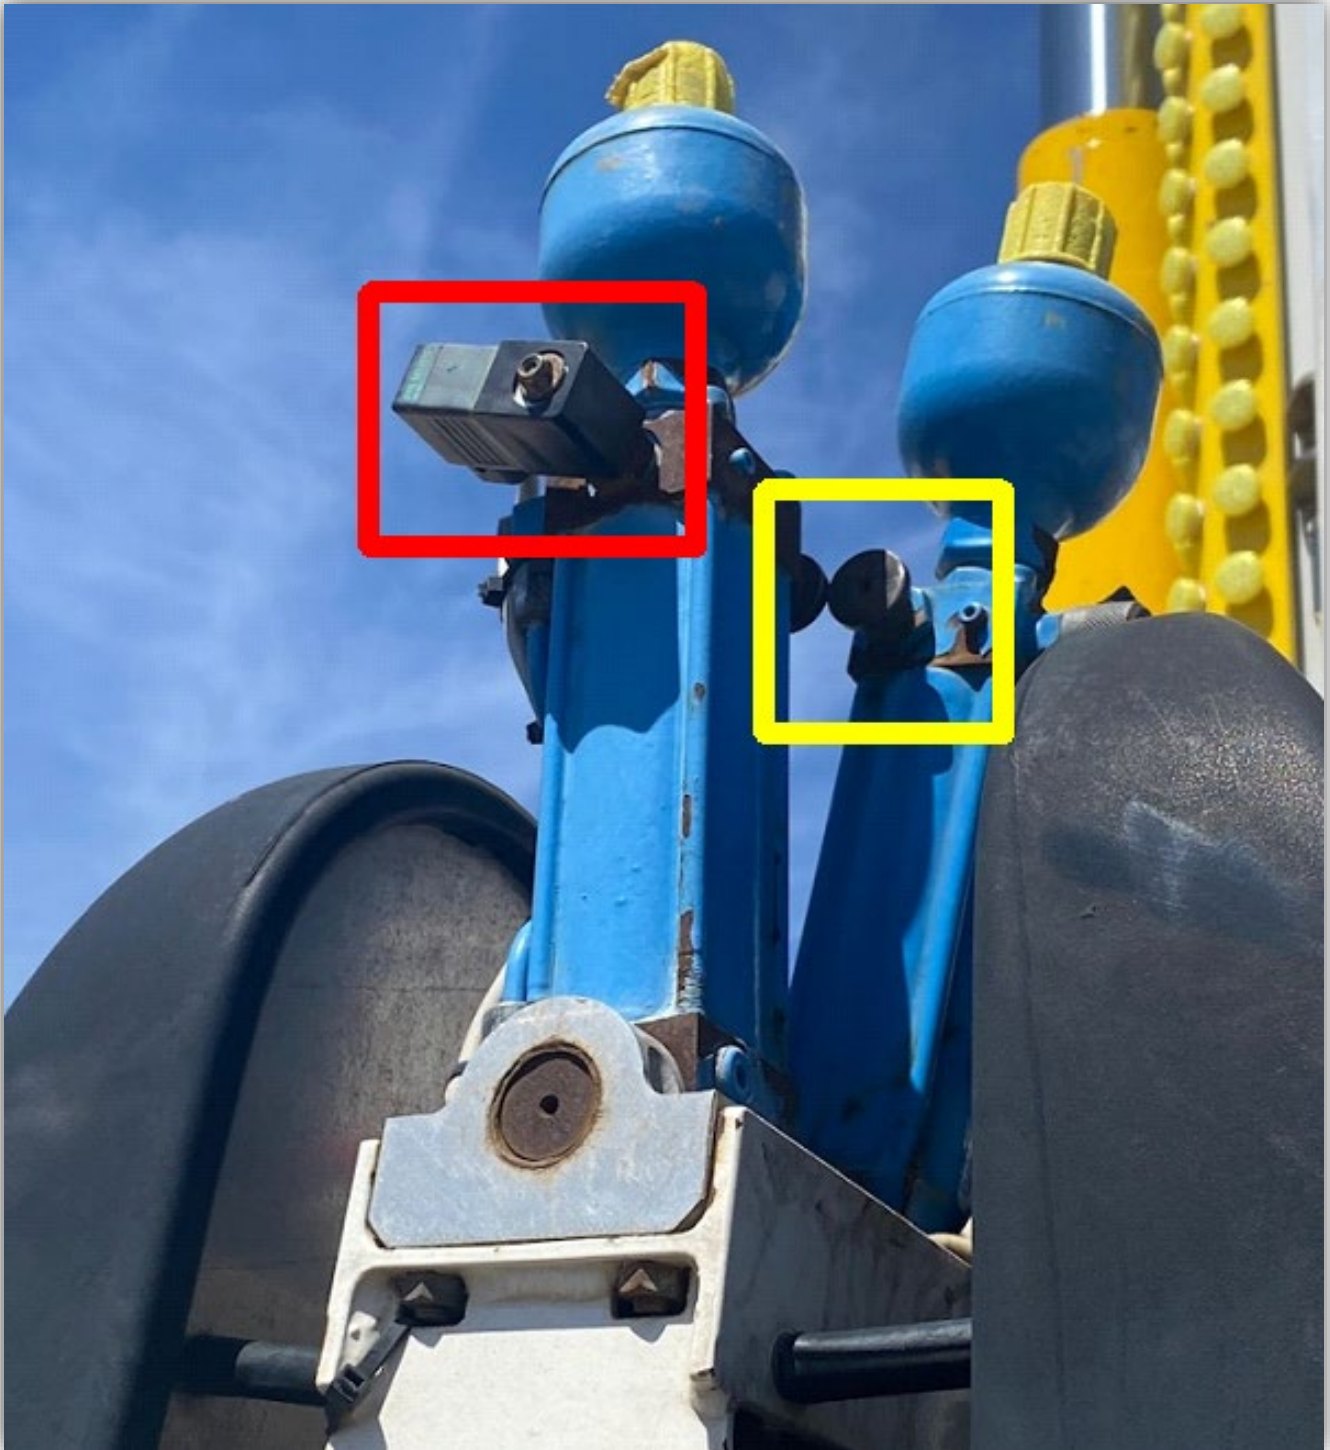
<p>Causes and contributing factors</p>	<p>The primary restraining device on the gondola chair likely failed to operate correctly due to an internal leak of the restraining device’s hydraulic system.</p> <p>Contributing factors to the incident:</p> <ul style="list-style-type: none"> <li>• The intermittently operating restraining device solenoid not being effectively repaired or replaced after being identified during the annual inspection, setup inspection and daily inspections.</li> <li>• The decision to continue operation of the ride with an intermittently operating restraining device solenoid.</li> <li>• Ineffective communication of the restraint solenoid issue to the management and ownership.</li> </ul>

Photo 6 – Primary restraint hydraulic actuators. [RED] an electric solenoid, [YELLOW] manual hydraulic bypass valve knob.

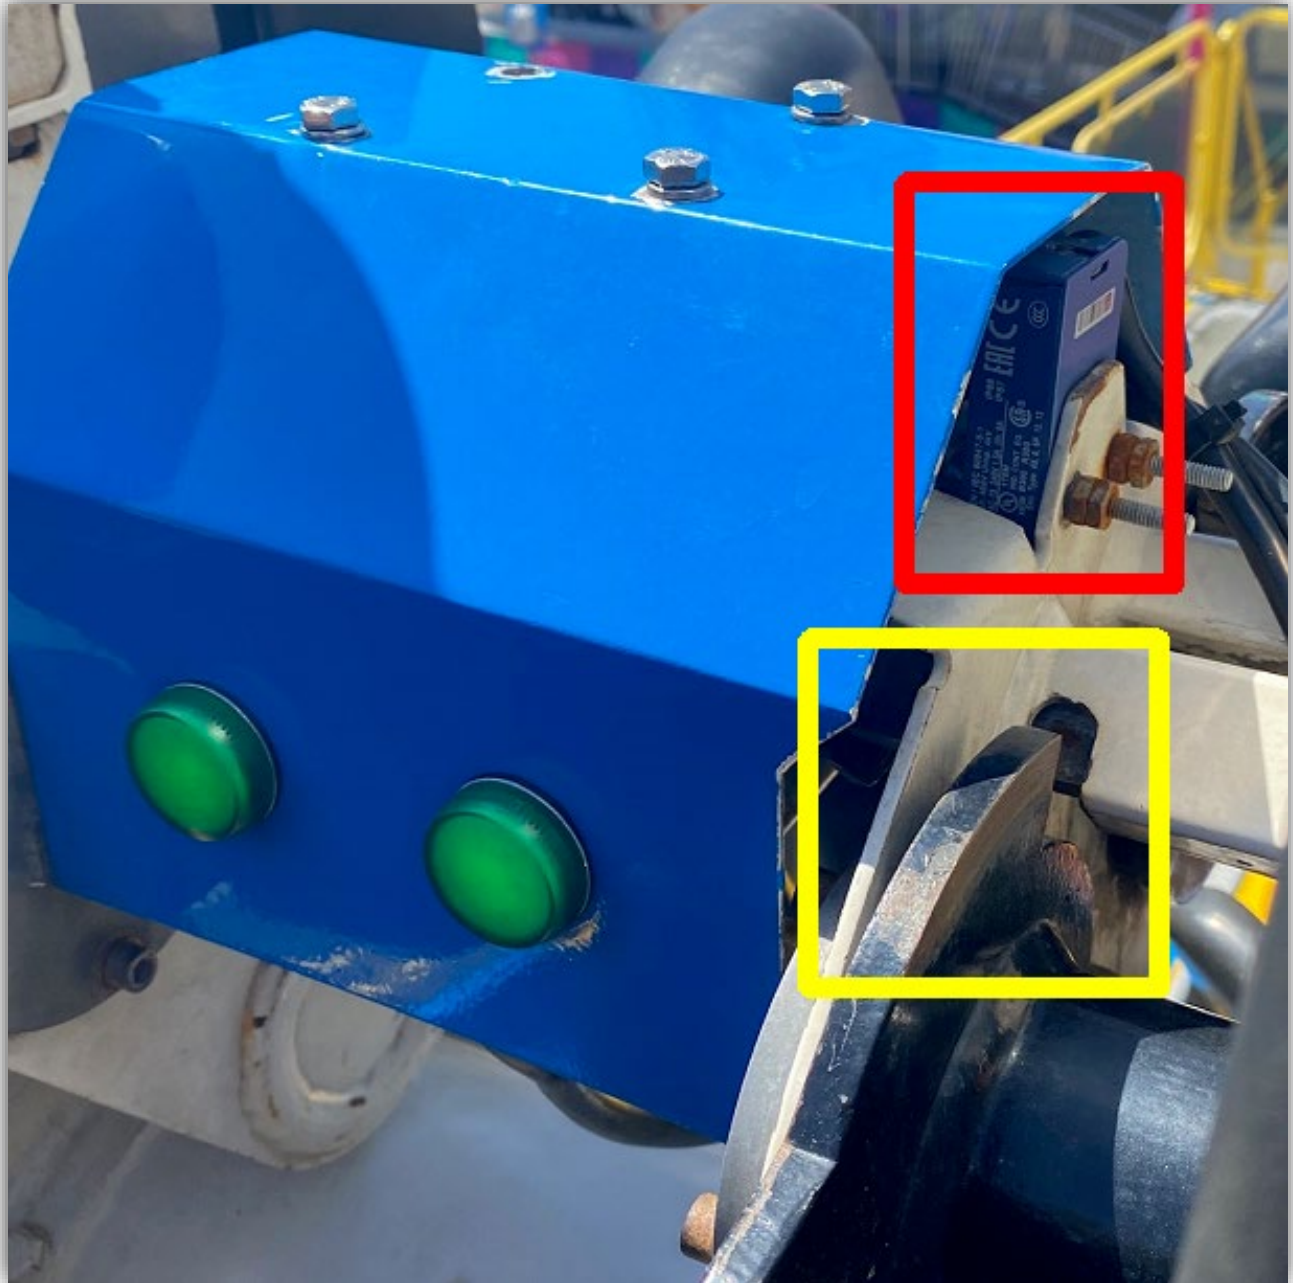
Photo 7 – Green indicator lights which illuminate when restraint is locked in the lower position. [RED] safety sensor. [YELLOW] restraint bar cam and secondary locking system.

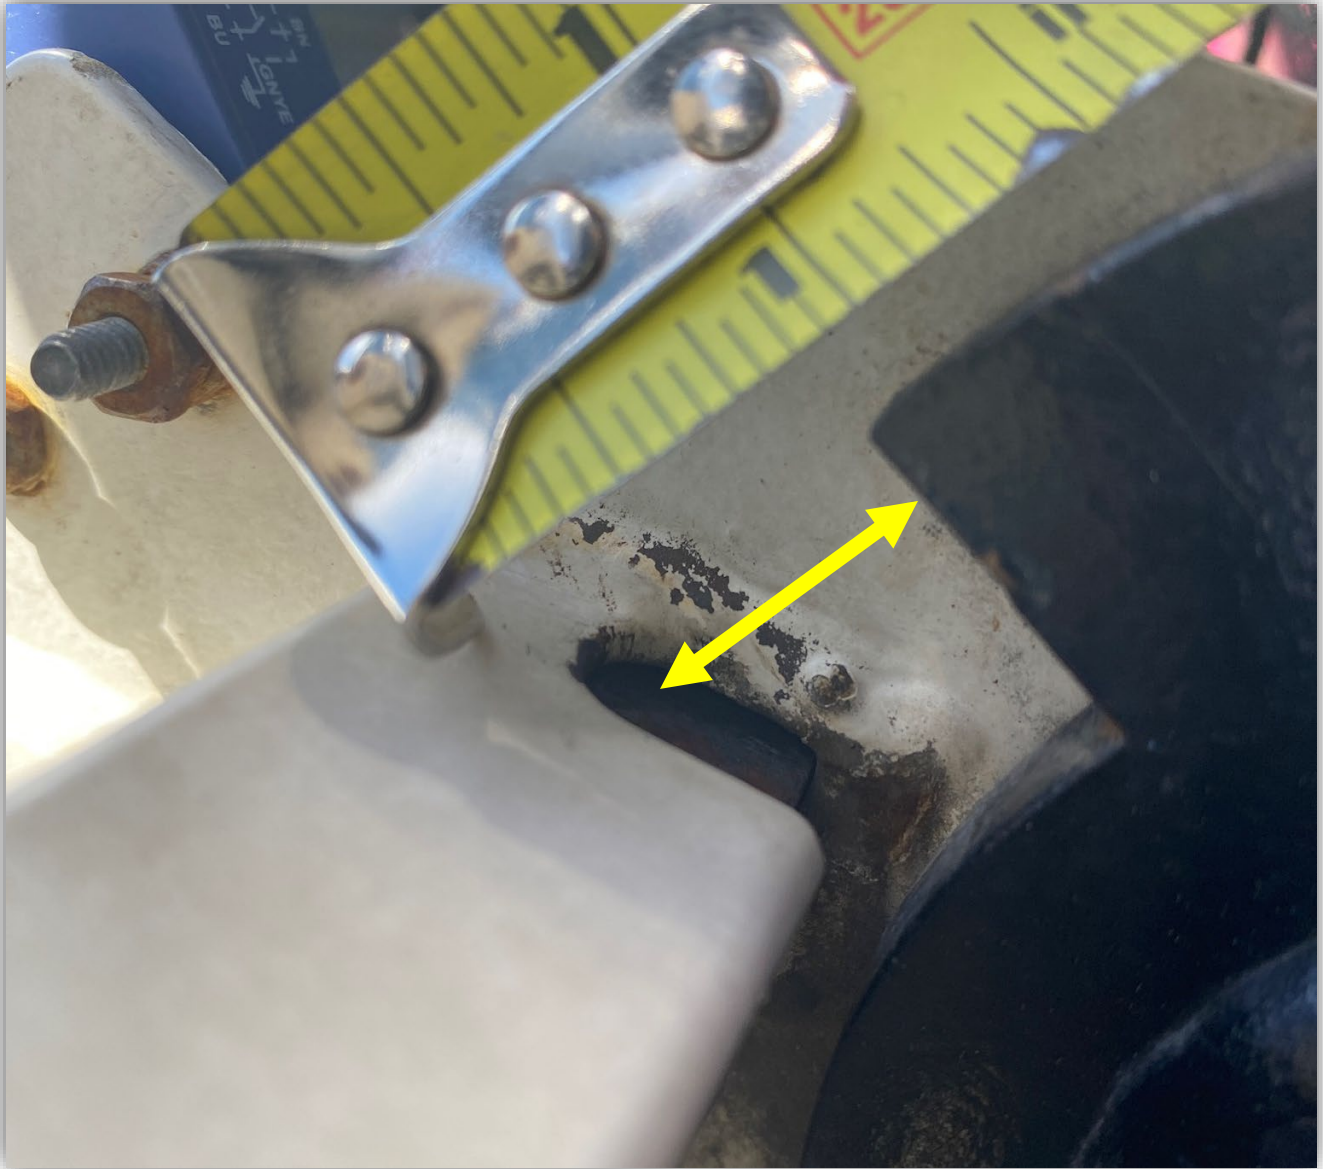
Photo 8 – Closeup of restraint bar cam and secondary locking bar. [YELLOW] Distance from cam to steel rod with the restraint in the fully closed position.

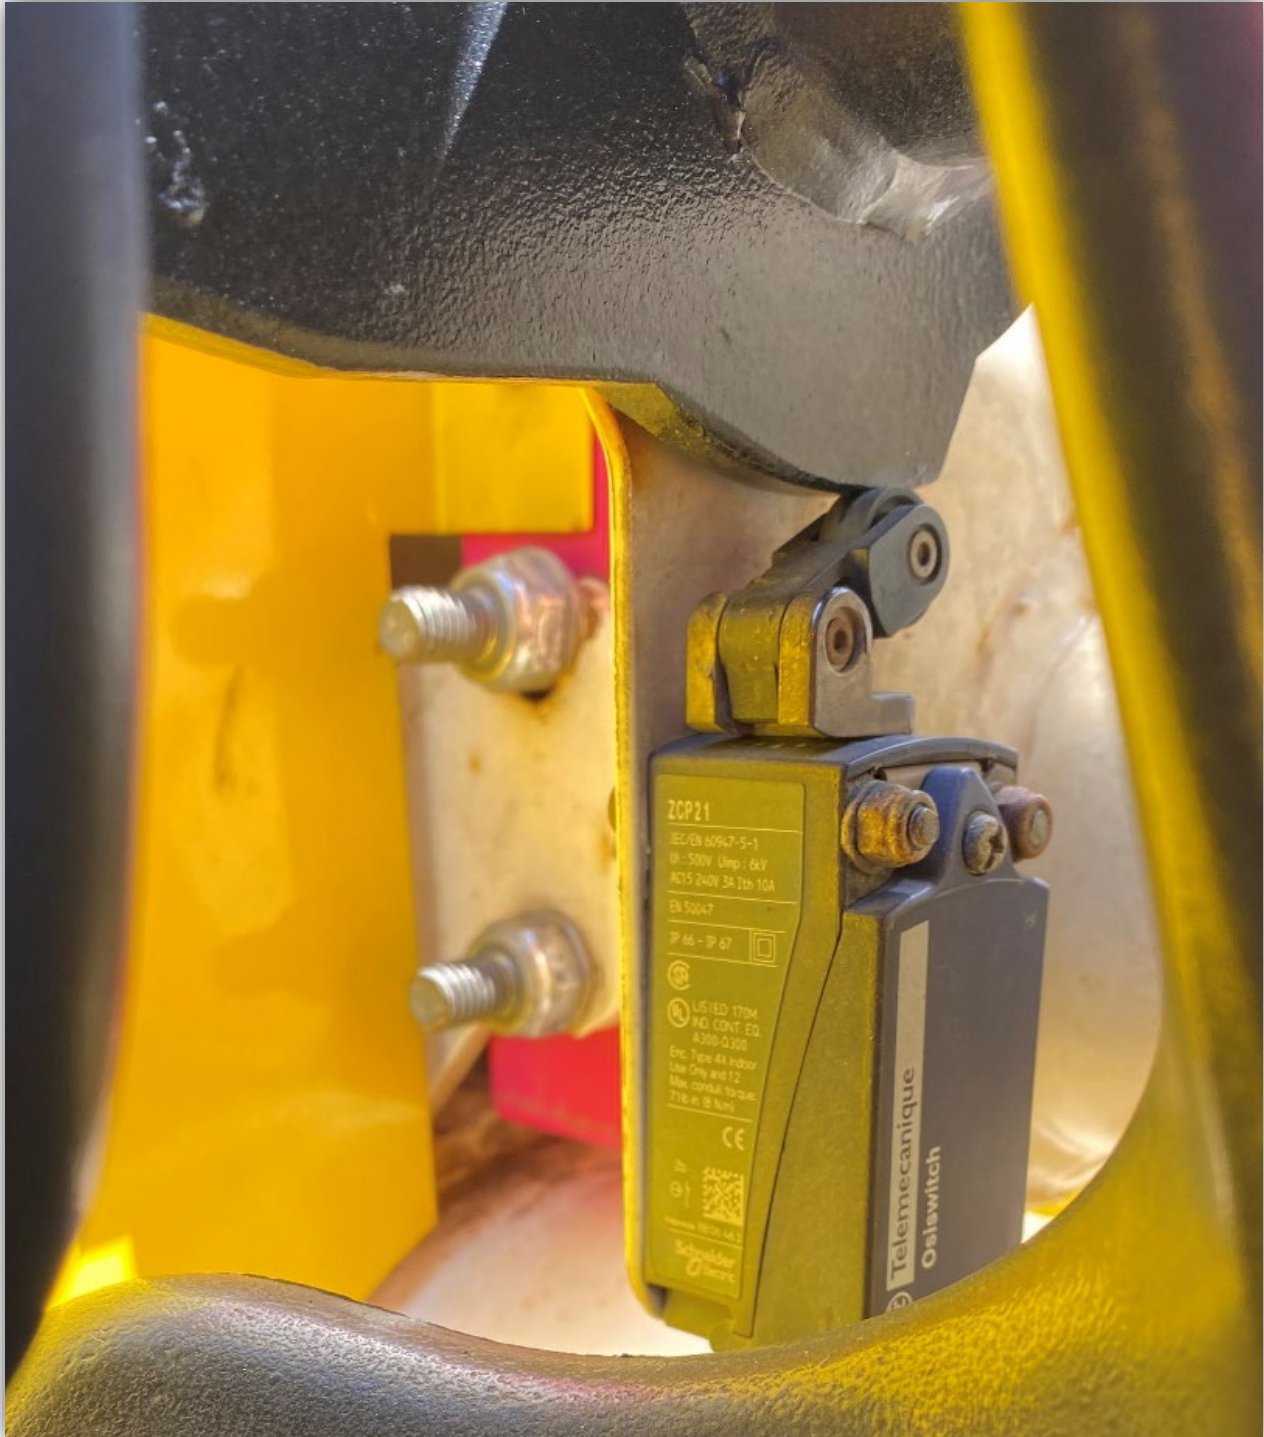
Photo 9 – Safety switch ensuring restraint bar is in the correct position to begin ride operation.

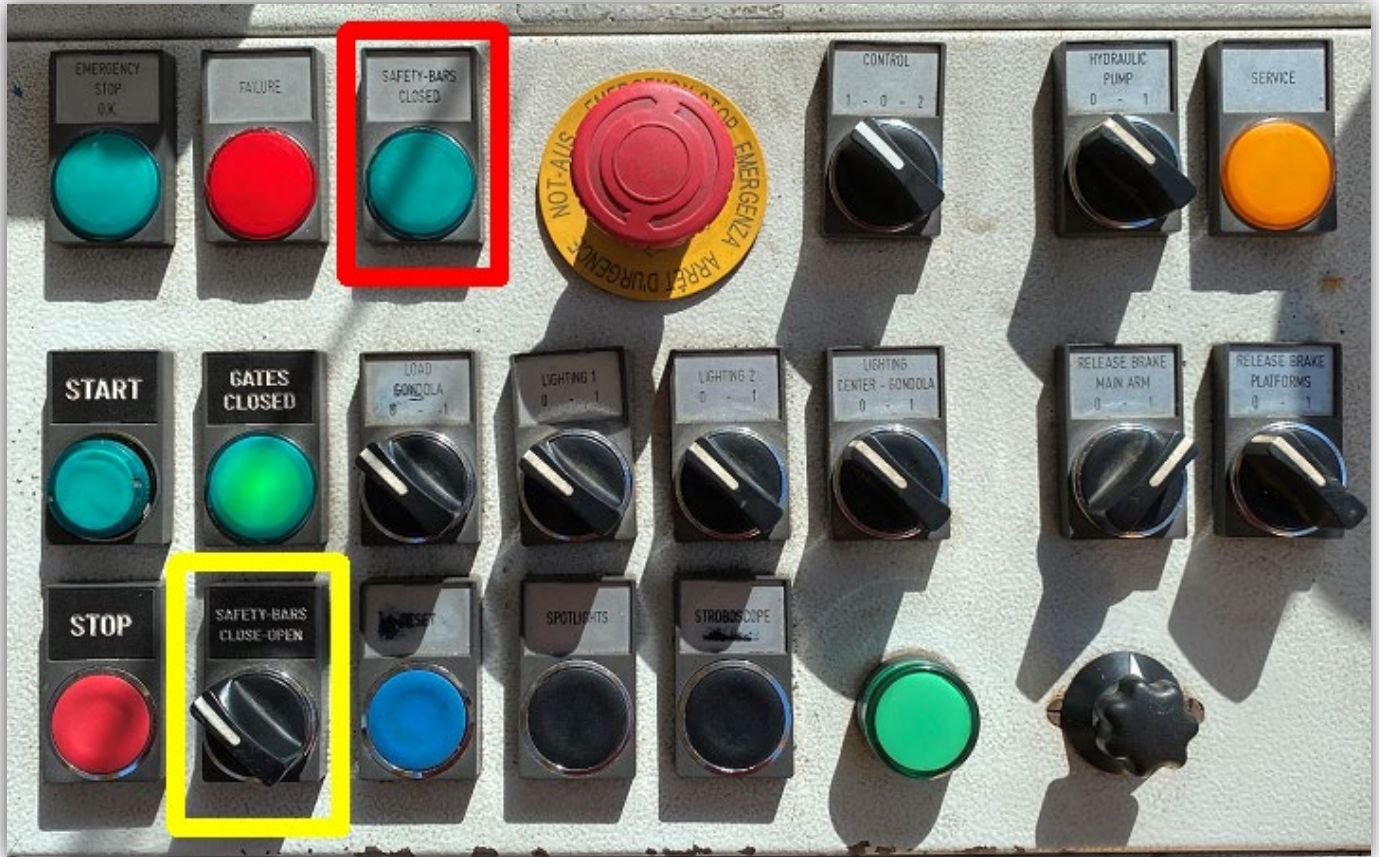
Photo 10 – Ride control center. [YELLOW] switch to operate the safety restraint bars. [RED] the indicator light identifying all safety restraint bars are closed.
