Incident Summary #II-1520328-2023 (#33311) (FINAL)

SUPPORTING INFORMATION	Incident Date	March 9, 2023	
	Location	Hixon	
	Regulated industry sector	Gas - Natural gas system	
	Impact	Qty injuries	3
		Injury description	Three individuals within an industrial building were taken to hospital for possible carbon monoxide poisoning. One individual collapsed on site, one individual suffered dizziness and nausea, and one was examined for precautionary measures.
		Injury rating	Moderate
	Damage	Damage description	N/A
		Damage rating	None
Incident rating	Moderate		
Incident overview	A newly built, gas-fired dry kiln produced a high concentration of carbon monoxide which led to carbon monoxide exposure to multiple individuals.		
INVESTIGATION CONCLUSIONS	Site, system and components	<p>Industrial Sawmill:</p> <ul style="list-style-type: none"> A sawmill, or lumber mill is a facility where logs are cut into lumber. Modern sawmills use a motorized saw to cut logs lengthwise to make long pieces, and crosswise to length depending on standard or custom sizes then the lumber is dried inside a kiln. <p>Lumber Dry Kiln:</p> <ul style="list-style-type: none"> Fresh-cut raw lumber is loaded onto open ra

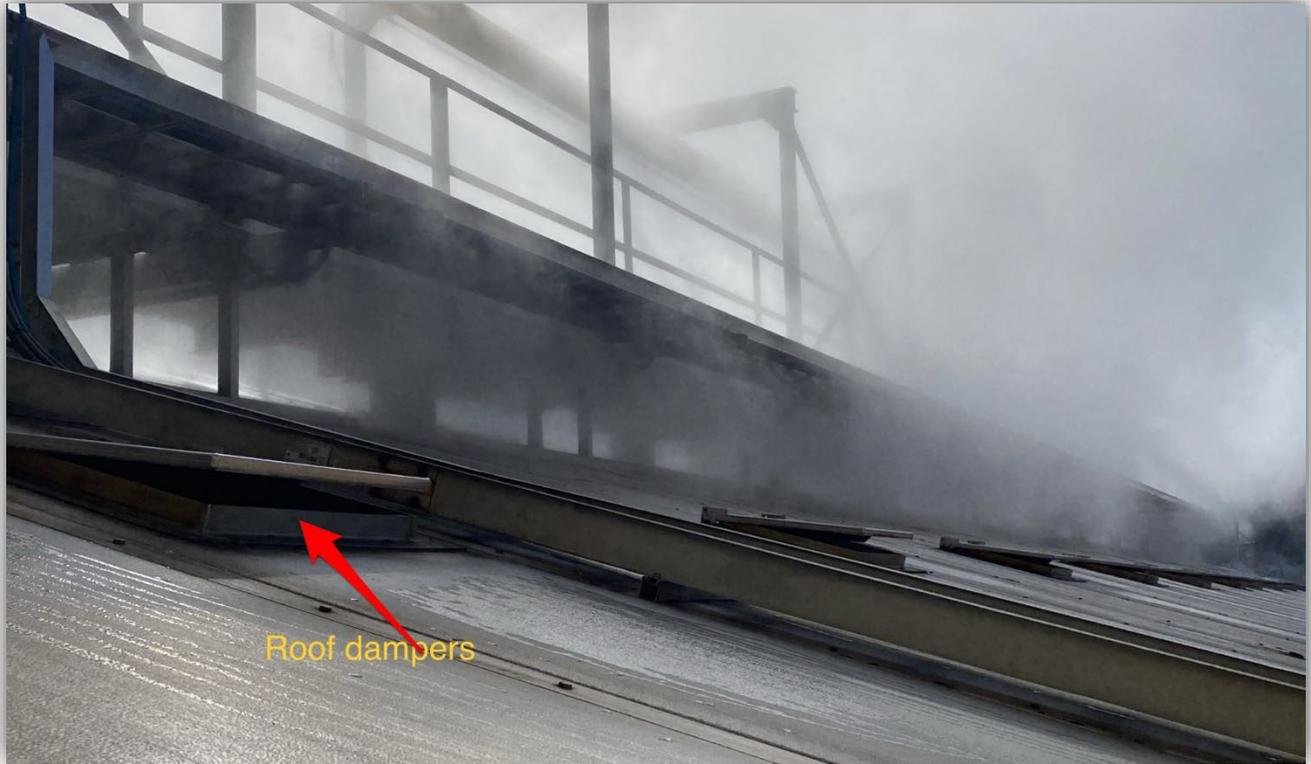
Image 2 – Red arrow showing adjustable vent dampers on the roof of the kiln.

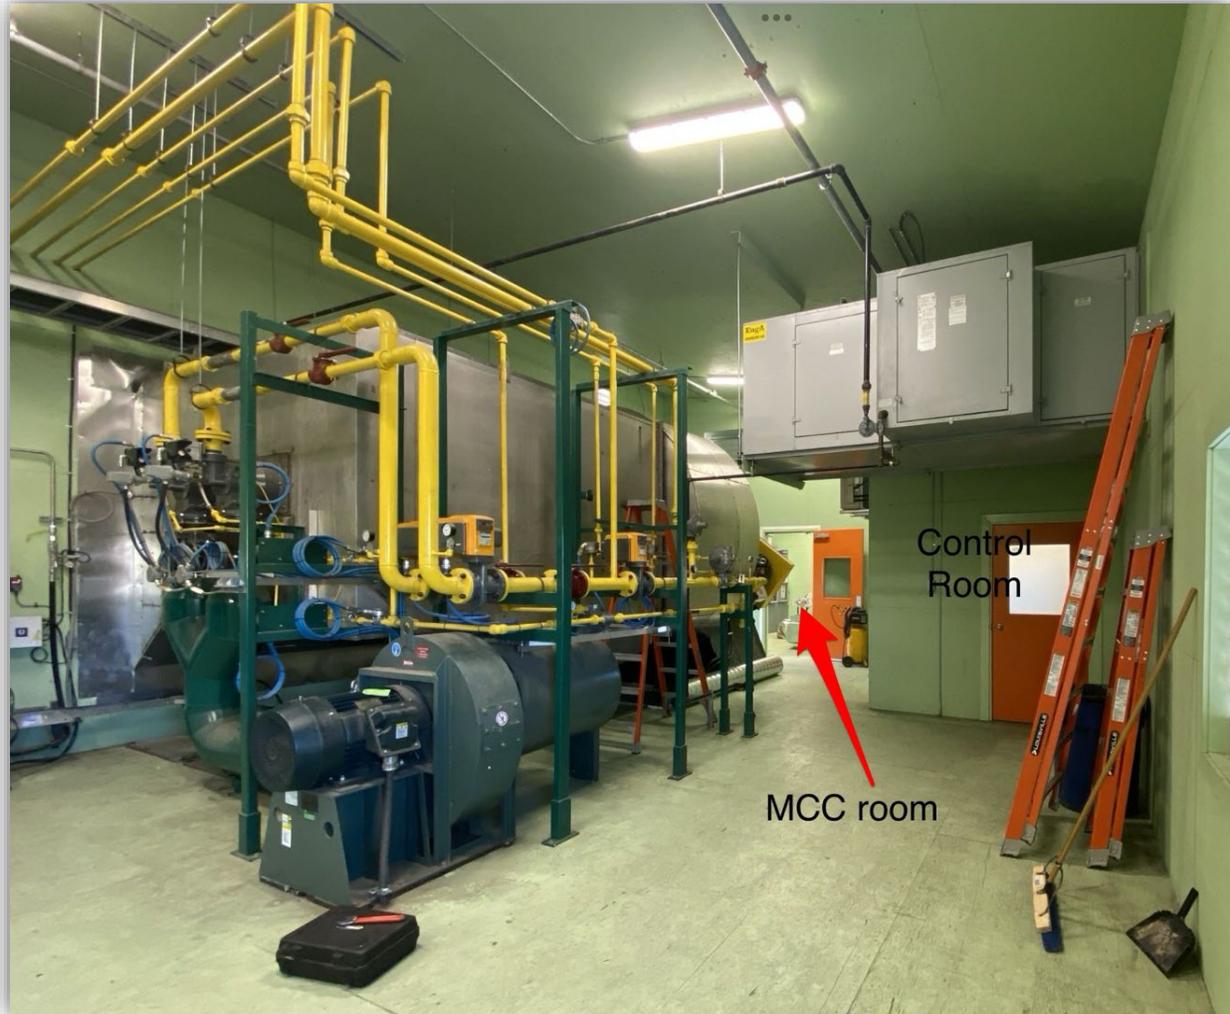
Image 3 – Kiln burner, control room and motor control room adjacent to lumber kiln.

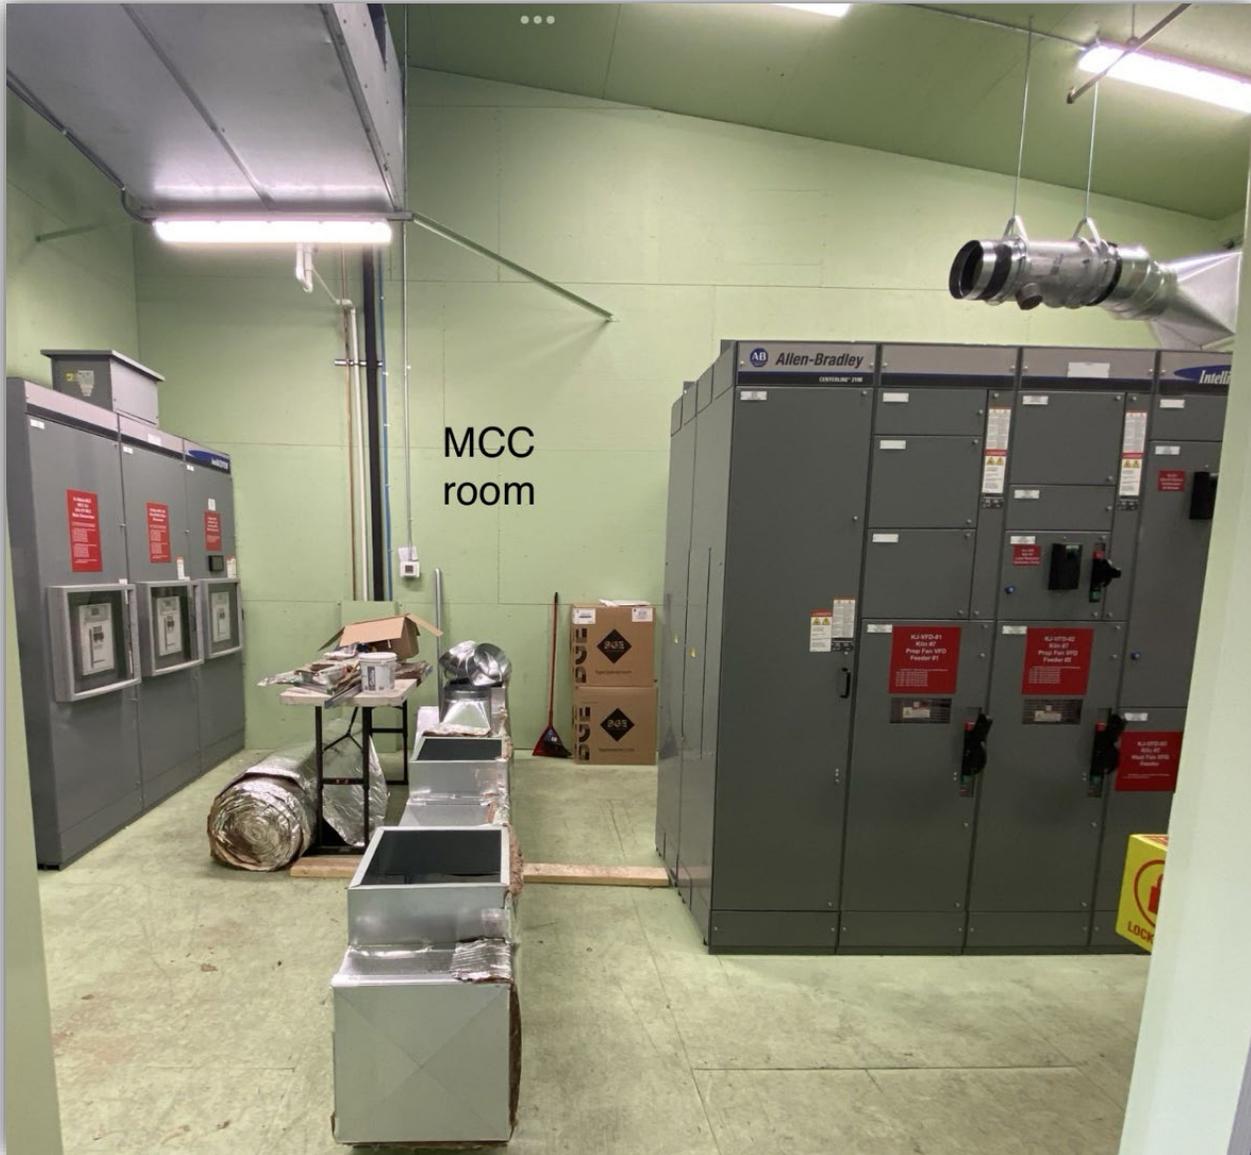
Image 4 – Electrical motor control room two of the workers were in when they were exposed to CO.

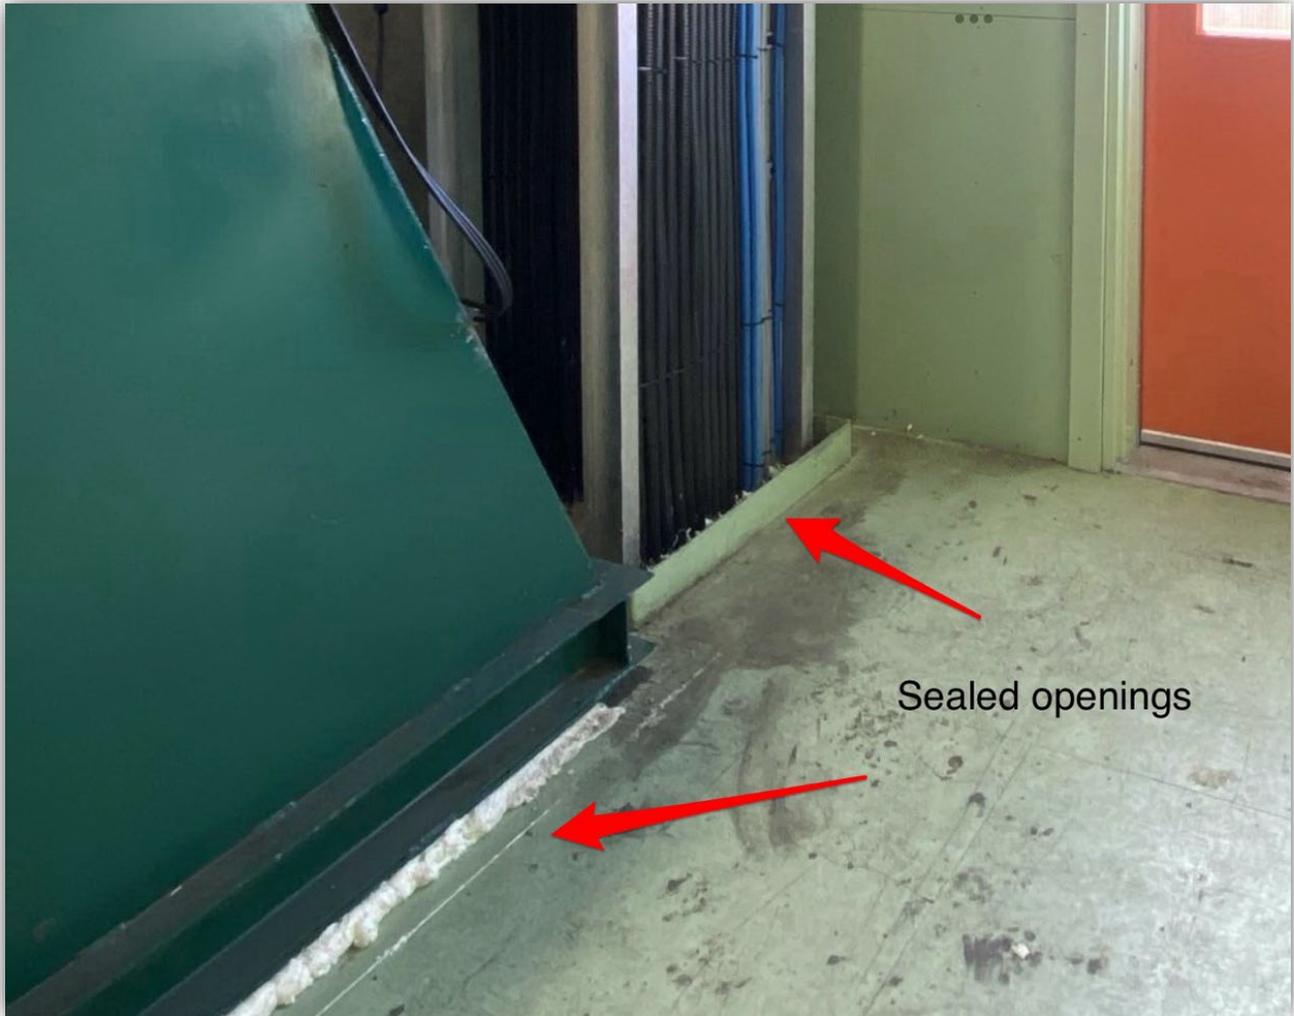
<p>Causes and contributing factors</p>	<p>The incident was caused by the dangerous levels of carbon monoxide being produced by incomplete combustion and entering occupied spaces through unsealed openings throughout the space.</p> <p>Contributing factors to the incident include:</p> <ul style="list-style-type: none"> • The operation of the kilns with the vents not allowing for sufficient venting of steam and products of combustion. • No O₂ or CO sensors in the kiln to monitor for safe operation. • No O₂ or CO sensors installed in the occupied workspaces to monitor for personal safety.

Image 5 – Openings in occupied space CO may have entered through that were sealed after the incident.
