Incident Summary (#5610850)

SUPPORTING INFORMATION	Incident Date			January 9, 2016
	Location			Panorama Mountain
	Regulated industry sector			High Voltage Electrical System
	Impact	Injury	Qty injuries	None
			Injury description	N/A
			Injury rating	N/A
		Damage	Damage description	Three 65E High Voltage fuses blew at the Main High Voltage Switch. The 500KVA 25/14.4KV to 120/208V pad mounted transformers oil pressure relief valve discharged, signalling an internal fault.
			Damage rating	Minor
		Incident rating		
Incident overview			A fault occurred in the 500KVA Transformer which caused the overpressure in the transformer oil tank to operate the oil pressure relief valve, also at the same time the High Voltage Primary 65E Fuses ahead of this transformer blew in the High Voltage Switch Gear de-energizing the electrical system.	
INVESTIGATION CONCLUSIONS	Site, system and components			When there is an internal fault on an oil filled transformer the operation of the pressure relief valve signals an internal mechanical failure. The draw-out bay-o-net 18C fuses at the transformer would not react as fast as the 65E primary fuses, these primary fuses would blow or react protecting the syst

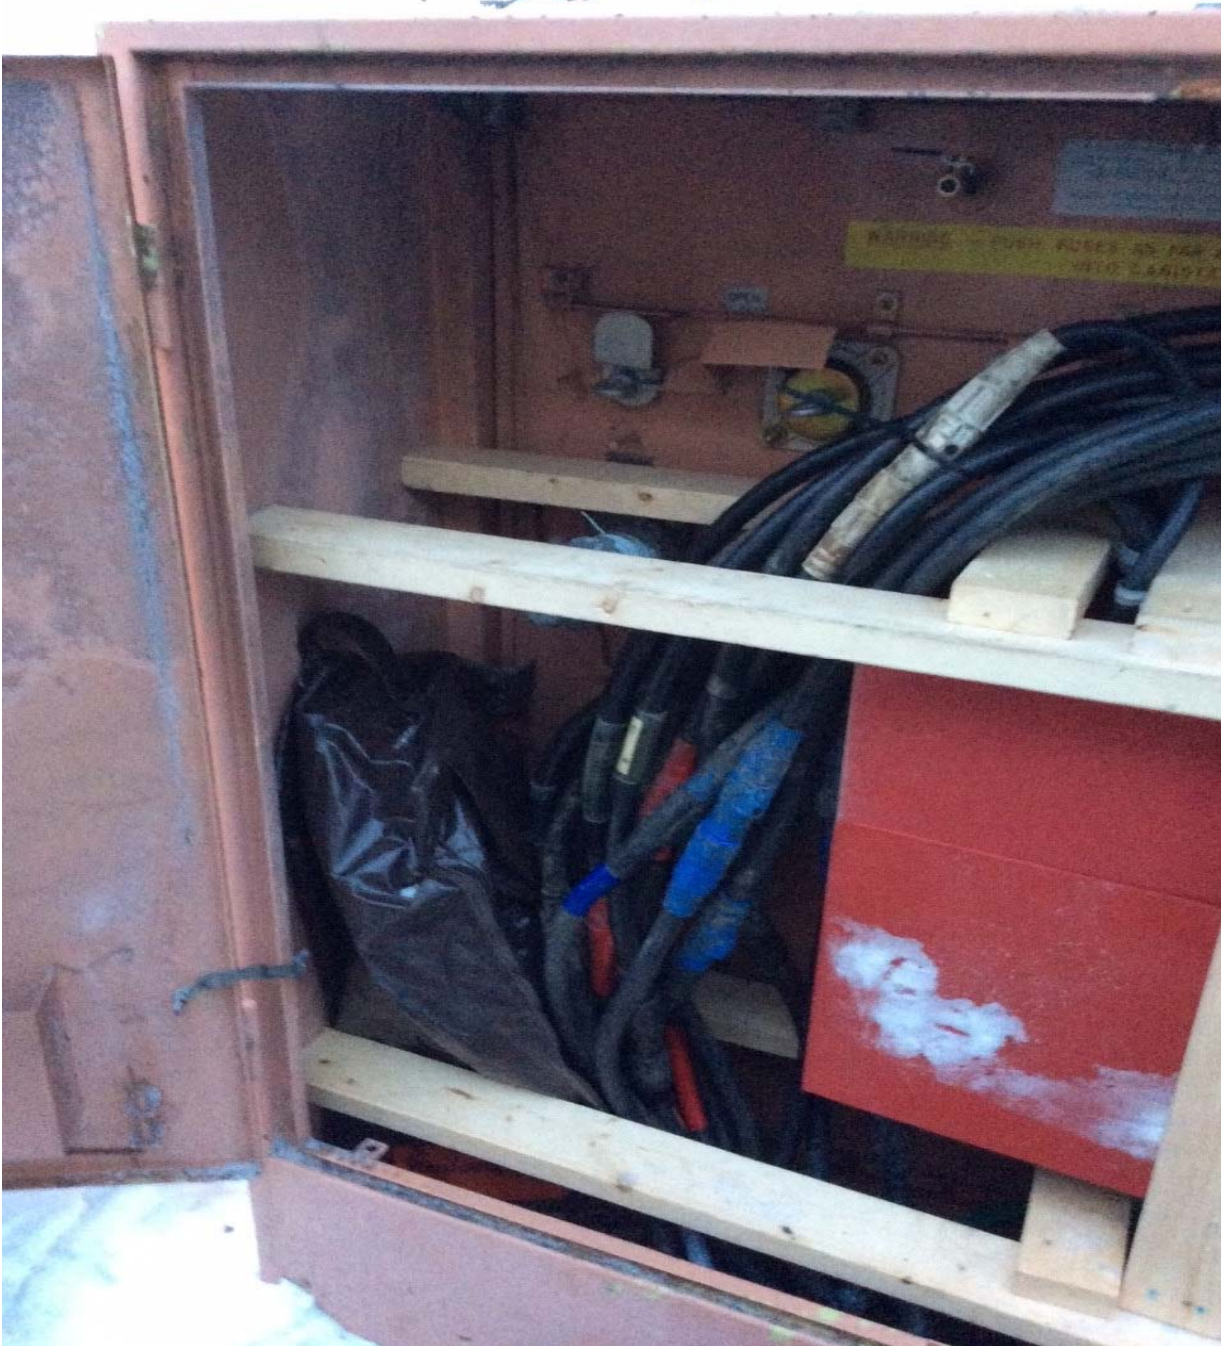
Transformer Compartment, High Voltage connections removed and Low Voltage Connection isolated for temporary Generator connection.

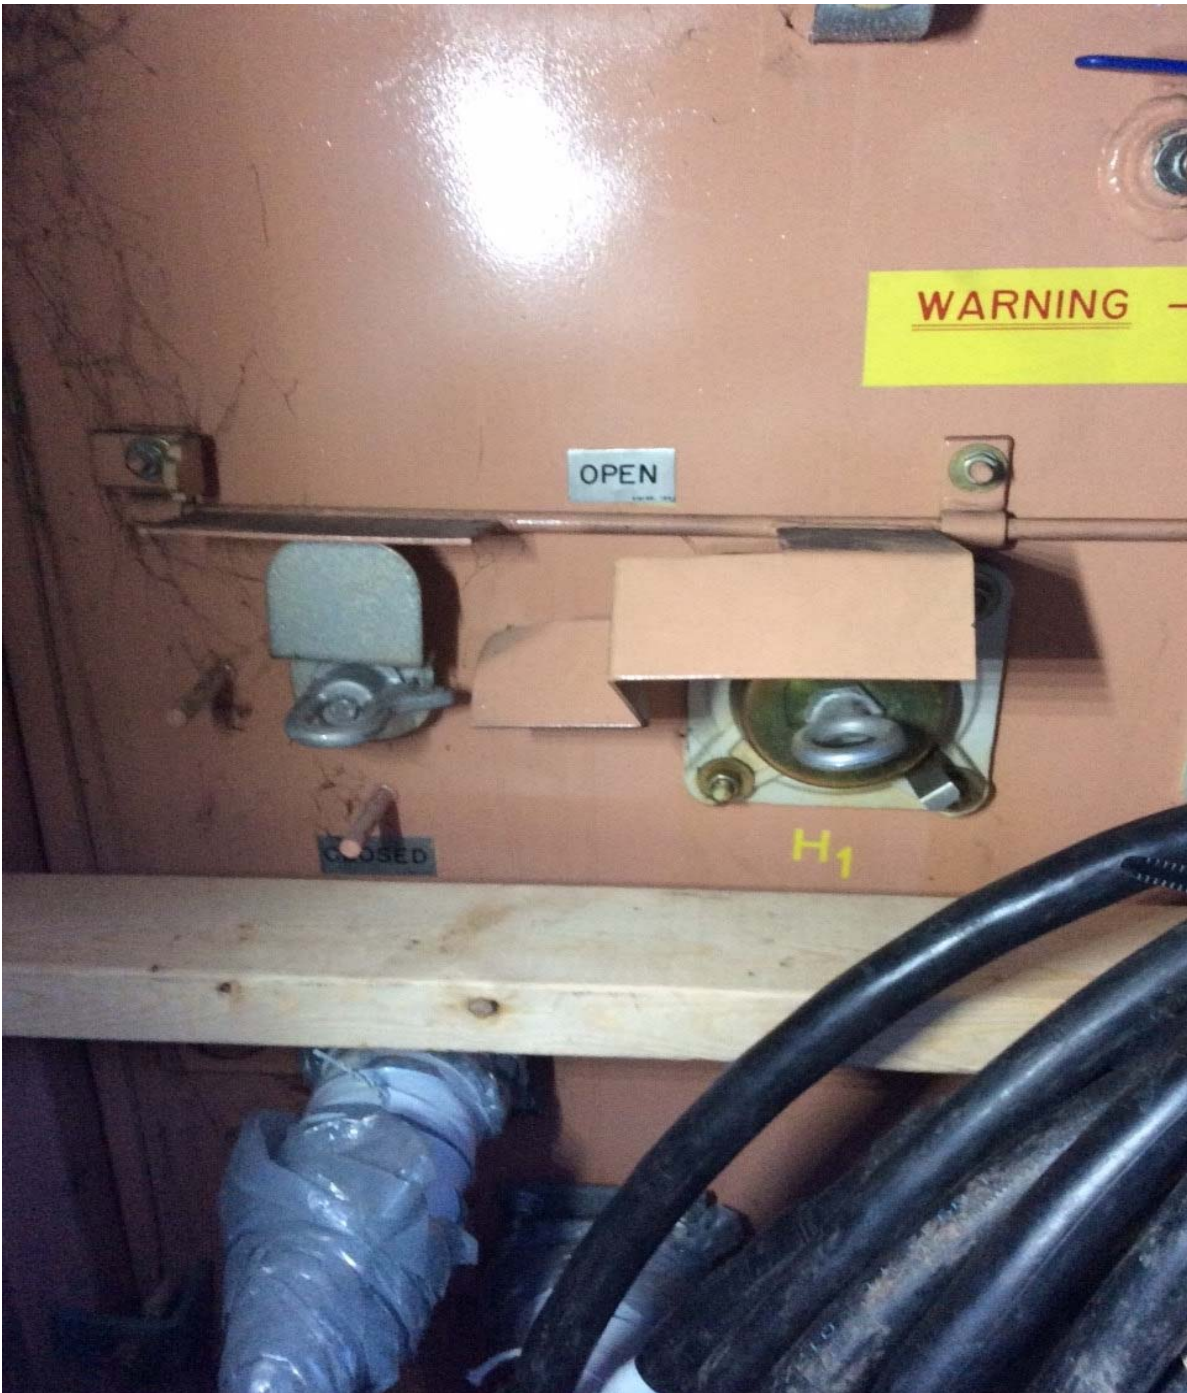
Close up of the High Voltage H1 connection to the draw out bay-o-net fuse.

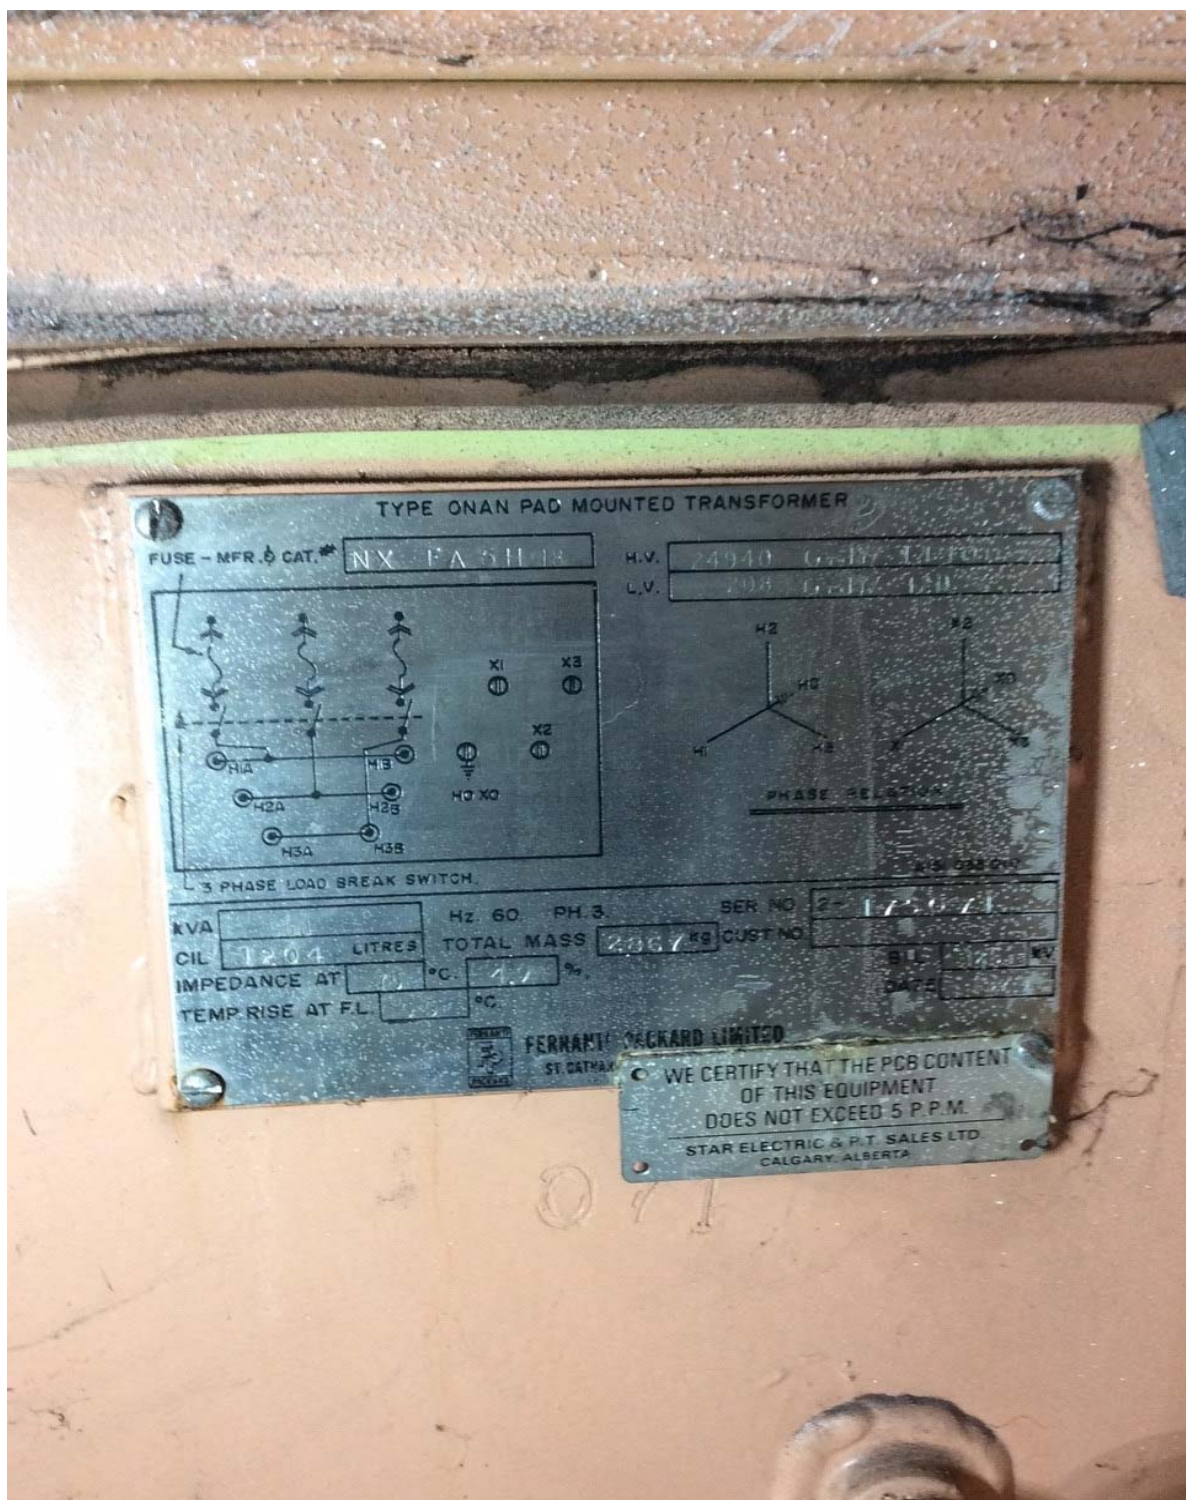
Causes and contributing factors	<p>The 500KVA transformer was manufactured in 1978 and used previously elsewhere, it was brought to its present location in the late 1990's to replace the old transformer, as a used product there is no information to indicate if the transformer was reconditioned before re-use.</p> <p>Oil samples indicated that there where issues developing and the transformer would eventually need to be replaced.</p>
--	---------------------------------	---

Name Plate of the blown Transformer.

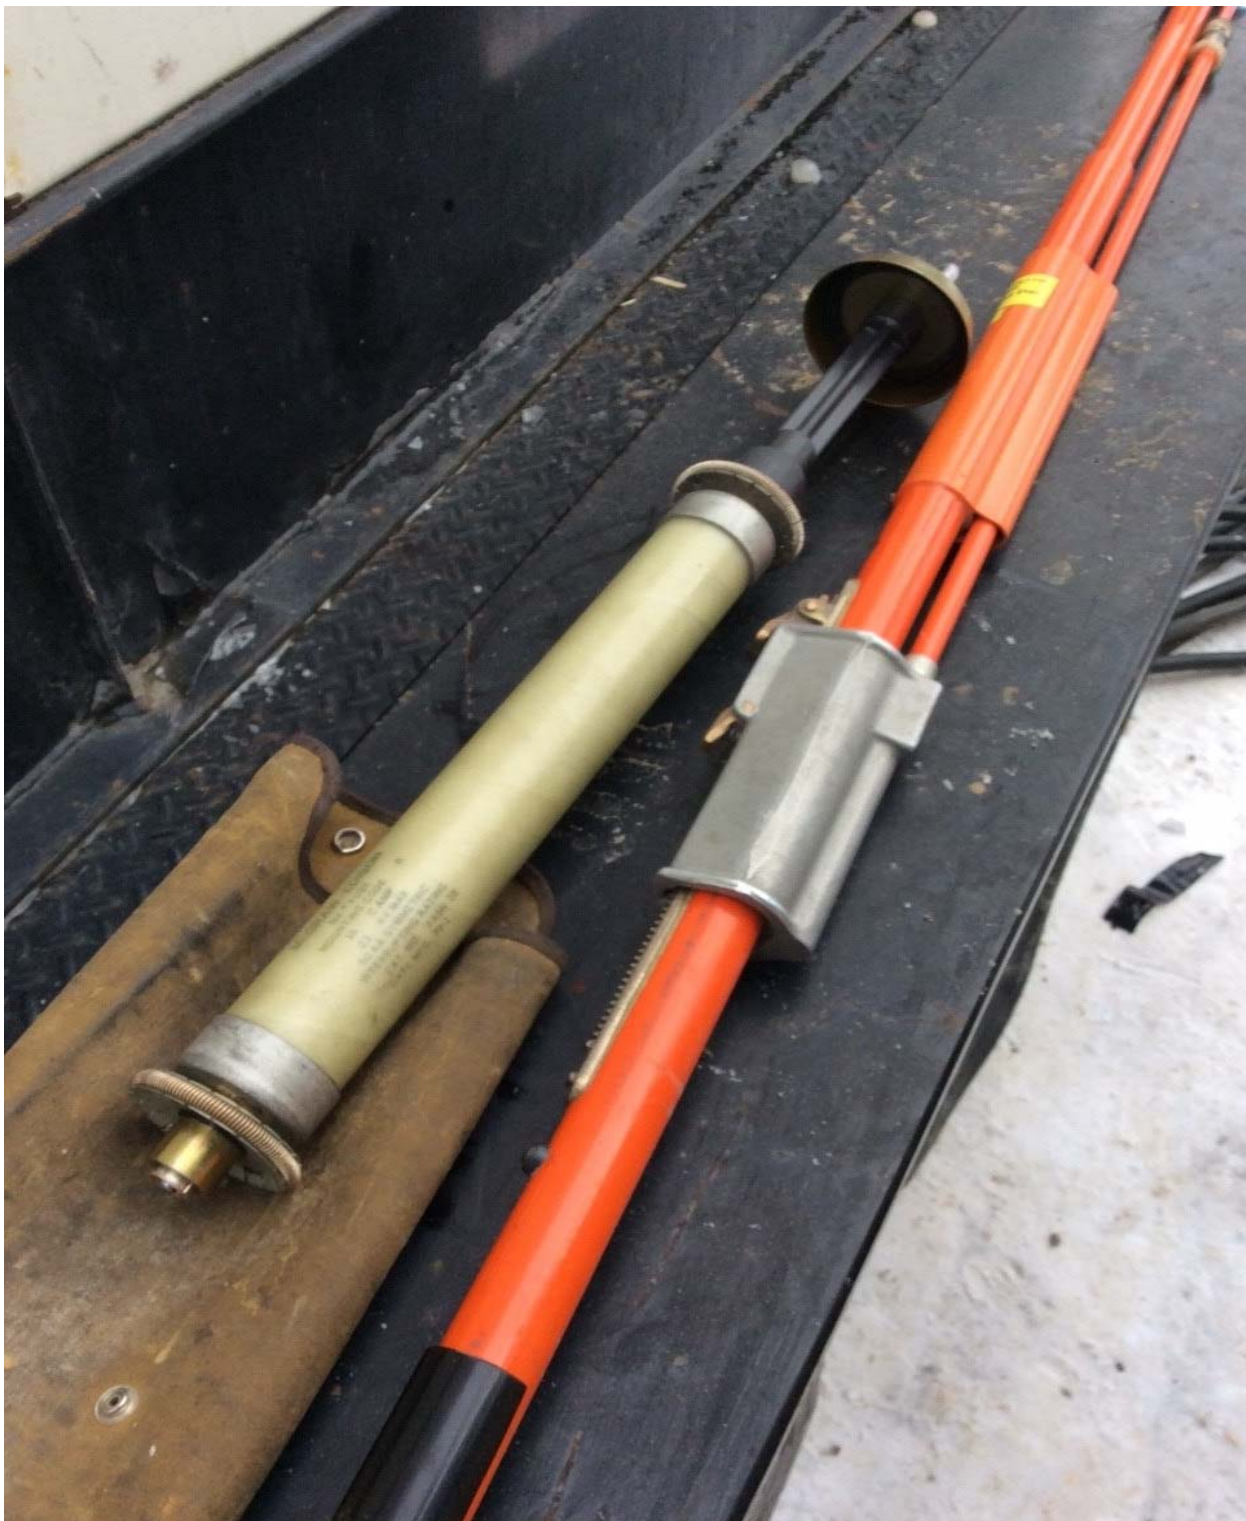
View of Bay-O-Net fuse pulled out of the H1 connection point.

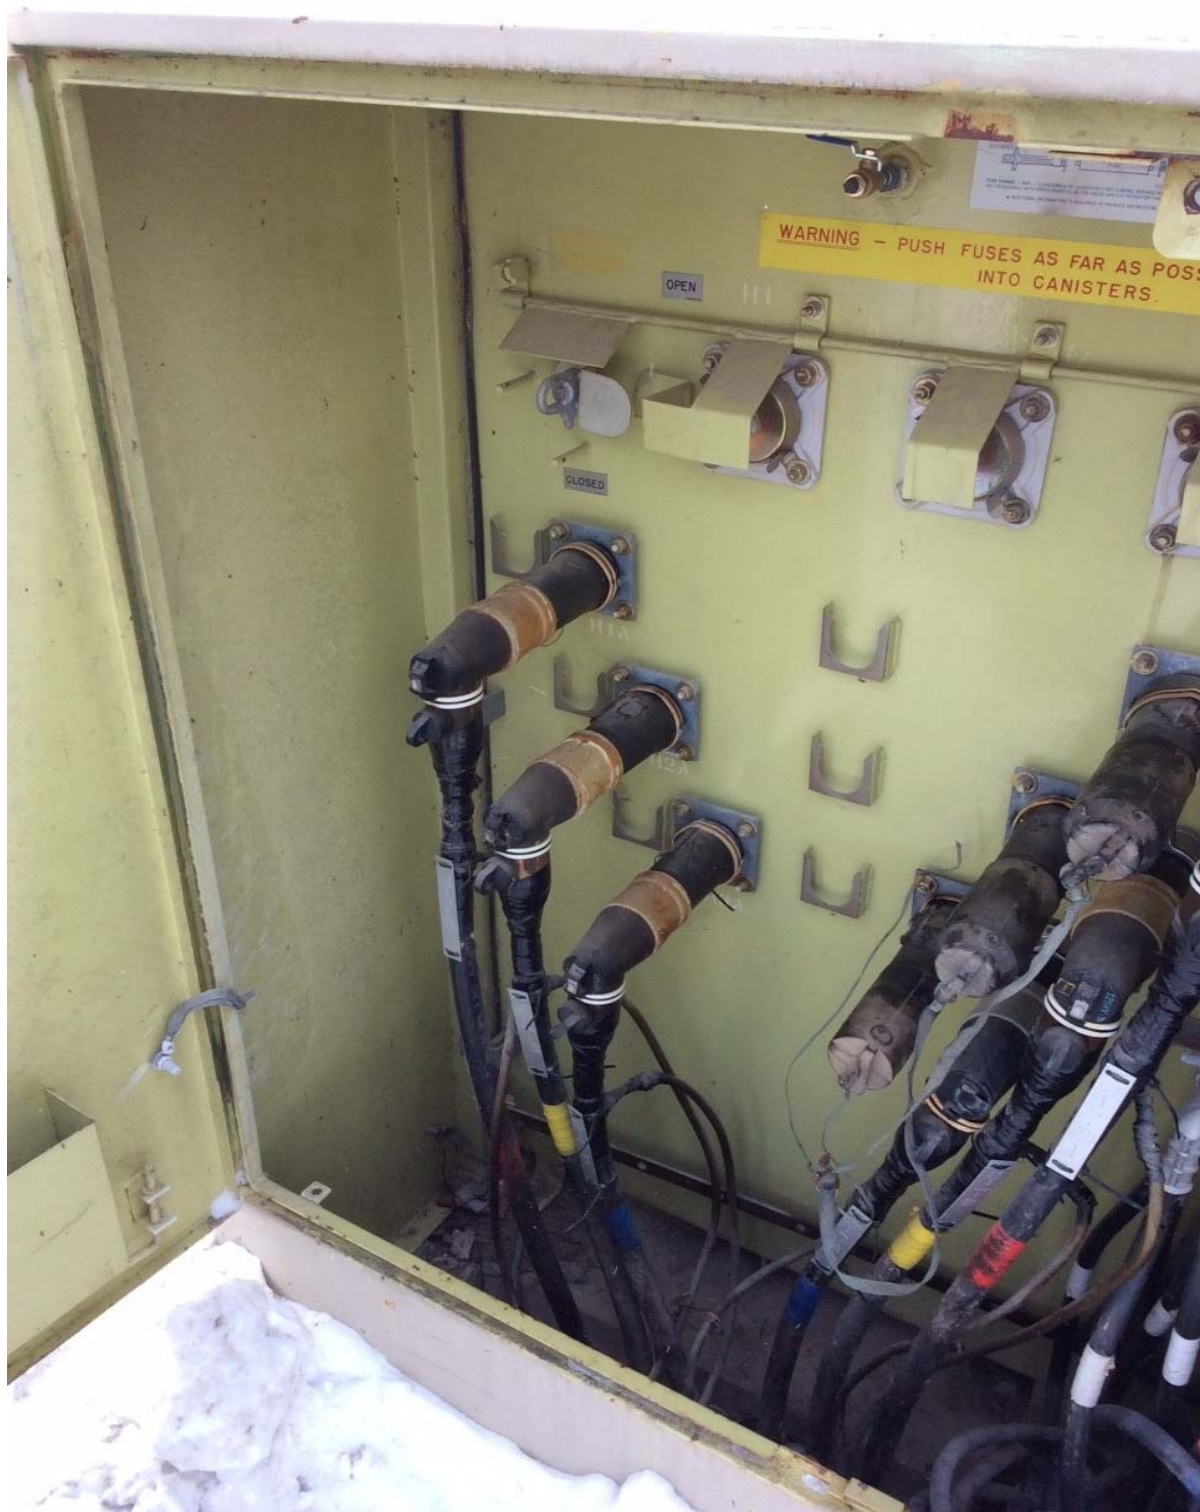
High Voltage connection parked in approved location at the 500KVA Transformer upstream from the blown 500KVA Transformer.
