## Incident Summary #II-1726846-2024 (#48017) (FINAL)

SUPPORTING INFORMATION	Incident Date		June 11, 2024
	Location		Terrace, BC
	Regulated industry sector		Gas
	Impact Injury	Qty injuries	0
		Injury description	N/A
		Injury rating	None
	Damage	Damage description	Furnace condensate corroded through a black iron gas pipe, leading to an uncontrolled release of natural gas.
		Damage rating	Moderate
	Incident rating		Moderate
Incident overview		Corrosive condensate from a high-efficiency furnace in a home was allowed to leak directly onto a black iron gas pipe located in a home's crawlspace. The condensate corroded a hole through the gas pipe, causing an uncontrolled release of natural gas.	
INVESTIGATION CONCLUSIONS	Site, system and components	<p>A black iron pipe conveys low-pressure natural gas from the gas meter, through the crawl space, to a high-efficiency natural gas furnace.</p> <p>A high efficiency condensing natural gas furnace provides heat throughout the dwelling. The furnace utilizes two heat exchangers: a primary heat exchanger, which extracts initial combustion heat, and a secondary heat exchanger, which further extracts heat from exhaust gases.</p> <p>As exhaust gases

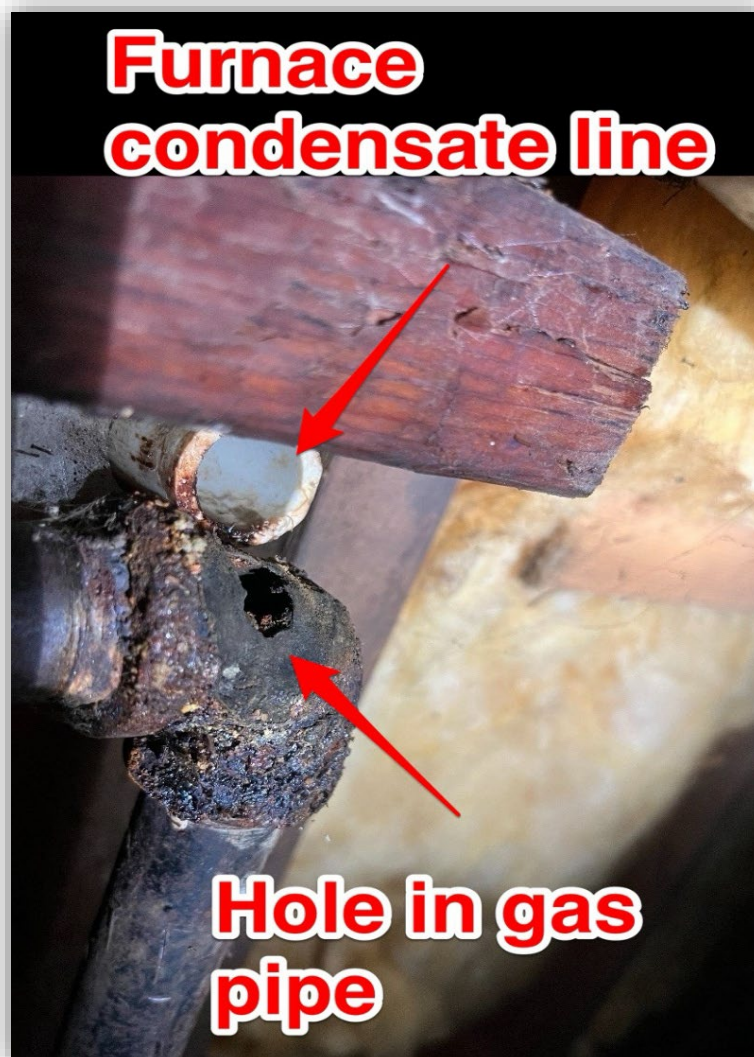
Failure scenario(s)	The furnace condensate drainpipe was routed from the furnace, down through the floor, and into the crawlspace, but was not terminated into a designated wastewater pipe. Instead, the highly acidic condensate discharged directly onto a black iron gas pipe, causing the pipe to deteriorate over time and ultimately resulted in an uncontrolled release of natural gas.

Facts and evidence	<p>A postal worker delivering mail to the residence smelled natural gas and reported it to the local gas utility. Upon arrival, a gas utility technician measured a gas concentration of 14% in the driveway and 39% at the entrance to the crawlspace. Natural gas is explosive at concentrations between 4% Lower Explosive Limit (LEL) and 14% Upper explosive limit (UEL).</p> <p>The gas meter was shut off and the house and crawl space were ventilated. A licensed gas contractor was hired to repair the gas piping system and reroute the furnace condensate drain line.</p>
Causes and contributing factors	<p>The improper installation of the furnace condensate drain caused the corrosion of the black iron piping, resulting in the uncontrolled the uncontrolled release of natural gas into the crawl space.</p>
