Incident Summary #II-873064-2019 (#13812) (FINAL)

| | Incident Date | | June 17, 2019 |
|---|---|---|---|
| | Regulated industry sector | | Elevating devices - Elevator |

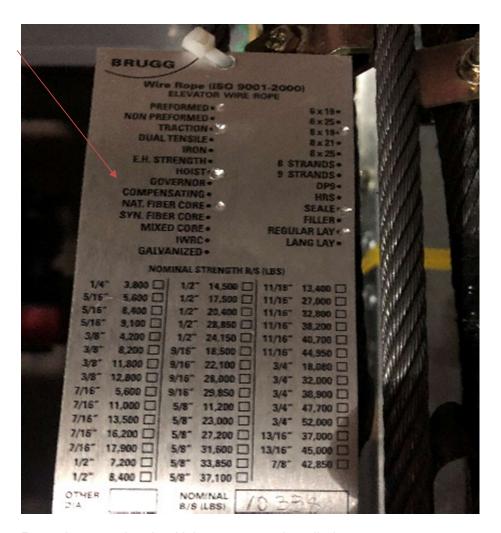
| | Facts and evidence | Via phone and email communications, the elevating contractor stated wrong types of wire ropes were supplied by the manufacturer. Contractor confirmed that no procedure for wire rope tensioning was provided to field installers. Contractor confirmed that they did not have wire rope tension gauge tool. Photos show rope wear and incorrect rope material used at installation. |
|--|---|---|
| | Causes and contributing factors | It is highly probably that the premature failure of the wire ropes and damage to the traction wheel were caused by an incorrect type of wire rope used during initial installation (nylon/fibre vs. steel core) along with inadequate rope tension. |

Rope data tag showing Nylon core rope installed

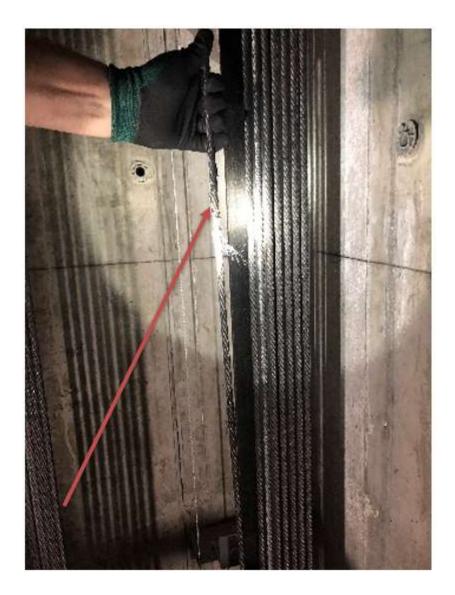
| | Incident Date | | June 17, 2019 |
|---|---|---|---|
| | Failure scenario(s) | | Incorrect wire ropes supplied and installed. An inadequate amount of wire rope tension led to premature wire rope wear and damage to the sheave grooves. |

Premature worn rope

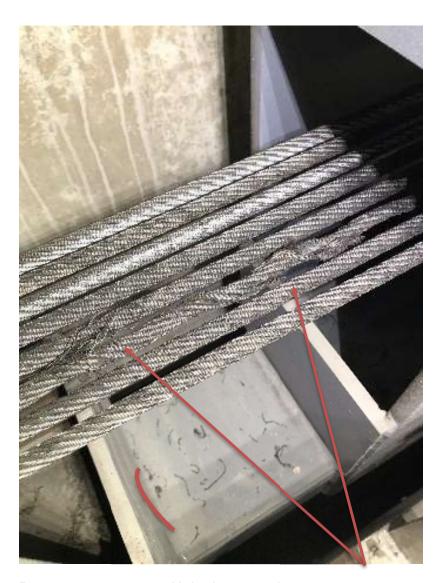
Premature worn rope with broken strands
